Little River Fire Station
Quantitative Engineering
Evaluation

Reference: 228601

Prepared for:
Christchurch City Council

Date: 10 April 2014

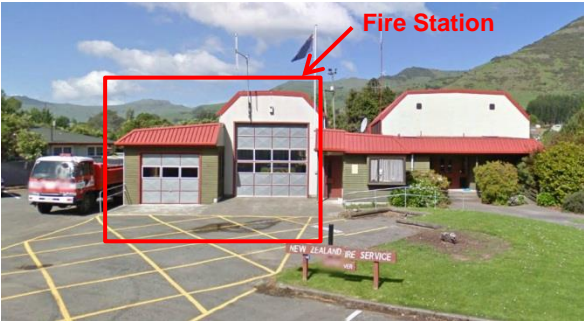
<p>Building western elevation.</p>

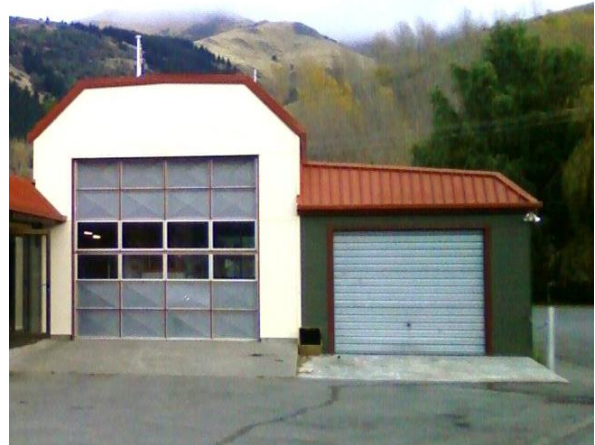
Building eastern elevation.

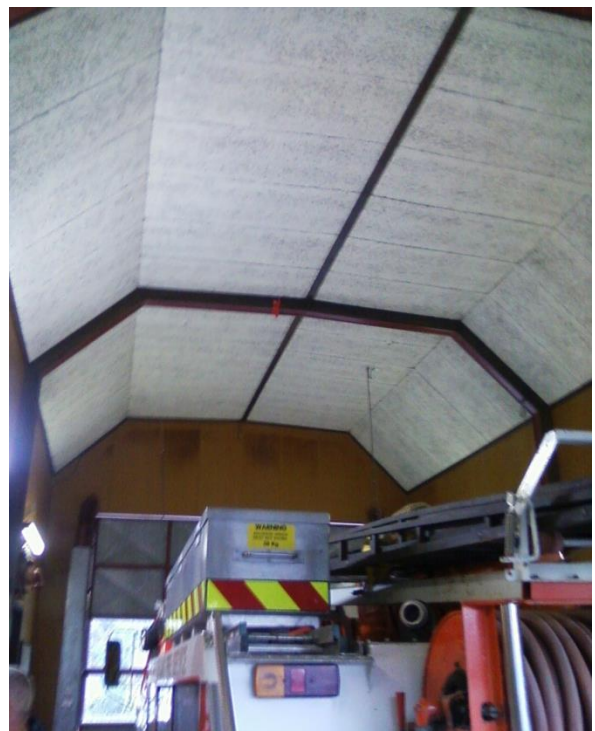
Building internal view.

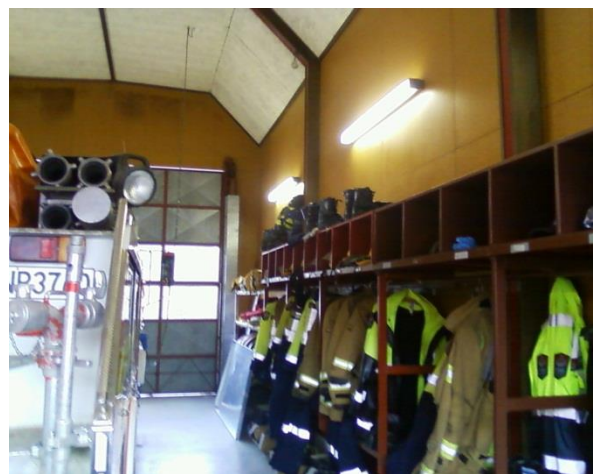
Building internal view.

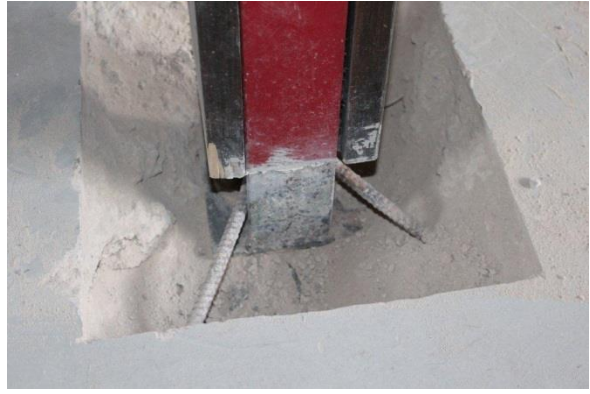
Intrusive investigations were carried out to determine the base fixing details of the steel portal frames and the detailing at the knee joints of the portal frames. The base fixings of the portal frames were found to consist of a base plate with two bolts cast approximately 100mm below finished floor level and a deformed bar approximately 15mm diameter bent in a hairpin shape placed through the web of the UB and cast into the slab. The knee joints were found to have a single stiffener each side of the web with a thickness similar to that of the UB flanges.

Base fixing detail of existing portal frames.

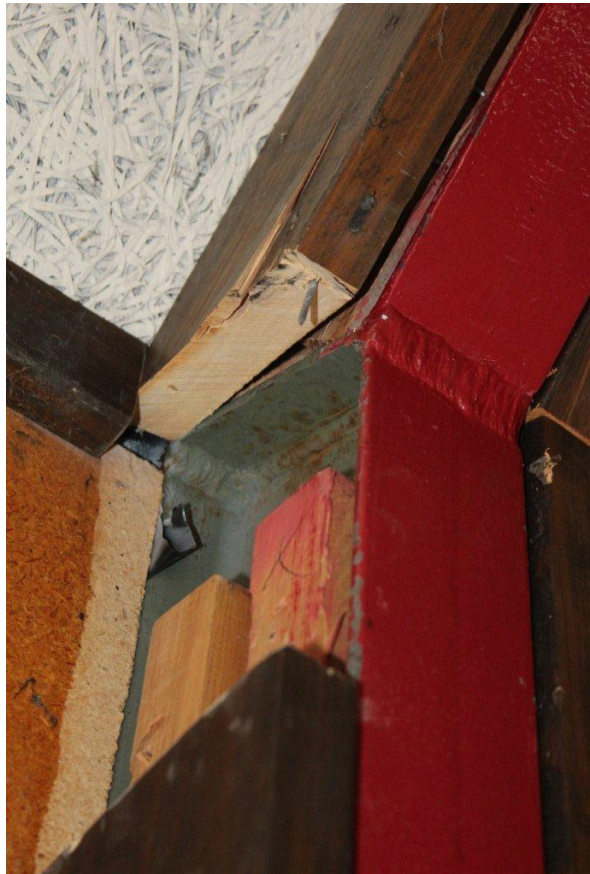
Typical knee joint of existing portal frames.
