**Heritage Park Little
River Office
PRK 3659 BLDG 005 EQ2**

Detailed Engineering Evaluation

Quantitative Assessment Report

Heritage Park Little River Office Quantitative Assessment Report

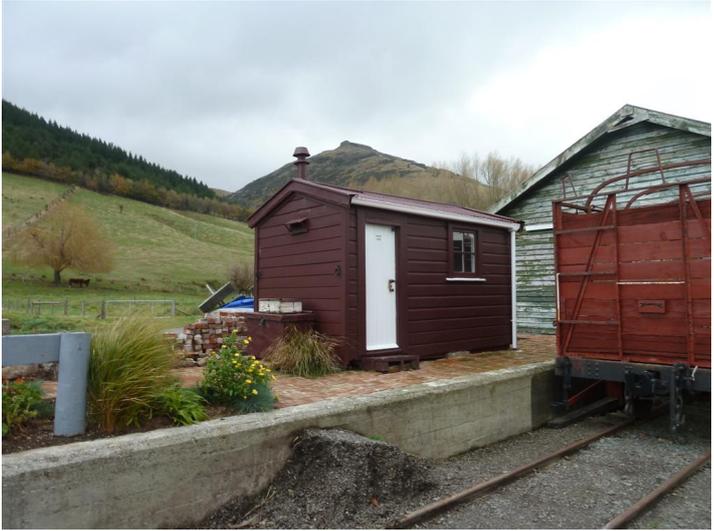
Site Name		
No.	Item description	Photo
1.	Exterior of office building

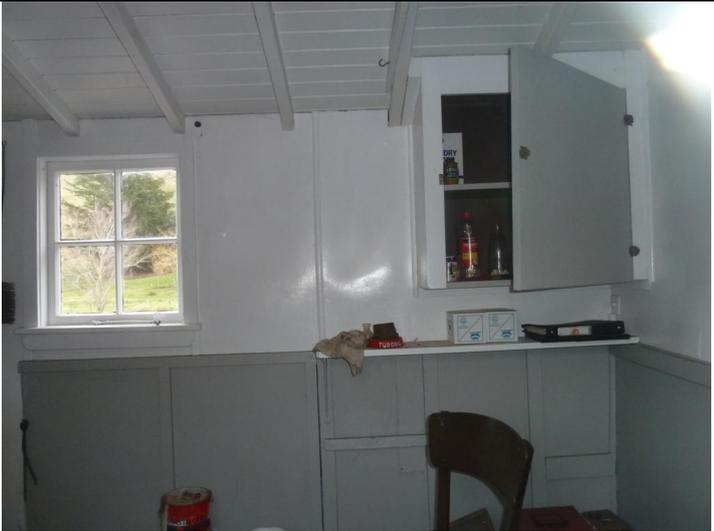
2.	Interior of office building

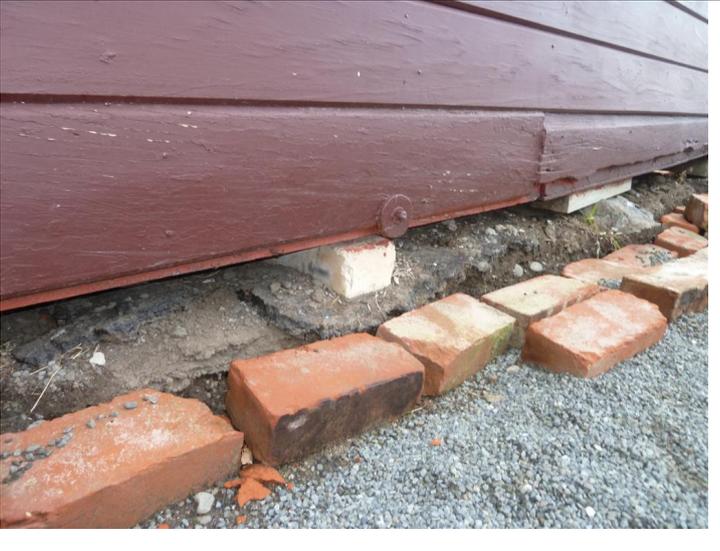
3.	Floor supported on brick packing

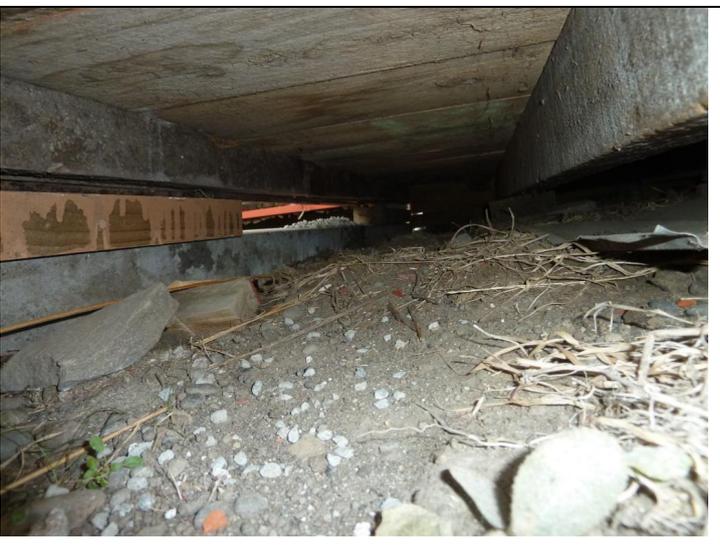
Visual inspection shows that there is no significant connection between bearers and the supporting concrete footings. This is not in accordance with current design codes.

4.	Underside of floor

The foundation connections are non-compliant and CCC may wish to upgrade them. This would increase the seismic capacity of the building to 100%NBS.

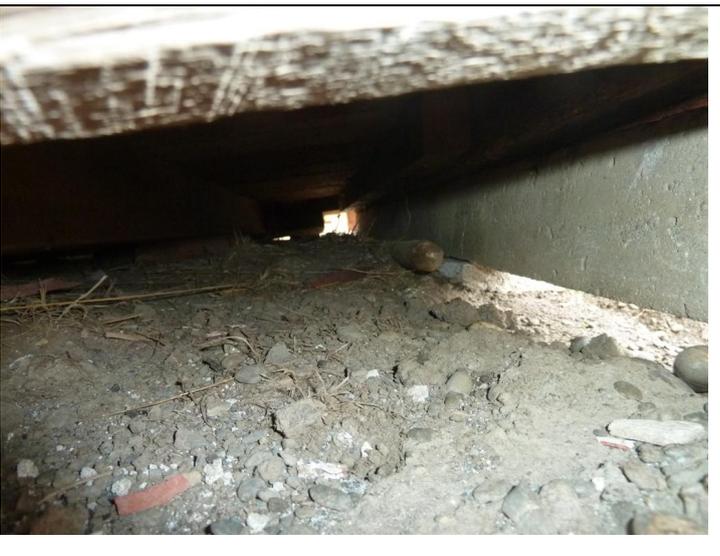
5.	Underside of floor
