Little River Service Centre
Qualitative Engineering Evaluation

Reference: 228602
Prepared for:
Christchurch City
Council

Address: 4236 Christchurch Akaroa Road

Revision: 2
Date: 23 August 2012

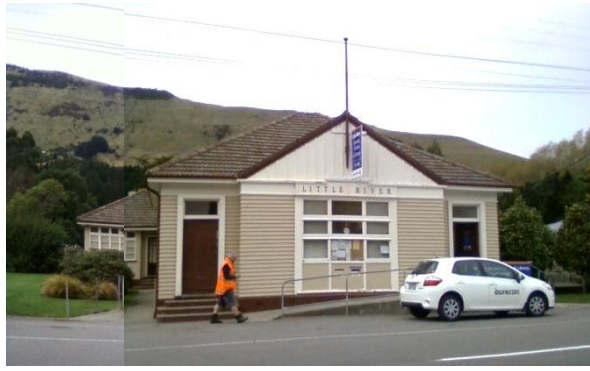
Building western elevation.

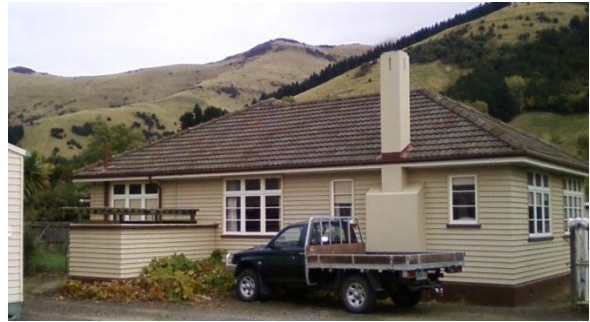
Building eastern elevation.

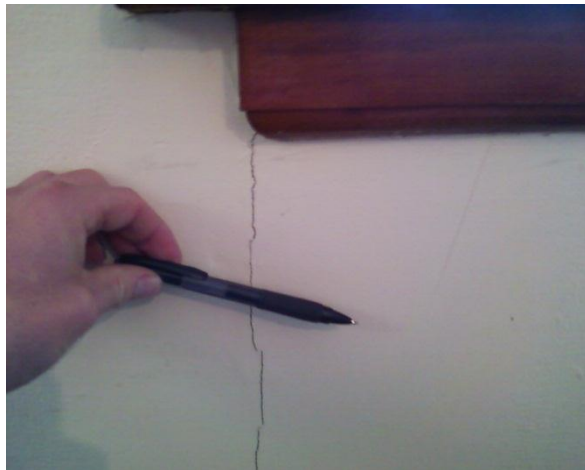
There was only minor observed damage to the Little River Service Centre as a result of seismic actions. This is hardly surprising as buildings of this nature are flexible and have high inherent ductility. Damage to the wall linings is a common occurrence in this type of construction and occurs as plaster board is relatively brittle causing cracks to develop with a limited amount of movement

Minor cracking to internal linings.

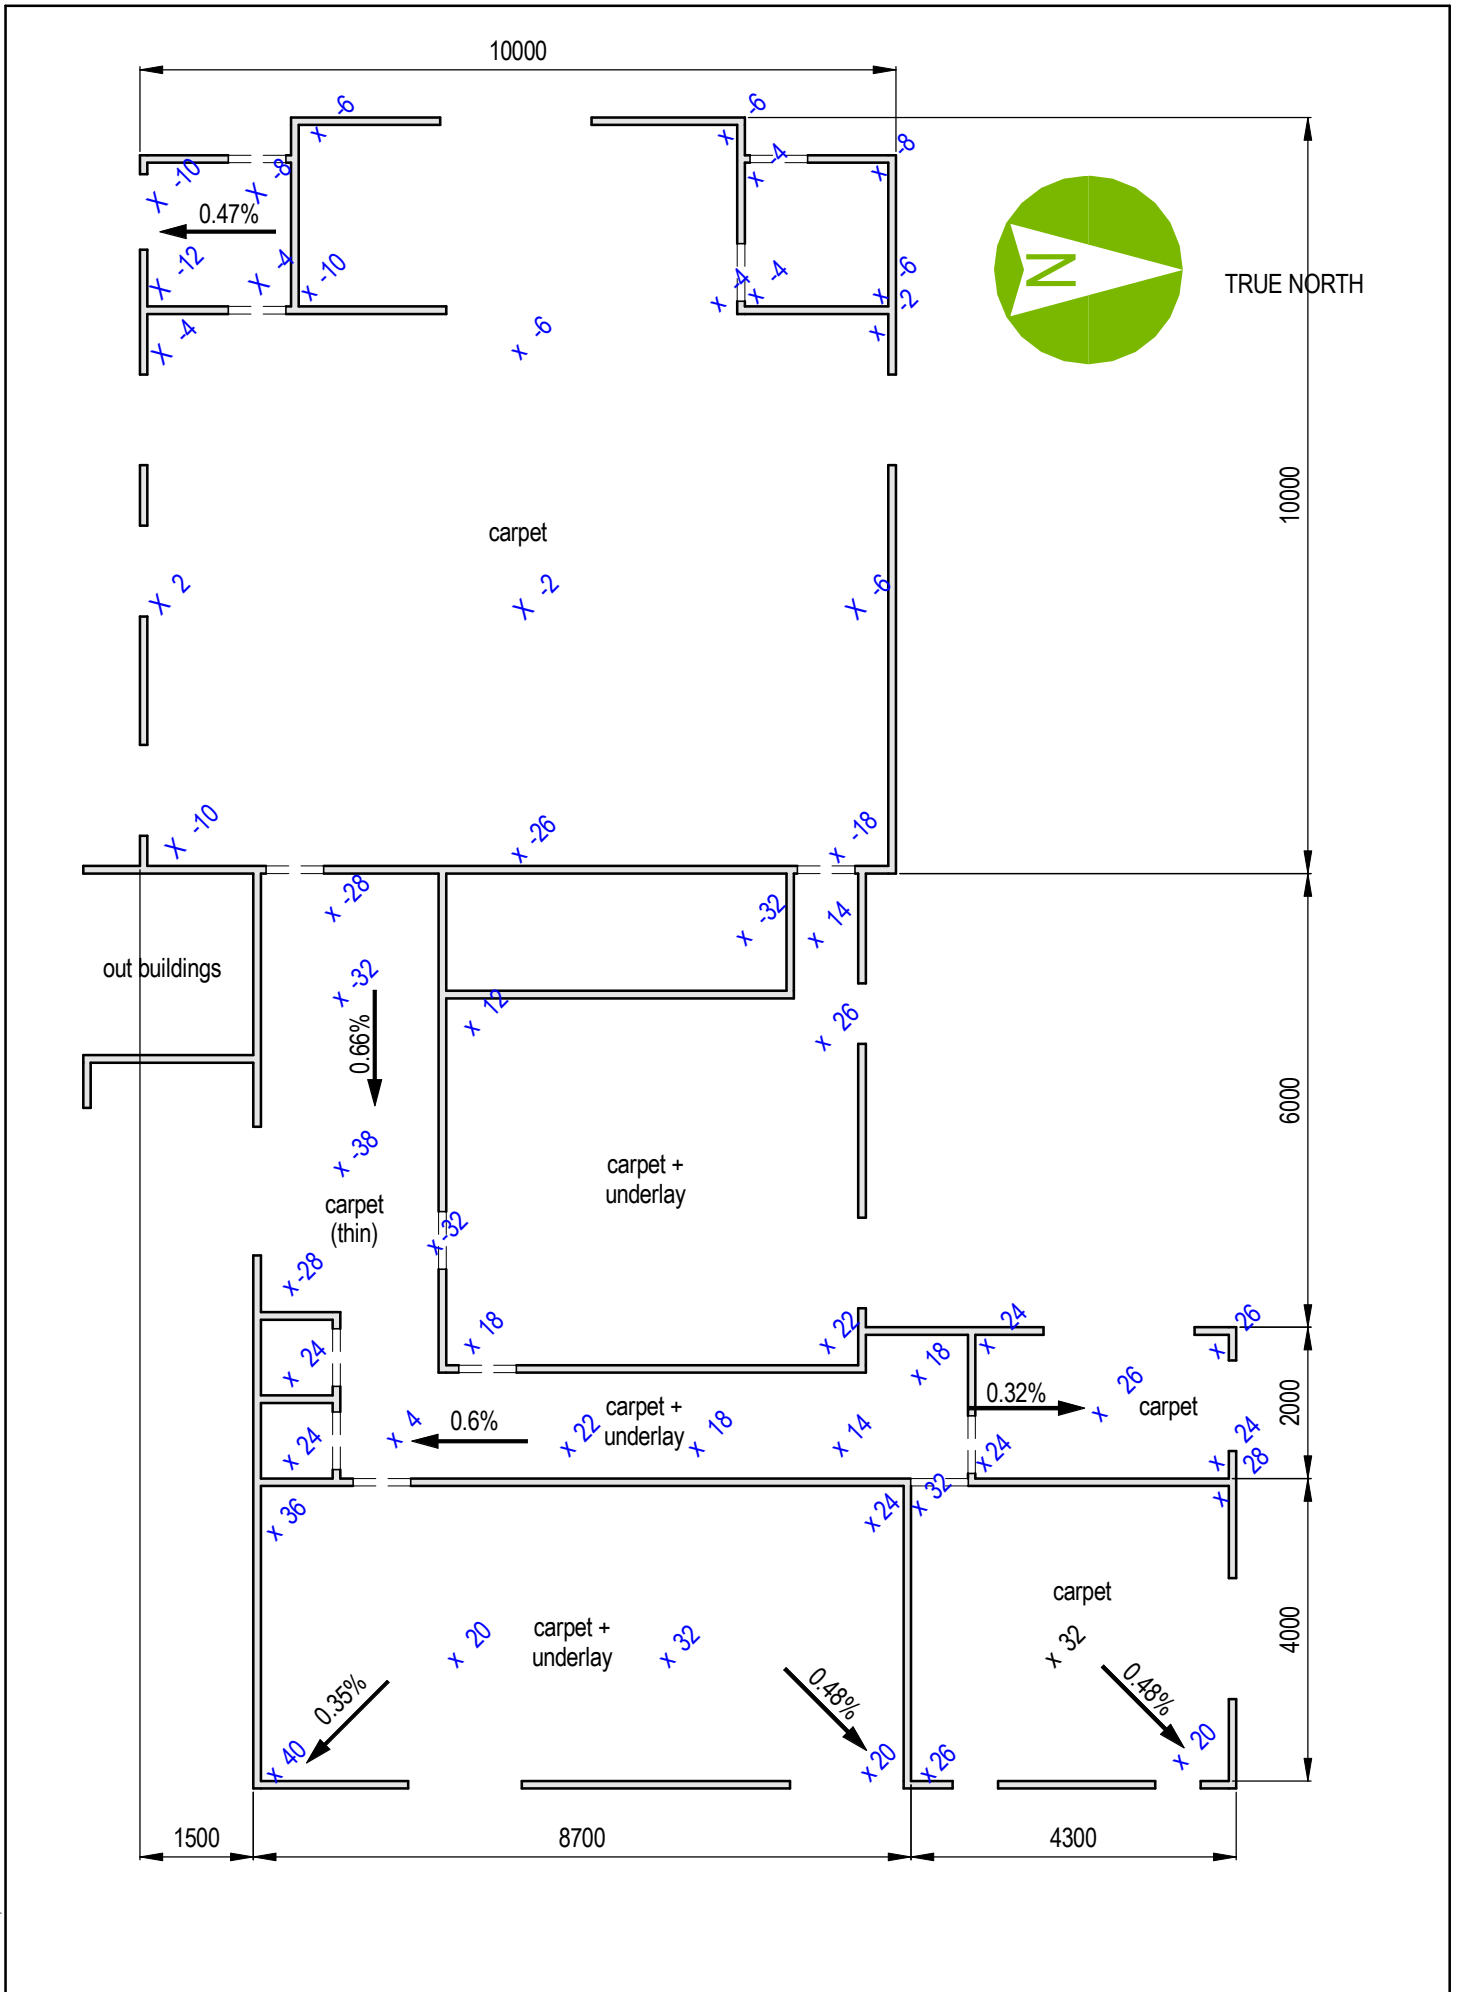
PROJECT
LITTLE RIVER SERVICE CENTRE CANTERBURY
TITLE
FLOOR LEVELS PLAN

We undertook a floor levels survey to establish the amount of settlement that has occurred. The results of the survey are presented on the attached drawings in Appendix A. All of the levels were taken on top of the existing floor coverings which will have introduced some variation.

The floor levels for the Little River Service Centre were found to be within acceptable levels once variations resulting from differing floor coverings are taken into account.
