Haybarn
PRK 2561 BLDG 005
Detailed Engineering Evaluation
Qualitative Report
Version Final

75 Lower Styx Road, Bottle Lake

Christchurch City Council

Date
15th May 2013

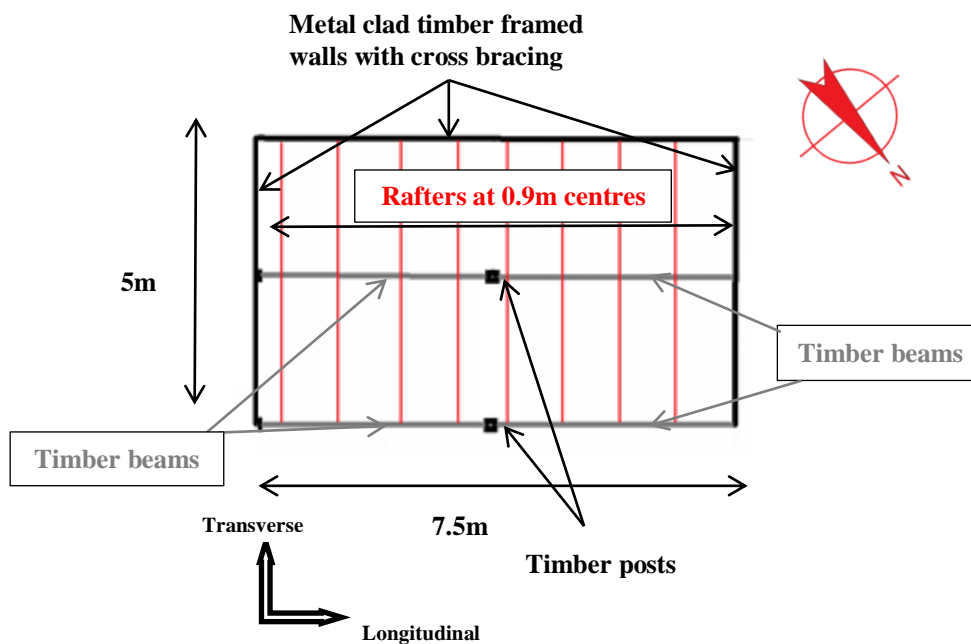
Figure 2 Plan Sketch Showing Key Structural Elements

The building is of timber frame construction. The roof of the building is corrugated iron on timber purlins. The spacing of the purlins is 0.9m centres as indicated in Figure 2. The timber purlins rest on the timber framed walls to the south-west and timber beams along the north-east side of the building. Intermediate support is provided by the central timber beams as shown in Figure 2. External walls along the north-west, south-west and the south-east are timber framed with metal cladding to the exterior and no internal linings. The north-east side of the building is open with a timber post providing support for the timber beams. There is no floor system in this building. Foundations are concrete strip footings to the north-east, south-east and the south-west perimeter. The timber posts are supported by concrete pile foundations.

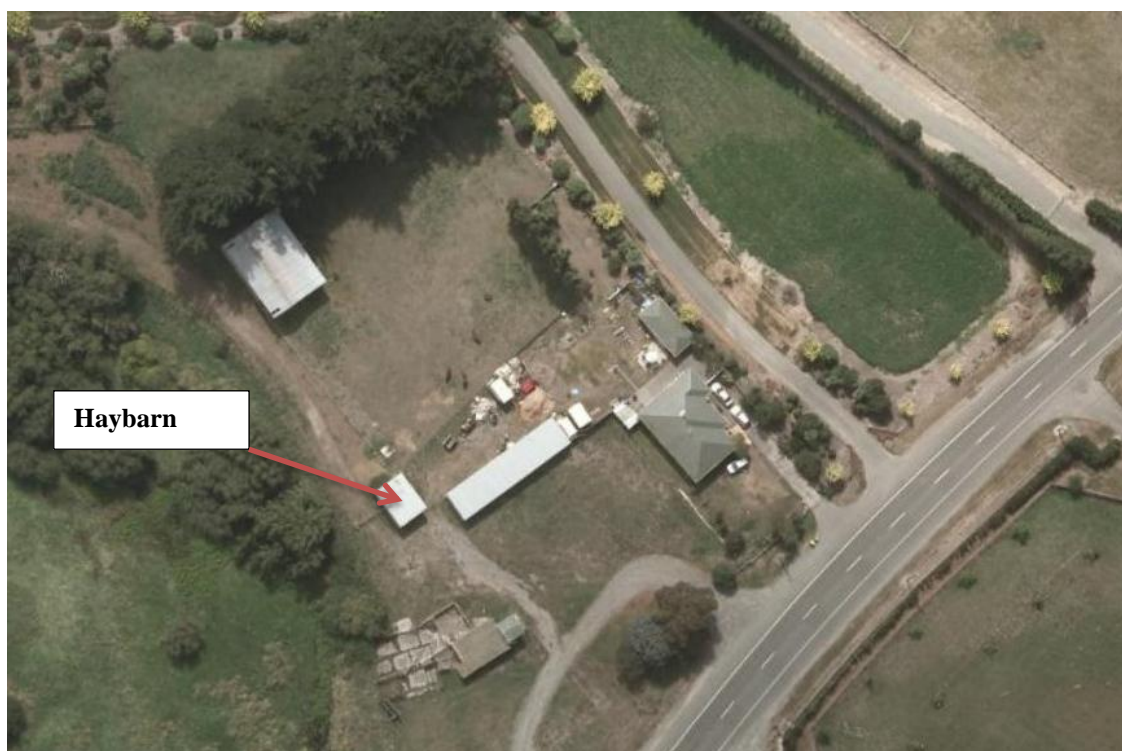
Figure 3 Post February 2011 Earthquake Aerial Photography ²

Aerial photography taken following the 22 February 2011 earthquake doesn't show clear signs of liquefaction (see Figure 3), however, liquefaction was observed close to the property.

Due to the anticipated presence of sand at the shallow depth, and the sites proximity to a local water course, it is considered possible that liquefaction will occur at the site. It is not clear from the post-earthquake aerial photography (Figure 3) whether liquefaction has occurred at the site, however, it was observed close to the property. The site is considered to have a moderate-high liquefaction potential at this stage of investigation.

It is recommended that three piezocone CPTs be conducted to target depths of 20m. This will allow a liquefaction assessment to be carried out.

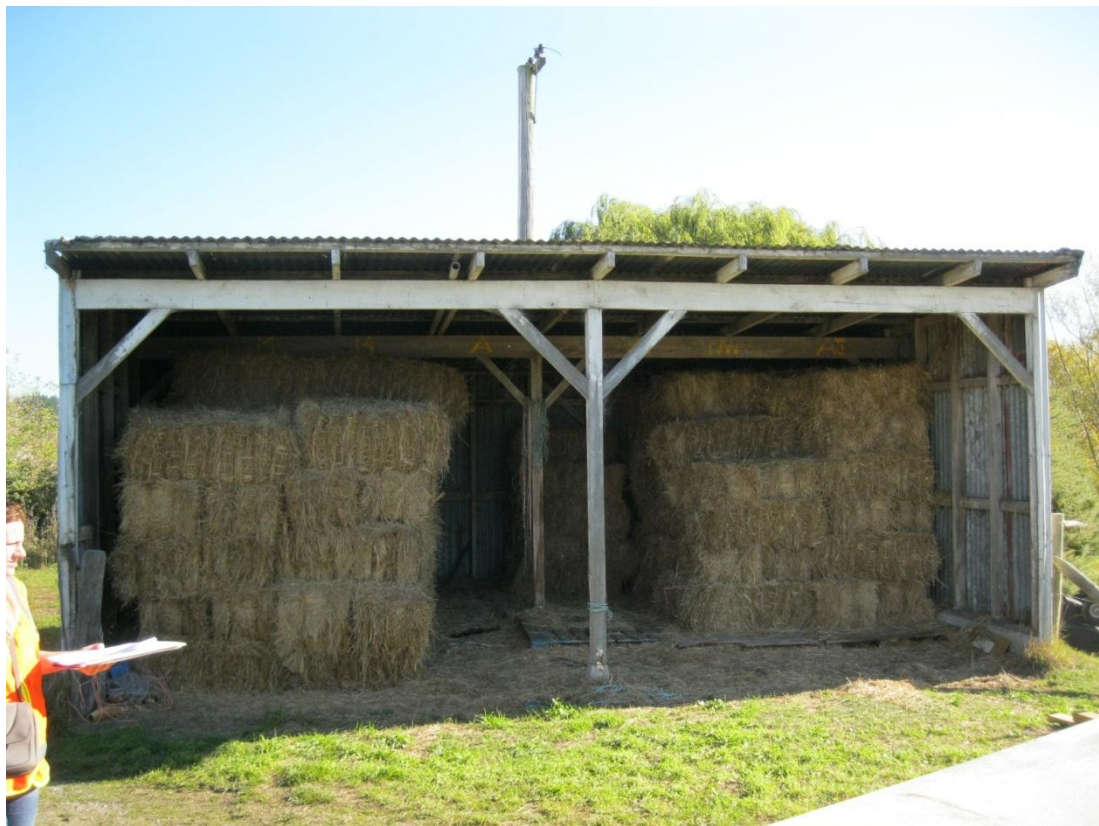
The presence of a large opening in the front face of the building along with only nominal roof diaphragm causes a significant plan irregularity critical structural weakness.

Photograph 2 View of the front of the haybarn. A large opening is clearly visible.

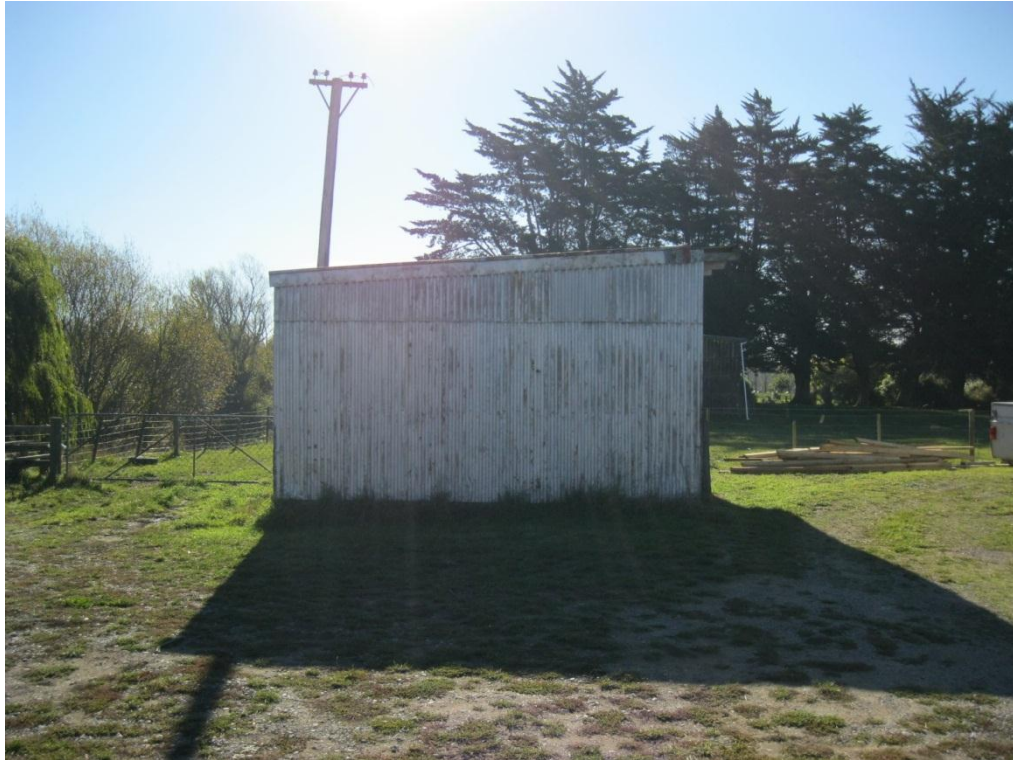
Photograph 3 View of the side wall of the haybarn.

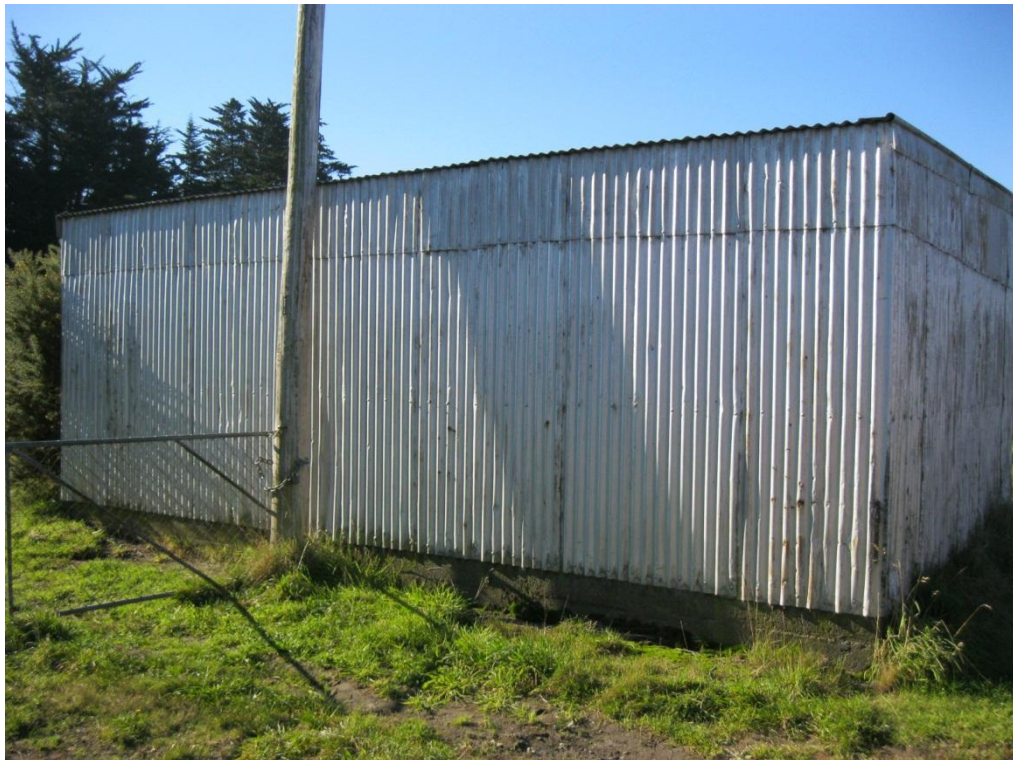
Photograph 4 View of the exterior of the rear wall of the haybarn.

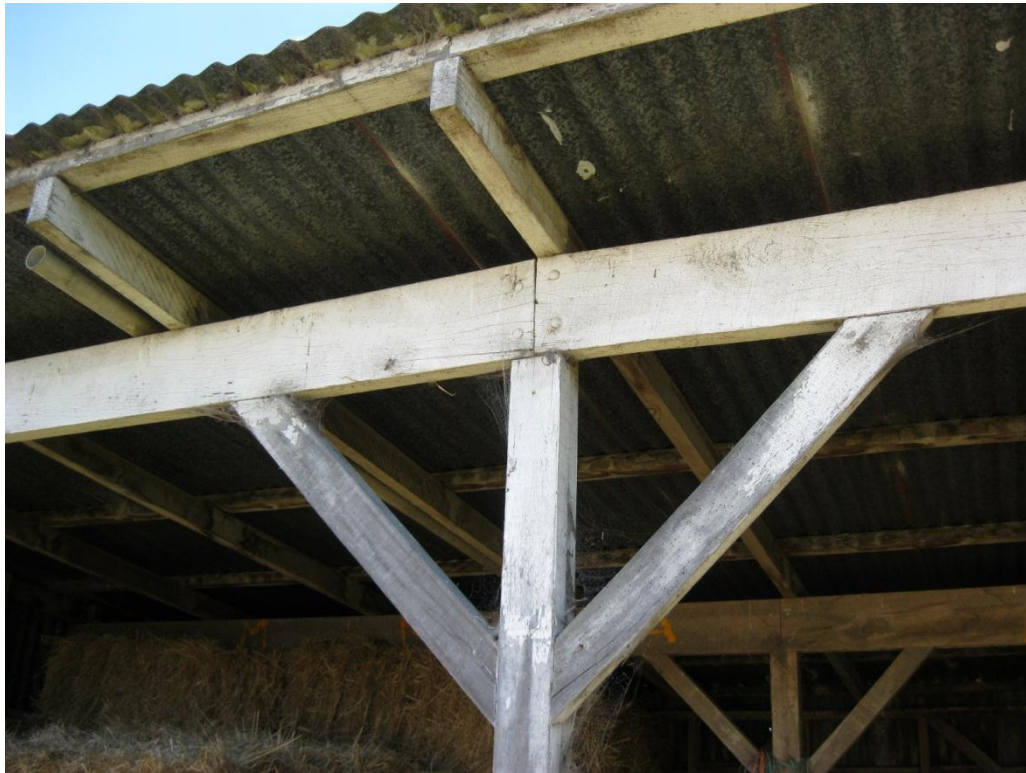
Photograph 5 Timber beam and post system on the front and centre of the building showing the knee connection. Lack of roof sarking is clearly visible.

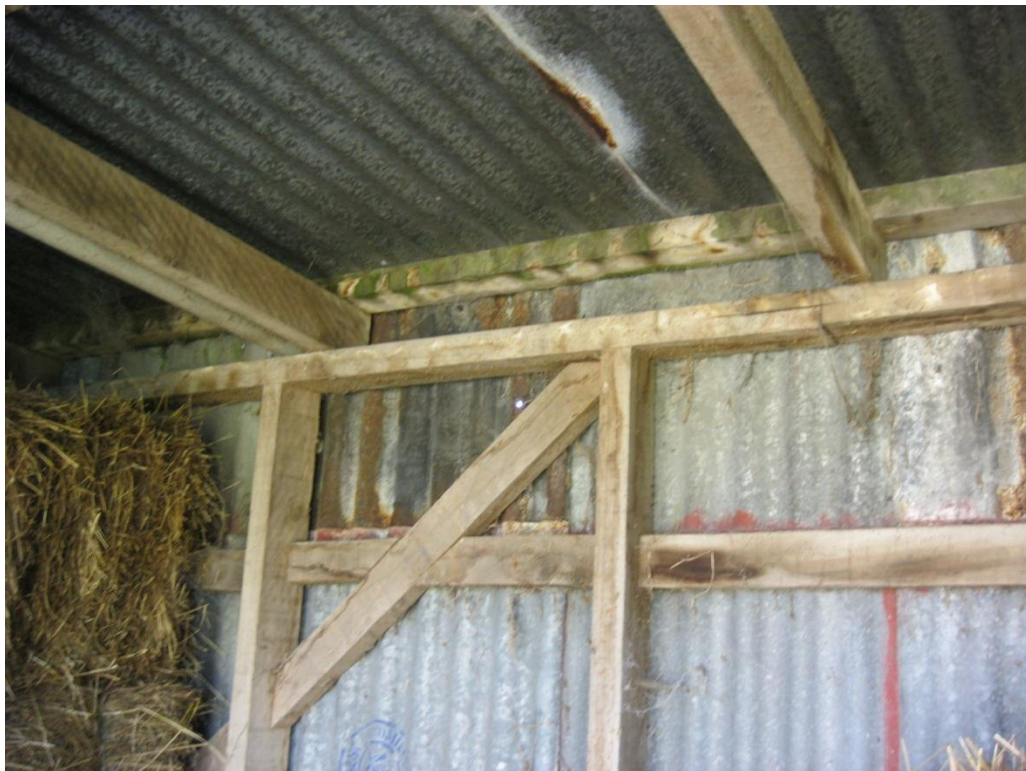
Photograph 6 Timber framed wall to the rear showing timber cross bracing.

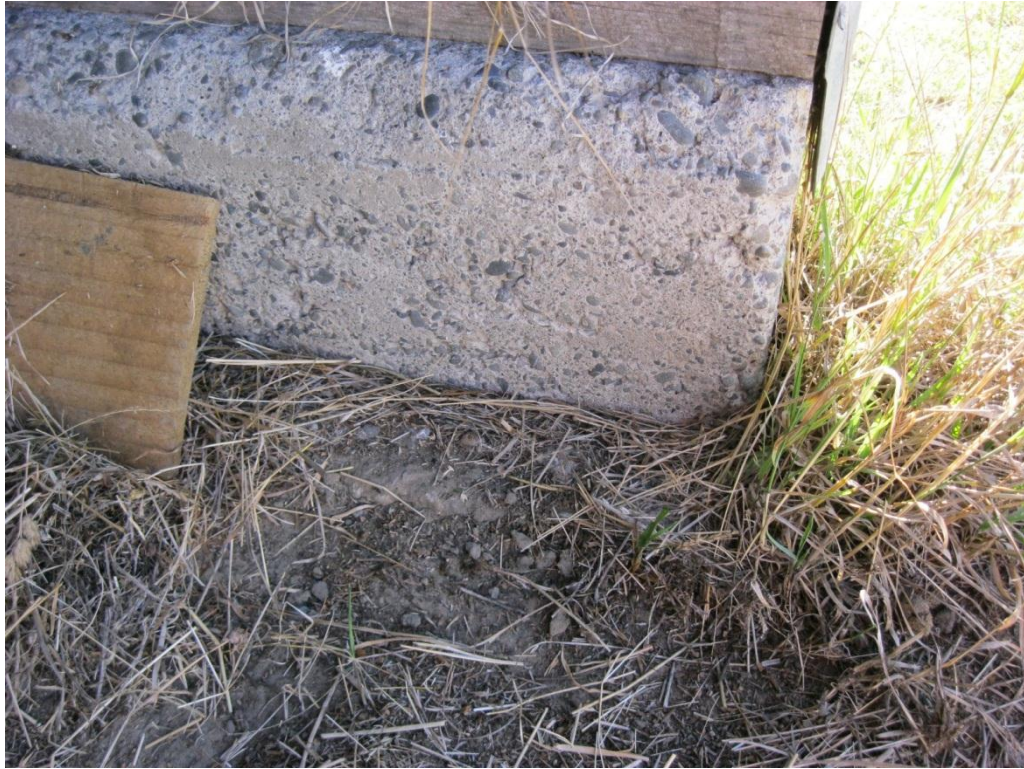
Photograph 7 Concrete strip footing foundations to the perimeter walls.

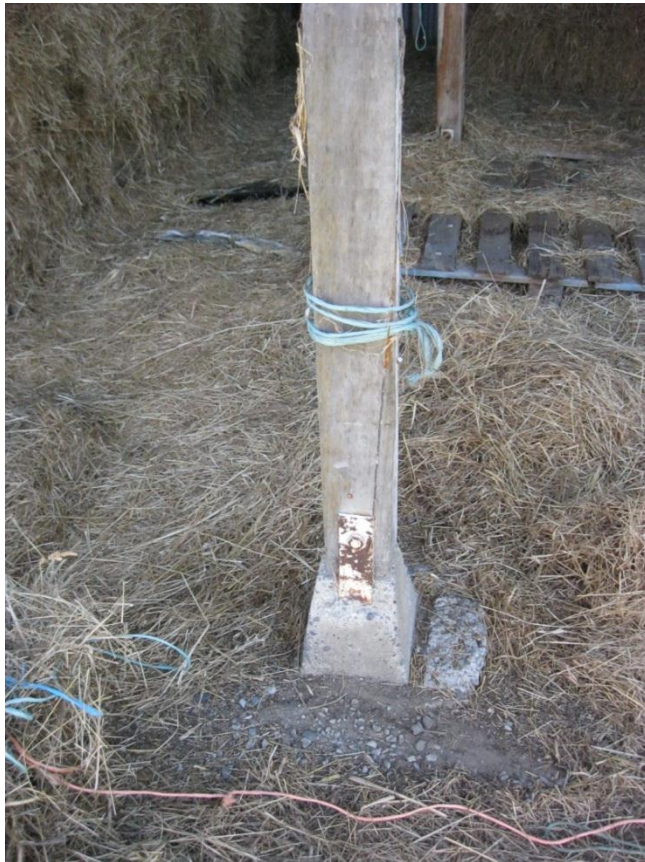
- ▶ No earthquake related damage was noted to the building.
- ▶ Cracking was noted to one of the timber posts along the front of the building. It is suspected that this damage is as a result of an impact with a vehicle.

The only damage noted to the building was cracking to the timber posts along the north-east of the building but this is not believed to be a result of the earthquakes. As this damage is considered to adversely affect the load carrying capacity of the structural system, a 5% reduction of the % NBS will be applied.

Photograph 8 Cracked timber support post.
