CHRISTCHURCH CITY COUNCIL
BU 3522-001 EQ2
Lyttelton Library
18 Canterbury St, Lyttelton

QUANTITATIVE ASSESSMENT REPORT

- Revision C
- 13 September 2013

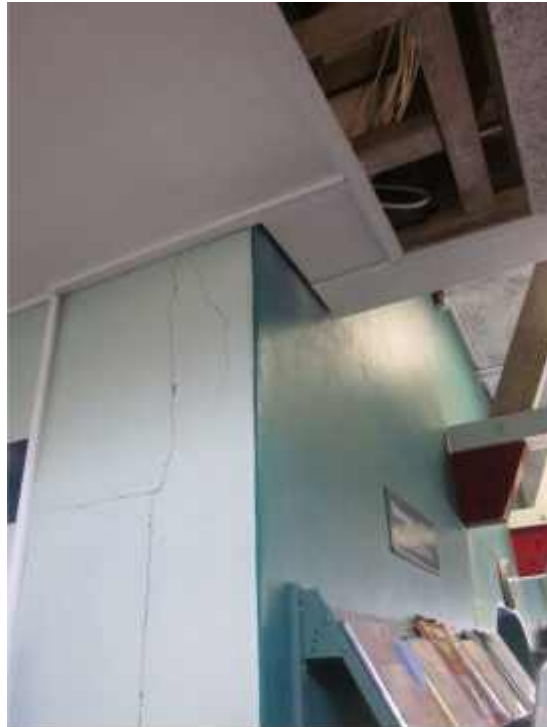
- Cracking of concrete shear walls both internally (the most critical location being the cracking in the wall in the vicinity of the timber truss support near the grid intersection D/5) and externally.

- 1) Minor cracking to the bed joints of concrete block walls (internal walls at basement level).
- 2) Cracking of concrete shear walls both internally - the most critical location being the cracking in the wall in the vicinity of the timber truss support near the grid intersection D/5 (refer to photos 22-28) and externally refer to photos 29, 30, 33, 36, 37, 39, 44, 47 and 48. In addition there is an area of concrete roof within the stair core which has minor cracking, refer to photo 45. Where wall coverings exist these should be removed so that the level of damage of the covered wall can be determined, if any cracks exist which are larger than 0.5mm in width notify the engineer who will inspect and advise an appropriate course of action.

PHOTO 24: Cracking in concrete walls near D/5 (view from the library)

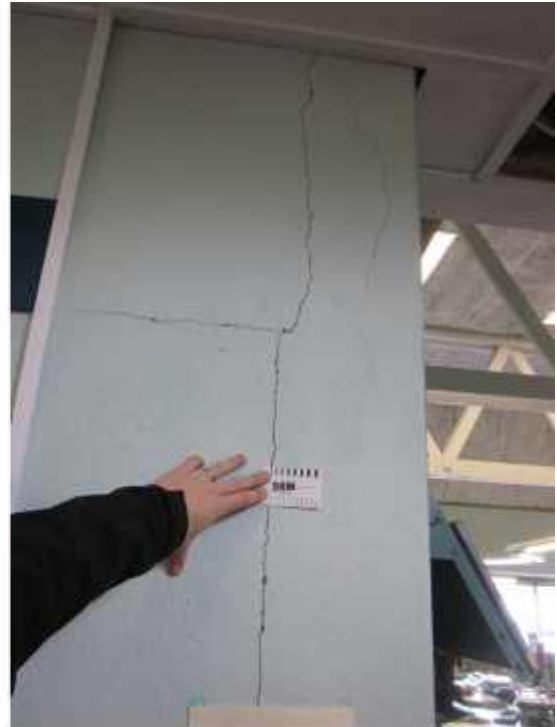
PHOTO 25: Cracking in concrete walls near D/5 (view from the library)

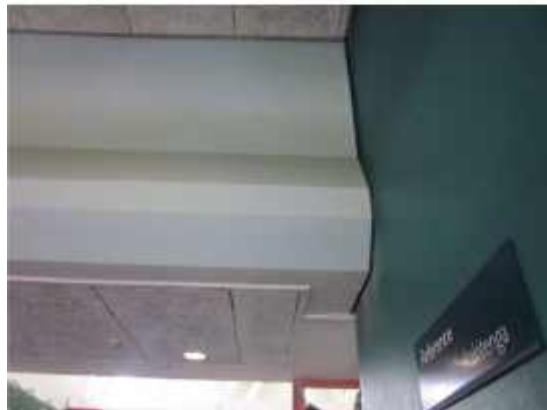
PHOTO 26: Cracking in concrete walls near D/5 (view from the library) – Truss T3 enclosed in the ceiling space

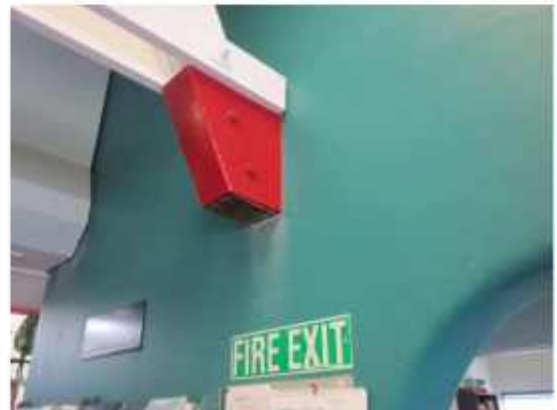
PHOTO 27: Dust coming out of the supporting bracket of roof truss T2

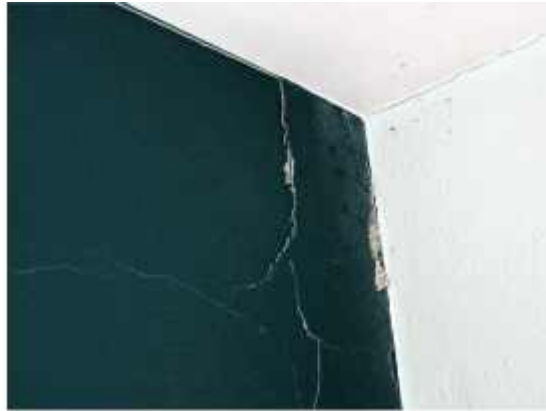
PHOTO 28: Cracking in concrete walls near D/5 (view from the office) – cracking appeared at the location of truss support attached from the other side of the wall)

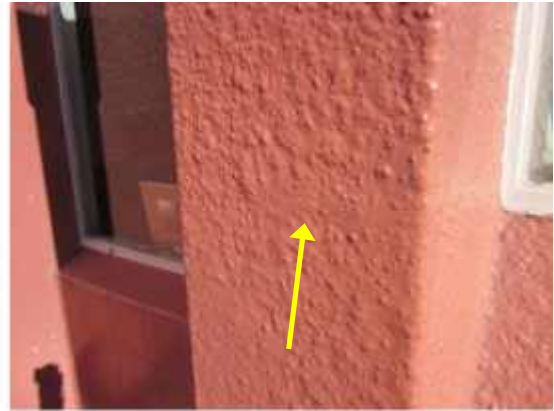
PHOTO 29: Typical external cracking of concrete shear walls

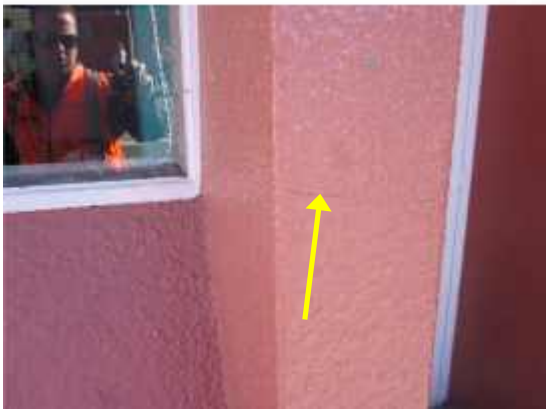
PHOTO 30: Typical external cracking of concrete shear walls

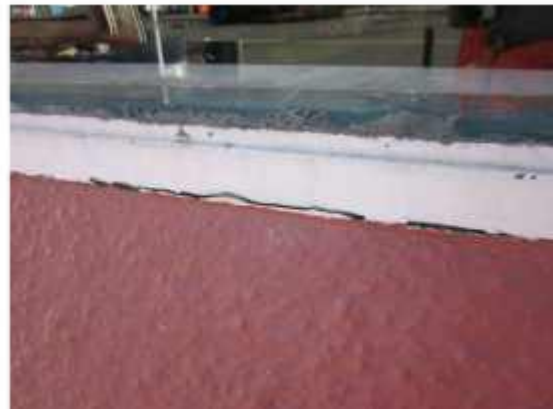
- 5) Cracking between adjacent materials – for example movement between concrete walls and window frames and concrete walls and adjacent plaster board linings. Refer photos 31 and 43.

PHOTO 31: Separation of window frames from surrounding structure

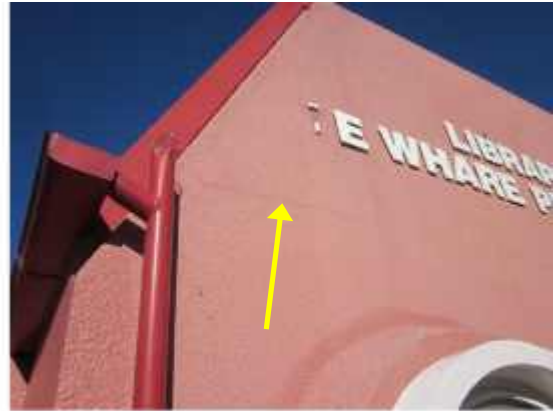
PHOTO 33: Typical external cracking of concrete shear walls

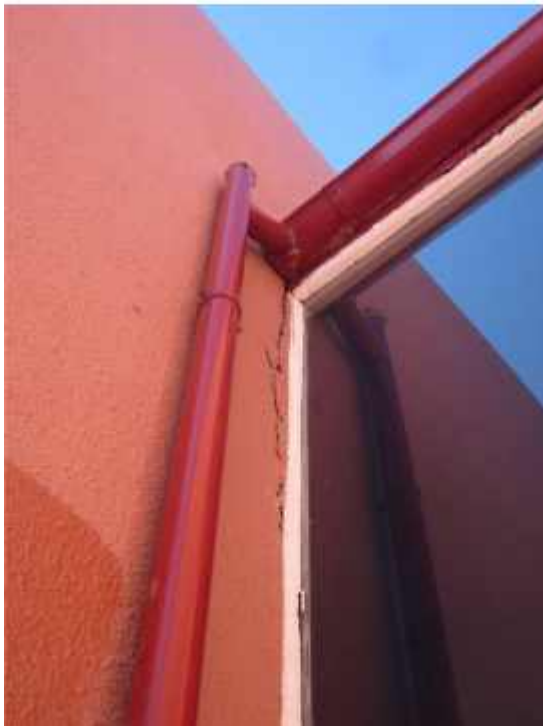
- Horizontal differential movement between two parts of the stepped roof which has caused the infill roof and walls between them to separate from the adjacent structures.

- 6) Horizontal differential movement between two parts of the stepped roof which has caused the infill roof and walls between the roof steps to separate from the adjacent structures. Refer to photos 34 and 35.

PHOTO 34: View of differential movement between adjacent roof structures.

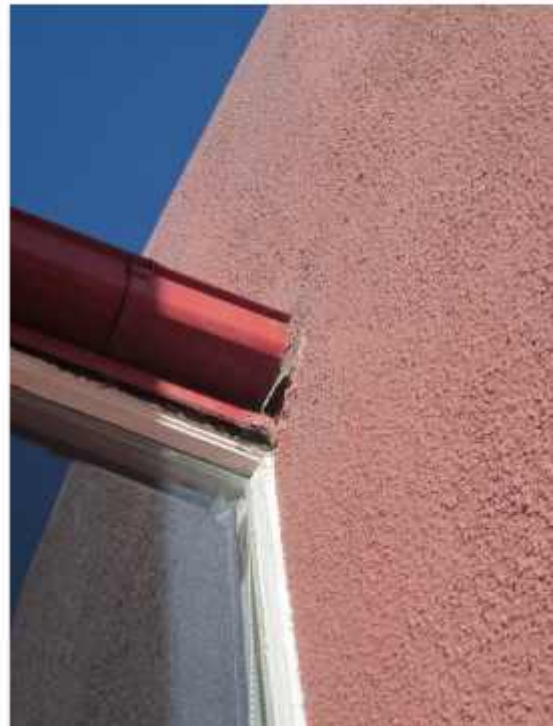
PHOTO 35: View of differential movement between adjacent roof structures.

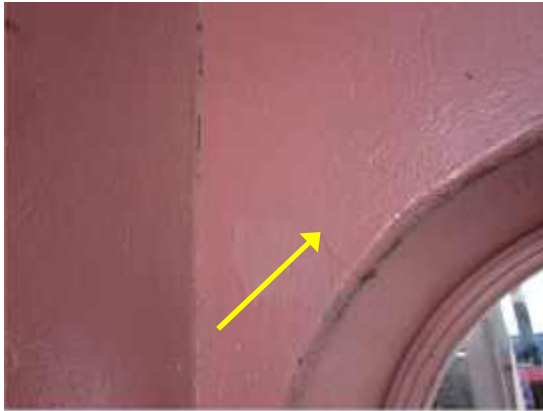
PHOTO 36: Typical external cracking of concrete shear walls

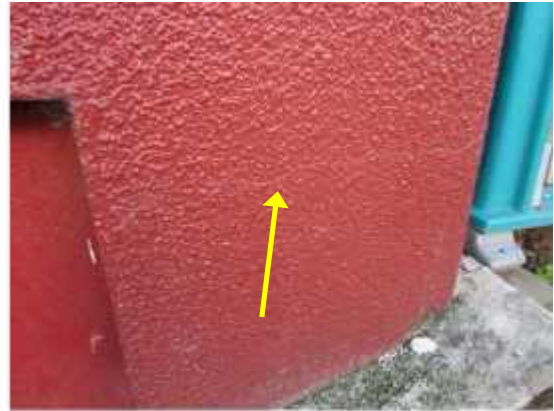
PHOTO 37: Typical external cracking of concrete shear walls

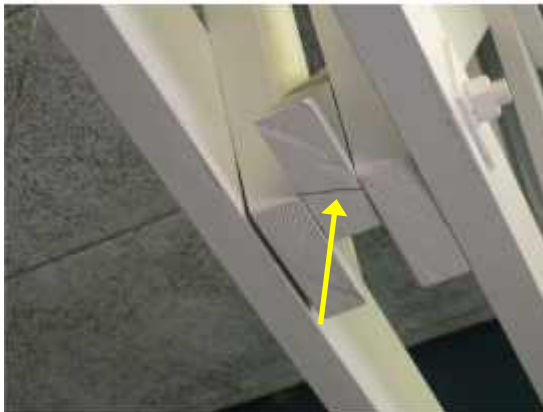
- During our initial inspection on 2 April 2012, one diagonal member of the timber roof truss was noted to have a crack near the end. During our next inspection on 15 October 2013, this member was found to be replaced by a new member of similar specification. We found the new member being sufficient for its purpose and therefore have not accounted for the reduction of the roof truss capacity in the quantitative assessment.

- 7) During our initial inspection on 2 April 2012, one diagonal member of the timber roof truss was noted to have a crack near the end (refer to photo 38) and we recommended that the member is replaced. During our next inspection on 15 October 2013, this member was found to be replaced by a new member of similar specification. We found the new member being

PHOTO 38: Crack in timber truss diagonal

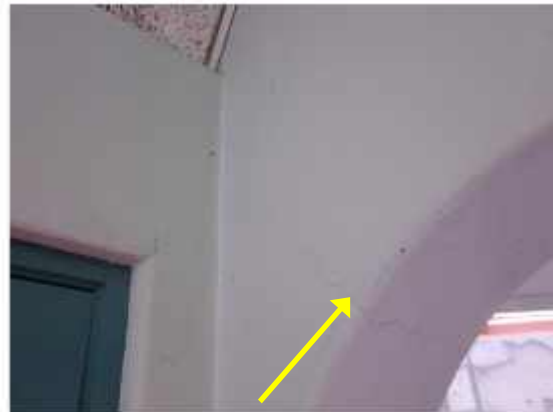
PHOTO 39: Typical internal cracking of concrete shear walls

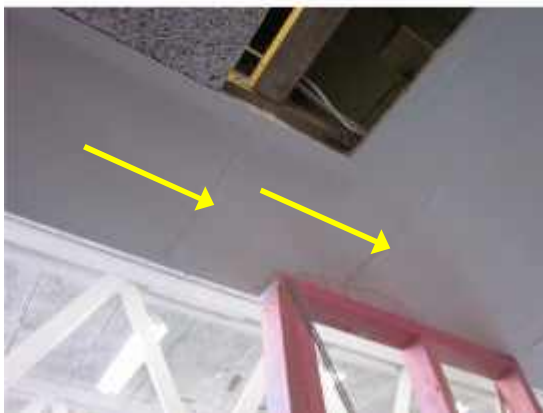
- 3) Widespread cracking of plasterboard walls and ceiling including junctions between plasterboard and different materials (most notably concrete shear walls). Refer to photos 40, 41 and 42. Where wall coverings exist these should be removed so that the level of damage of the covered wall can be determined and the appropriate steps taken.

PHOTO 40: Typical plasterboard ceiling cracking

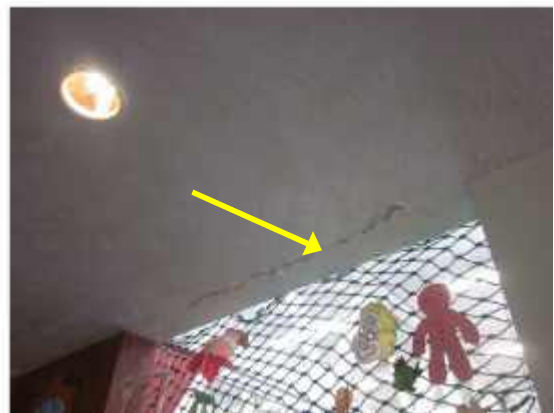
PHOTO 41: Typical plasterboard ceiling cracking

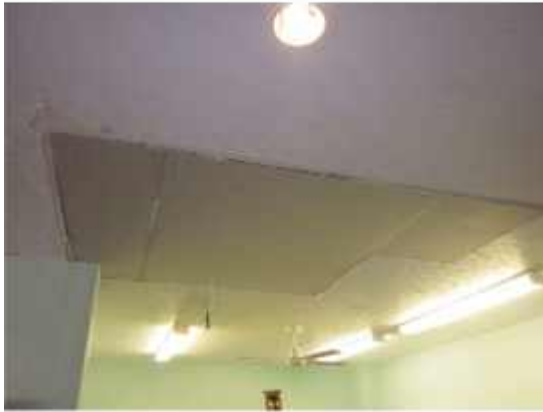
PHOTO 42: Typical plasterboard ceiling cracking with previous making safe work

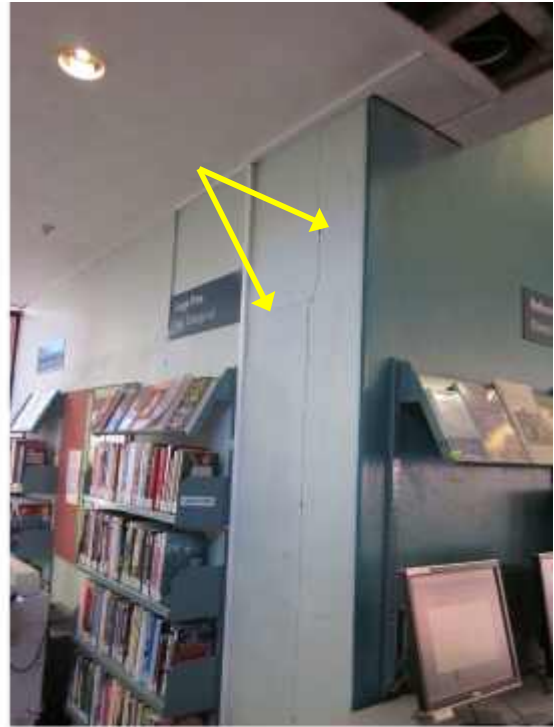
PHOTO 43: Typical plasterboard wall cracking adjacent to concrete wall

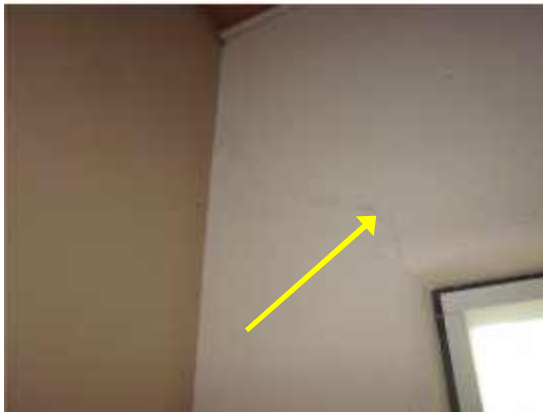
PHOTO 44: Typical internal cracking of concrete shear walls

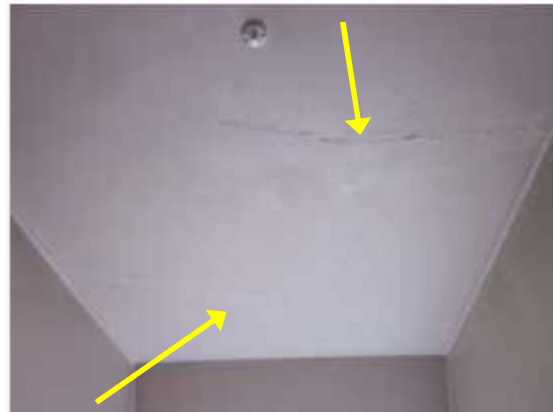
PHOTO 45: Cracking of concrete roof in stair core

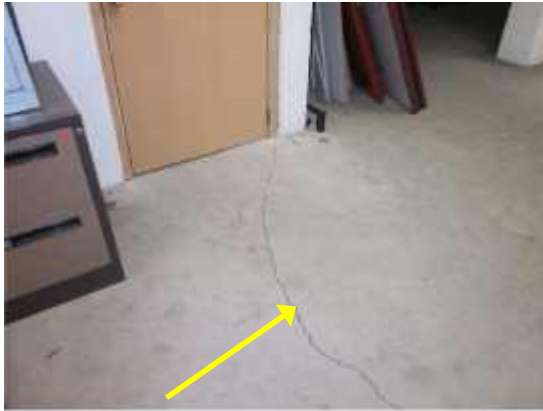
PHOTO 46: Typical cracking of concrete slab on grade

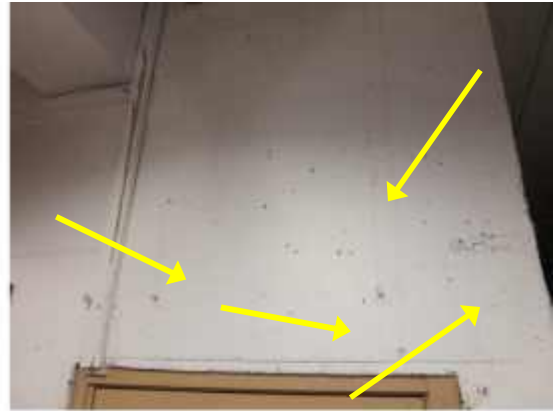
- 8) The building appears to have settled relative to the ground bearing floor slab leaving the floor slab significantly damaged with large cracks approaching 5 to 10mm wide, refer to photo 47.

PHOTO 47: Typical internal cracking of concrete shear walls. Wide spread in this location.

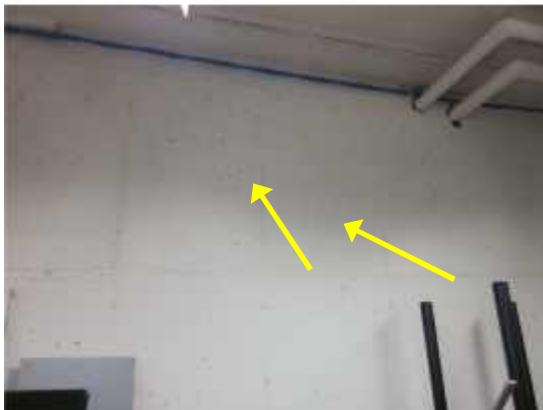
PHOTO 48: Typical internal cracking of concrete shear walls.
