Macfarlane Park Toilets  
Qualitative Engineering Evaluation

**Reference:** 229184

**Prepared for:**  
Christchurch City  
Council

**Date:** 14 October 2013

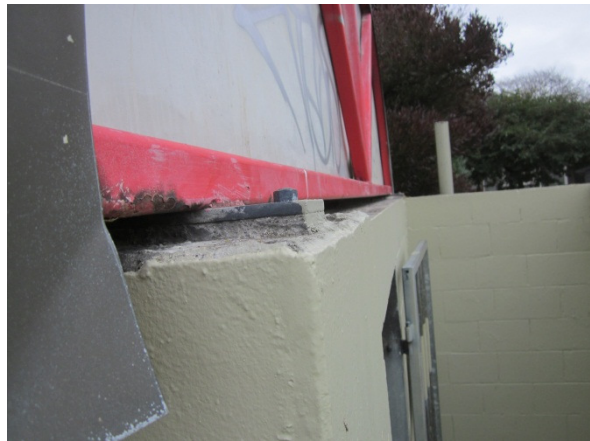
Typical roof frame to wall connection detail.

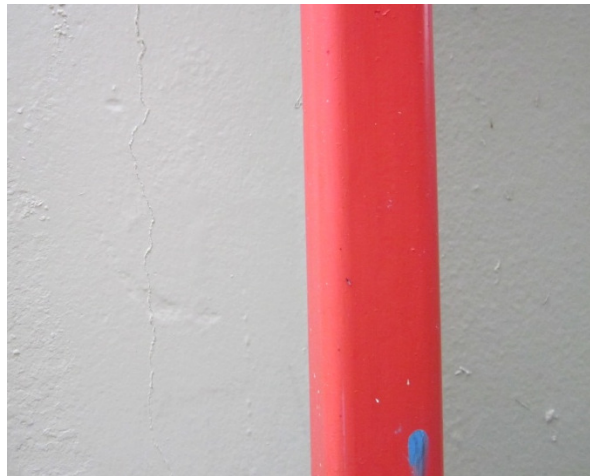
Minor cracking in external render.

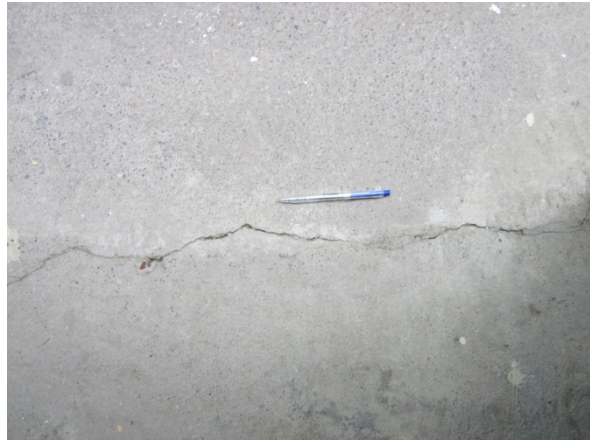
Minor cracking in concrete paths around the building.

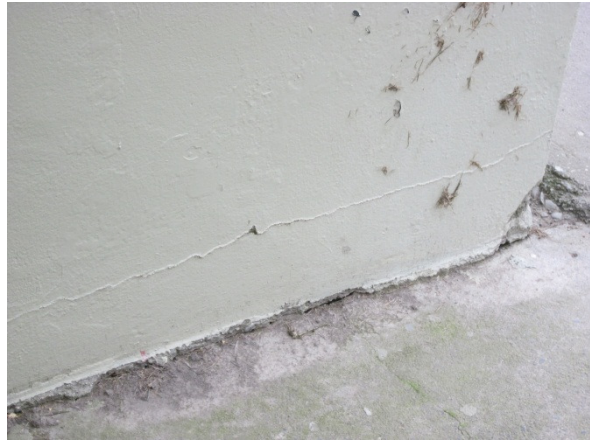
Minor settlement of concrete paths around the building.

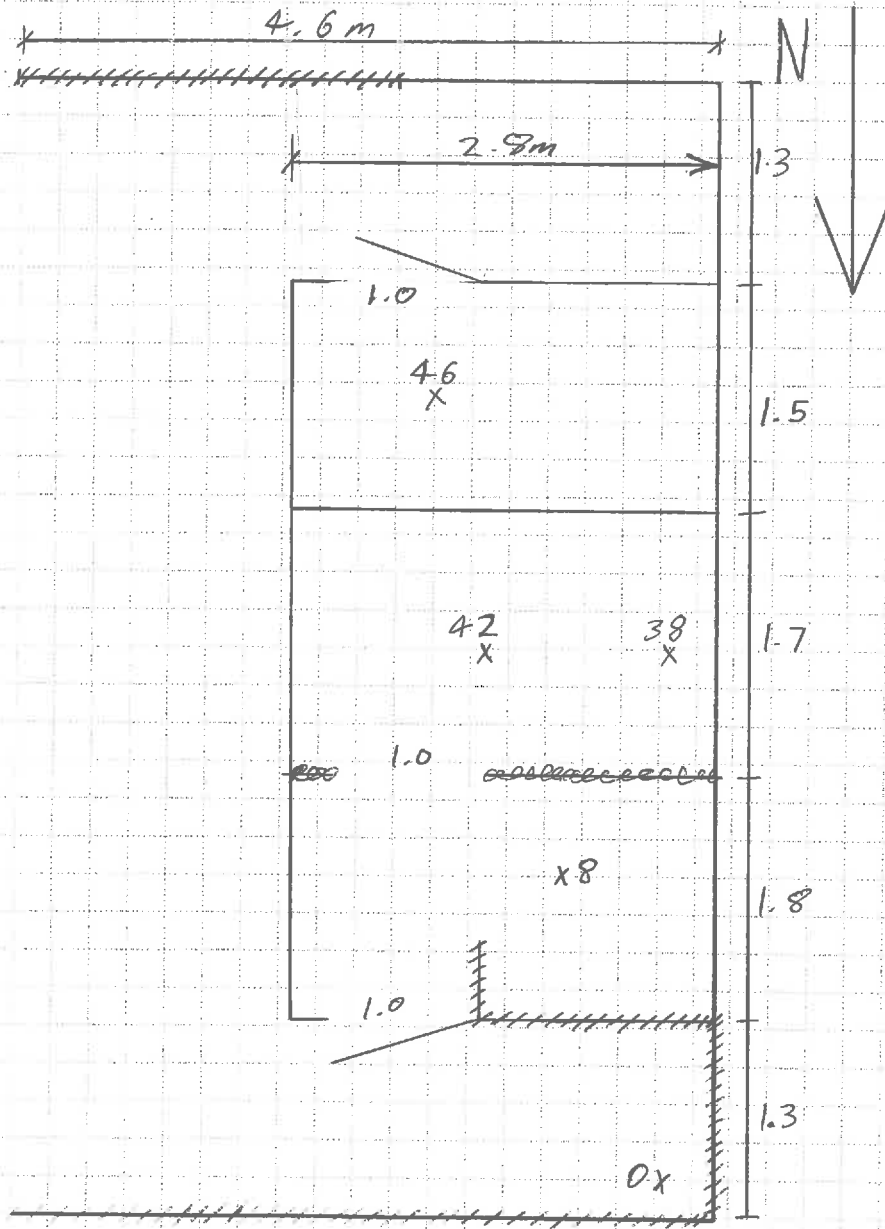
Client: CCC	Date: 29/05/2012
Project/Job: Macfarlane Park Toilets (Skilton st)-DEE	Job No: 229184
Subject: Floor Plan & Levels	Sheet No: 1 By: HB

The floor levels for the Macfarlane Park Toilets were found to be within acceptable levels. The majority of the variations in floor level that were recorded appeared to related to the original construction and more recent changes to the layout of the building.
