CLIENTS | PEOPLE | PERFORMANCE

Malvern Park Toilets & Rugby Pavilion
PRK 0614 BLDG 003 EQ2
Detailed Engineering Evaluation
Quantitative Report
Version FINAL

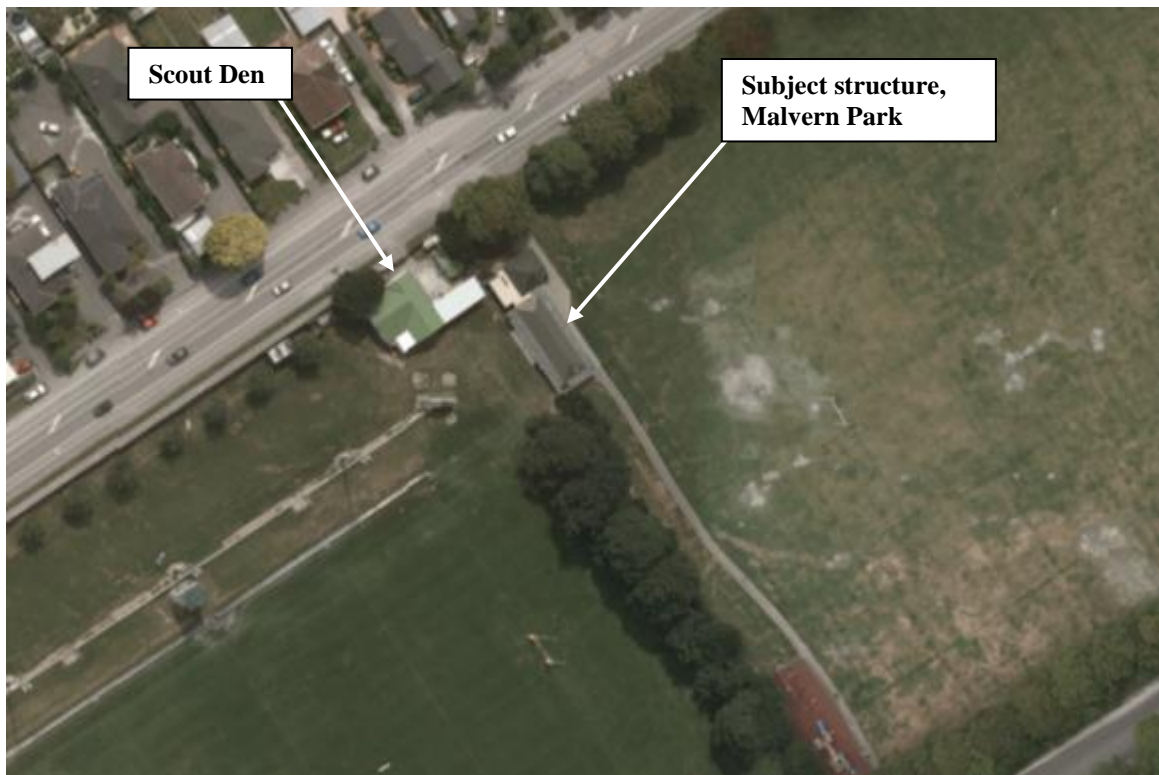
8.2.6 Summary of Ground Conditions

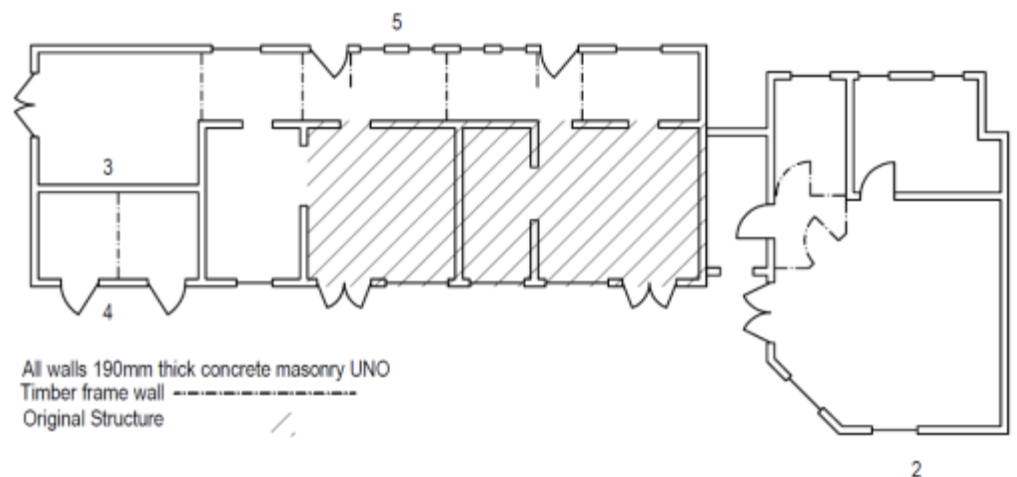
Figure 5 Plan Identifying Reinforced Concrete Masonry Walls

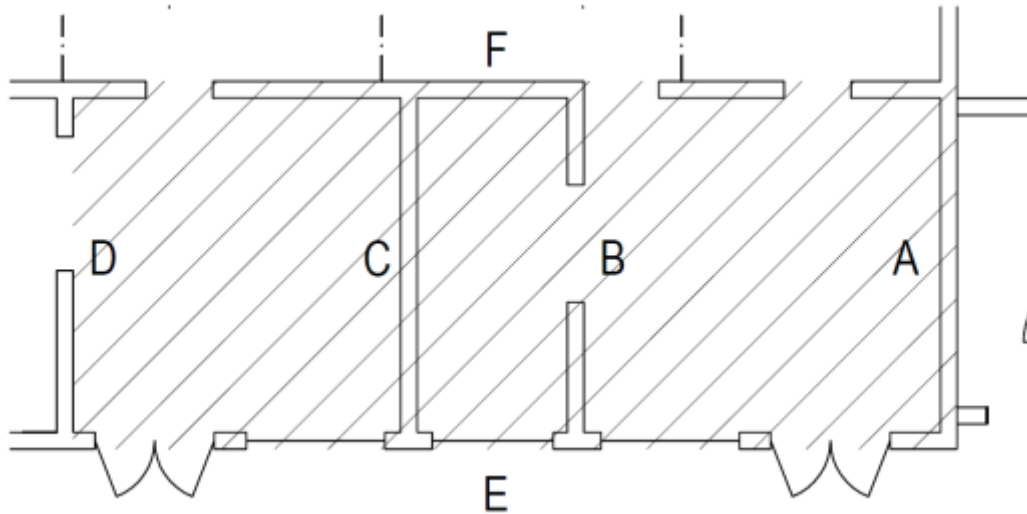
Figure 6 Plan Identifying Original Structure's Wall Lines.

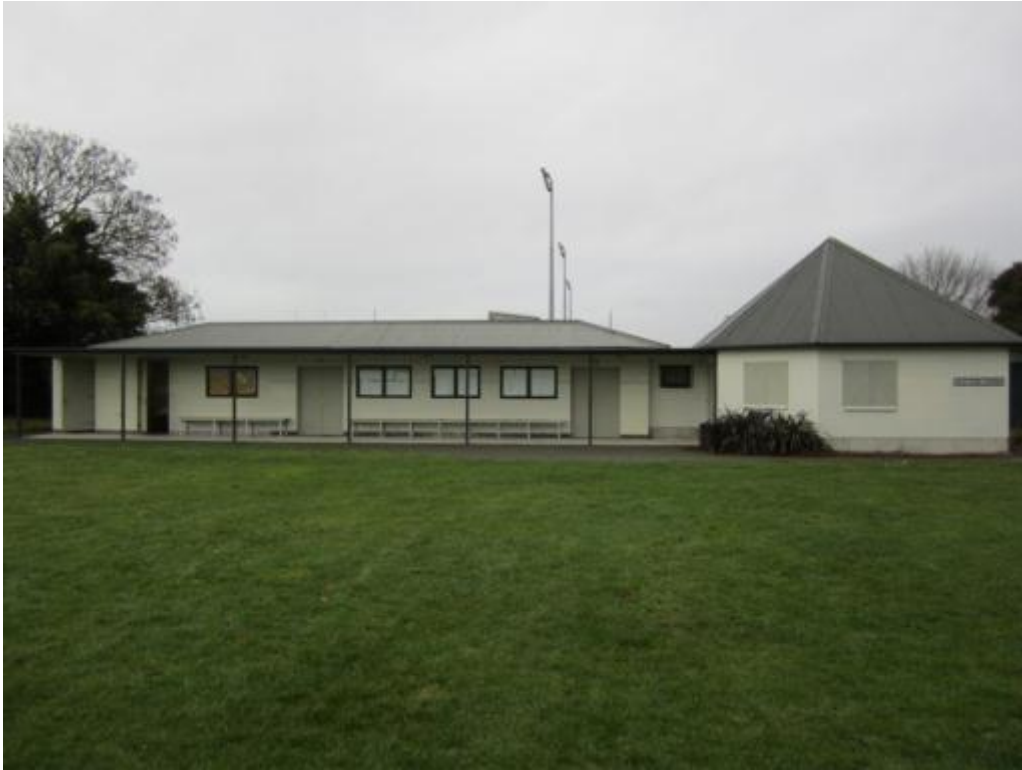
Photograph 1 View of building from the Northeast.

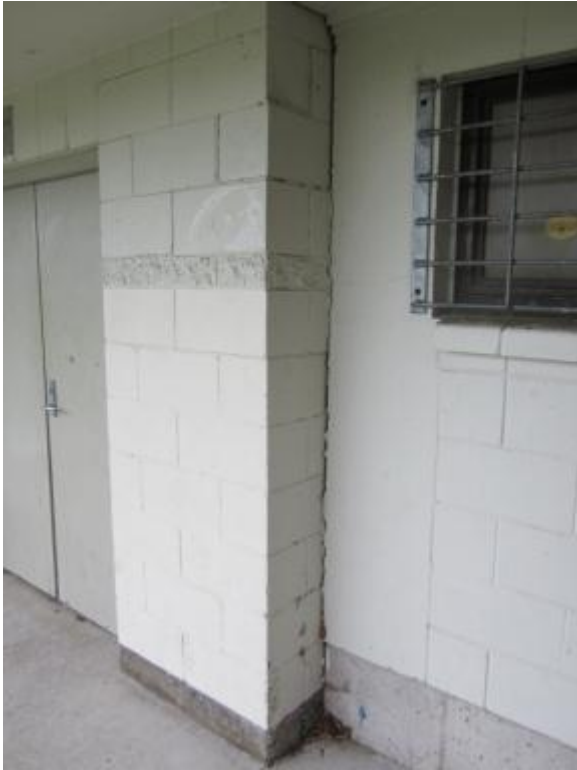
Photograph 3 Gap between two sections of structure, cracking to mortar top left.

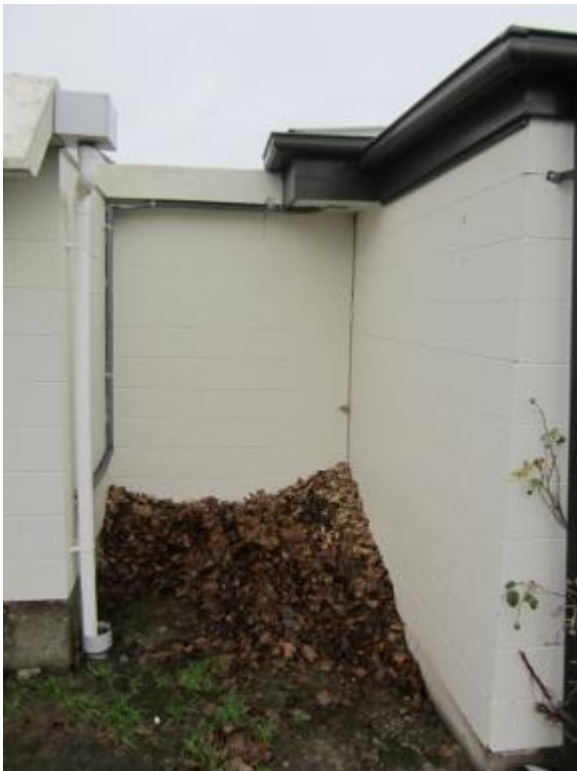
Photograph 4 Gap between building sections in back right corner.

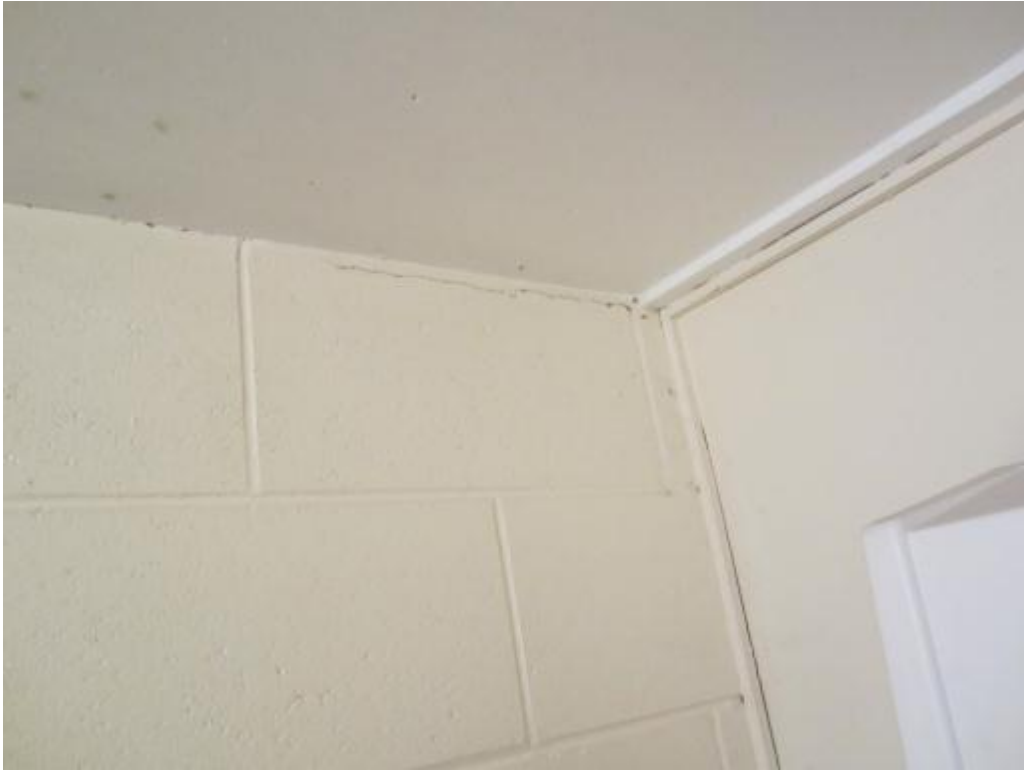
Photograph 5 Crack along bedding mortar of precast concrete roof slabs.

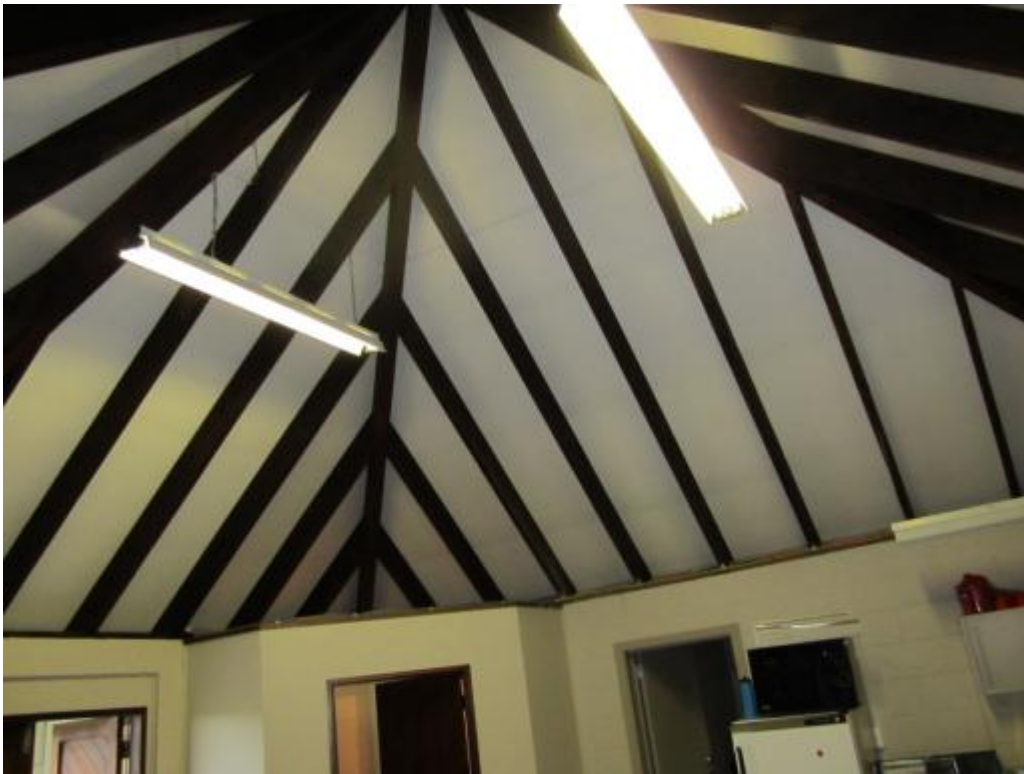
Photograph 6 Internal view of vaulted roof.

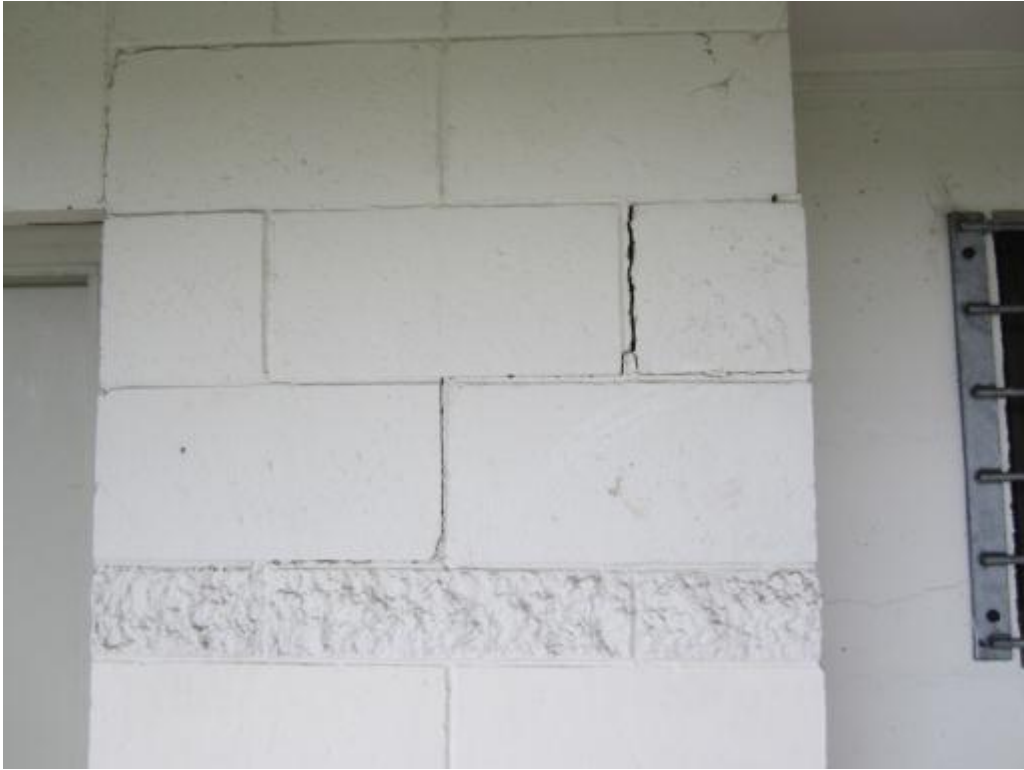
Photograph 7 Masonry pier containing diagonal crack.

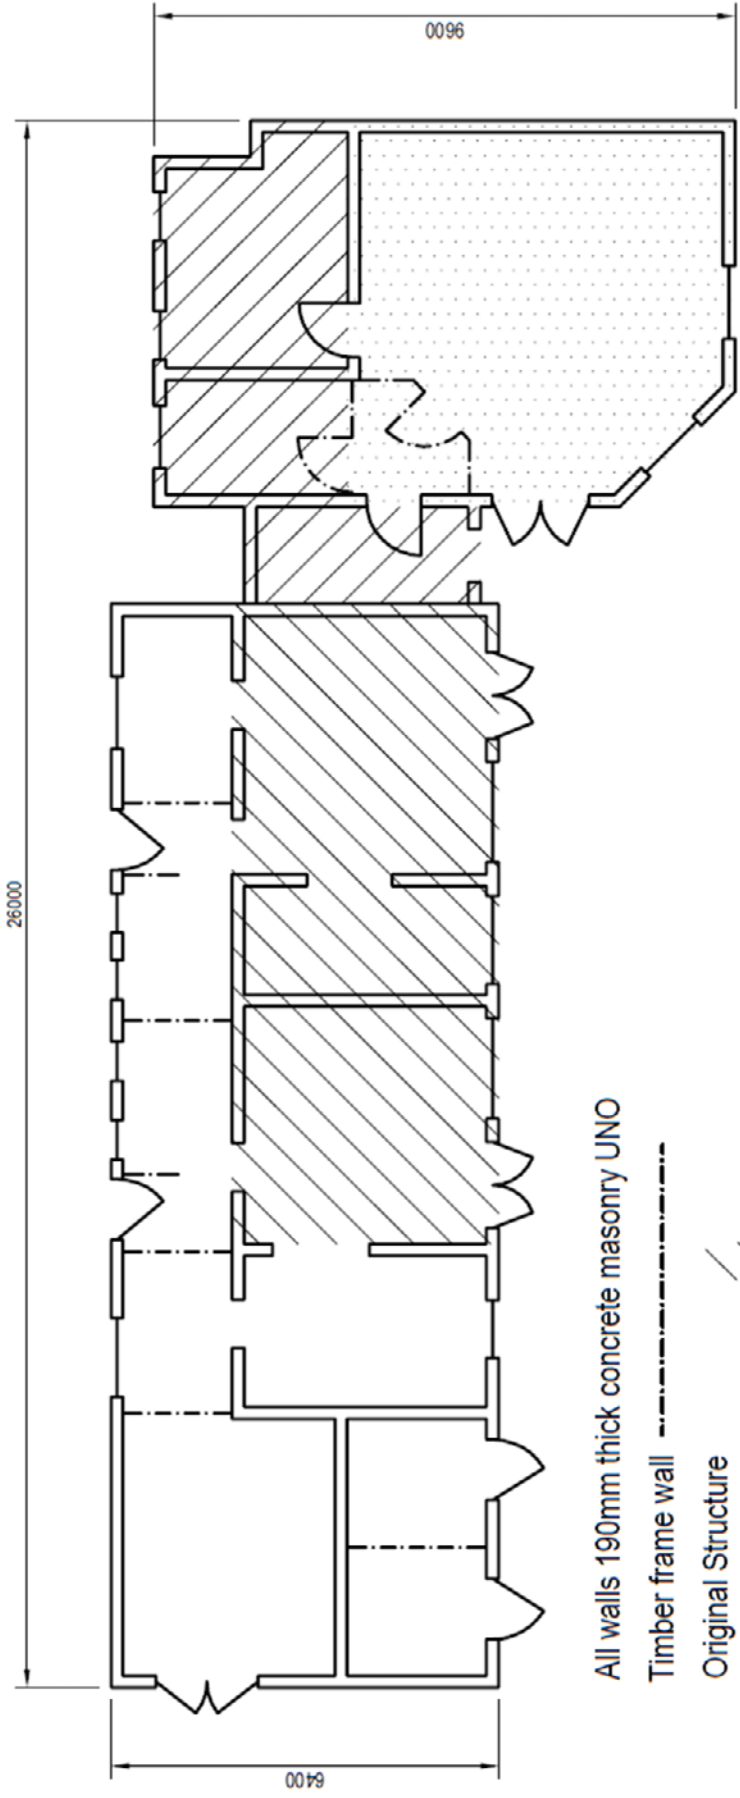
All walls 190mm thick concrete masonry UNO
