Manse Place Housing Complex  
Qualitative Engineering Evaluation

**Reference:** 232537  
**Prepared for:**  
Christchurch City Council

Functional Location ID: BE 0414 EQ2

Address: 319 Main North Road

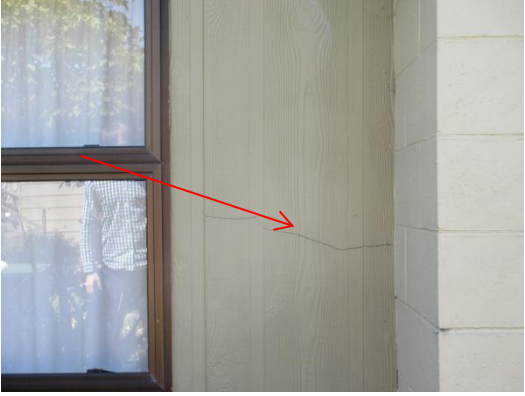
- Some cracks were found in the exterior cladding (Photos #1).
- A few cracks were found in the interior Gib lining.
- The roof structure was inspected locally by accessing a trap tile and appeared to be in good condition in the area inspected.
- A floor level survey using the zip level was carried out on the slab-on-grade and structural slab and has shown that the levels do not exceed DBH guidelines limits (see Appendix A).

<p>#1.</p>	<p>Cracking on exterior cladding of block A at Manse Place Housing Complex.</p>

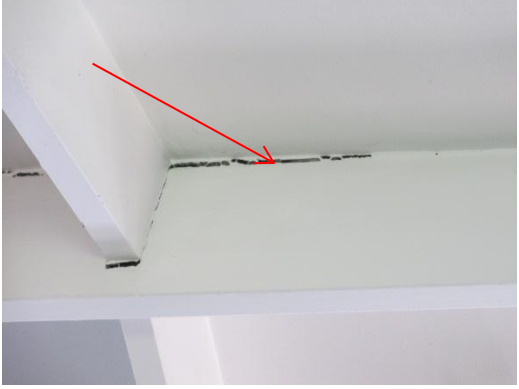
<p>#2.</p>	<p>Gab between primary beam and secondary beam in Residents' lounge.</p>

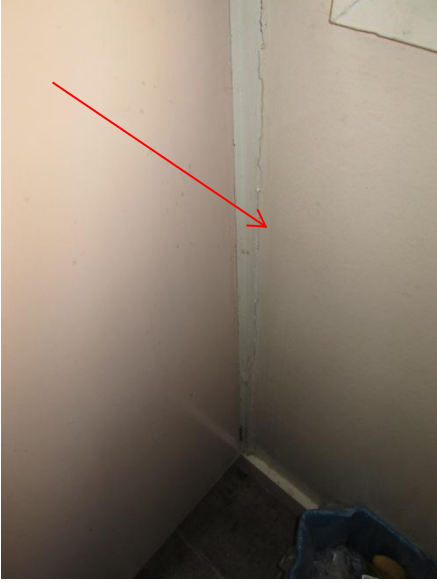
- Some cracks were found in the exterior cladding (Photo #4).
- A few cracks were found in the interior Gib lining (Photos #3 and #5).
- The roof structure was inspected locally by accessing a trap tile and appeared to be in good condition in the area inspected.
- A floor level survey using the zip level was carried out on the slab-on-grade and structural slab and has shown that the levels do not exceed DBH guidelines limits (see Appendix A).

<p>#3.</p>	<p>Cracking in interior lining of unit 15 in Block B at Manse Place Housing Complex.</p>

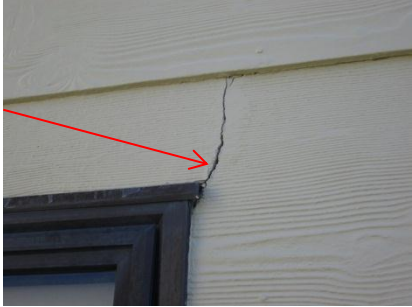
<p>#4.</p>	<p>Cracking on exterior cladding of Block B at Manse Place.</p>

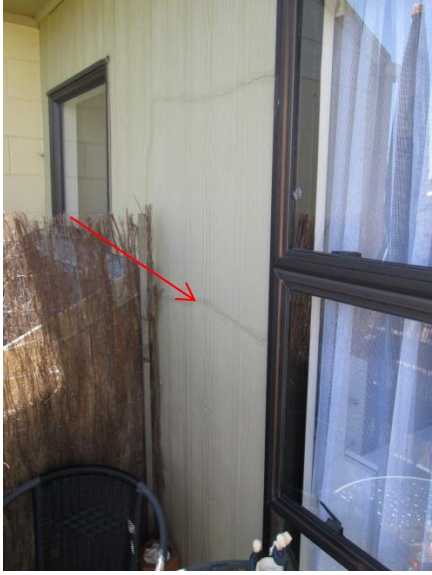
<p>#5.</p>	<p>Crack in exterior cladding at Manse Place Housing Complex Block B (Unit 24).</p>

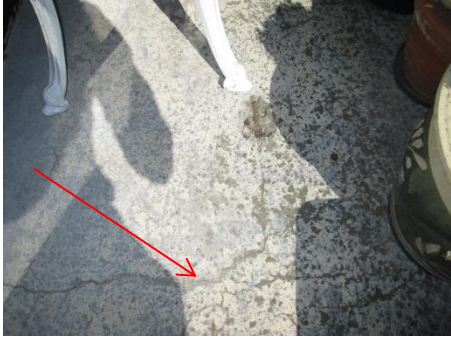
<p>A photograph showing a vertical crack in the exterior cladding of a building. The crack runs down the side of a white door or window frame. A red arrow points to the crack. The background shows a window with blue curtains and a dark chair.</p>
<p>#6.</p>	<p>Damaged exterior concrete patio slab in Block A.</p>

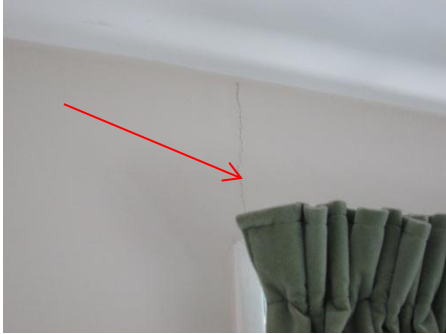
- A few cracks were found in the interior Gib lining (Photos #7, #8).
- There is cracking in the exterior patio slabs.
- A floor level survey using the zip level was carried out on the slab-on-grade and structural slab and has shown that the levels do not exceed DBH guidelines limits (see Appendix A).

<p>A photograph of a concrete patio slab. The slab is cracked and shows signs of wear and discoloration. A red arrow points to a crack in the concrete. A person's leg and foot are visible in the upper left corner.</p>
<p>#7.</p>	<p>Cracking in interior lining inside unit 28 Block C.</p>

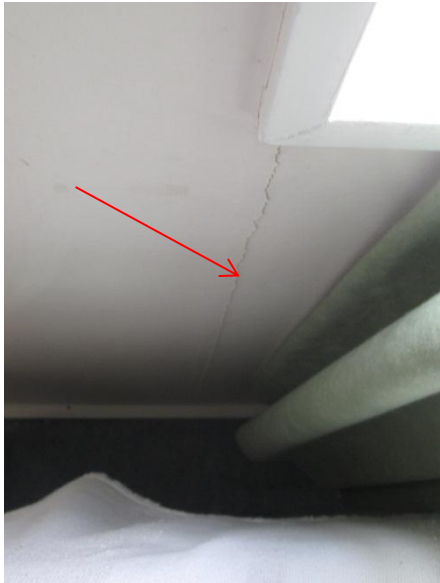
<p>A photograph of the interior lining of a room. A vertical crack is visible in the white wall, extending from the ceiling down towards a green curtain. A red arrow points to the crack.</p>
<p>#8.</p>	<p>Cracking in interior lining inside unit 28 Block C.</p>

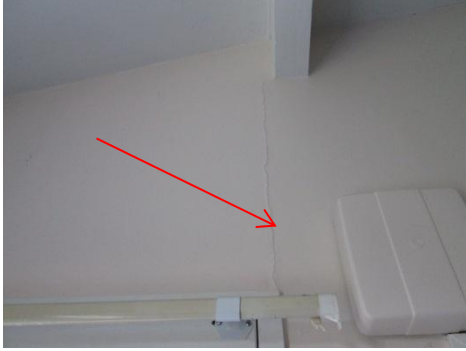
- A few cracks were found in the interior Gib lining (Photo #9).
- There is cracking in the exterior patio slabs (Photos #10).
- A floor level survey using the zip level was carried out on the slab-on-grade and structural slab and has shown that the levels do not exceed DBH guidelines limits (see Appendix A).

#9	Cracking in interior lining inside unit 36 Block D.

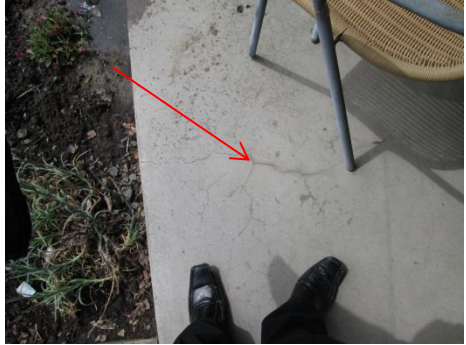
A photograph showing a vertical crack in a white interior wall. A red arrow points to the crack. A white door handle is visible at the bottom of the frame.
#10	Cracked exterior slab in Block D.
