**Mary McLean Place
Housing Complex
PRO 0942**

**Detailed Engineering Evaluation
Quantitative Assessment Report**

**202a Opawa Road, Woolston,
Christchurch 8023**

Date: November 2013
Reference: 6-QC379.00
Status: Final

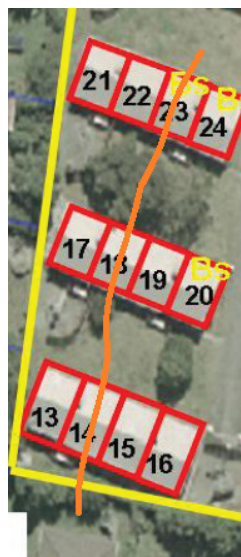
Figure 8: Locations of ground crack through blocks D, E and F.

There is a significant crack in the ground that runs approximately 8m in from the west boundary and continues for approximately 70m. It passes under unit 18 and has caused this part of the building to be stretched by approximately 50mm. The crack continues through the adjacent blocks (unit 22) to the north and (unit 14) to the south causing 10 to 15 mm cracks in these foundations. These cracks are shown in Figure 8.

A site investigation would be required if building repairs or redevelopment is proposed. This investigation would ascertain the cause of the lateral spread ground cracking, e.g. establish if damage is either due to historic fill, old river channel or liquefaction.

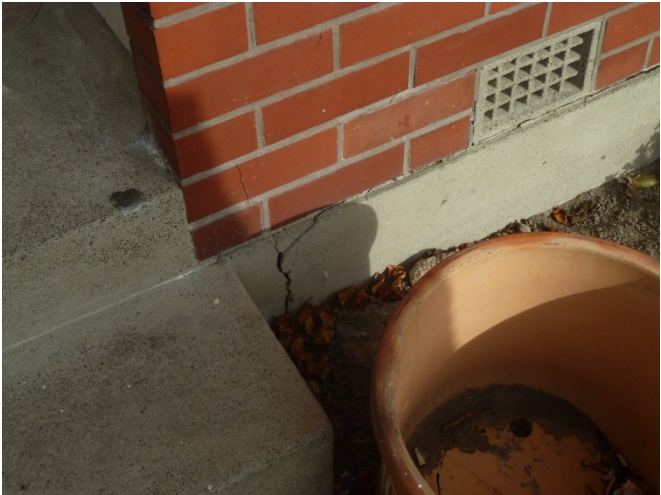
Cracking in the foundations of units 10, 14, 18, 19 and 23 was observed. These cracks were approximately up to 50mm wide (photos 9-11) in the foundations of unit 18 and 10mm-15mm wide in units 23 and 14.

10	Major cracking in foundations of unit 14

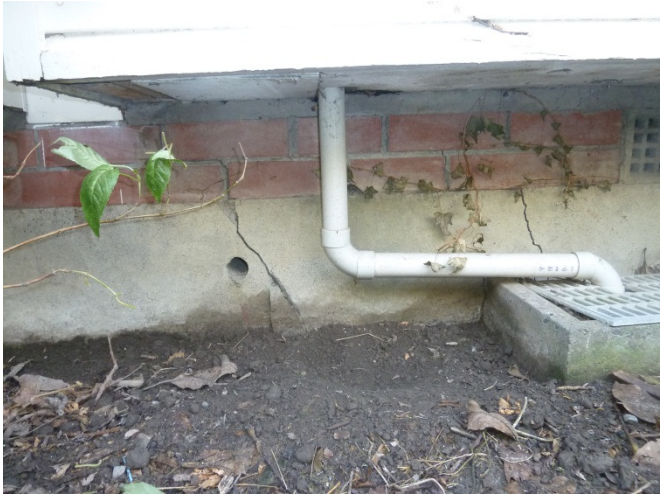
11	Cracking in foundations of unit 10

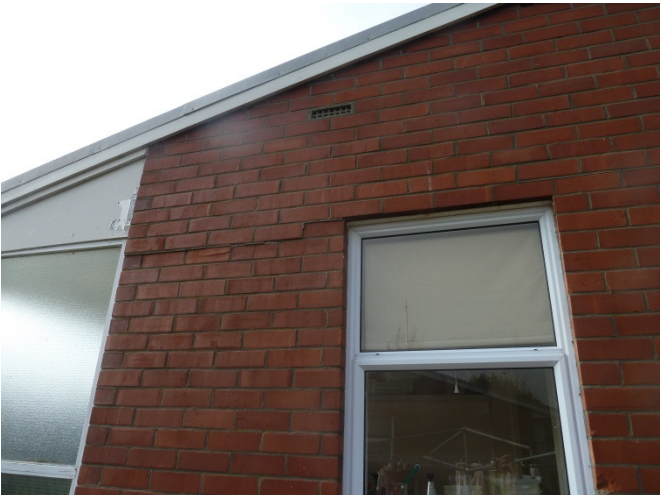
The end walls of units 12 and 28 experienced cracking in the mortar of the brick veneers (photo 13).

12	Cracking in mortar end wall of unit 12

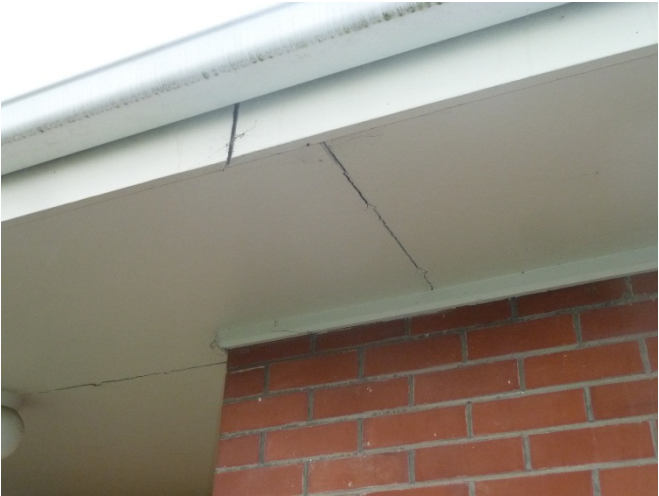
16	Cracking in soffit

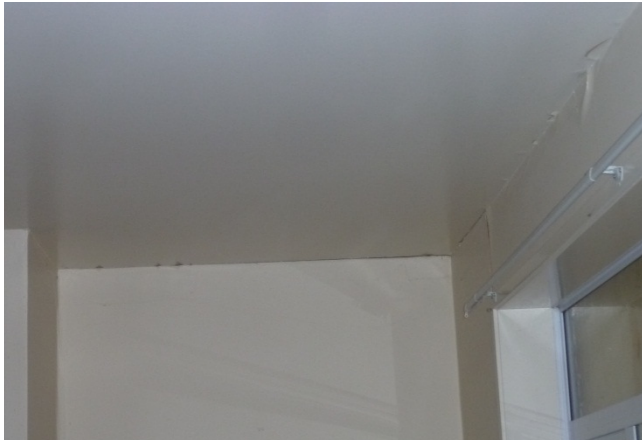
Some minor cracking of ceiling diaphragms and of plasterboard lined walls was observed in a majority of the units that were inspected.

17	Cracking in plasterboard and ceiling lining
