Maurice Hayes Place Housing Complex PRO 0855

**Detailed Engineering Evaluation
Quantitative Assessment Report**

Maurice Hayes Housing Complex Quantitative Assessment Report

Date: November 2013
Reference: 6-QC381.00
Status: Final

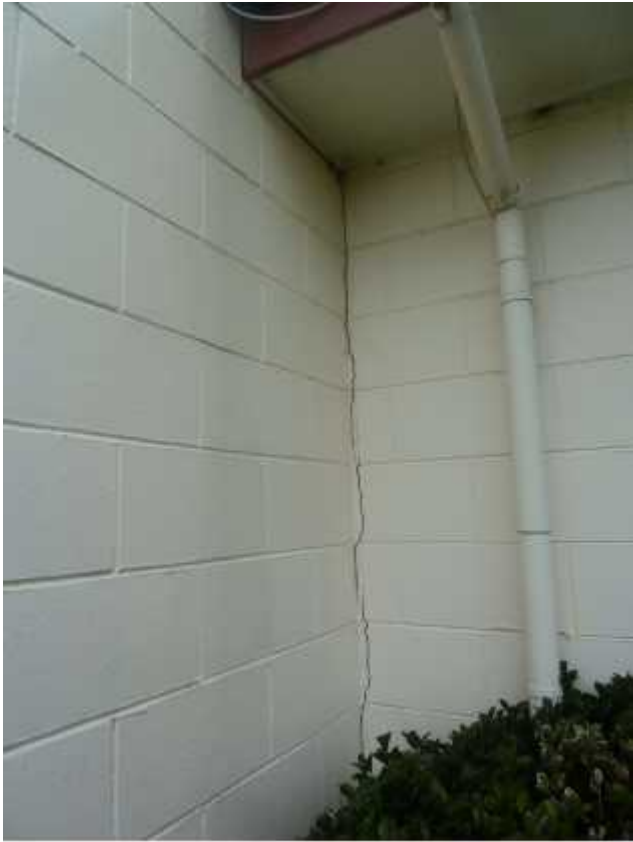
Cracking has occurred down the block veneer wall junction line between Units 17-18 (Photo 9, 10).

9	Cracking of exterior block veneer at wall junction between units 17-18

The step cracking of unit 6 suggests discontinuous settlement. The vertical crack between units 17 and 18 suggests that Block D has experienced lateral displacement. The lateral displacement is likely to be towards the tributary stream. No other evidence of lateral displacement was identified on the site visit.

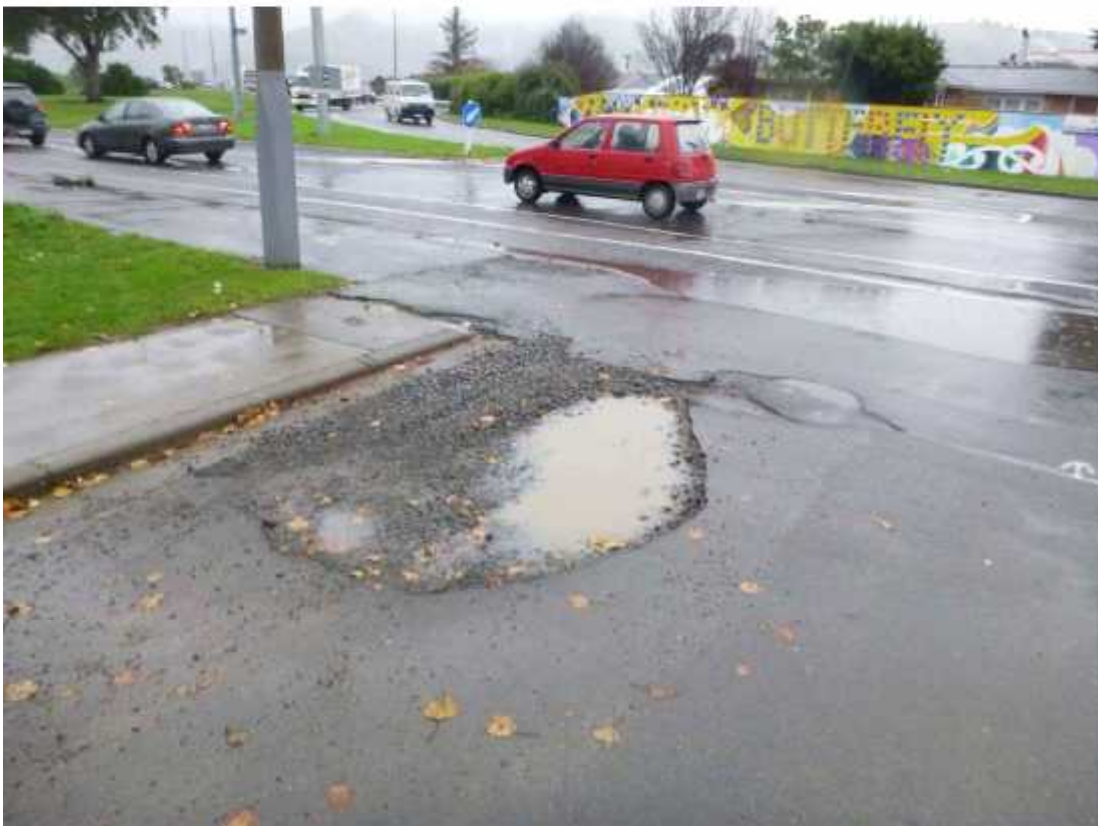
- Uplift, sand and silt evidence of liquefaction at properties entrance, refer to photo 2.
- 8mm crack between concrete path sections at unit 4/5 entrance, refer to photo 5.

Photo 2: Damaged access road

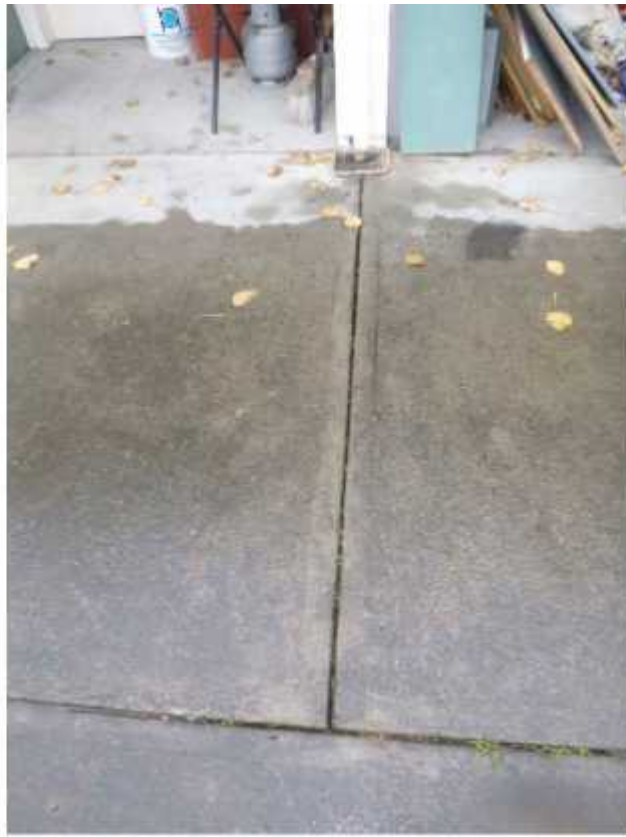
Photo 5: Spreading of concrete porch, up to 8mm

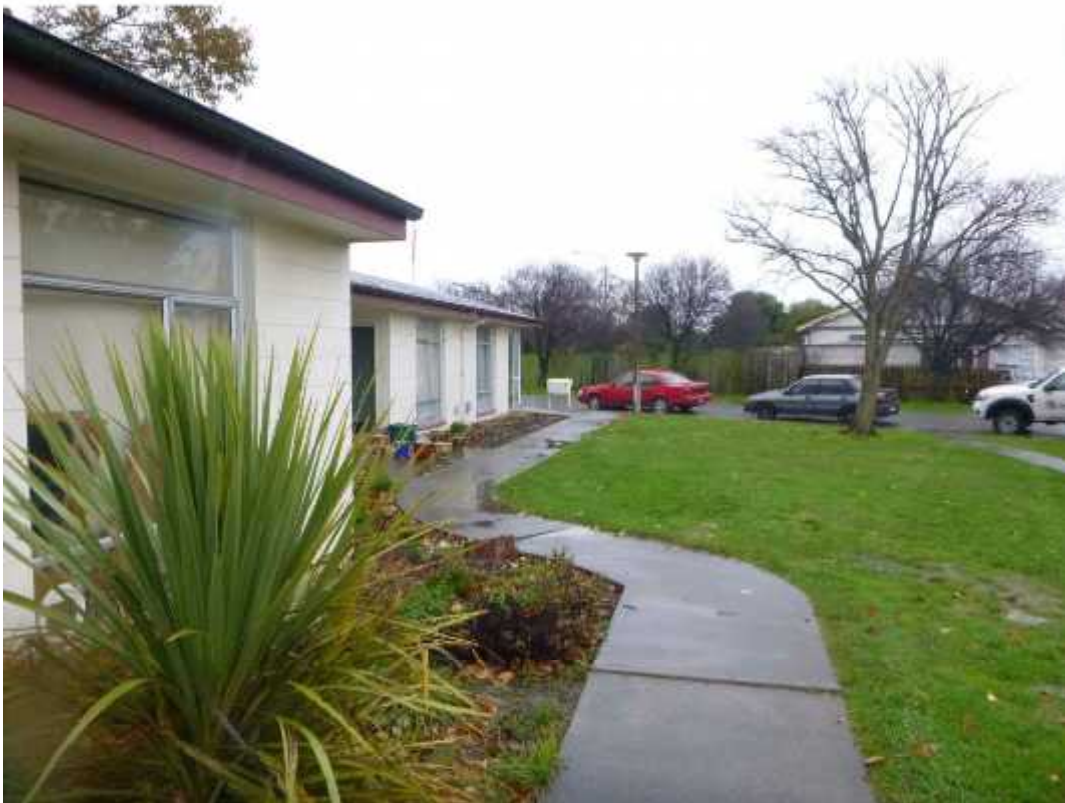
Photo 6: Front elevation of Block A, differential settlement of concrete path and liquefaction sand evident

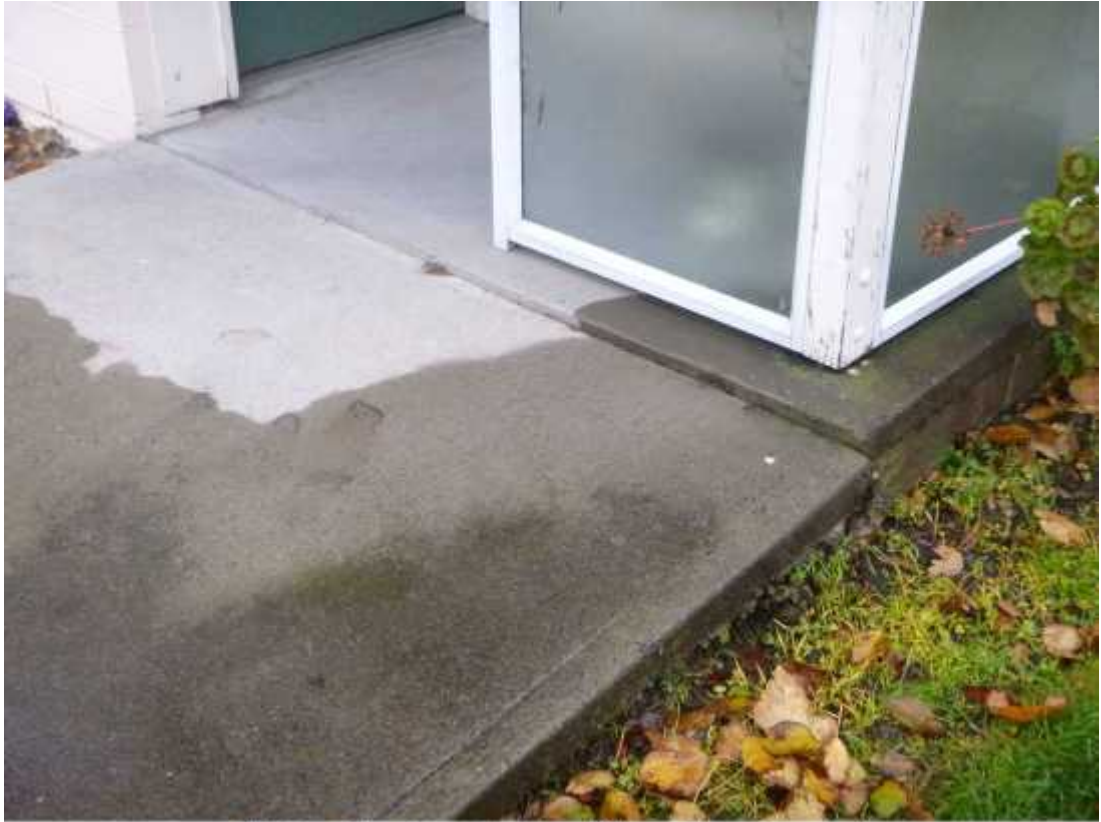
Photo 7: Front porch unit 1, differential settlement

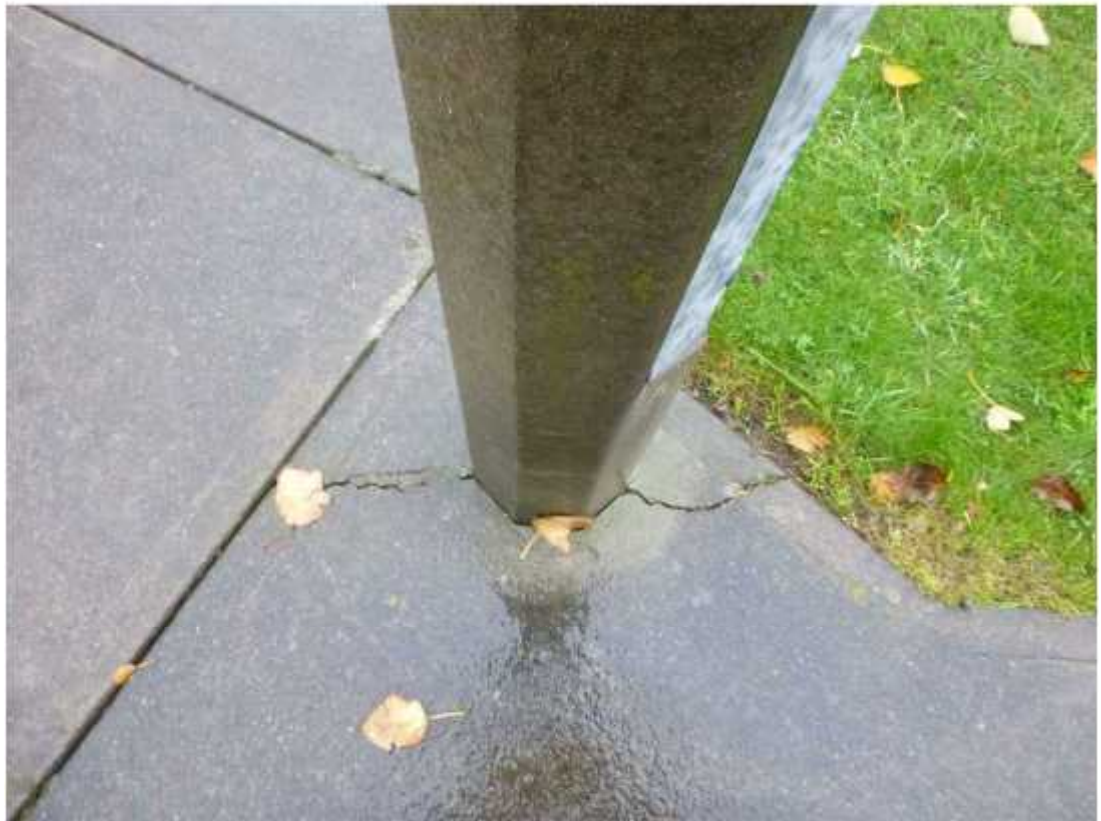
- 4mm crack around concrete lamp post, refer to photo 8.
- Step crack in brick wall and foundation on south side of unit 6, refer to photo 11.
- Depression in pavement, refer to photo 17 and 18.

Photo 8: Crack at lamp post adjacent unit 1

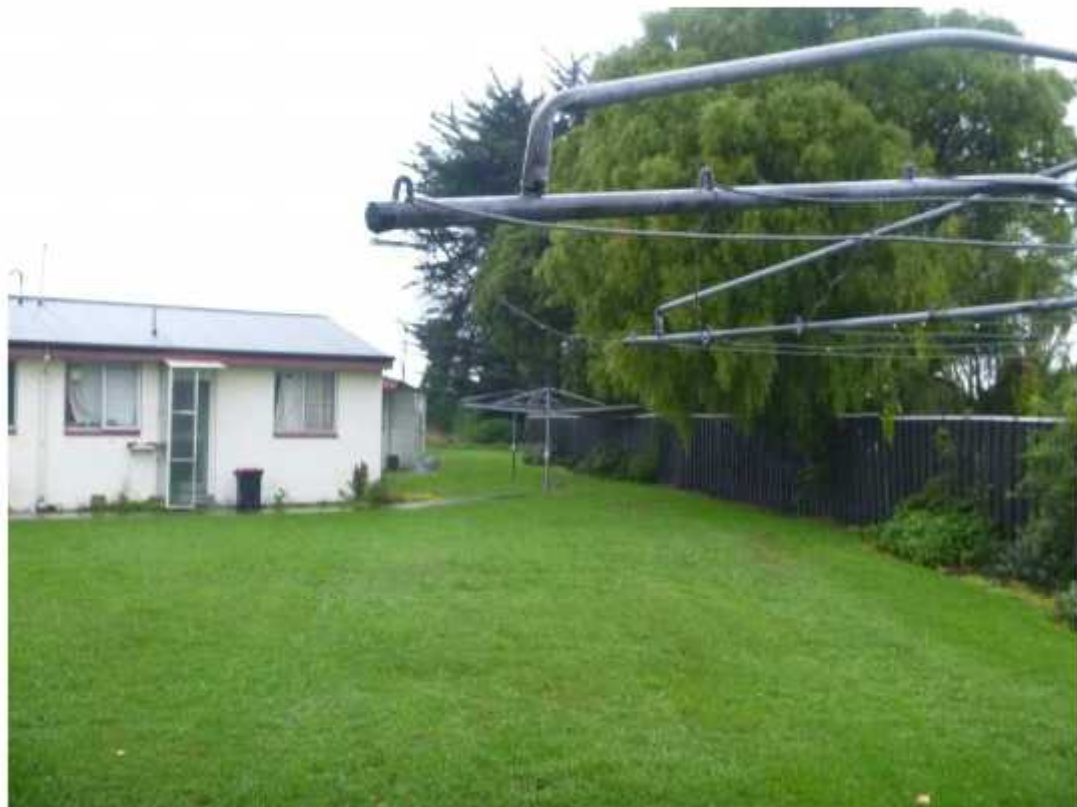
Photo 10: Back elevation of unit 15 and undulating ground profile

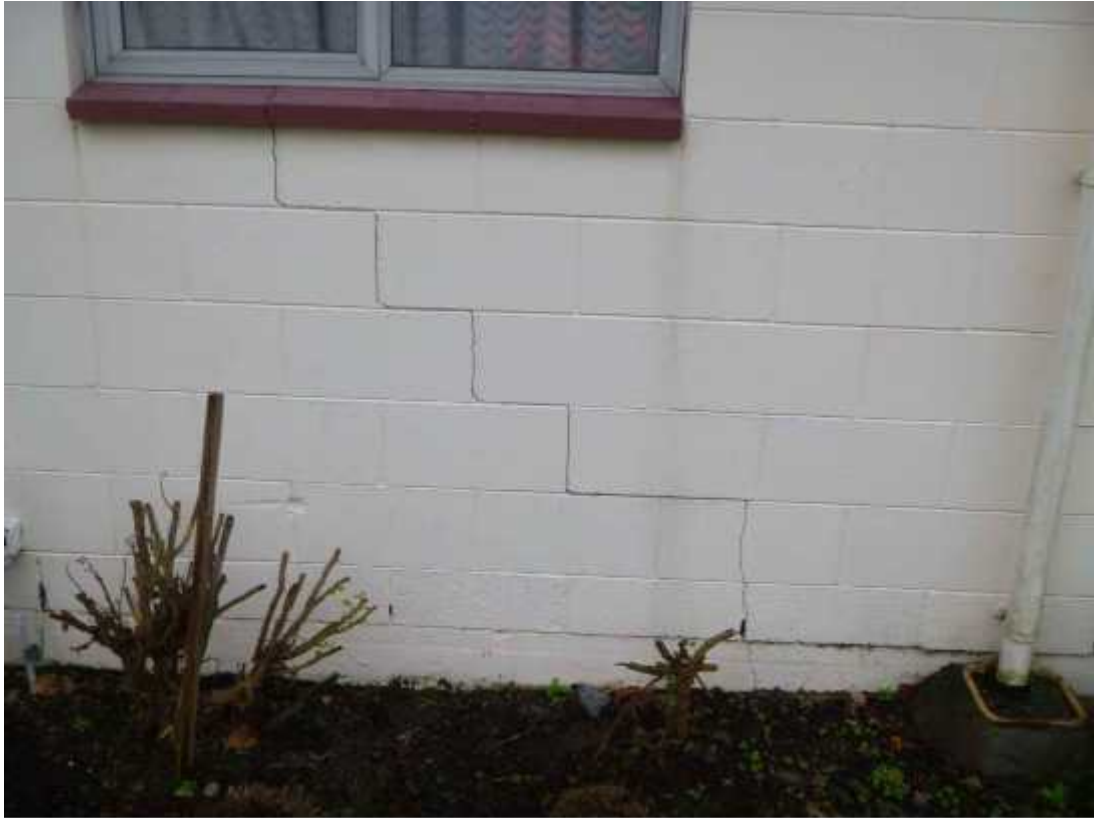
Photo 11: Back elevation of unit 6, step cracking of brick wall and foundation crack

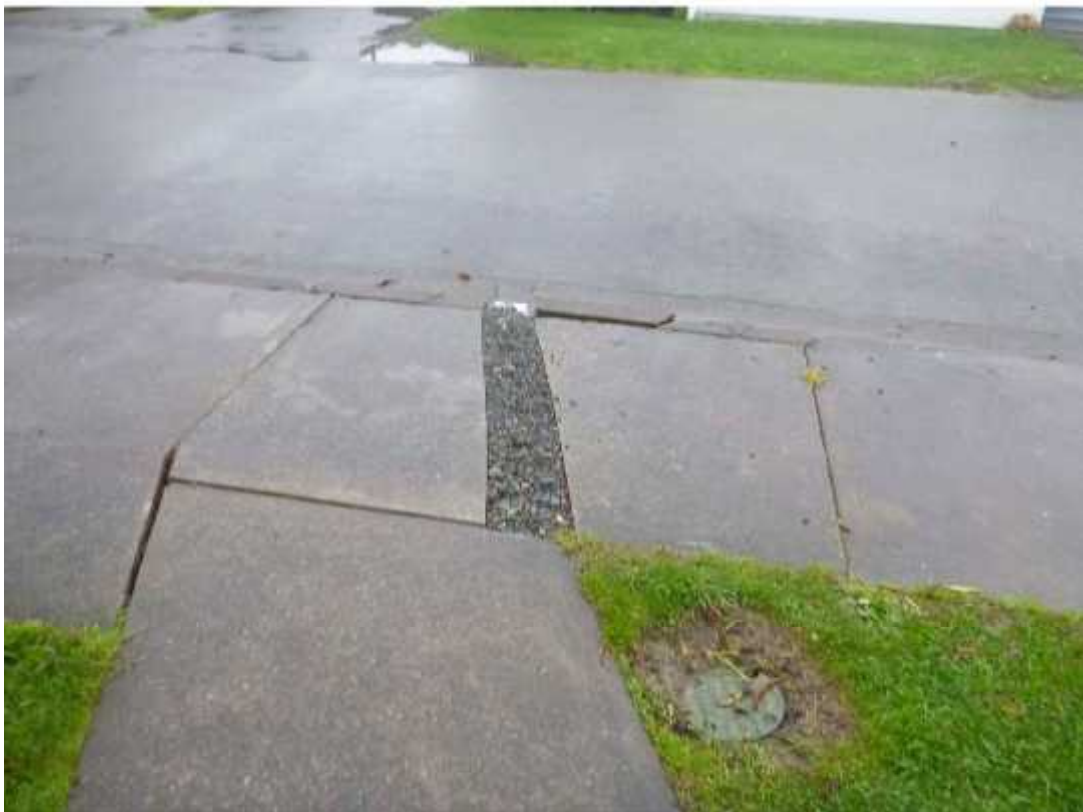
Photo 14: Separation of concrete path and curb damage

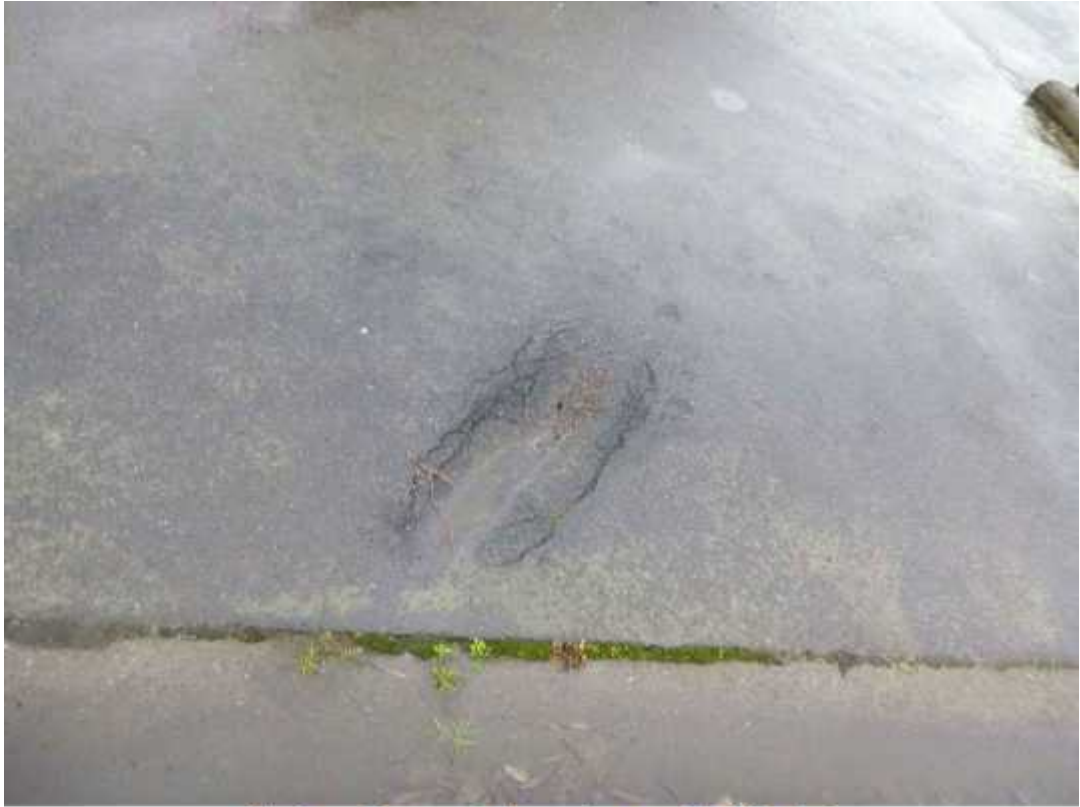
Photo 17: Pavement depression north of Block C

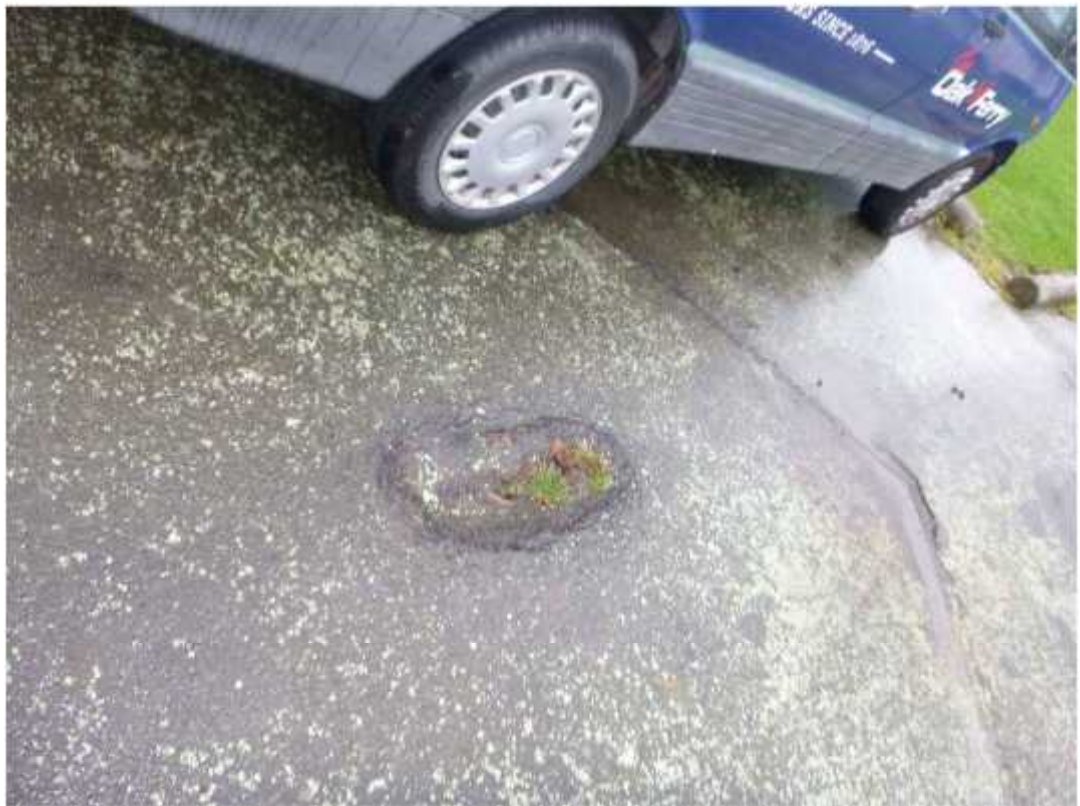
Photo 18: Pavement depression

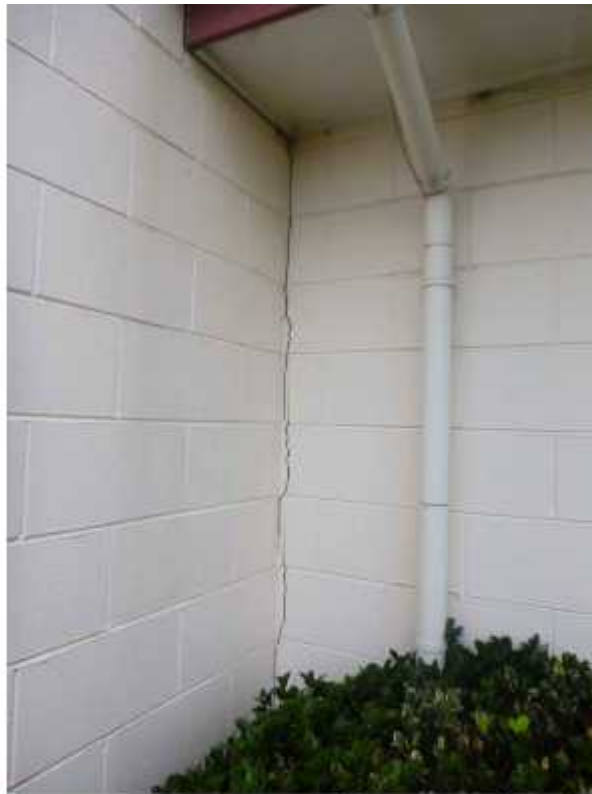
- 4mm vertical crack of the brick wall between unit 17 and 18 on the west side, refer to photo 19.
- 1-2mm cracking along bottom of brick wall and concrete floor slab of the north corner of unit 19, refer to photo 21

Photo 19: Brick veneer crack between unit 17 & 18

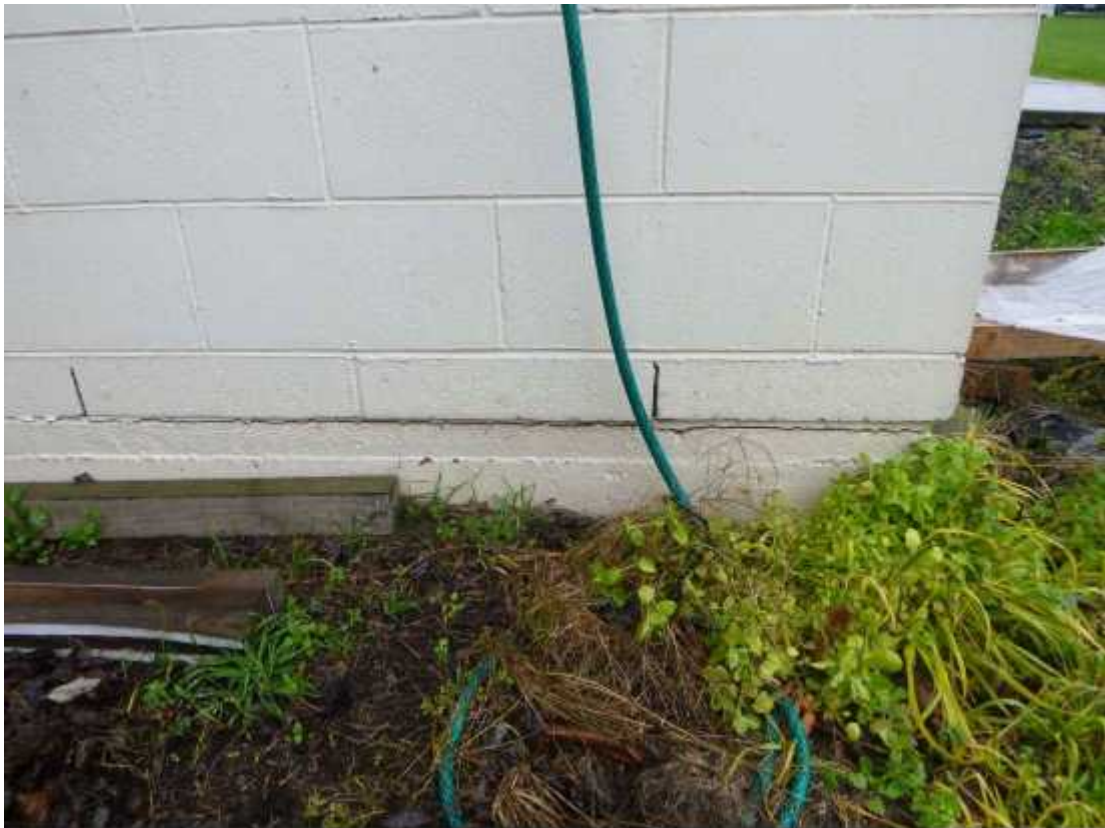
Photo 21: Cracking between brick veneer and foundation, north east corner of unit 19

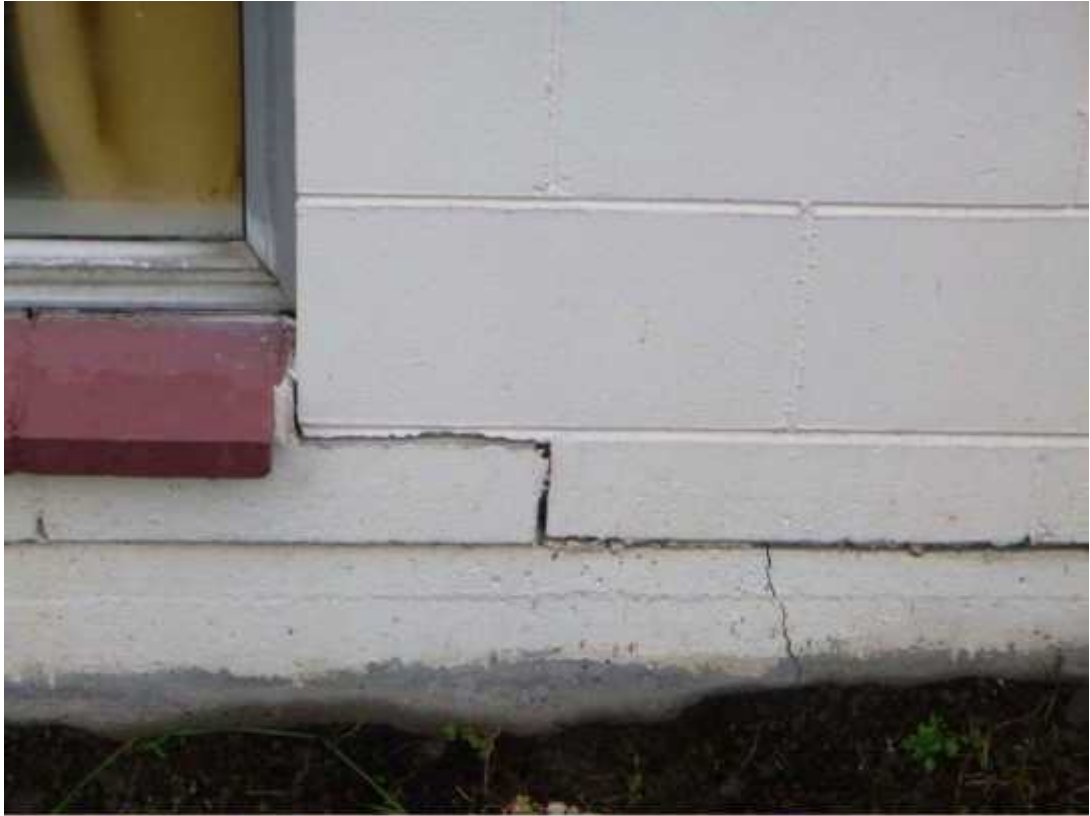
- 1-4mm crack at corner of window near entrance side of unit 19, refer to photo 23.
- 4mm crack in pavement, refer to photo 25.

Photo 23: Cracking of brick veneer and foundation, north west corner beneath window of unit

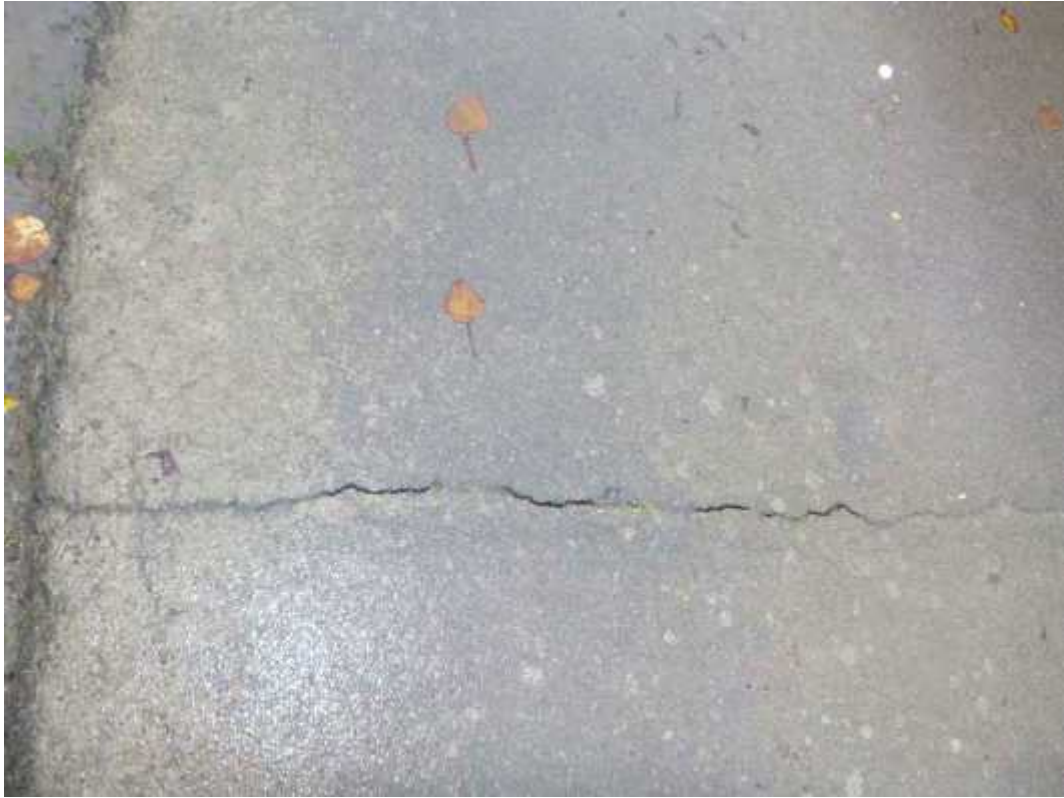
Photo 25: Pavement cracking on access road
