# City Care Milton Street Depot – Tradesmens Workshop Detailed Engineering Evaluation BU 1141-001 EQ2 Quantitative Report

Prepared for Christchurch City Council (Client)

By Beca Carter Hollings & Ferner Ltd (Beca)

4 October 2013

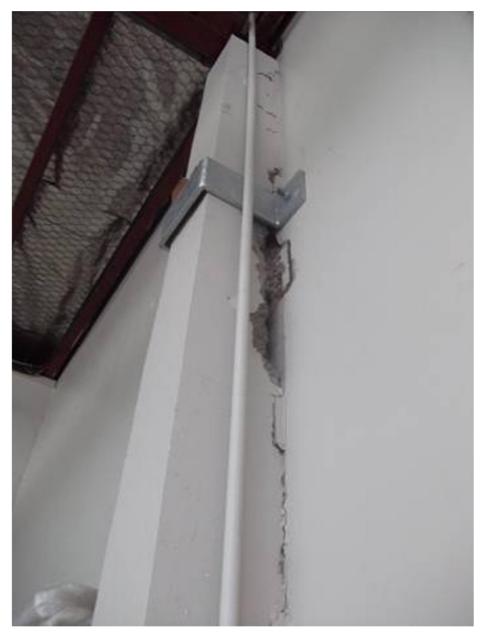
Photo 7: Damage to column encasement

The two areas have similar lateral load resisting systems, orientated in orthogonal directions. This will result in the buildings responding differently in each load direction and may be the cause of the damage to column in the Sign Shop area.

**Damage Description:** Possible pull out of connection causing damage to column encasement, with temporary repair bracket

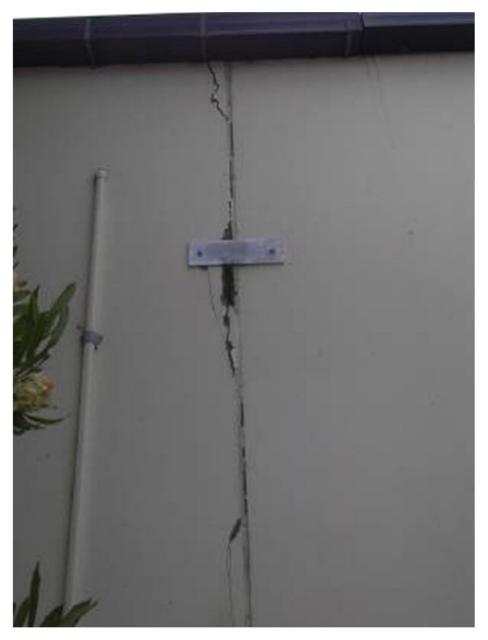
Photo 8: Damage to wall on other side of Photo 7.

**Damage Description:** Possible pull out of connection causing damage to column encasement, with temporary repair bracket

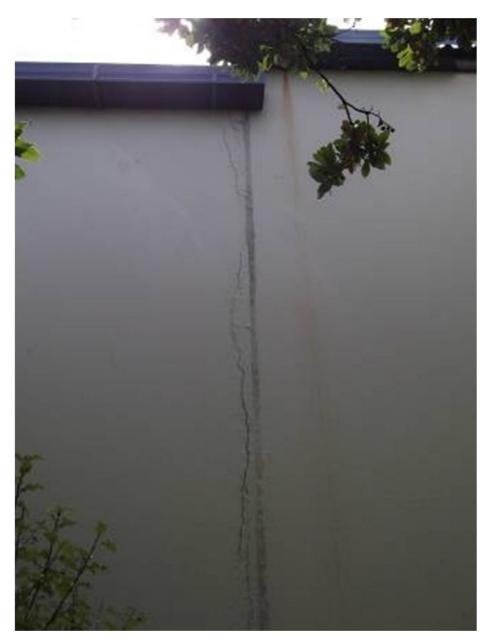
Damage Description: Cracking to concrete wall panel adjacent to movement joint

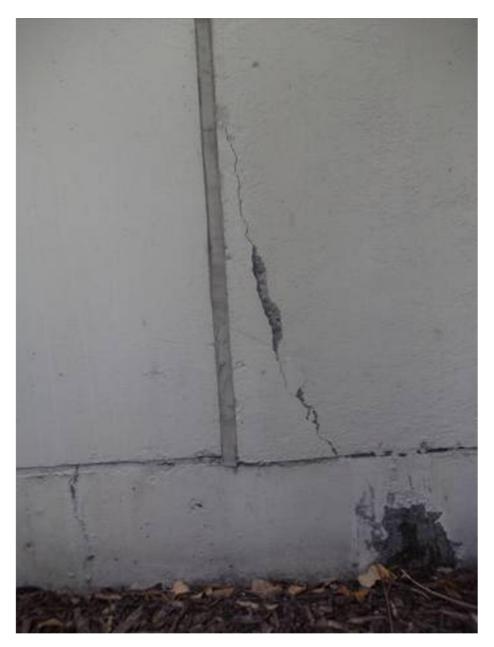
Photo 10: Typical cracking to concrete wall panel

**Damage Description:** Cracking to concrete wall panel at bottom corner adjacent to movement joint

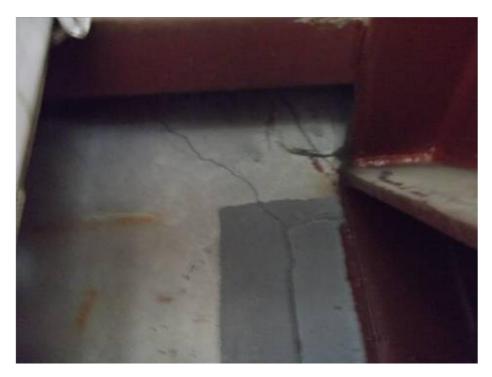
Photo 11: Typical cracking to concrete wall panel

Damage Description: Cracking to concrete wall panel protruding from weld plate at portal knee

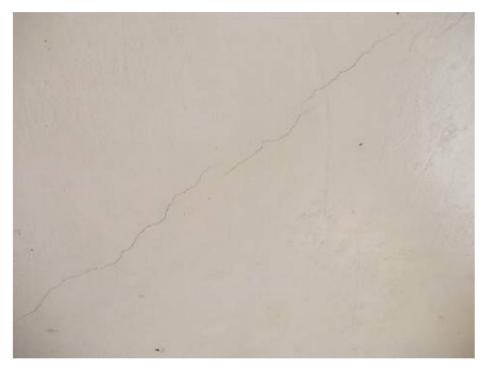
Photo 12: Cracking to concrete wall

Damage Description: Diagonal crack to concrete wall in stairwell

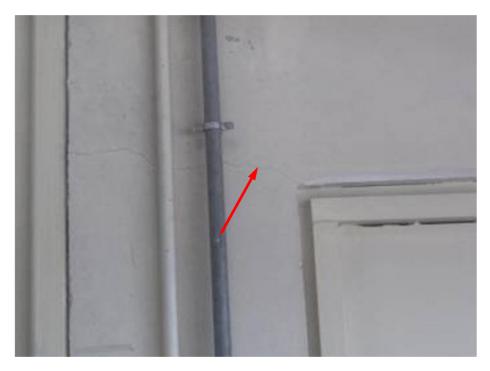
Photo 13: Cracking to concrete wall

Damage Description: Cracking to concrete panels in Plant Hire area protruding from doorway

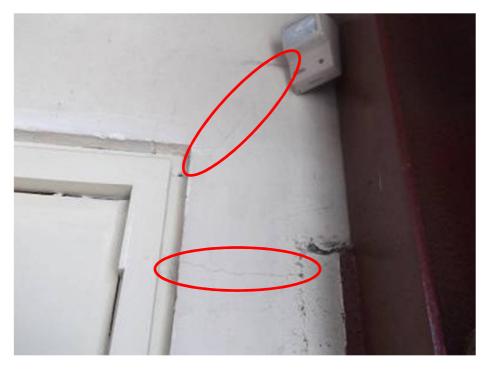
Damage Description: Cracking to concrete panels in Plant Hire area by doorway

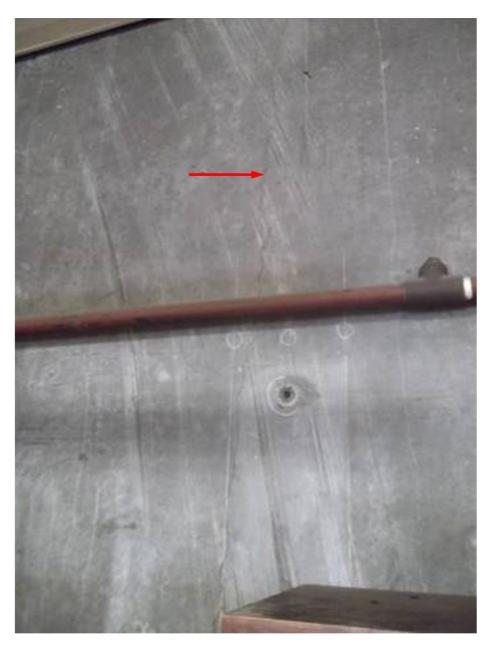
Damage Description: Cracking to concrete panels in Plant Hire area
