**CHRISTCHURCH CITY COUNCIL**  
PRK\_1415\_BLDG\_003 EQ2  
Old School Reserve Shed  
172 Major Hornbrook Rd, Mt Pleasant

QUALITATIVE ASSESSMENT REPORT  
FINAL

- Rev B
- 07 March 2013

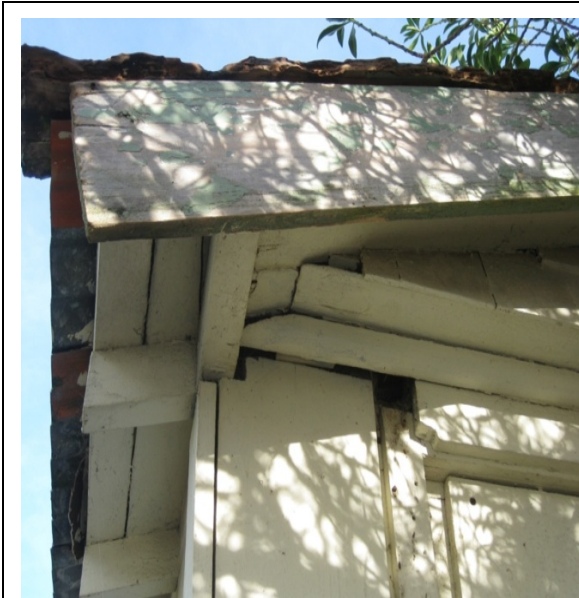
- 1) No earthquake-related external damage was observed during our site inspection.
- 2) Gaps opening up between the timber elements throughout the building were noted, but this is likely due to the age of the building and is not earthquake-related damage.
- 3) Cracking through the timber weatherboards were noted throughout the building, but this is likely due to the age of the building and is not earthquake-related damage.
- 4) Missing timber elements on the north soffit was noted, but this is not earthquake-related damage.

Photo 5: Gaps opening up between timber elements on north soffit.

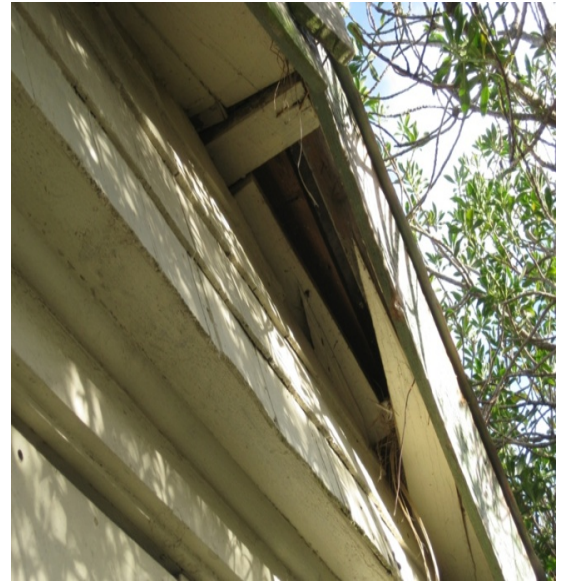
Photo 6: Missing timber elements on north soffit.

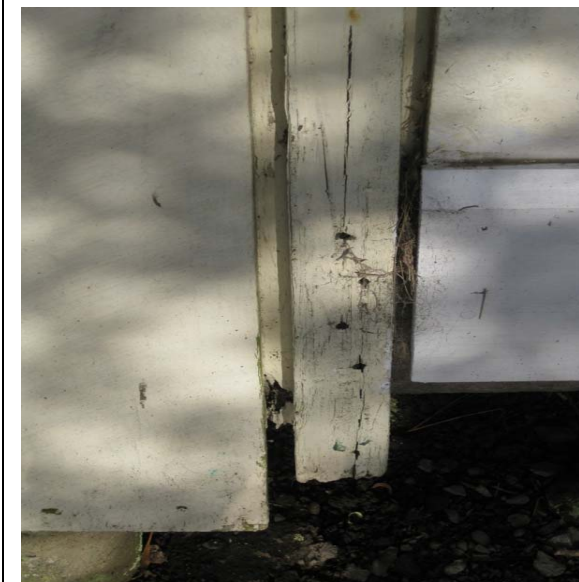
Photo 7: Longitudinal cracks in timber element on north wall.

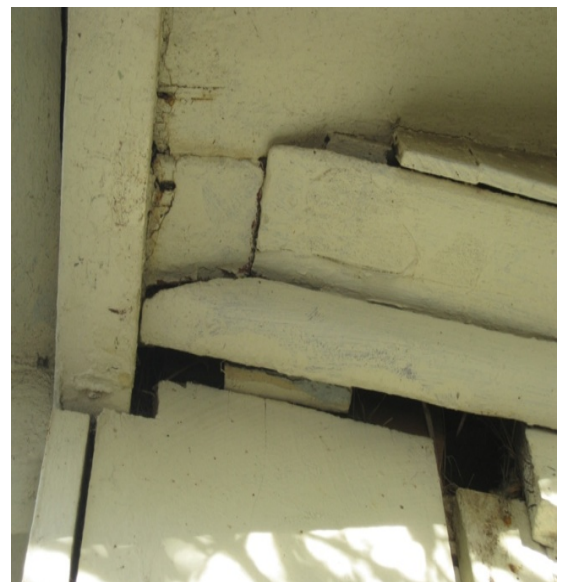
Photo 8: Gaps opening up between timber elements on north soffit.

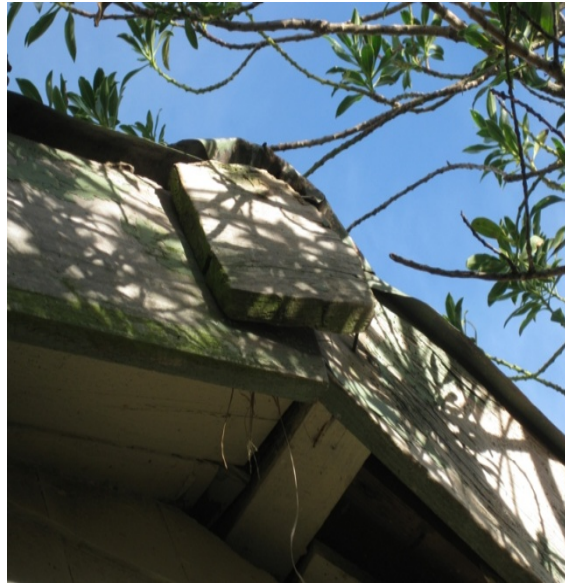
Photo 9: Loose timber element on north side of the building at roof level.

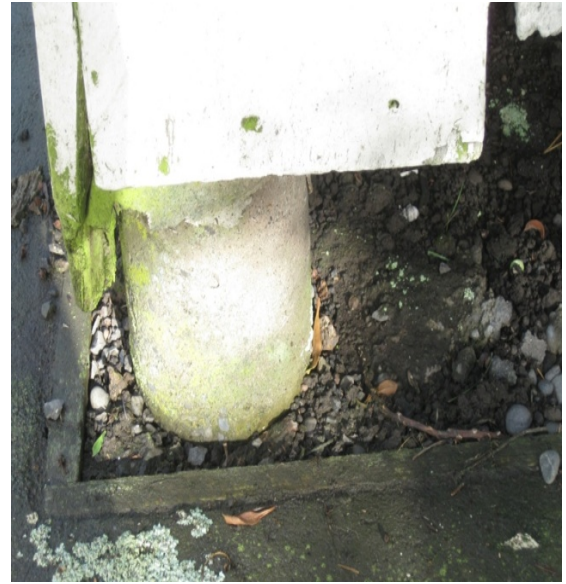
Photo 10: 150mm diameter concrete pile on northeast corner of building.

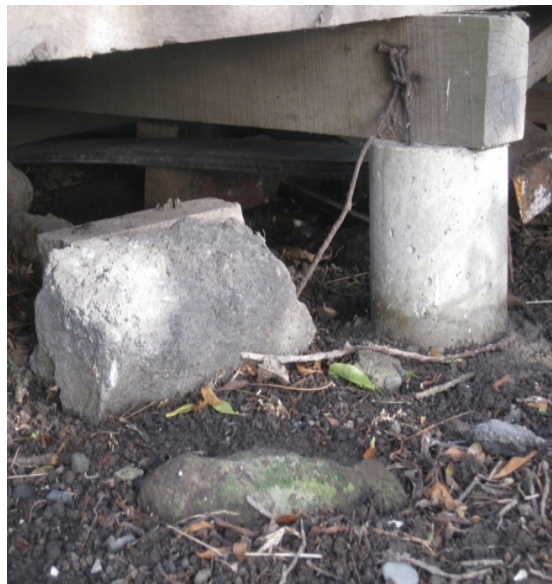
Photo 11: 150x50mm timber bearer spanning along the building at mid-span resting on concrete pile.

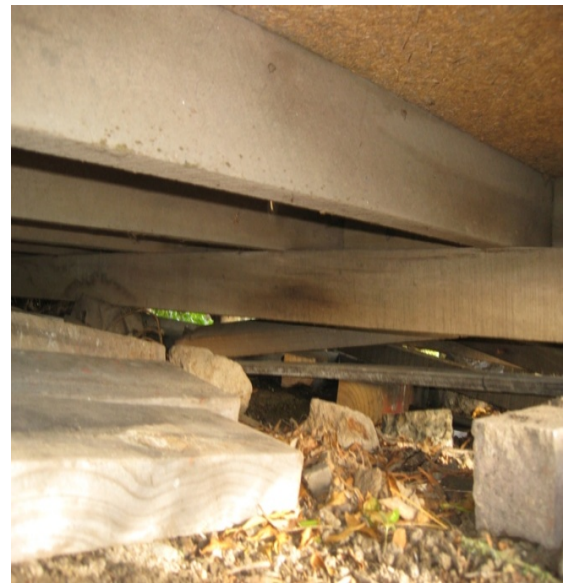
Photo 12: 150x50mm timber joists at 475mm centres spanning across the building with bearer at mid-span.

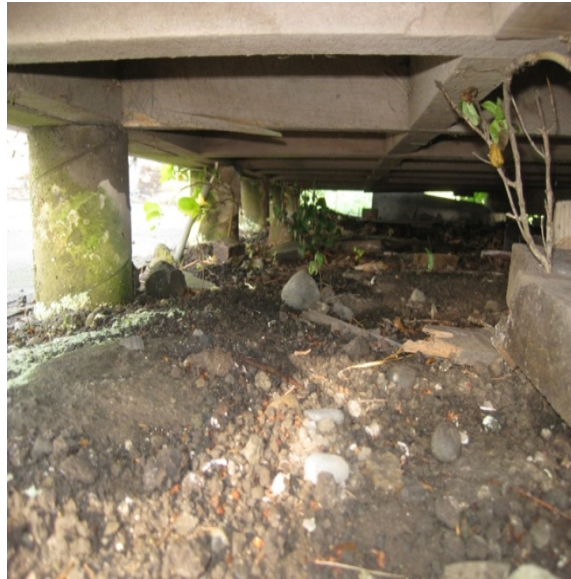
Photo 13: Concrete piles on east perimeter of building, with joists and 150x50mm nogs shown.

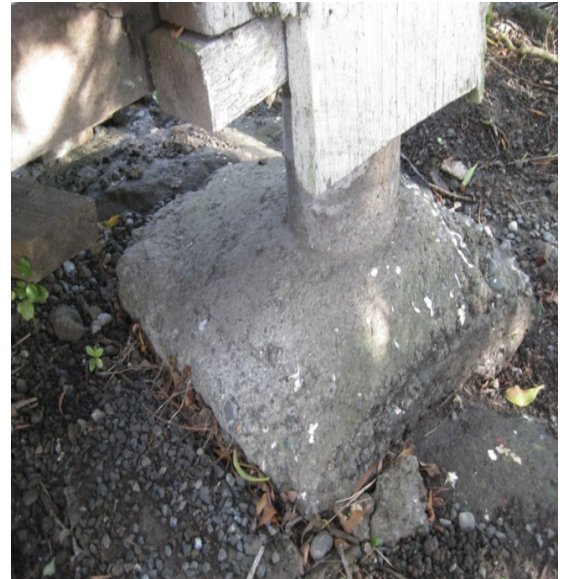
Photo 14: Concrete pile on northwest corner of building with 450mm square concrete footing exposed.

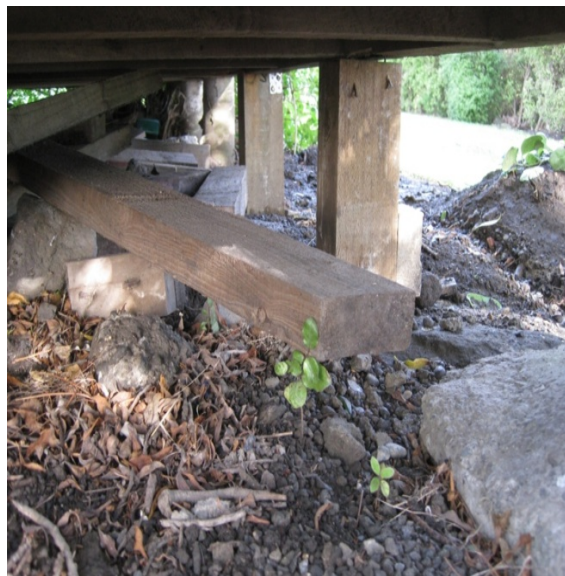
Photo 17: Two 130mm square timber piles in concrete footings replacing concrete piles on the west side.

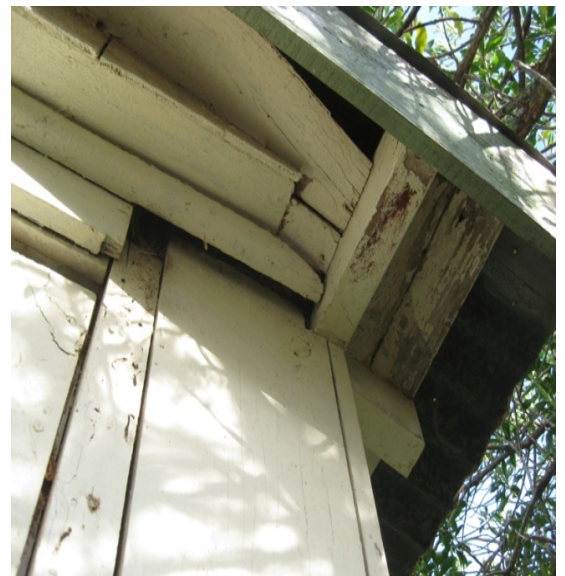
Photo 18: Gaps opening up between timber elements on north soffit.

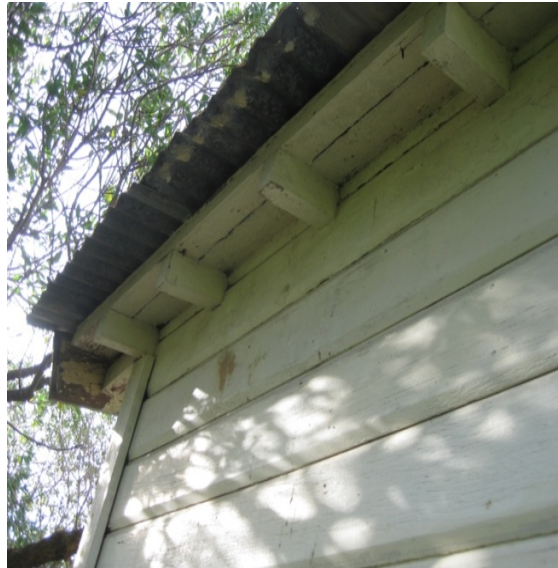
Photo 19: West soffit with timber elements and corrugated metal roof sheeting above.

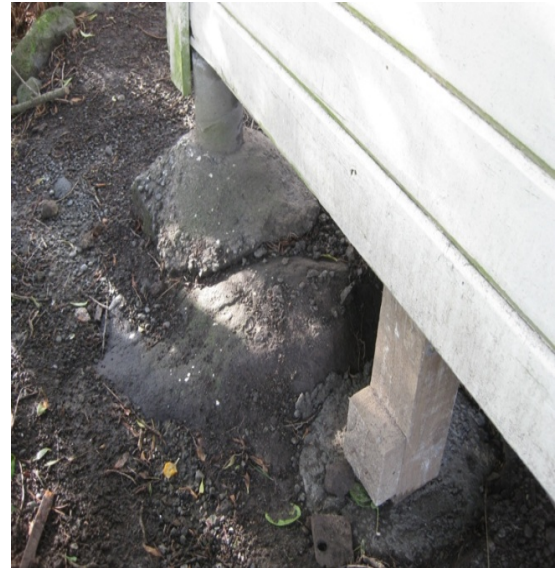
Photo 20: Northwest concrete pile and timber pile shown.

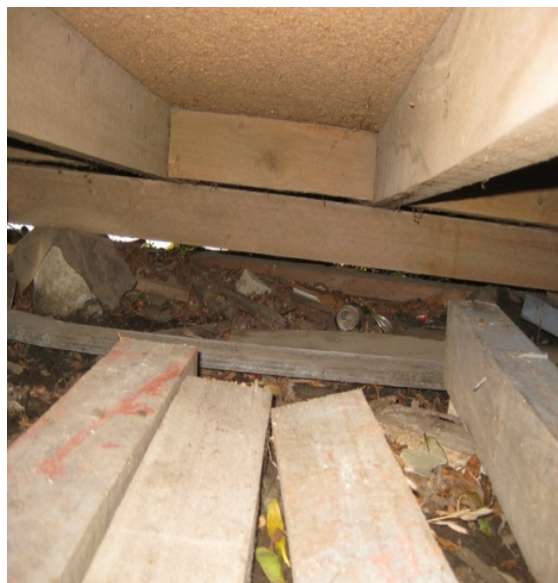
Photo 21: Timber joists on bearer at mid-span.

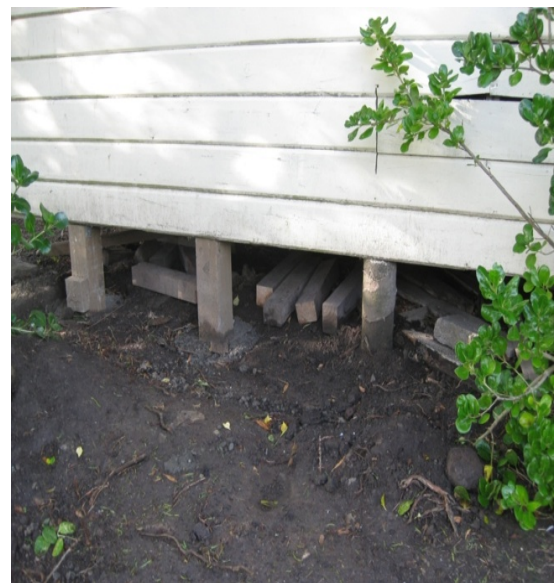
Photo 22: Two timber piles with a concrete pile on their right on the west side of the building are shown.

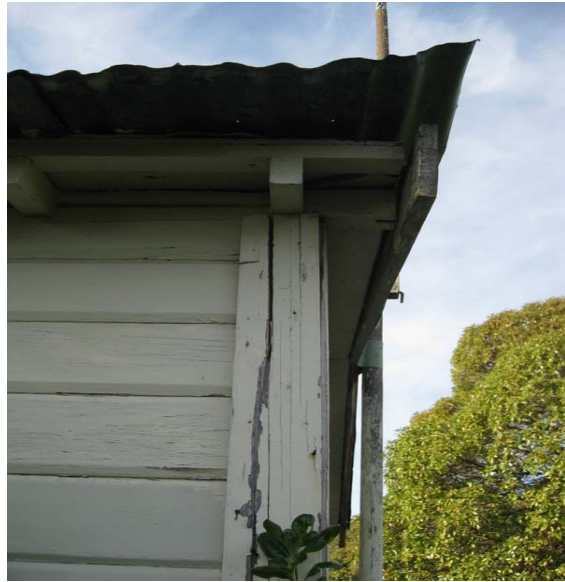
Photo 27: Longitudinal crack along timber element on southwest corner of building.

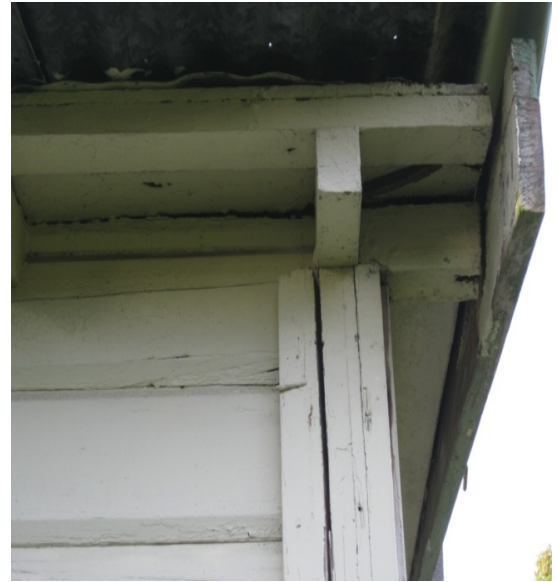
Photo 28: Longitudinal crack along timber element on southwest corner of building.

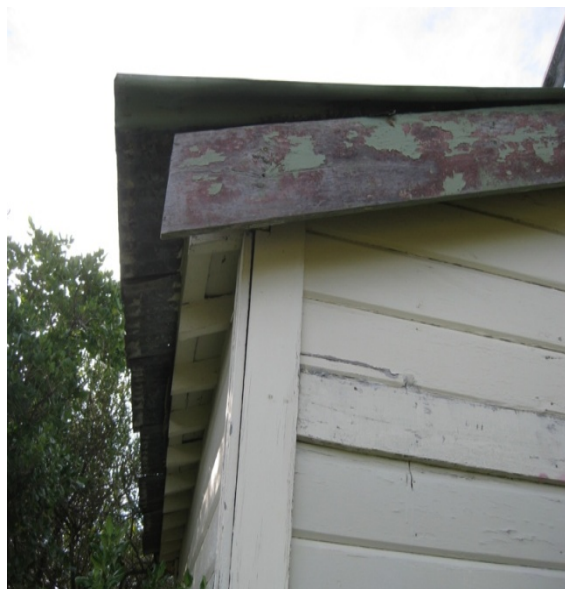
Photo 29: West soffit with corrugated metal roof sheeting above 80x50mm timber rafters at 450mm centres.

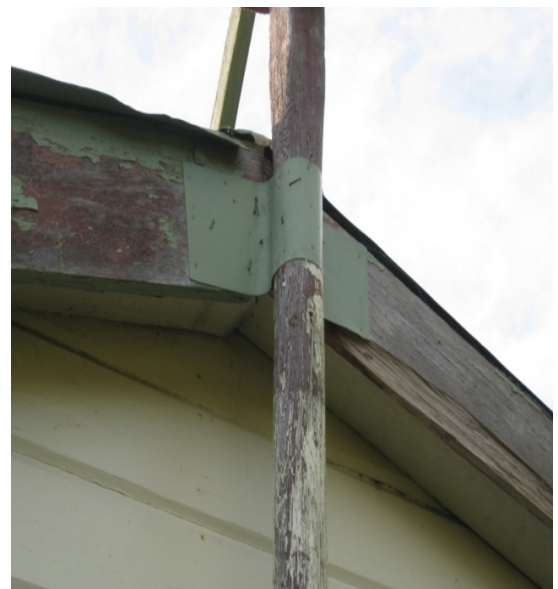
Photo 30: Metal plate support for timber post on south side of building.

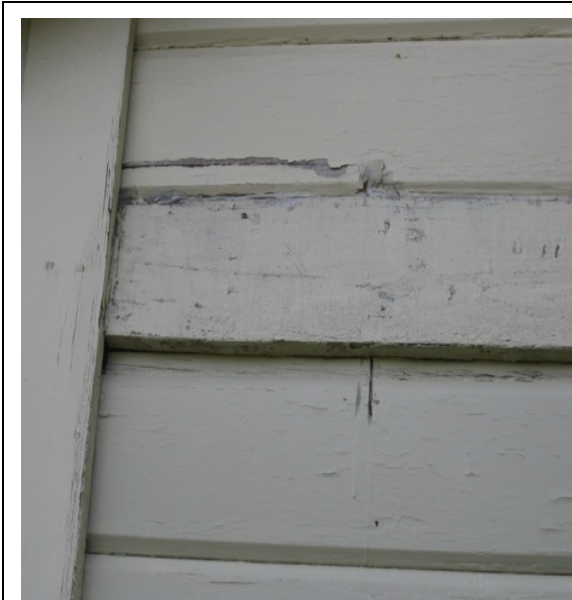
Photo 31: Longitudinal crack in timber weatherboard on south wall.

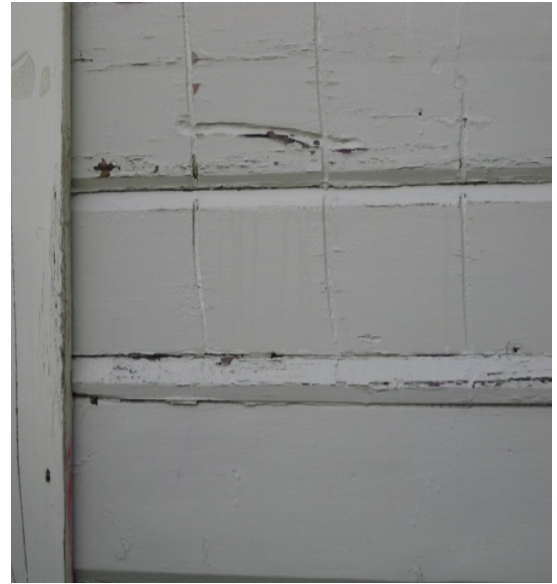
Photo 32: Longitudinal crack in timber weatherboard on south wall.

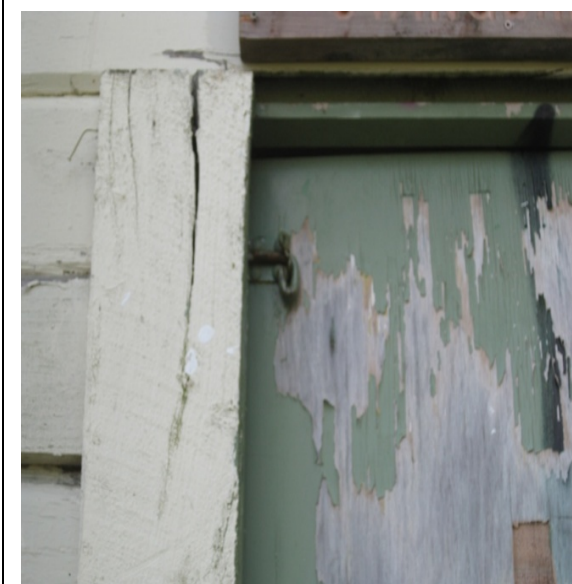
Photo 33: Longitudinal crack in timber element on south wall.

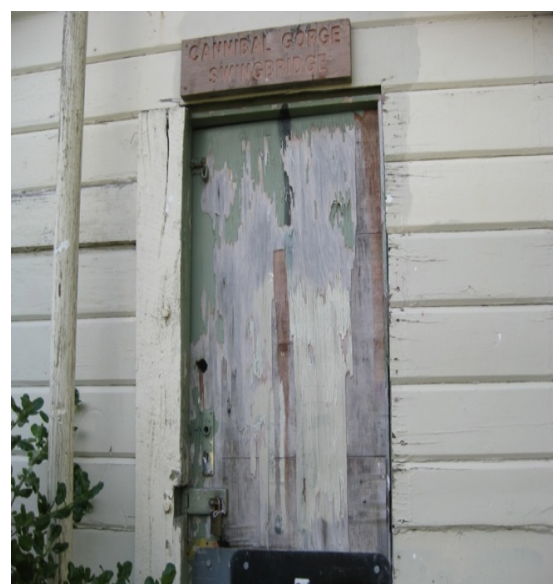
Photo 34: Entrance on south side of building.

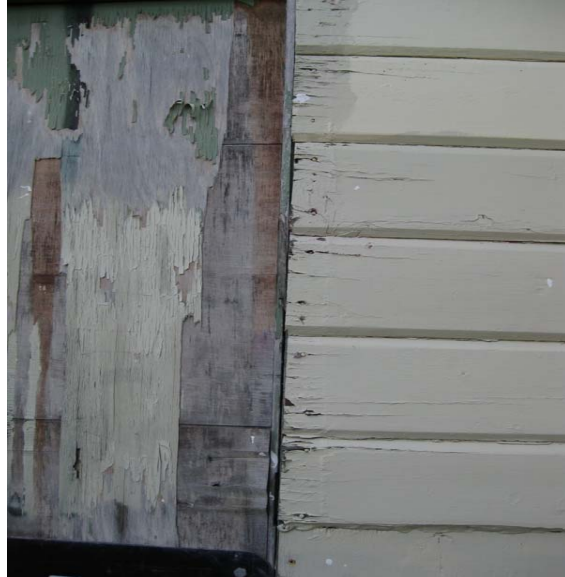
Photo 35: Longitudinal cracking in timber weatherboards at connections on south wall of building by entrance.

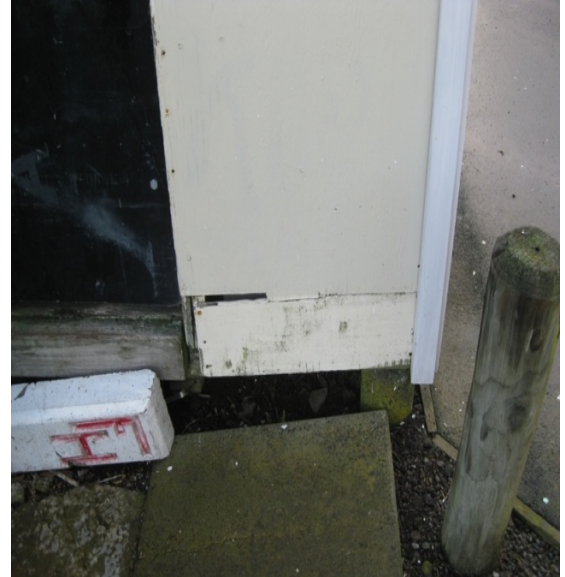
Photo 36: Plasterboard cladding on south wall, east of the entrance.

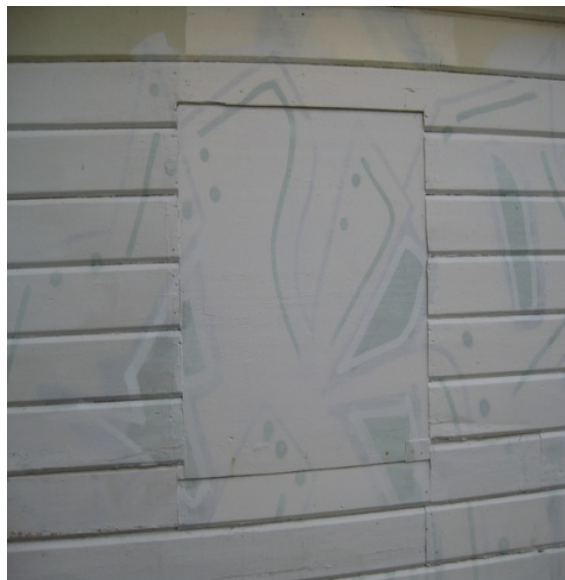
Photo 37: Covered opening on east wall.

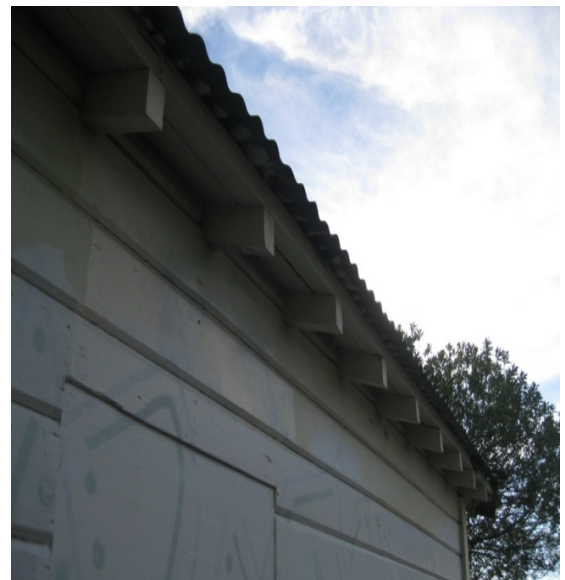
Photo 38: East soffit with corrugated metal roof sheeting above 80x50mm timber rafters at 450mm centres.

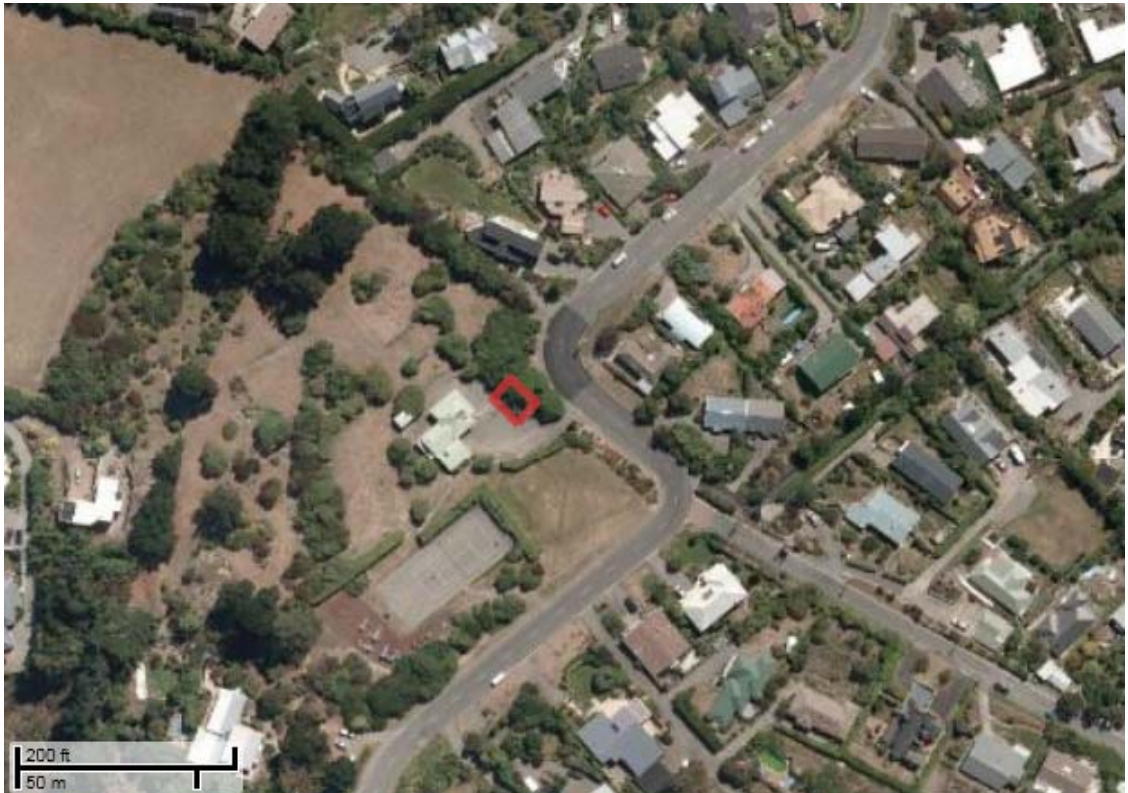
### ■ Figure 4 – Aerial photography from 24 Feb 2011 (<http://viewers.geospatial.govt.nz/>)

Aerial photography does not show any earthquake land damage i.e. rock fall or tension cracks after the 22 Feb 2011 event, however this type of damage may have occurred but not be visible. There has been shaking damage to roofs of some nearby dwellings.

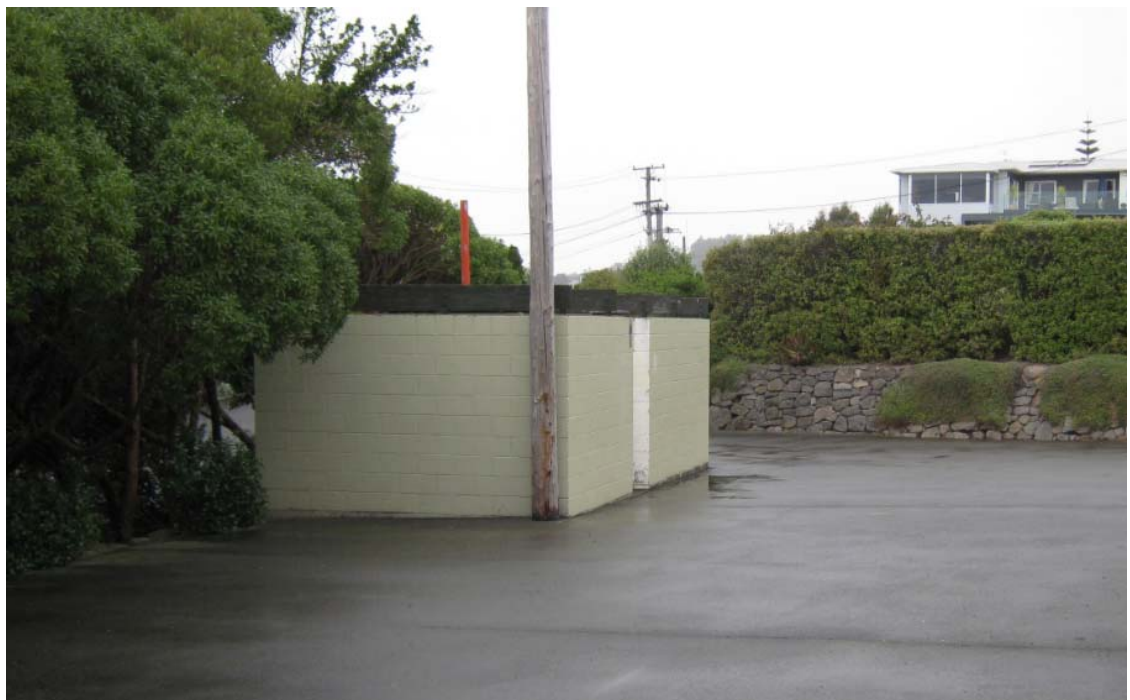
Very little damage could be seen on the toilet buildings on site, with minor hairline cracks in the foundation. Nearby buildings also exhibit very minor damage.

■ **Figure 6** Toilet block at Old School Reserve.

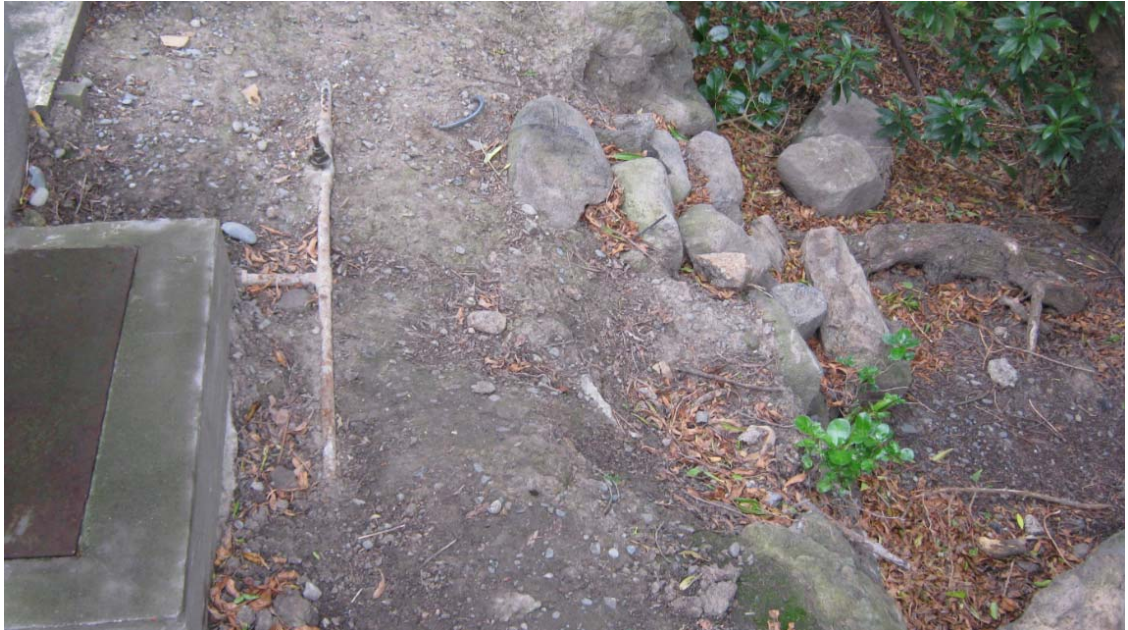
■ **Figure 8** Failed dry stack garden wall behind the toilet block
