Norman Kirk Memorial Pool – Main Plant Room Detailed Engineering Evaluation BU 3513-001 EQ2 Qualitative Report

Prepared for Christchurch City Council (CCC)

By Beca Carter Hollings & Ferner Ltd (Beca)

12 July 2013

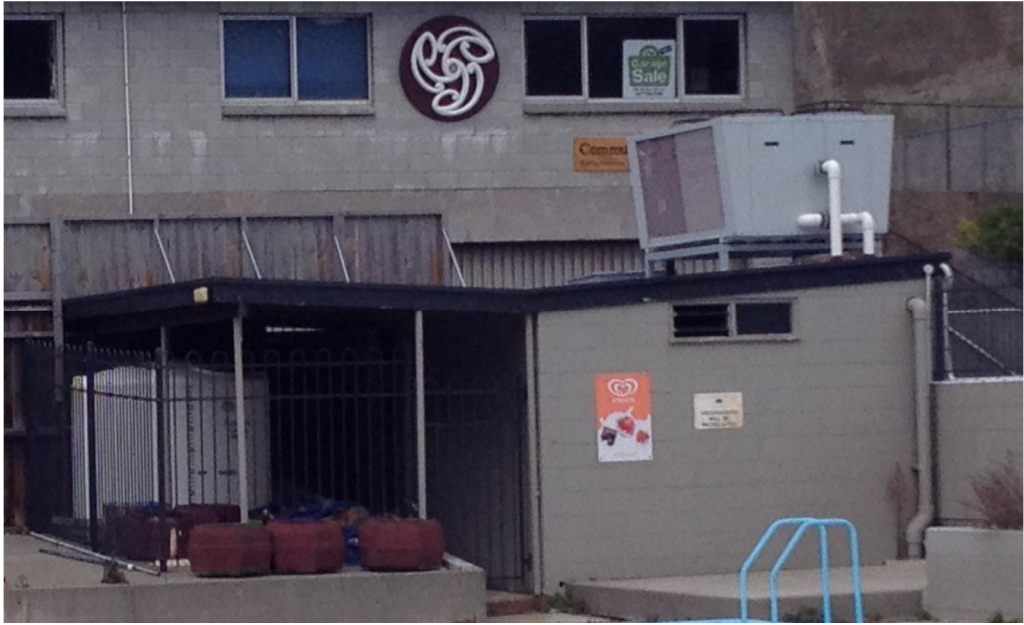
Photo 1: External view of Main Plant Room.

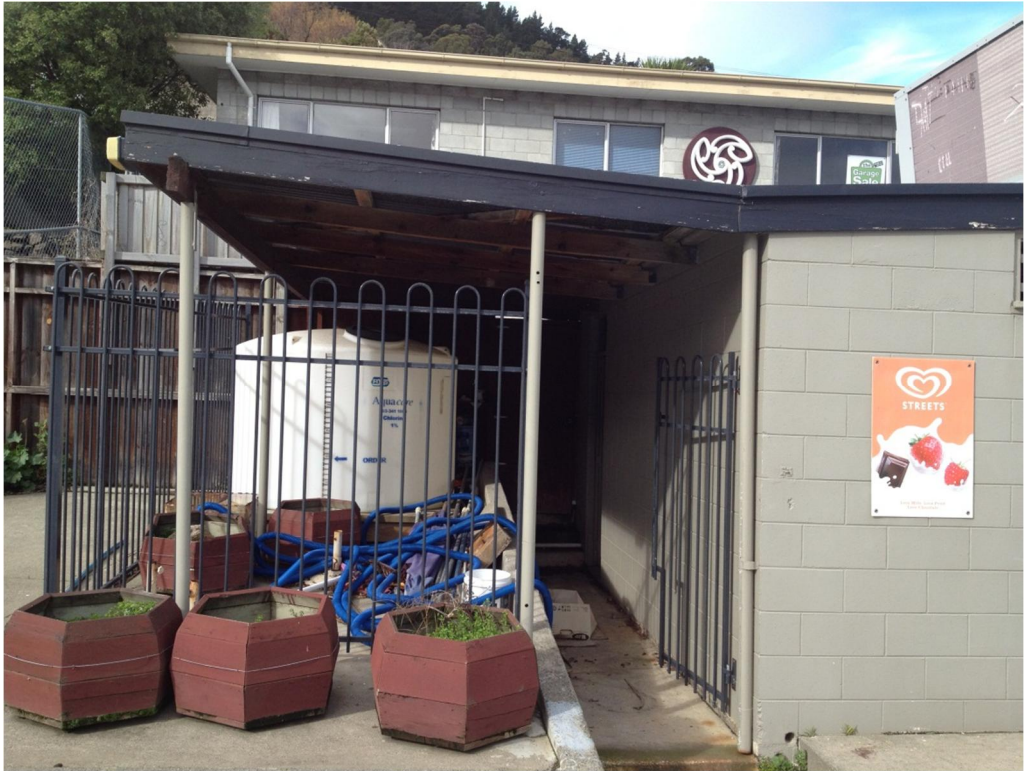
Photo 2: External view of Main Plant Room.

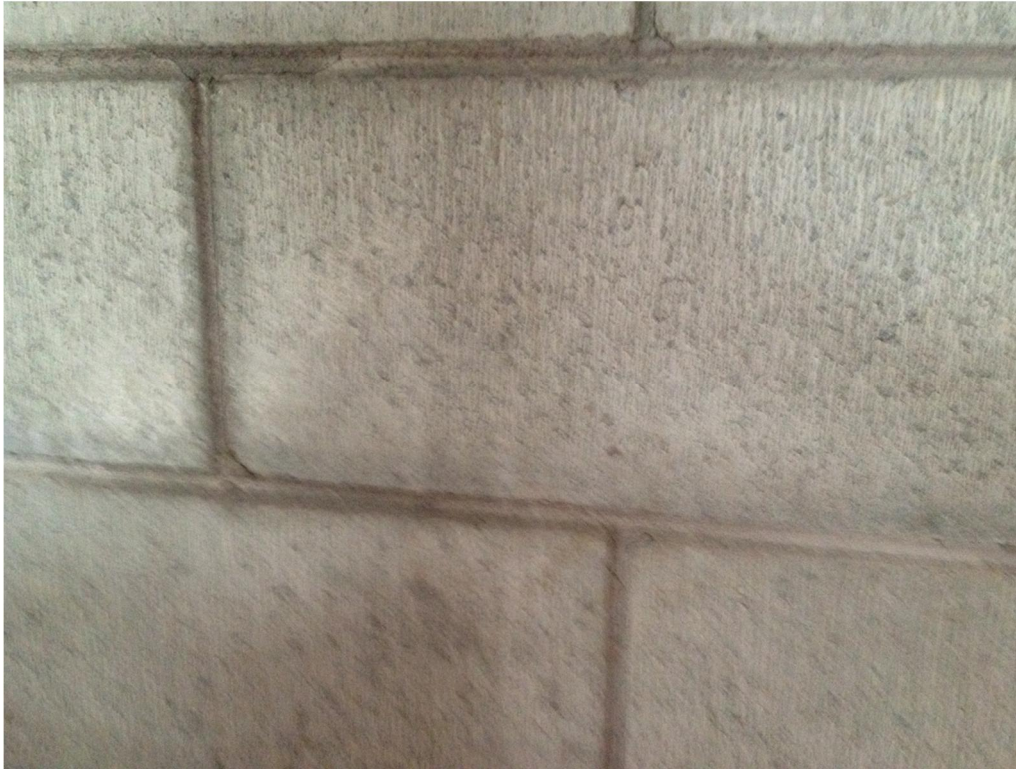
- n Minor cracking to concrete masonry block work mortar.

Photo 3: Internal concrete masonry block work.

Damage Summary: Minor mortar joint cracking.

Minor repairs are required to reinstate the existing structural system. No additional load paths are expected. A repair methodology has not been prepared at this stage.

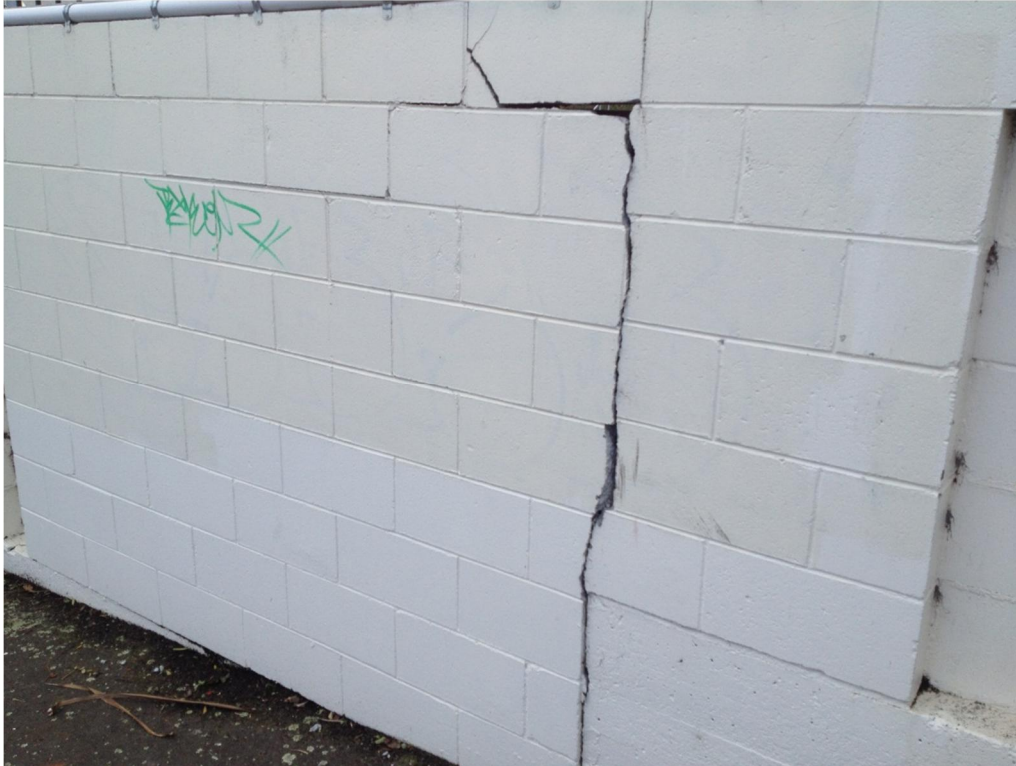
- n Extensive cracking to mortar and block work of adjacent concrete masonry block wall that extends along the driveway at the south of the site (between the Main Plant Room and Lean-to Shelter).

To the west of the Main Plant Room (along the driveway to the south of the site) is a partially filled and lightly reinforced concrete masonry block wall that sustained damage to both the blocks and mortar. The cracking is vertical in nature and the damage observed suggests local differential settlement. It was identified that the likely cause for the differential settlement is the founding of the concrete masonry wall on two concrete retaining walls (refer Photo 4 in Appendix A). The differential settlement on the western side of the cracking coincides with the differential settlement and sloped pavement in the Lean-to Shelter proximity (refer BU 3513-006 EQ2 Qualitative Report).

Photo 4: Adjacent concrete masonry block wall along driveway between Main Plant Room and Lean-to Shelter. The Main Plant Room is immediately to the right of this photo (view from south).

Damage Description: Cracking and differential settlement of concrete masonry block wall.

- n An investigation is undertaken to determine the structural integrity of the retaining wall along the driveway at the south of the site.
- n A geotechnical investigation is undertaken into the stability of the surrounding landscape and large retaining wall to the east of the site.

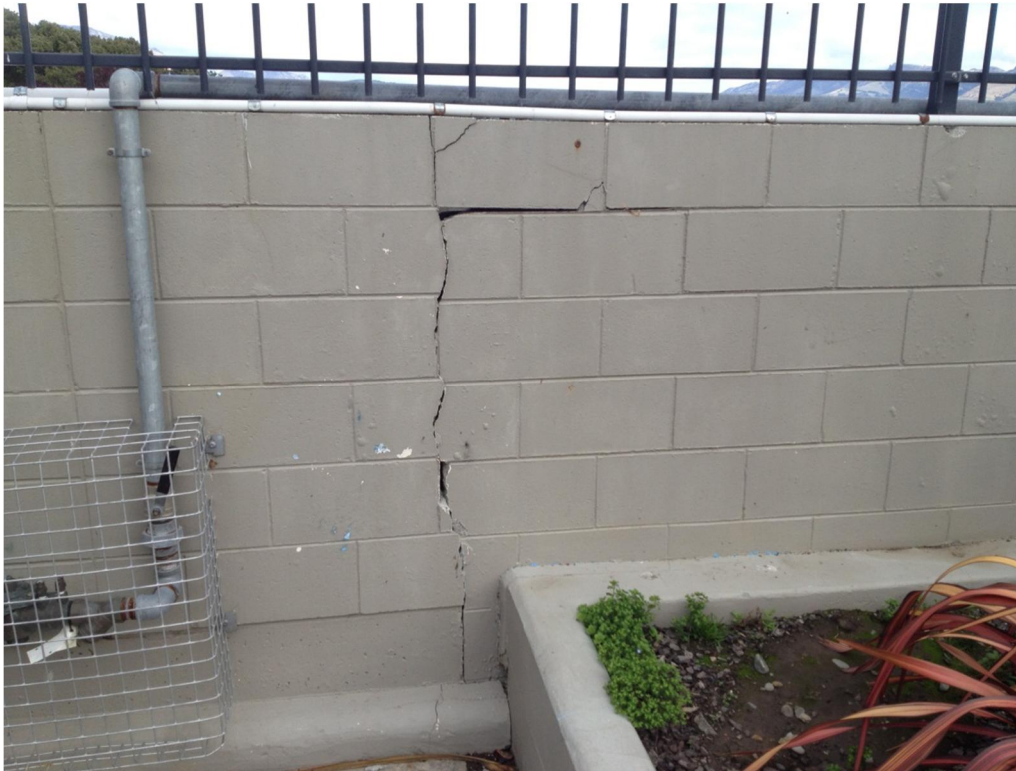
Photo 5: Adjacent concrete masonry block wall along driveway between Main Plant Room and Lean-to Shelter. The Main Plant Room is immediately to the left of this photo (view from north).
Damage Description: Cracking and differential settlement of concrete masonry block wall.

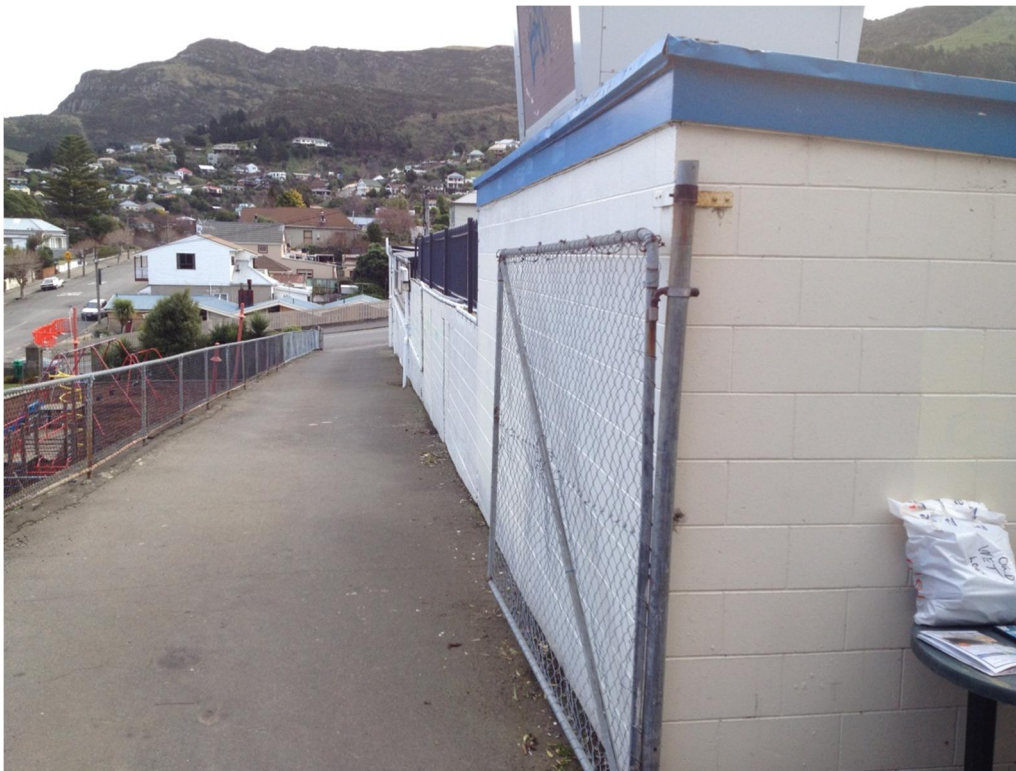
Photo 6: View along the driveway at the south of the site. The Main Plant Room is in the foreground (view from east).

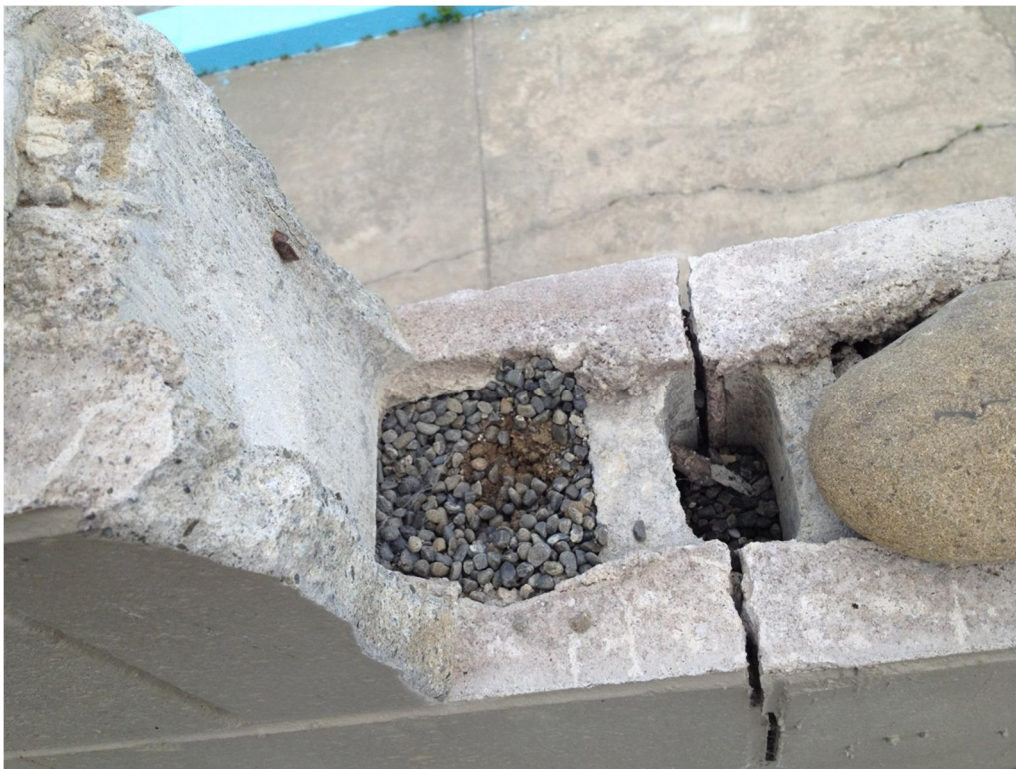
To the north side of the pool is a concrete retaining wall approximately 2m high with a 2m high concrete masonry block fence on top that is significantly damaged (refer Photo 7 and Photo 8 in Appendix A). The block fence section appears to be very lightly reinforced and has minimal fill. It appears likely that the block fence will need to be demolished and reconstructed with an appropriately engineered replacement.

Photo 8: Concrete masonry fence to the north of the pool.

Damage Description: Cracked and dislodged concrete masonry units.
