# Norman Kirk Memorial Pool - Men's Change Room Detailed Engineering Evaluation BU 3513-003 EQ2 Qualitative Report

## Norman Kirk Memorial Pool Men's Change Room BU 3513-003 EQ2

### Detailed Engineering Evaluation Qualitative Report – SUMMARY Version 1

54 Oxford St  
Lyttelton

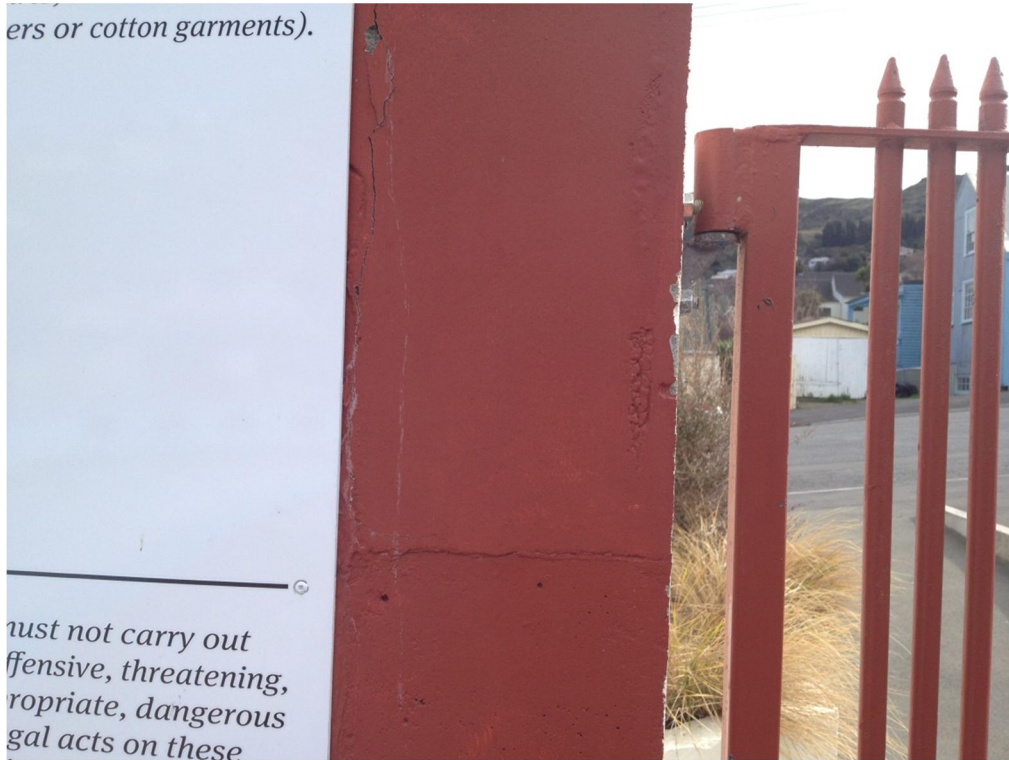
**Photo 5:** External masonry/rendering at office building.  
**Damage Description:** Cracking/spalling to external rendering.

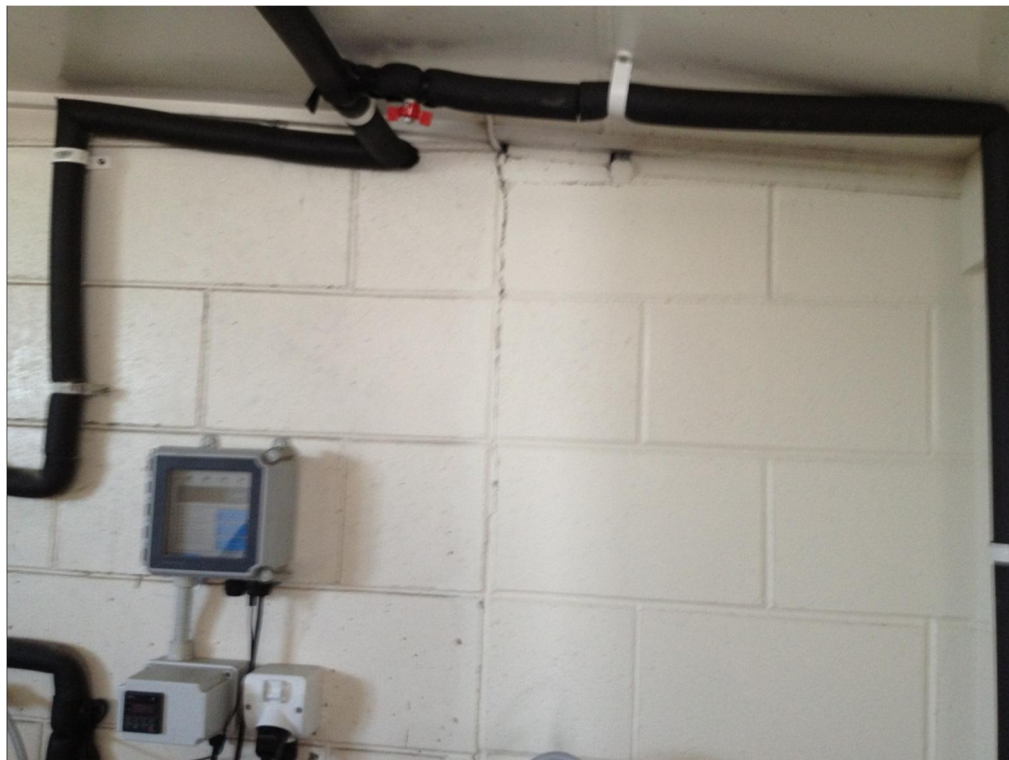
**Photo 6:** Internal concrete masonry block wall of Plant Room.  
**Damage Description:** Concrete masonry and mortar cracking.

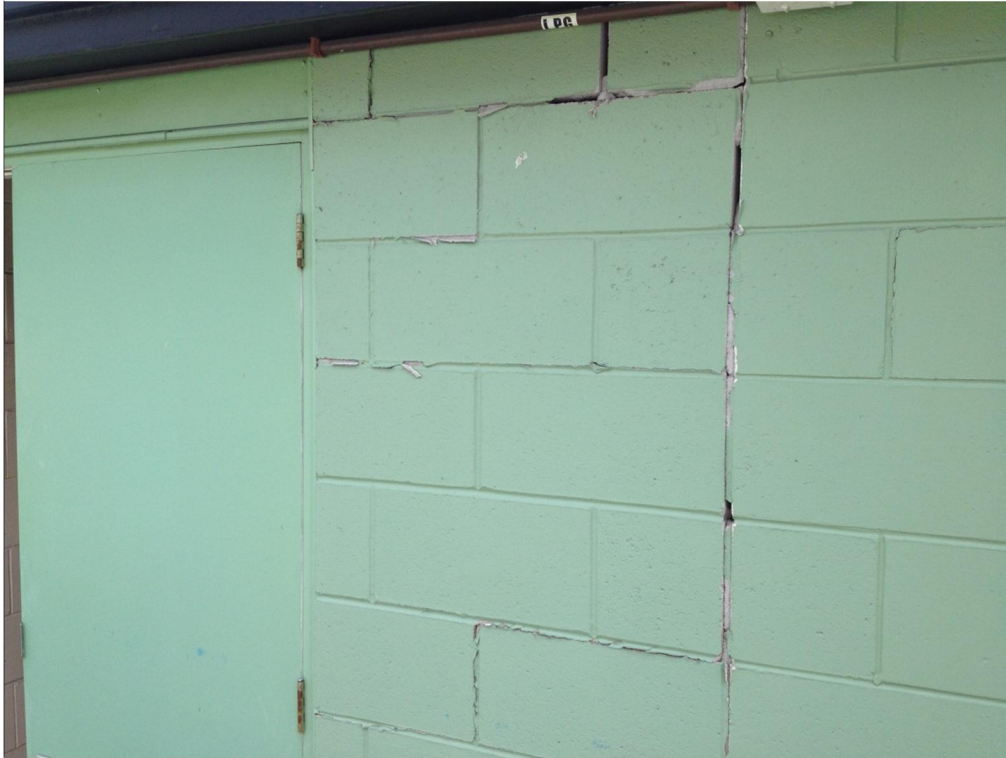
**Photo 7:** External concrete masonry wall of Plant Room.

**Damage Description:** Cracking of concrete masonry mortar.

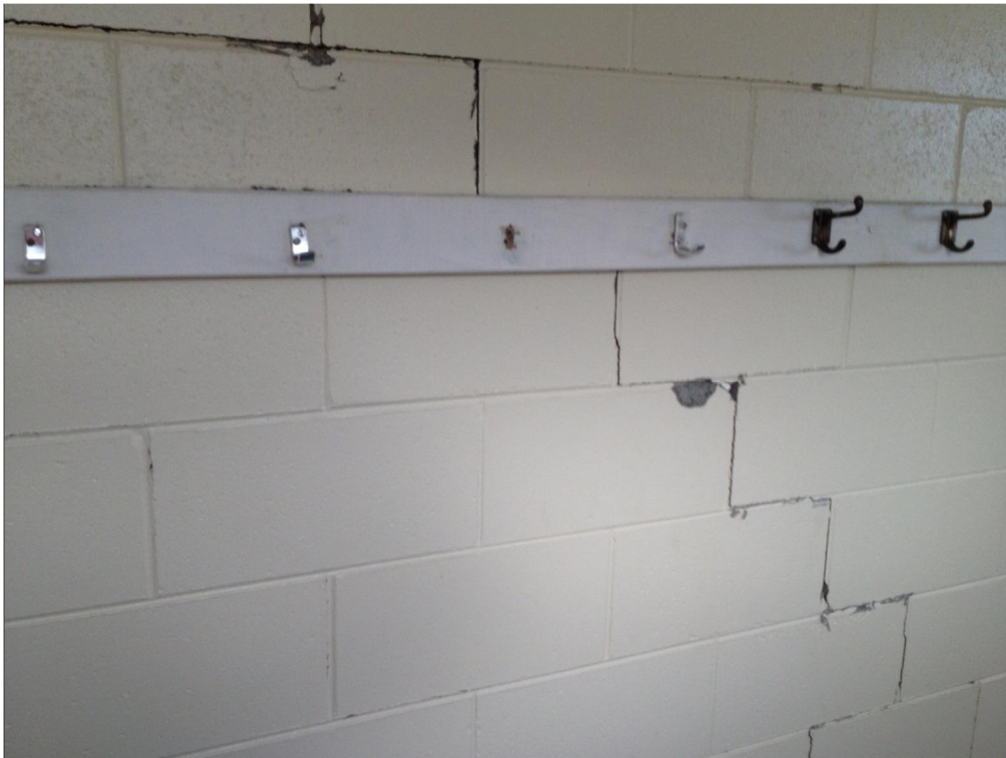
**Photo 8:** Internal concrete masonry wall in Men's Change Room.

**Damage Description:** Stepped mortar cracking.

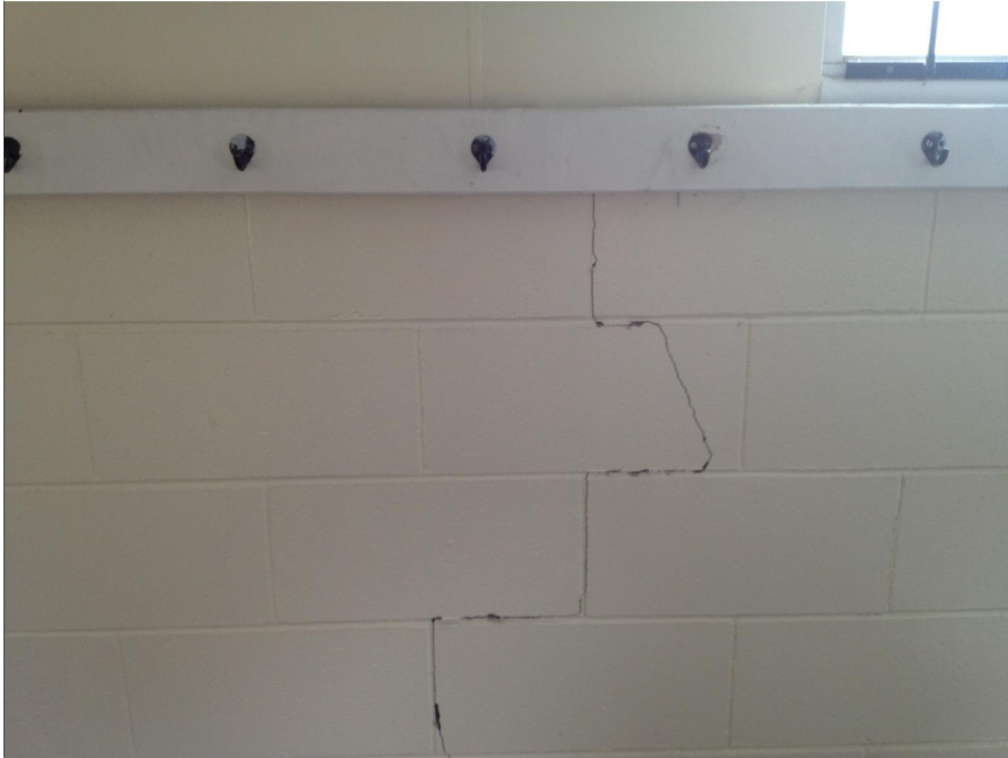
**Photo 9:** Internal concrete masonry wall of Men's Change Room.  
**Damage Description:** Concrete masonry and mortar cracking.

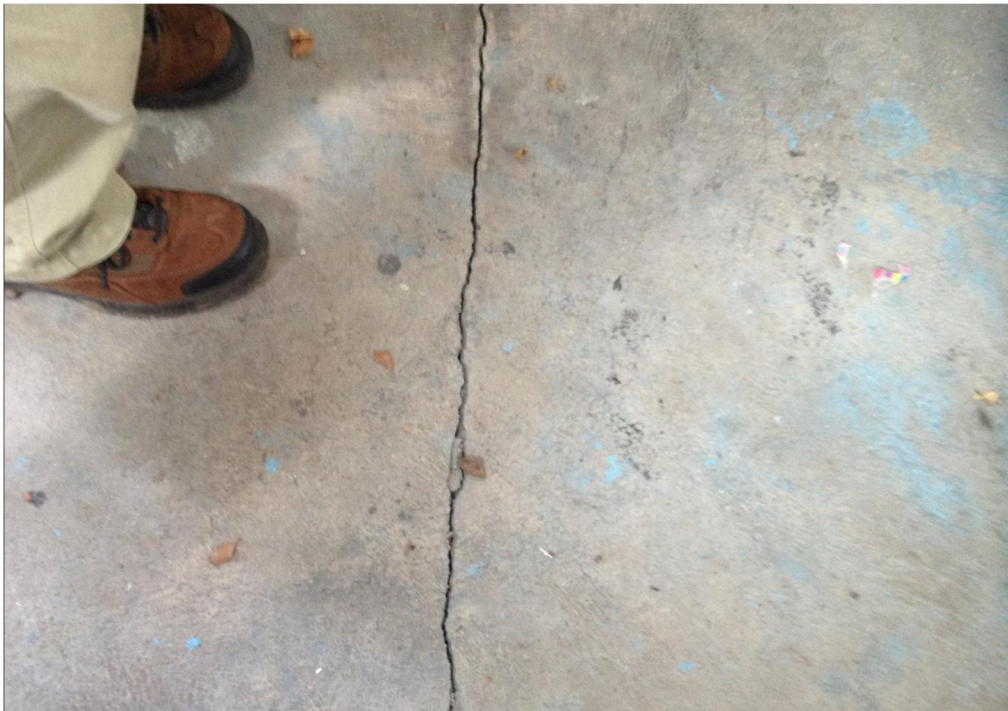
**Photo 10:** Ground slab in Men's Change Room.  
**Damage Description:** Cracking to ground slab.

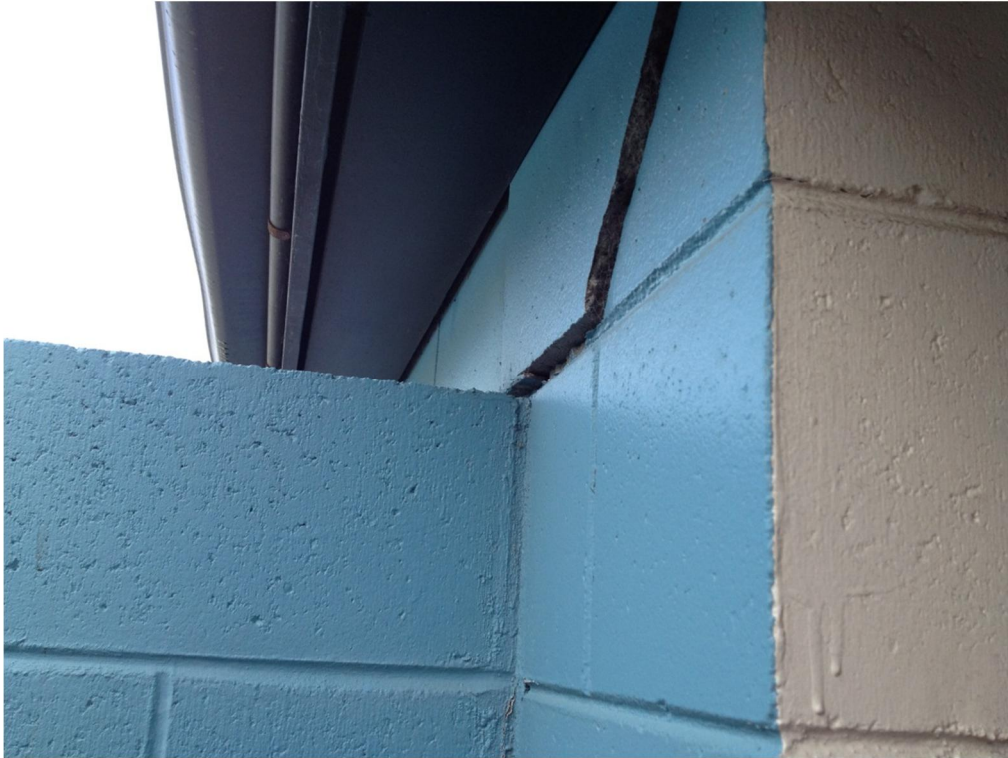
**Photo 11:** External concrete masonry block wall outside of Men's Change Room.  
**Damage Description:** Cracked and dislodged concrete masonry unit.

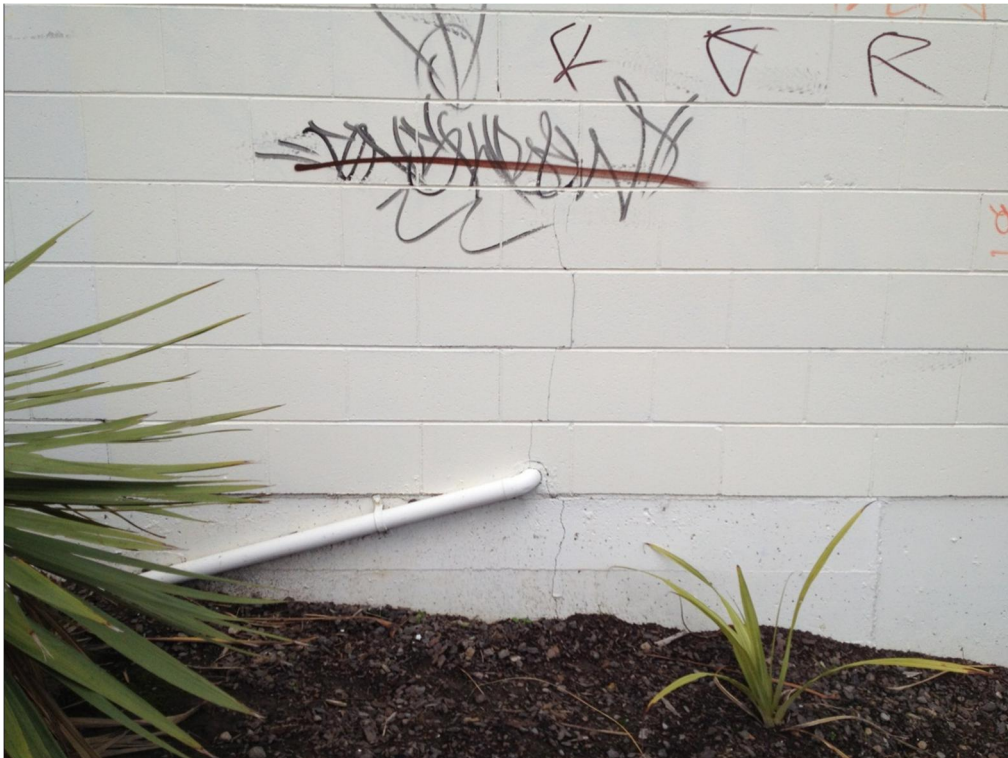
**Photo 12:** Concrete masonry block wall and concrete retaining wall on western side.  
**Damage Description:** Cracking in concrete masonry and mortar, and concrete retaining wall.

- n Intrusive investigations are carried out to determine the lateral load resisting system of the plasterboard lined timber framed section of wall on top of the western block wall.
- n An investigation is undertaken to determine the structural integrity of the retaining wall supporting the western wall.

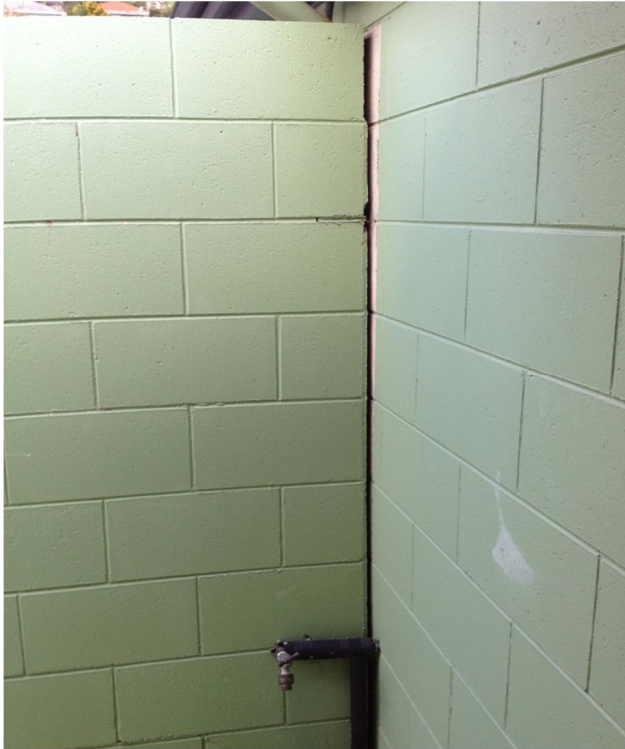
**Photo 13:** Privacy entrance wall to Disabled Bathroom (view from east).

No Critical Structural Weaknesses were identified for the Men's Change Room main building structure, however the entrance privacy wall appears to be of unreinforced concrete masonry construction.

**Damage Description:** Separation and tilting of adjacent concrete masonry walls.

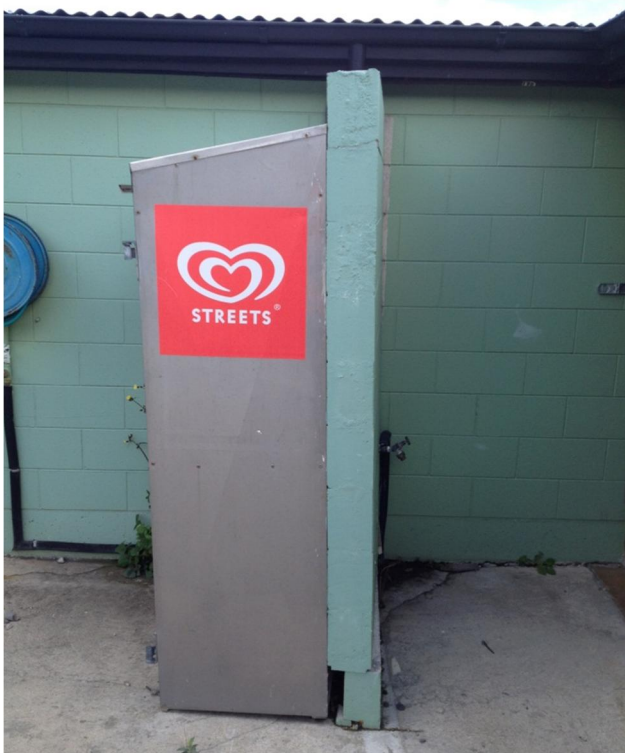
**Photo 14:** Privacy entrance wall to Disabled Bathroom (view from north).

**Damage Description:** Mortar cracking, lateral movement and tilting of concrete masonry wall.

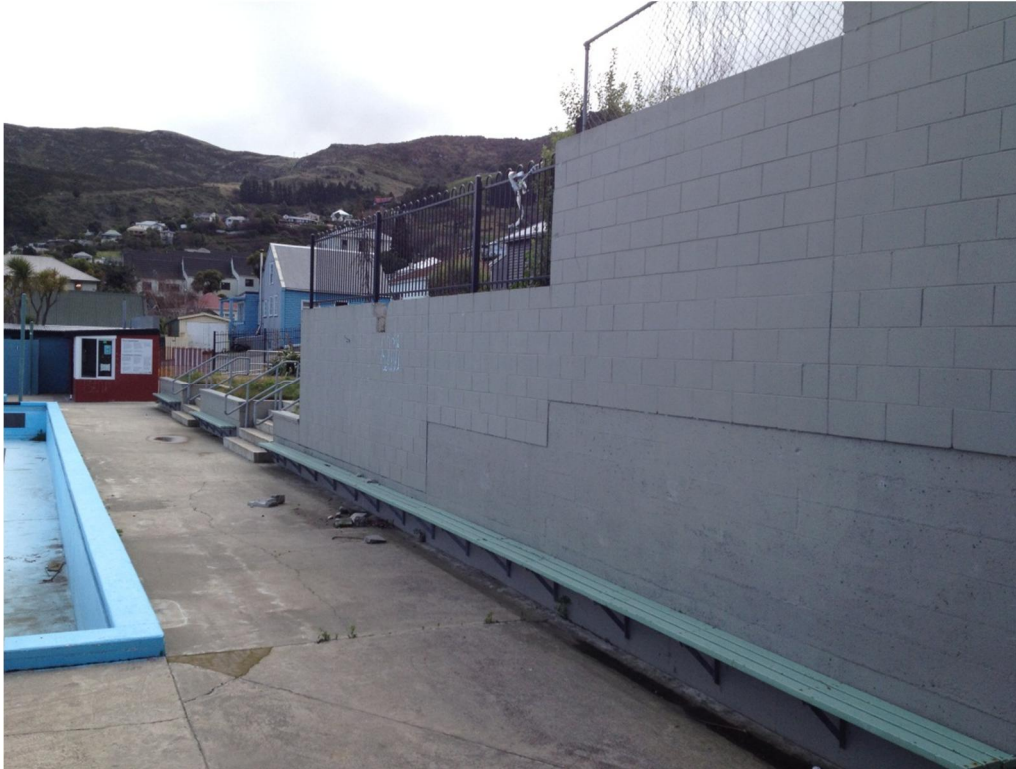
**Photo 15:** Concrete retaining wall and concrete masonry block fence to the north of the pool (view from south-east).

To the north side of the pool is a concrete retaining wall approximately 2m high with a 2m high concrete masonry block fence on top that is significantly damaged (refer Photo 15 and Photo 16 in Appendix A). The block fence section appears to be very lightly reinforced and has minimal fill. It appears likely that the block fence will need to be demolished and reconstructed with an appropriately engineered replacement.

**Damage Description:** Cracking and differential settlement of concrete masonry block wall.

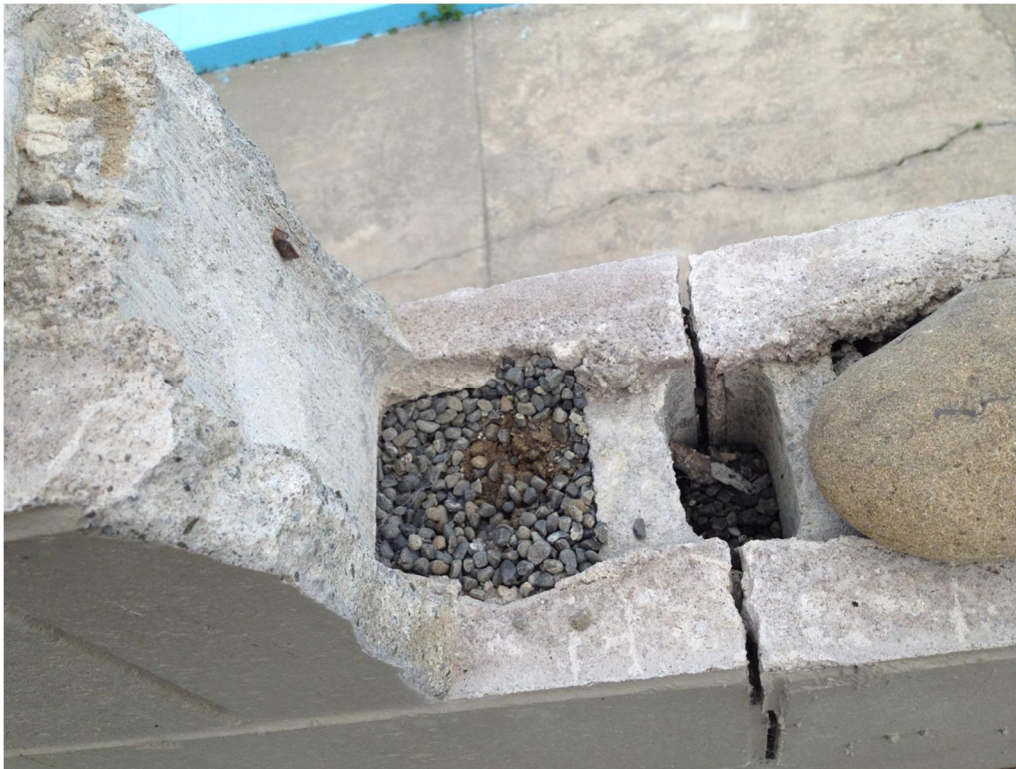
**Photo 16:** Concrete masonry fence to the north of the pool.

**Damage Description:** Cracked and dislodged concrete masonry units.
