CHRISTCHURCH CITY COUNCIL
PRK_1311_BLDG_006 EQ2
North Beach Surf Club Toilets
93 Marine Parade, North New Brighton

QUALITATIVE ASSESSMENT REPORT

FINAL

- Rev B
- 23 May 2013

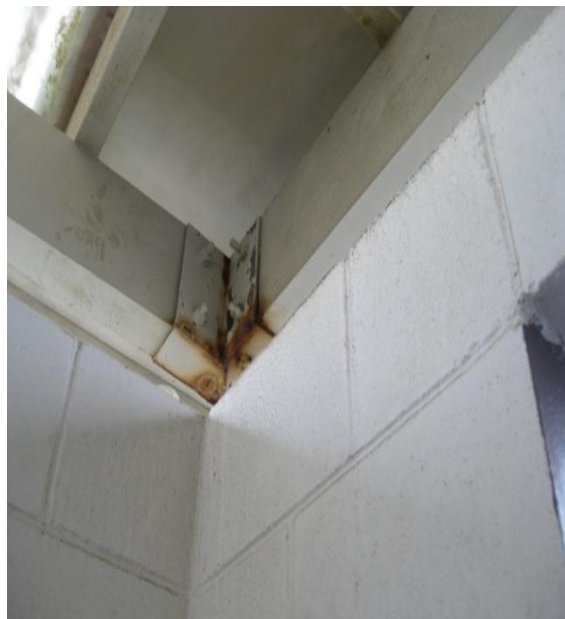
- 1) Cracking occurring as gaps between longitudinal and transverse masonry walls open up at mortar joints.
- 2) Paint removal throughout the structure was noted, but is not the result of earthquake-related damage.
- 3) Rusting on all steel elements was noted, but is not the result of earthquake-related damage.

Photo 7: Rusting of timber-masonry steel connection (typical).

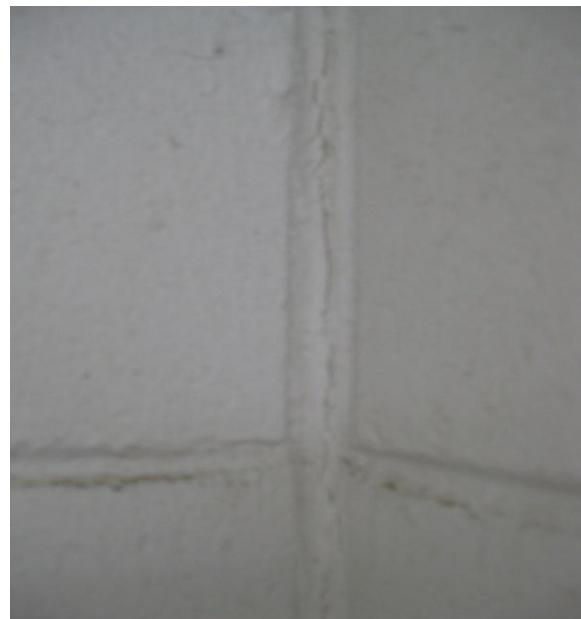
Photo 8: Cracking along mortar joint between internal and external wall.

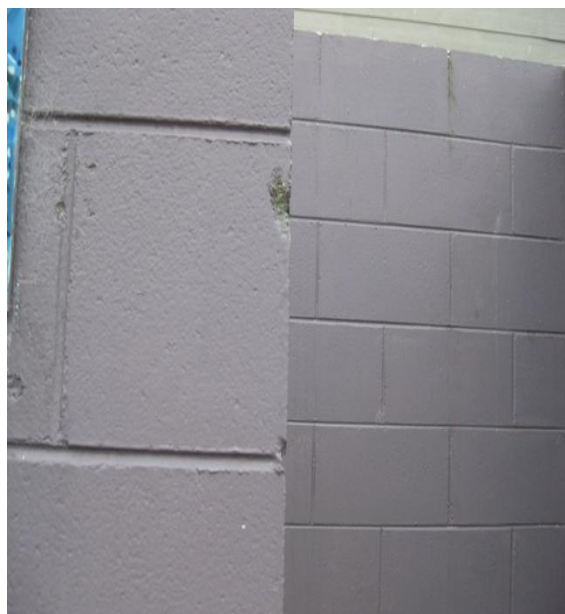
Photo 11: Existing impact damage to masonry on changing room entrance.

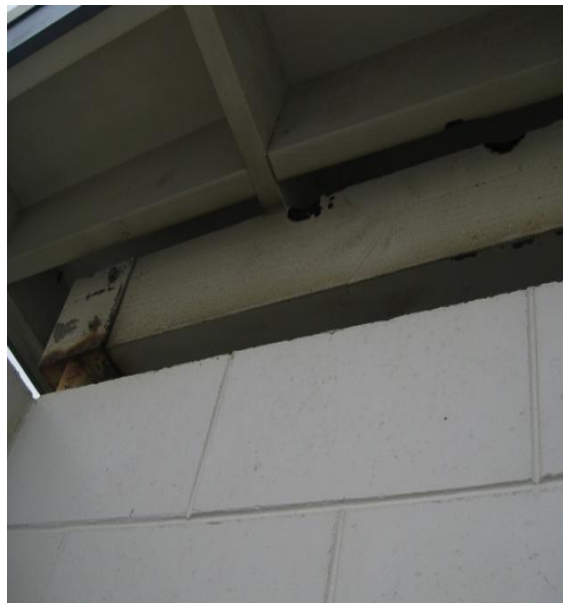
Photo 13: Paint removal on timber edge roof beam and rusting of timber-masonry steel connection.

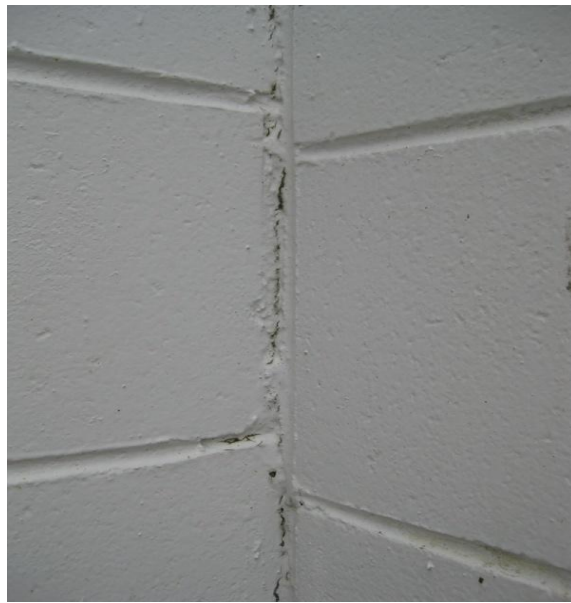
Photo 17: Gap opening up between shared wall and internal masonry wall along the mortar joint.

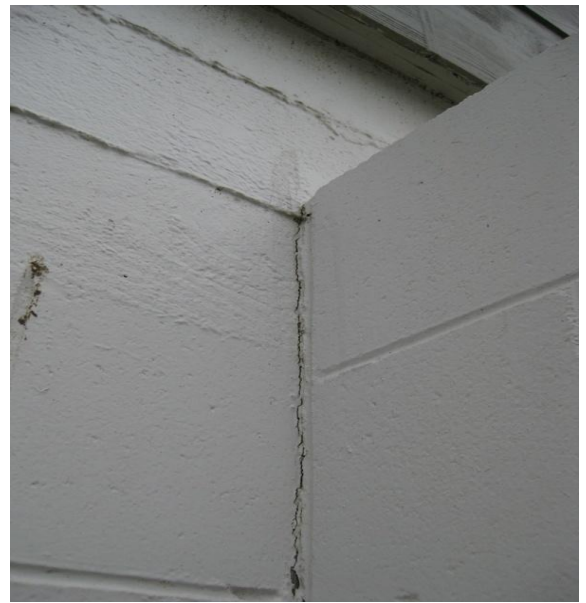
Photo 18: Gap opening up between shared wall and internal masonry wall along the mortar joint.

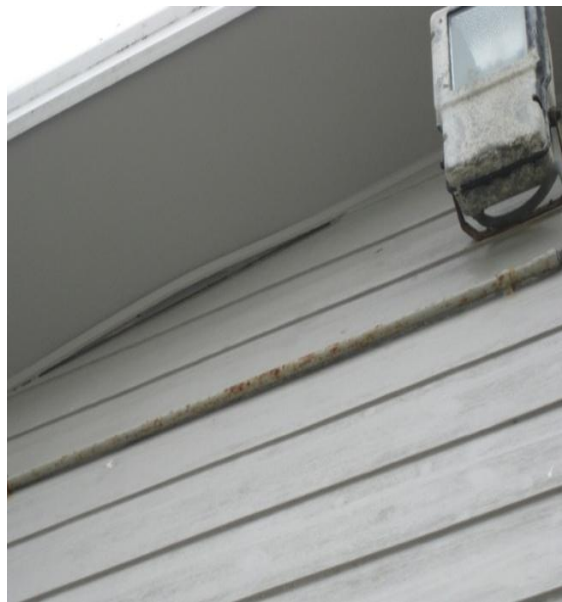
- 1) Buckling of soffit lining element on South wall.
- 2) Cracking at assumed external plasterboard cladding joints on north and east first storey walls.
- 3) Gap opening up between external concrete ground slab and first-floor wall on the south side.

Photo 19: Buckling of soffit cladding element on south wall.

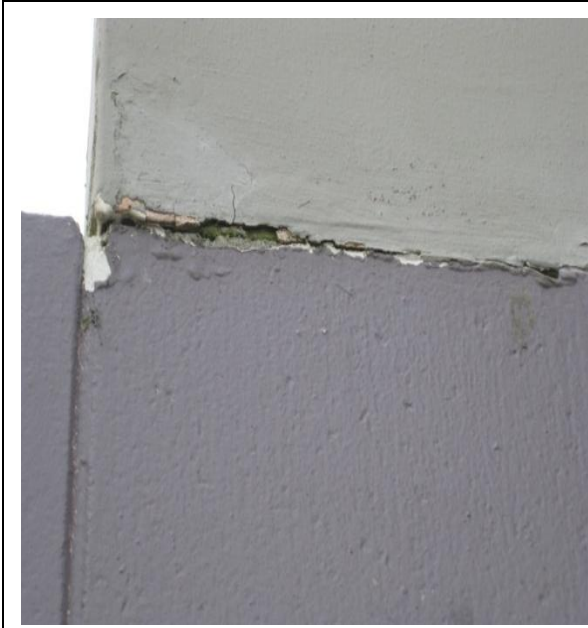
Photo 21: Gap opening up between masonry wall and wall extension (material unknown).

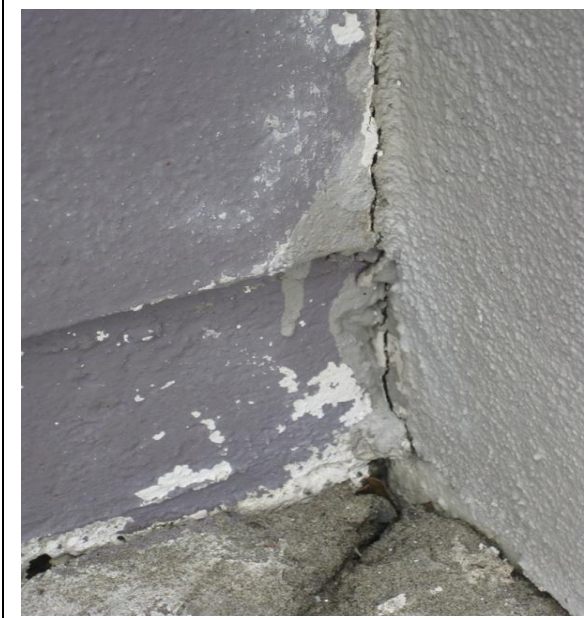
Photo 23: Gap opening up between external changing room masonry wall and Surf Club southern wall.

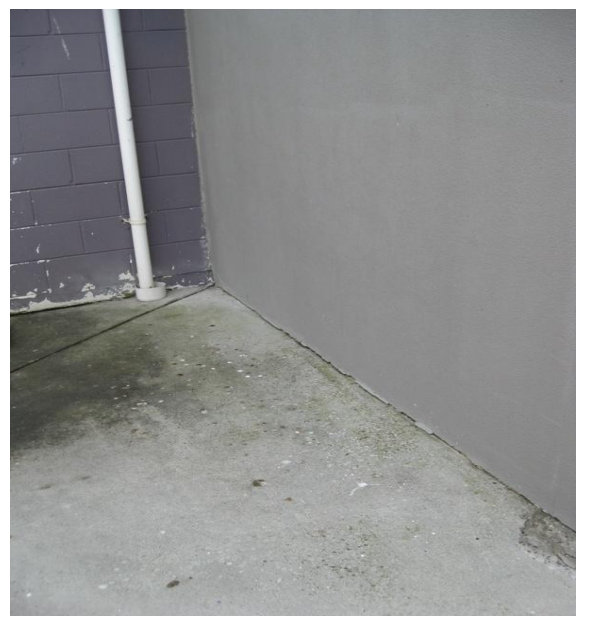
Photo 24: Gap opening up between Surf Club south wall and external ground slab.

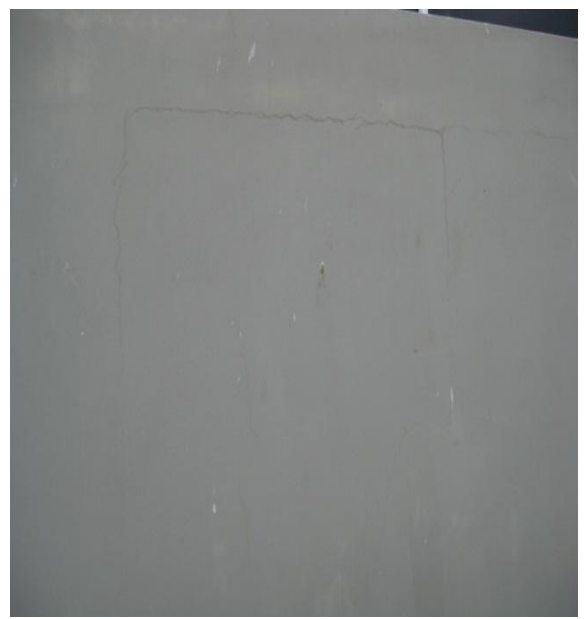
Photo 26: Cracking at assumed plasterboard joints on the first-floor east wall external cladding (typical).

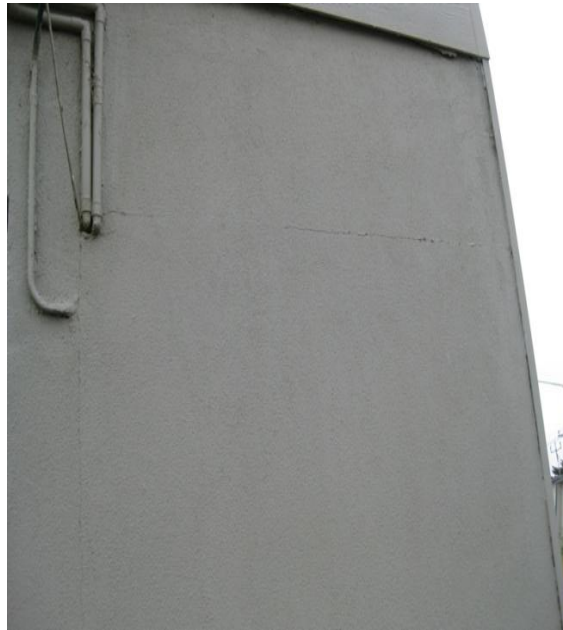
Photo 29: Cracking at assumed plasterboard joints on the first-floor east wall external cladding (typical).

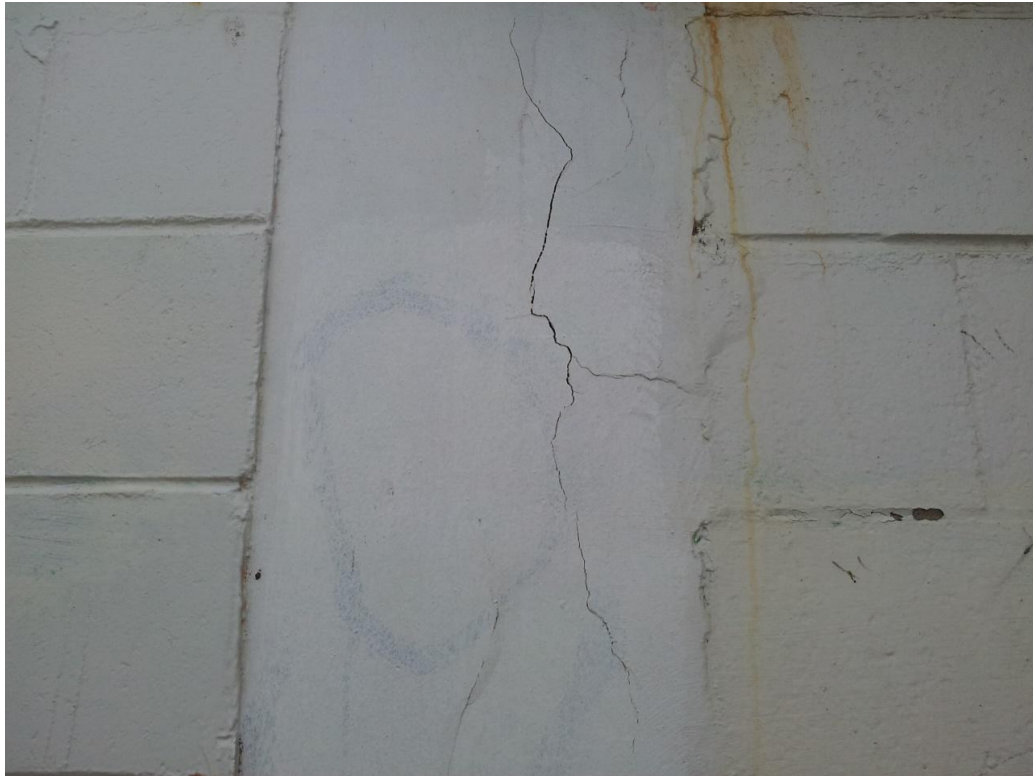
Some cracks in the masonry walls were observed during the external inspection of the site; otherwise no obvious structural damage was noted.

■ **Figure 9 - Observed cracks in the wall**
