Paeroa Reserve Pump Shed  
Qualitative Engineering Evaluation

**Reference:** 231562  
**Prepared for:**  
Christchurch City Council

Functional Location ID: PRK\_2936\_BLDG\_003

**Date:** 14 October 2013

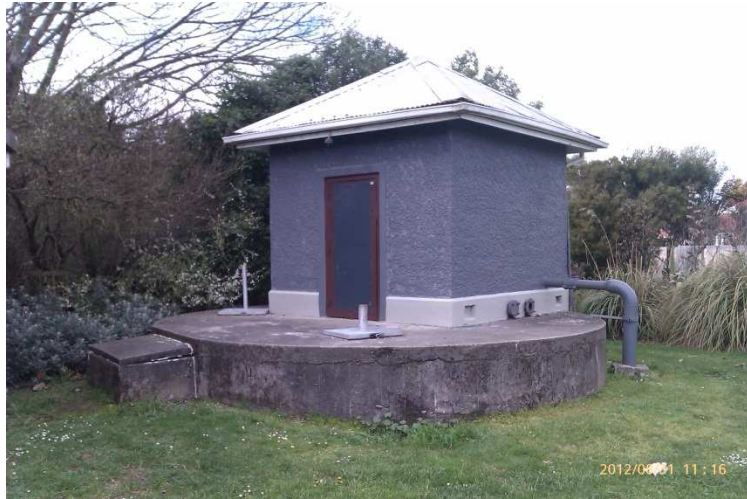
Image 1.

General view of the Paeroa Reserve Pump Shed.

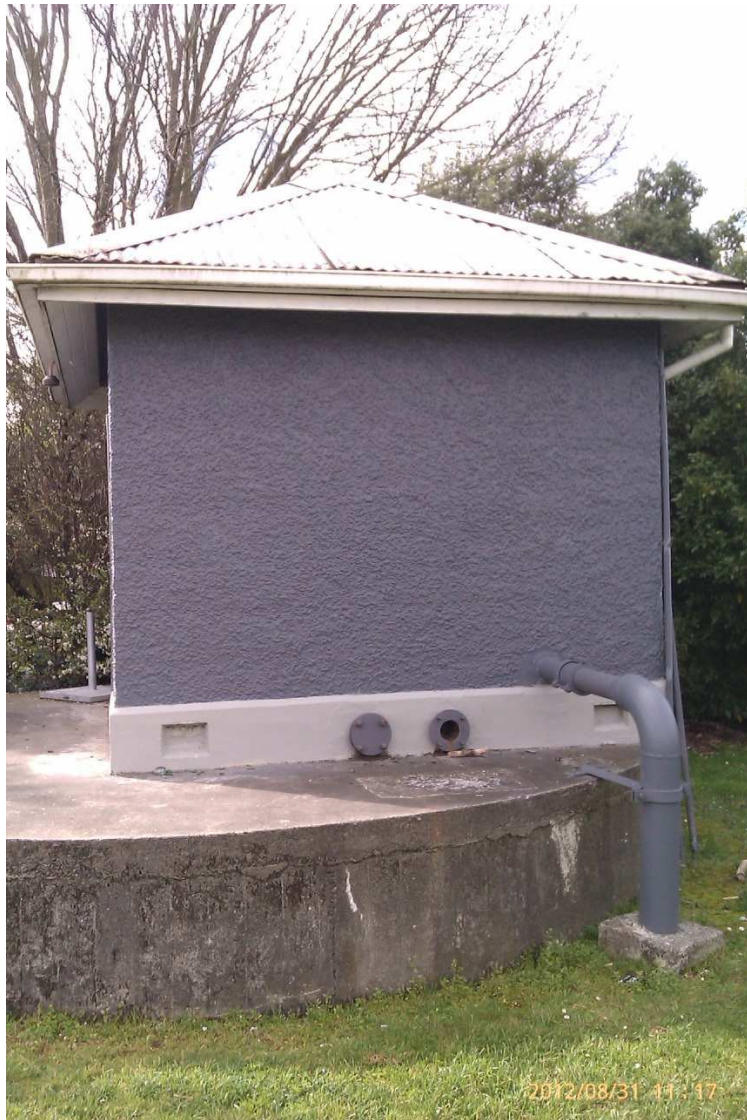
Image 2.

Side view.

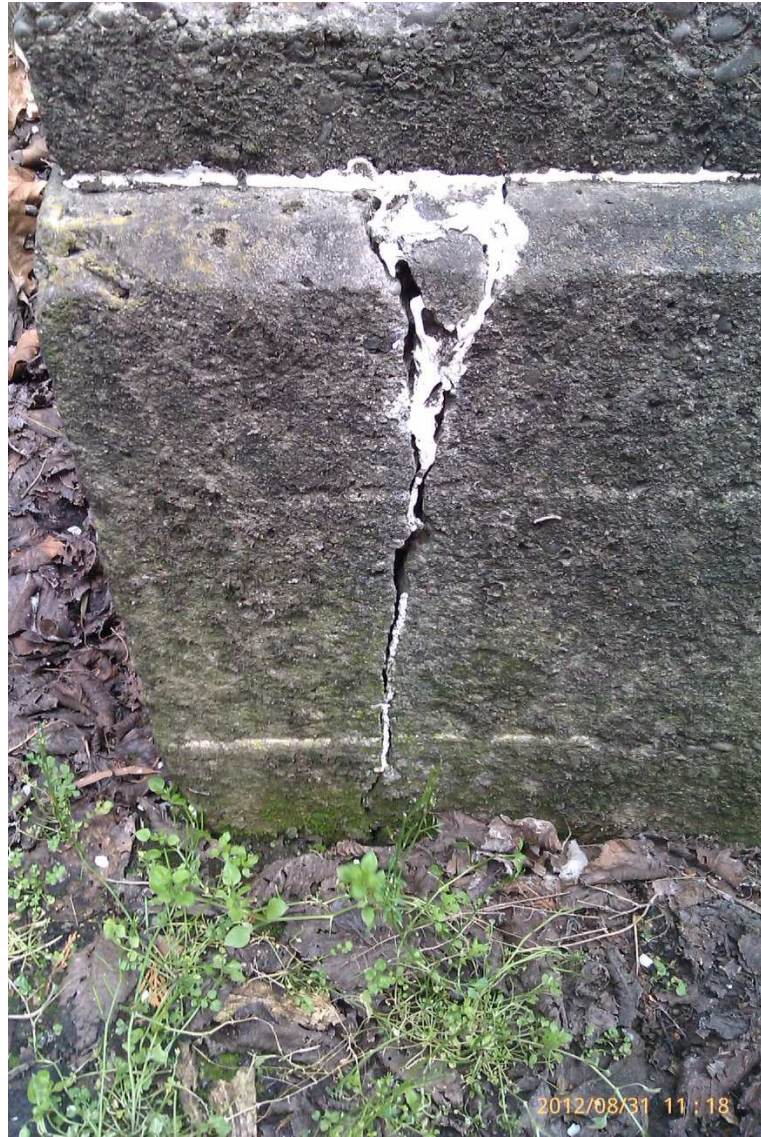
Image 3.

It was observed that the building has not suffered any structural damage. There is cracking in the concrete water tank supporting the pump shed, which appears to have been previously repaired. However the cracks have widened since the repairs were last carried out.

Separate to the structure being assessed, the water tank supporting the pump shed contains cracking, which has previously being repaired, but has since opened up. The crack that was visible during the inspection is shown in the Appendix and is in the order ranging from 5mm to 15mm width.

Cracking of the concrete water tank under the pump shed.

The crack appears to have been previously repaired, but has since opened up.

The concrete foundation, which appears to be the top of a concrete water tank has cracks that have been previously repaired, but have since widened. It is our recommendation that the cracking in the concrete water tank should be investigated to determine its magnitude and extent and the concrete water tank should be assessed for any structural damage.

Extend of cracking of the water tank should be investigated.
