Papanui Domain – Toilets
Qualitative Engineering Evaluation

Reference: 229180

Functional Location ID: PRK 0558 BLDG 002

Date: 4 July 2013

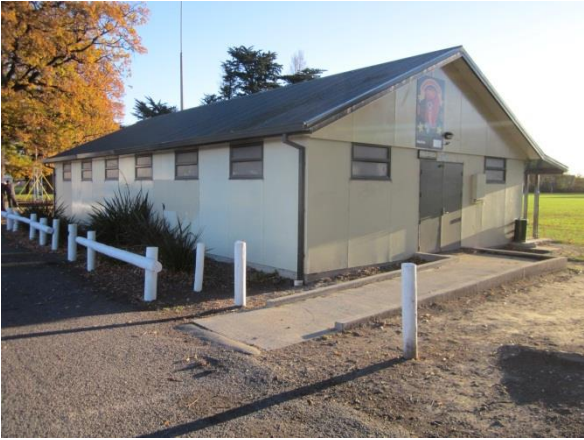
<p>Northern elevation of Papanui Domain – Toilets.</p>

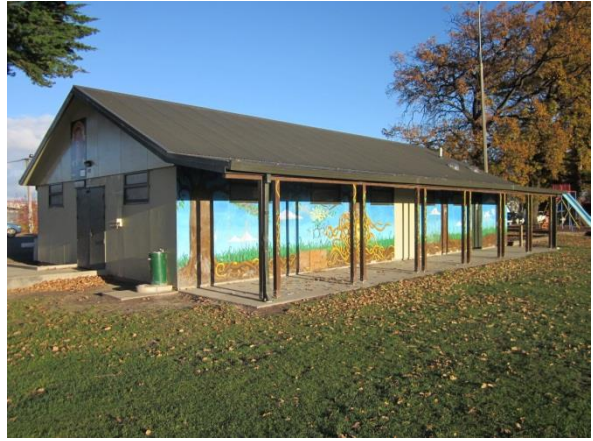
Western elevation of Papanui Domain – Toilets.

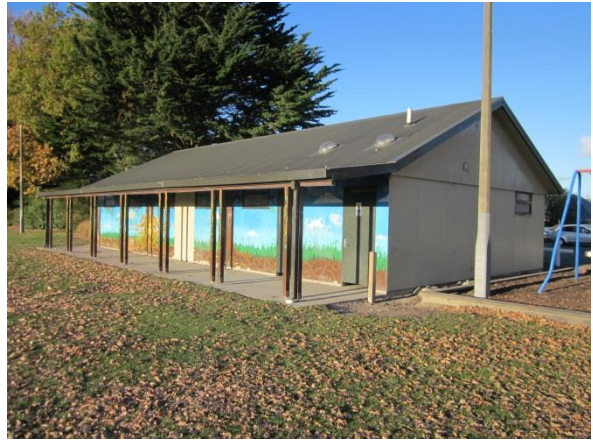
Southern elevation Papanui Domain – Toilets.

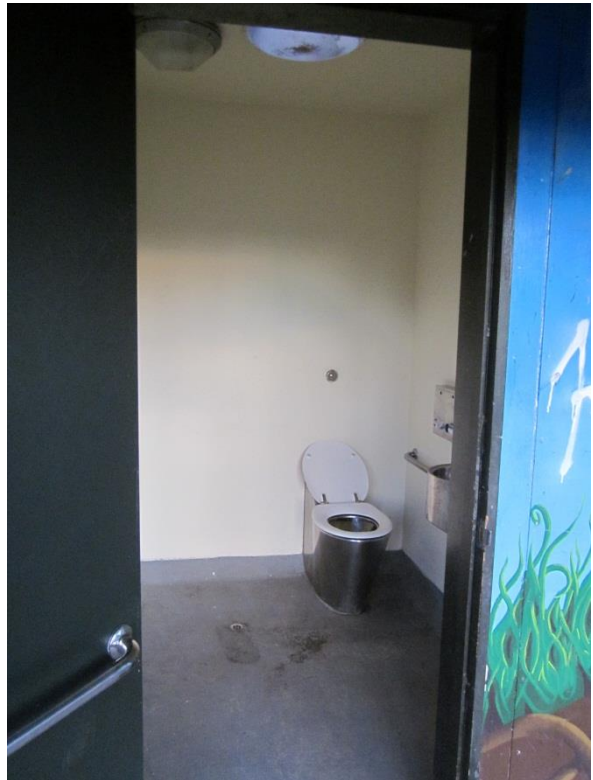
Internal view of toilets.

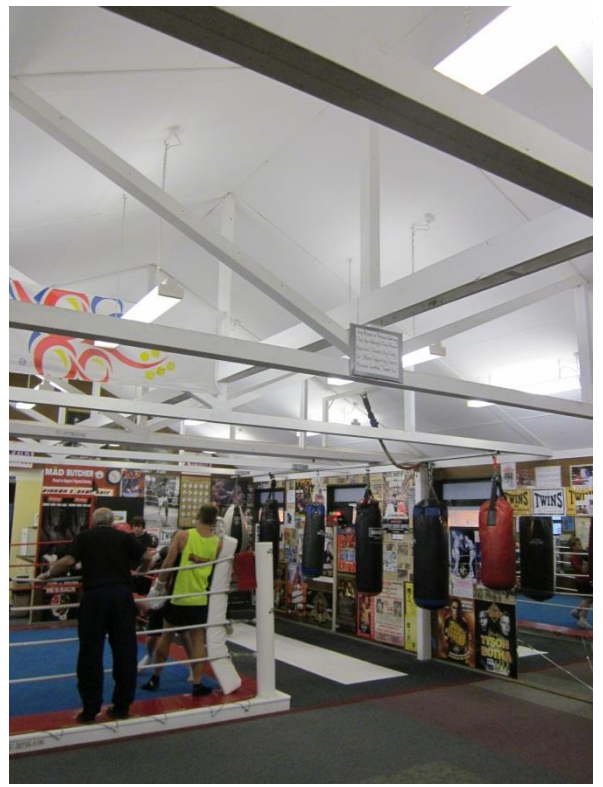
Internal view of boxing club showing roof truss.

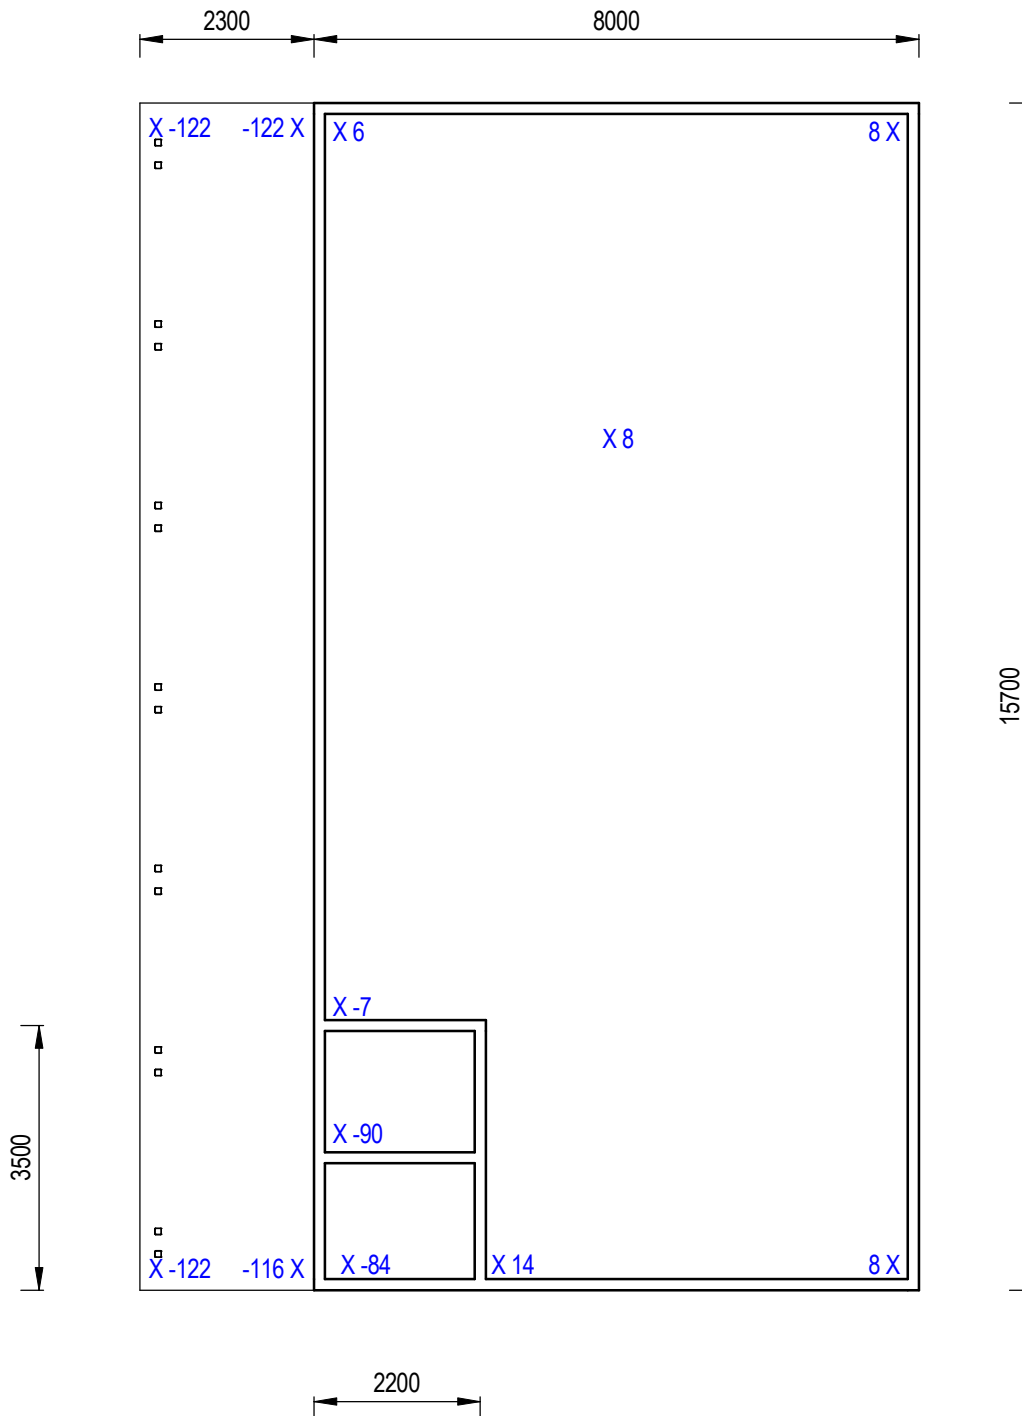
PROJECT
PAPANUI DOMAIN 61 SAWYERS ARMS ROAD
TITLE
TOILETS LEVEL SURVEY

The floor levels for the Papanui Domain – Toilets were found to be within the recommended tolerances excluding the toilet floor and veranda which slope for drainage purposes.
