Christchurch City Council
PRK_2119_BLDG_001 EQ2
Parklands Reserve - Toilet/Changing Rooms
Queenspark Drive / Donnington St

QUALITATIVE ASSESSMENT REPORT
FINAL

- Rev B
- 23 May 2013

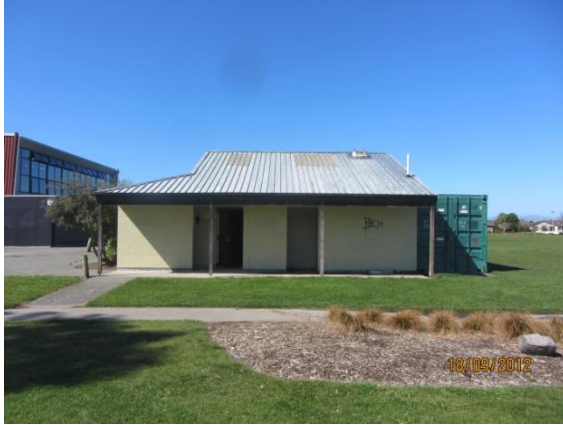
Photo 1: West Elevation

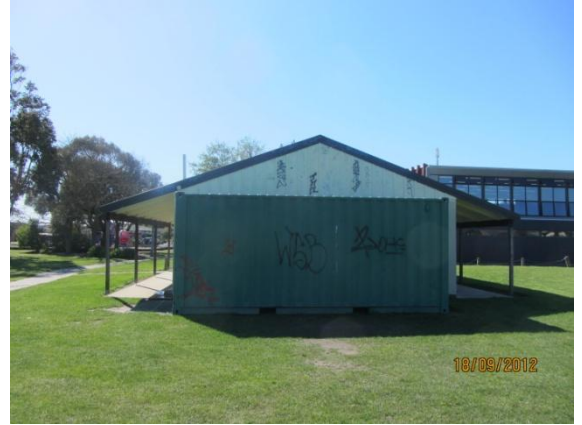
Photo 2: South elevation

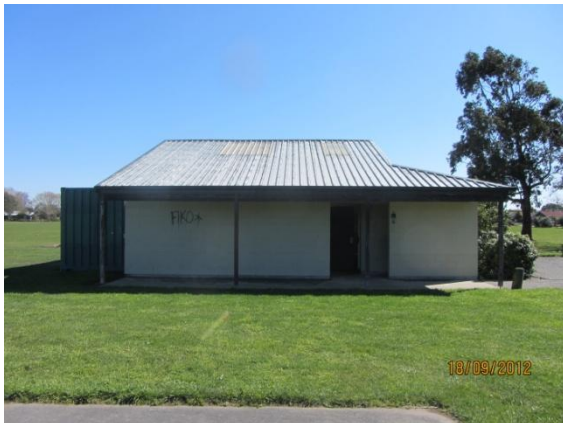
Photo 3: East elevation

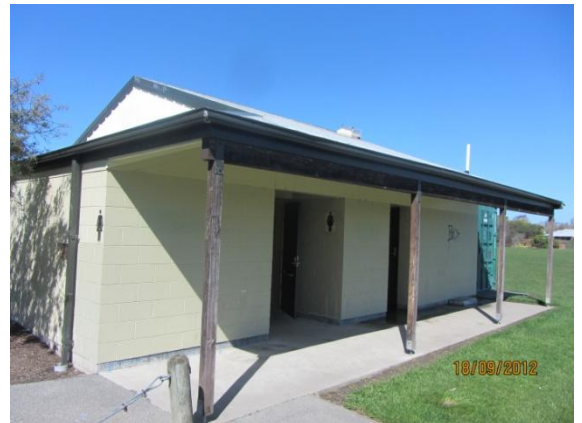
Photo 4: View of womens toilet entrance

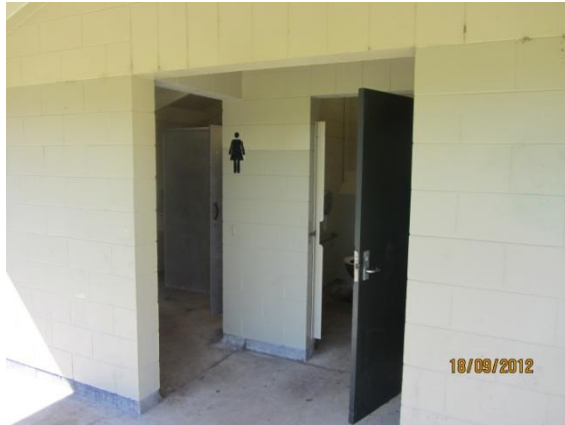
Photo 5: Close up view of womens toilet entrance

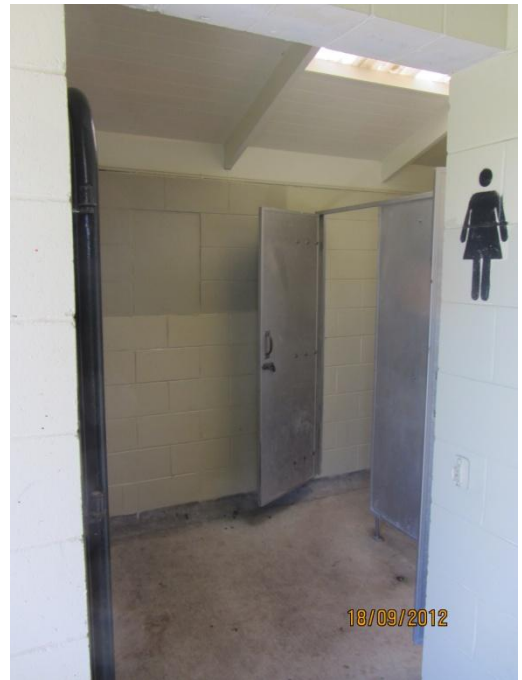
Photo 6: Interior view of womens toilet

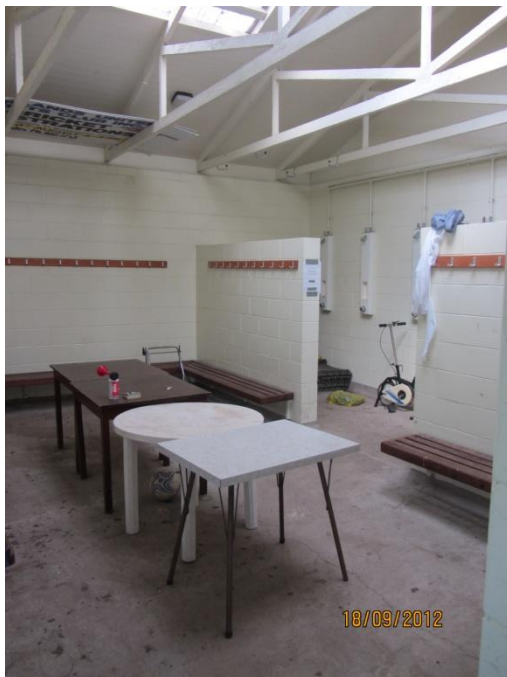
Photo 7: Interior view inside changing rooms

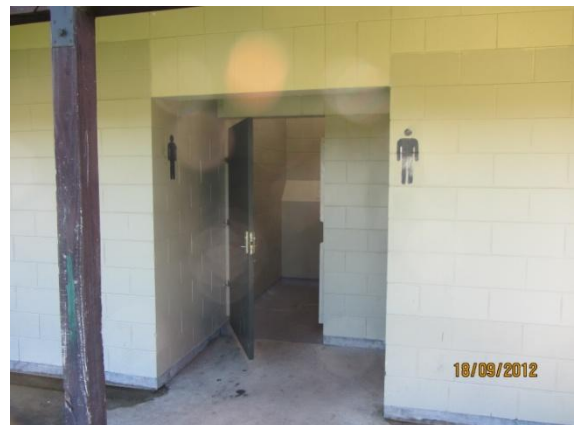
Photo 8: Mens toilet entrance

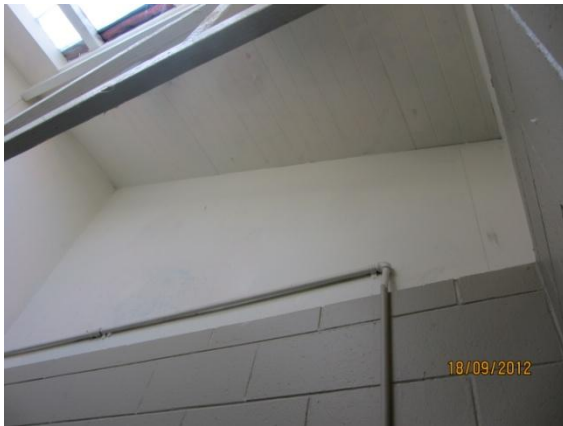
Photo 9: View of roof
