CHRISTCHURCH CITY COUNCIL
PRK_0818_BLDG_002
Toilets at Phillipstown Court
261 Ferry Road, Waltham

QUALITATIVE ASSESSMENT REPORT
FINAL

- Rev B
- 26 November 2013

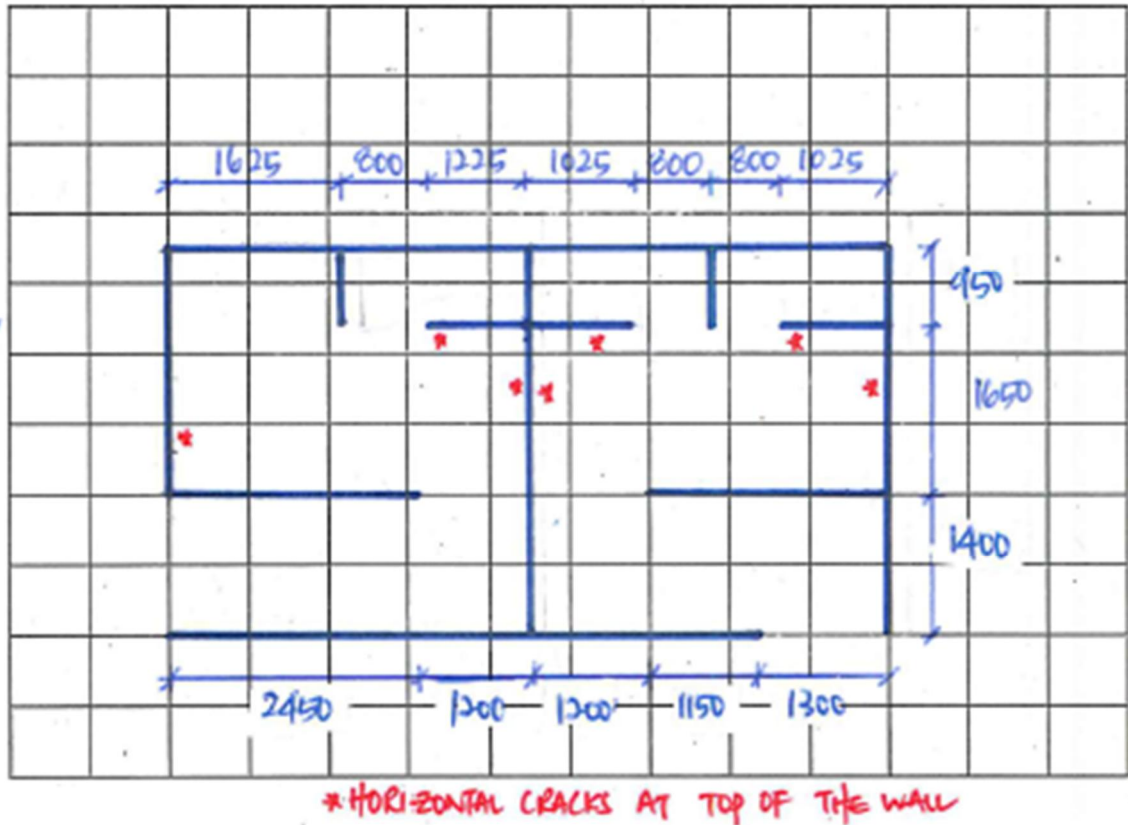
■ Figure 3 Toilet Block Floor Plan

- Hairline cracking to the top of the wall (as indicated in Figure 3).

SKM undertook a visual inspection of the building on 19 August 2013. Photos of the damage can be found in Appendix 1 – Photos. Cracking was discovered at the top of the reinforced concrete masonry block walls typically around this building as indicated in the sketch below.

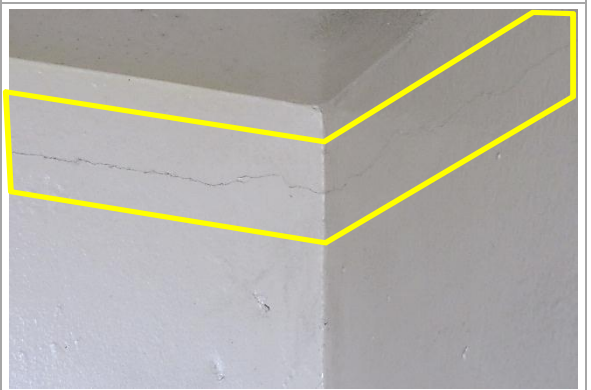
Photo 6: Cracks at the top section of the walls (typical)

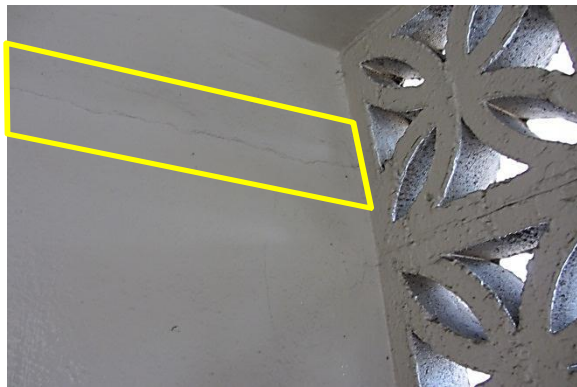
Photo 7: Crack at the top section of the wall adjacent to decorative masonry blocks

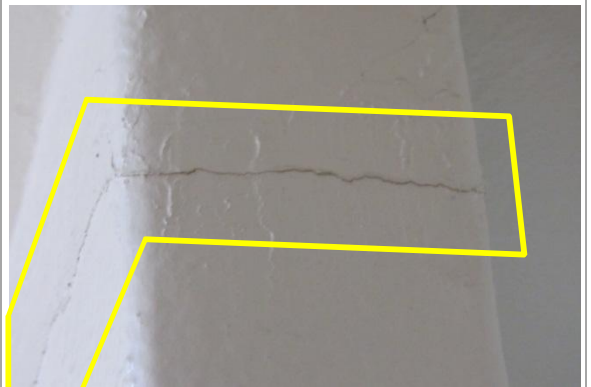
Photo 8: Closer view of the crack (refer to Photo 9)

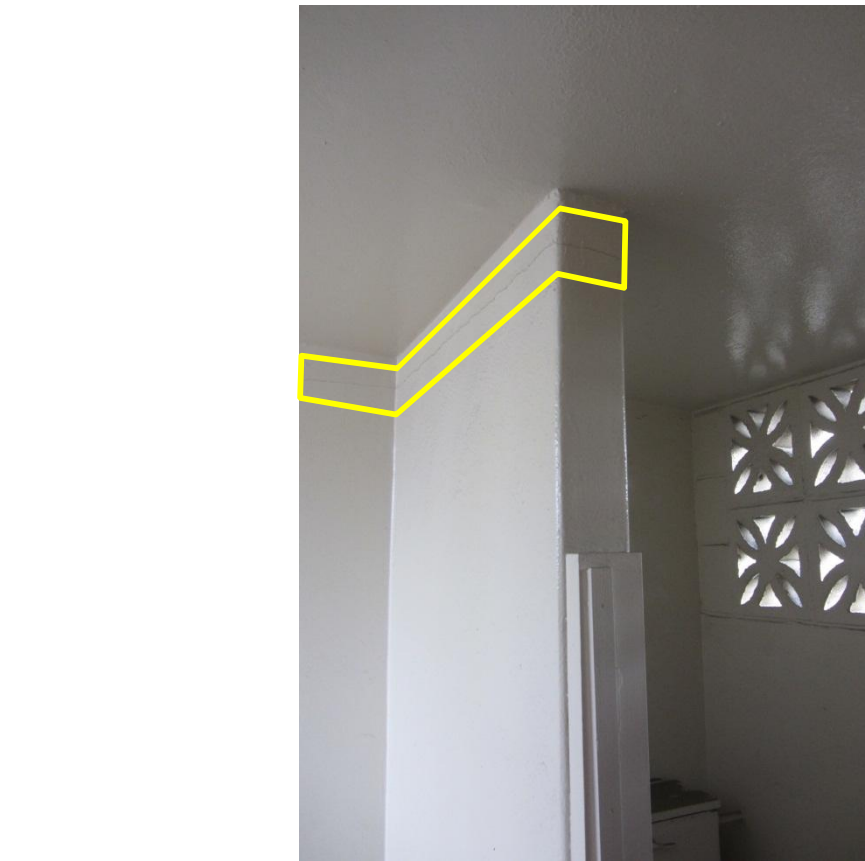
Photo 9: Cracks at the top section of the partition walls (typical)
