Pigeon Bay Boat Park Toilet  
Qualitative Engineering Evaluation

**Reference:** 231563  
**Prepared for:**  
Christchurch City Council  
**Revision:** 2  
**Date:** 5 July 2013

Functional Location ID: PRK 3102 BLDG 002

Address: 124 Wharf Road

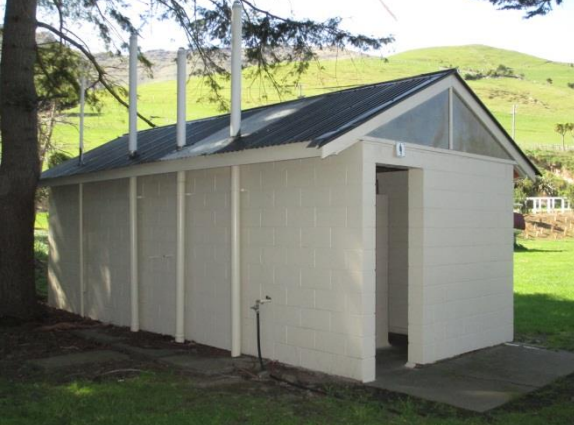
<p>Building northern elevation.</p>

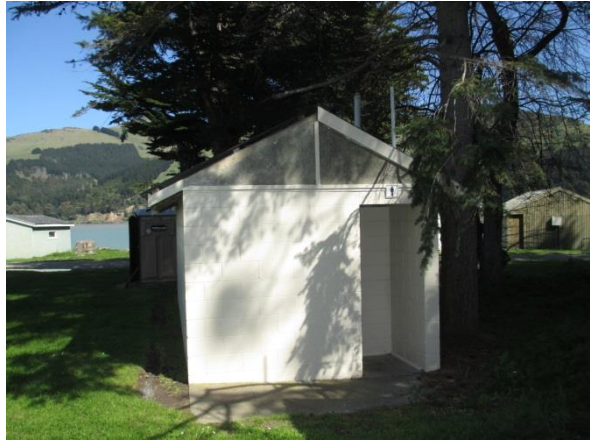
Building Western elevation.

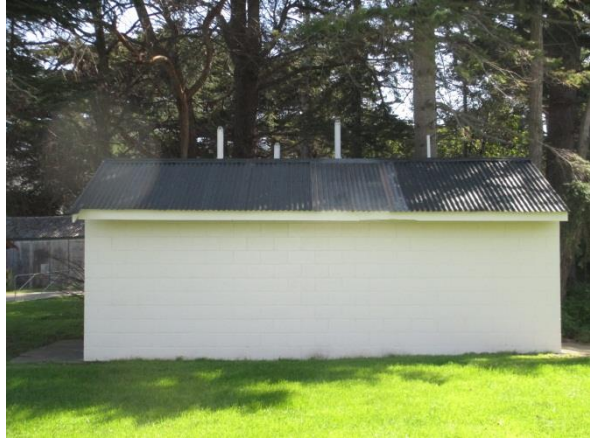
Building southern elevation.

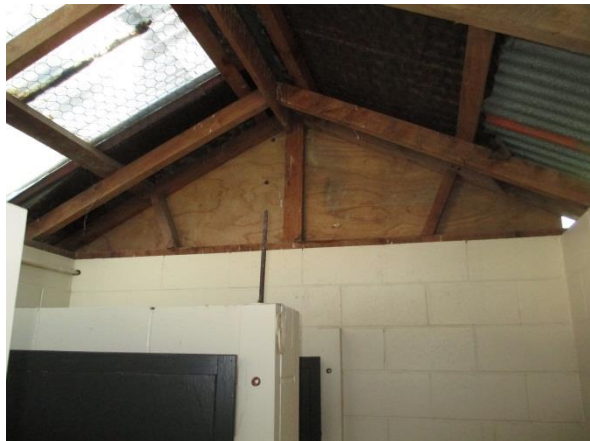
Building internal view.

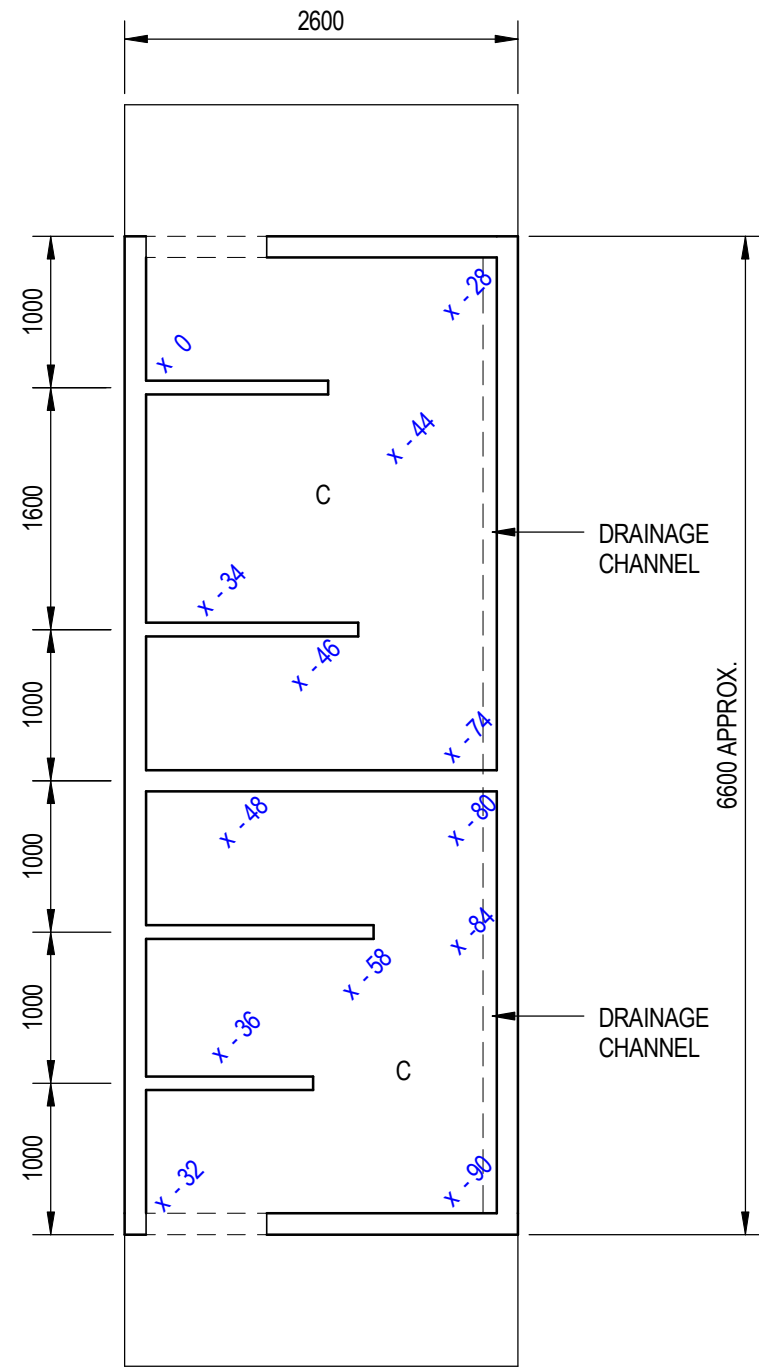
**GROUND LEVEL**

The floor levels for the Pigeon Bay Boat Park Toilet were found to be within acceptable tolerances. Floor level variances that were noted are intended to provide drainage.

MAXIMUM VARIATION ACROSS GROUND LEVEL = 90mm
