Christchurch City Council

PRK_3575_BLDG_001 Port Levy Fire Shed Detailed Engineering Evaluation Report

September 2013

Detailed Engineering Evaluation

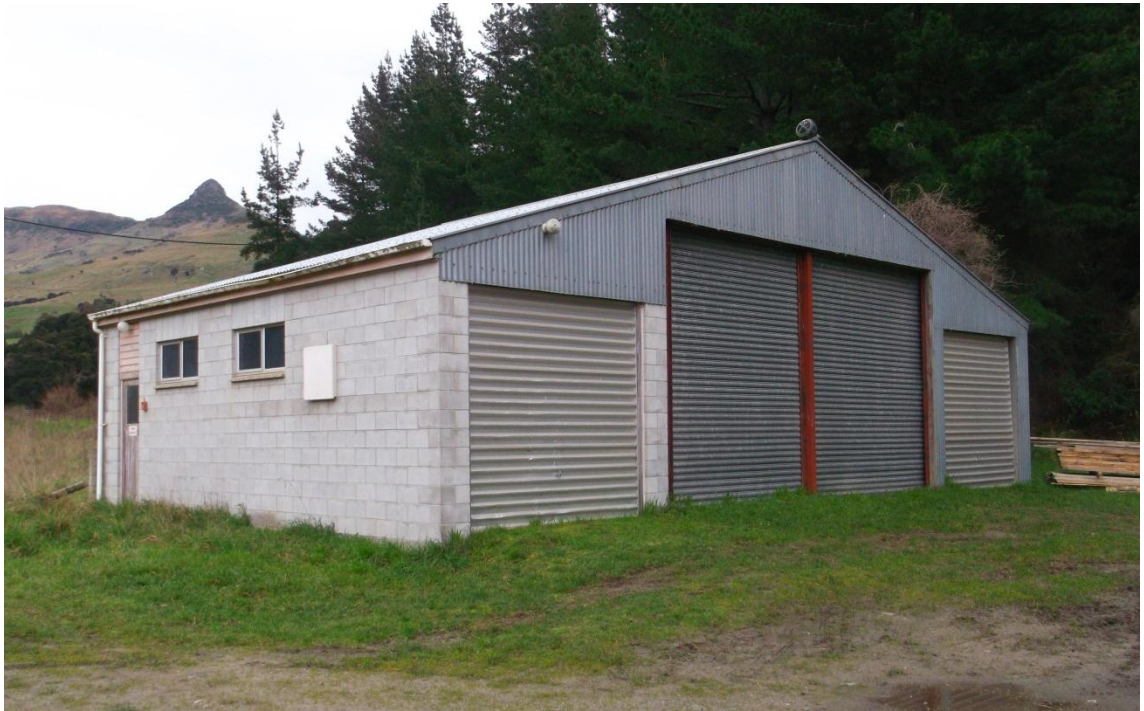
Photo A1: North and east elevations

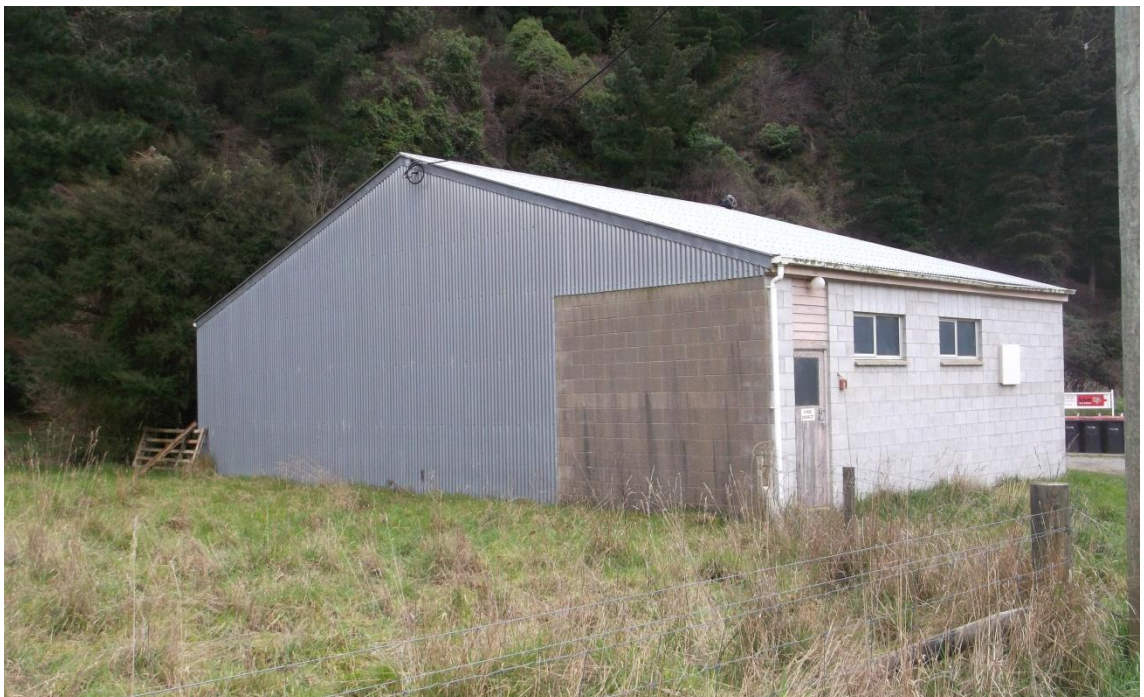
Photo A2: South and east elevations

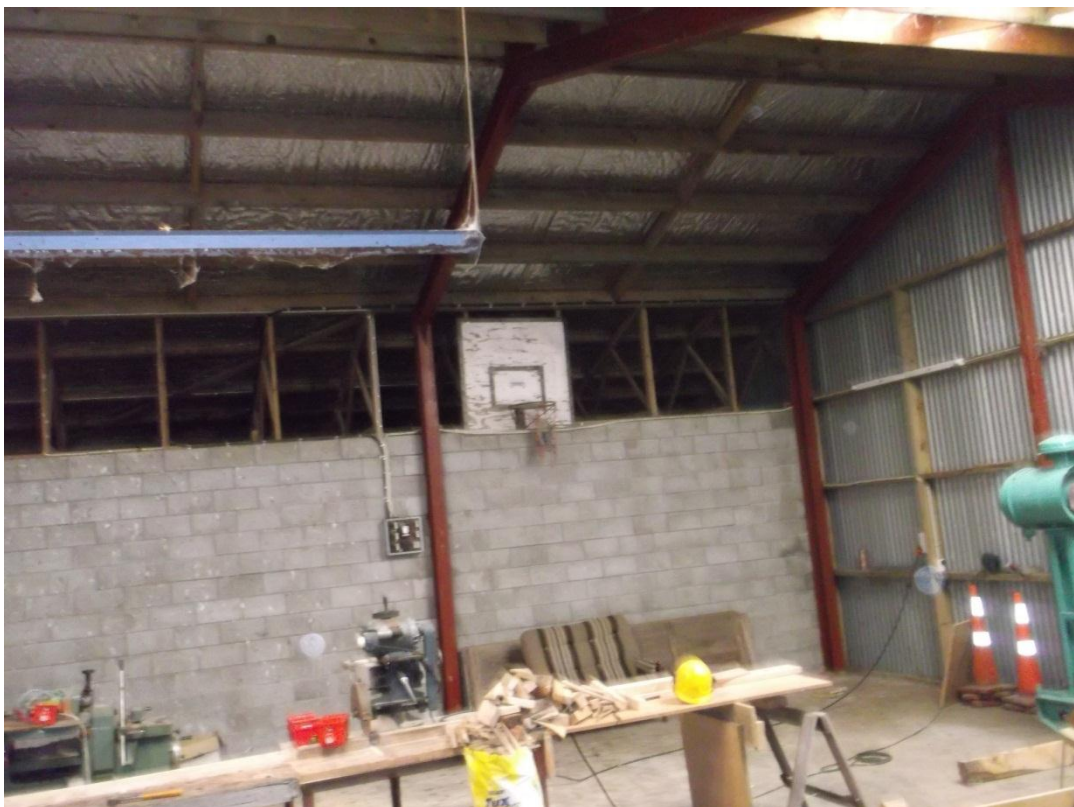
Photo A4: Interior of Fire Shed, looking towards reinforced masonry section.

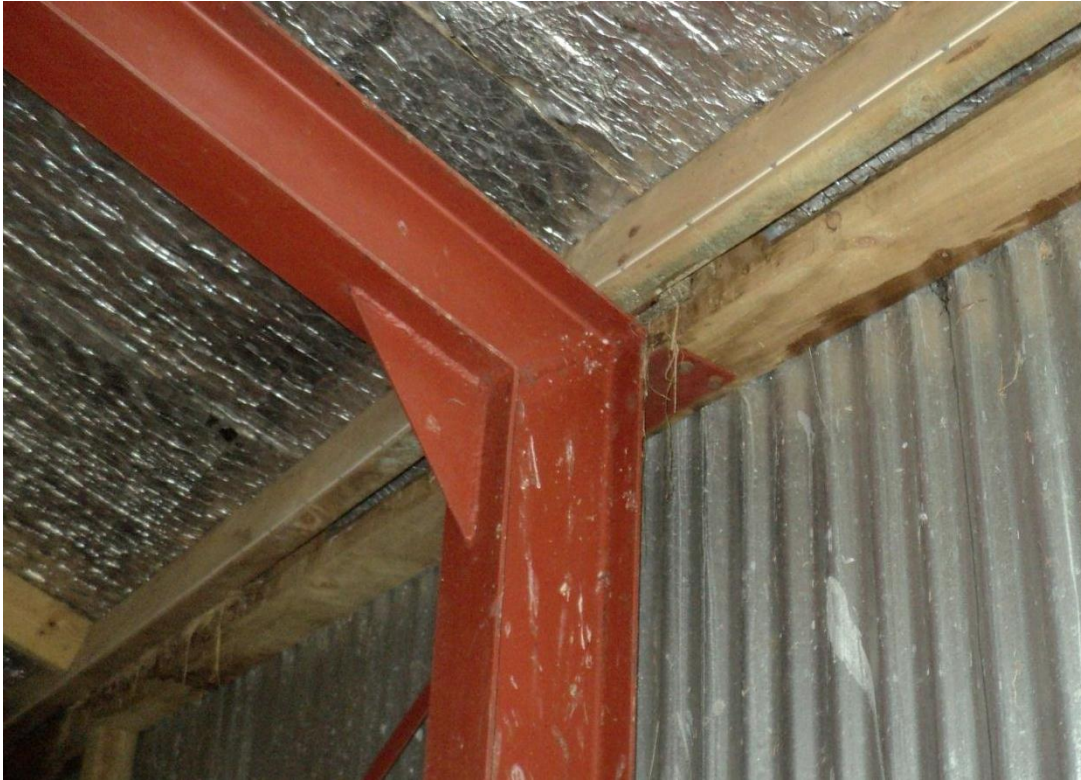
Roof elements such as timber purlins, diagonal cross bracing, and steel portal frames were clearly visible; it is expected that these will provide adequate stability.

Photo A5: Connection between steel portal frame and timber roof framing

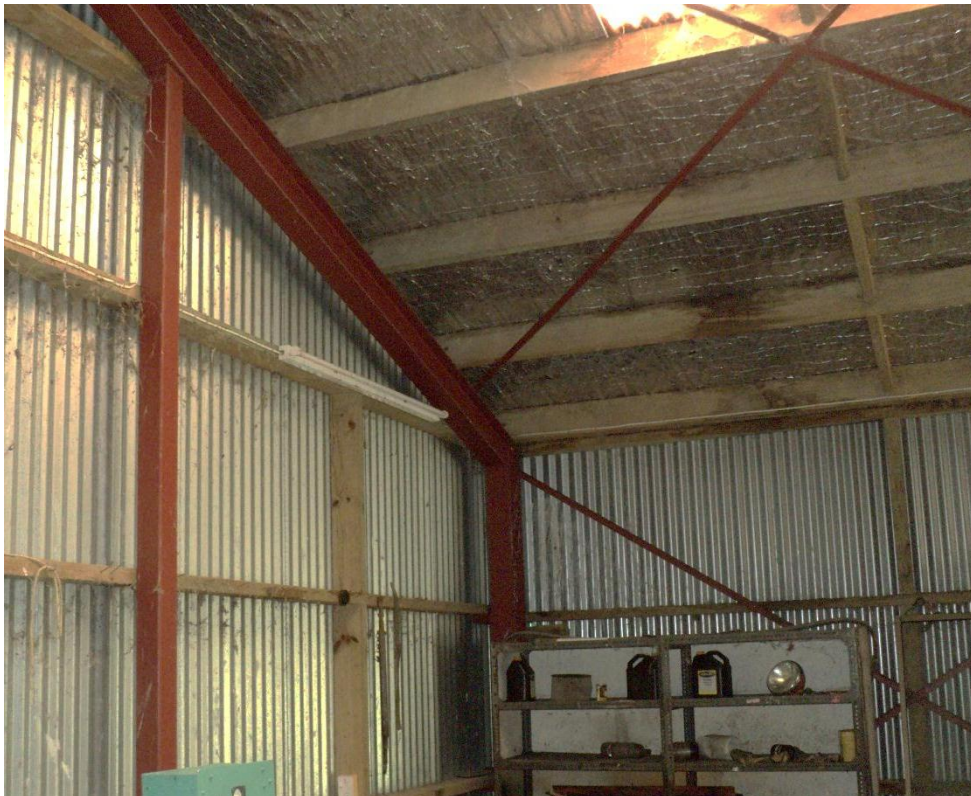
In the transverse direction, lateral load resistance is provided by the reinforced concrete masonry walls, Gib board ceiling lining in the smaller garage acts as a ceiling diaphragm, transferring lateral loads to the reinforced concrete masonry walls. Further lateral load resistance in the transverse direction is also provided by roof and wall steel strap cross bracing which transfers loads to the steel portal frames.

Photo A6: Interior view of west corner of building – showing wall and ceiling bracing.
