Toilet/Pavilion Queenspark
PRK 0109 BLDG 001
Detailed Engineering Evaluation
Qualitative Report
Version Final

210 Queenspark Drive, Parklands

Christchurch City Council

Date
17th May 2013

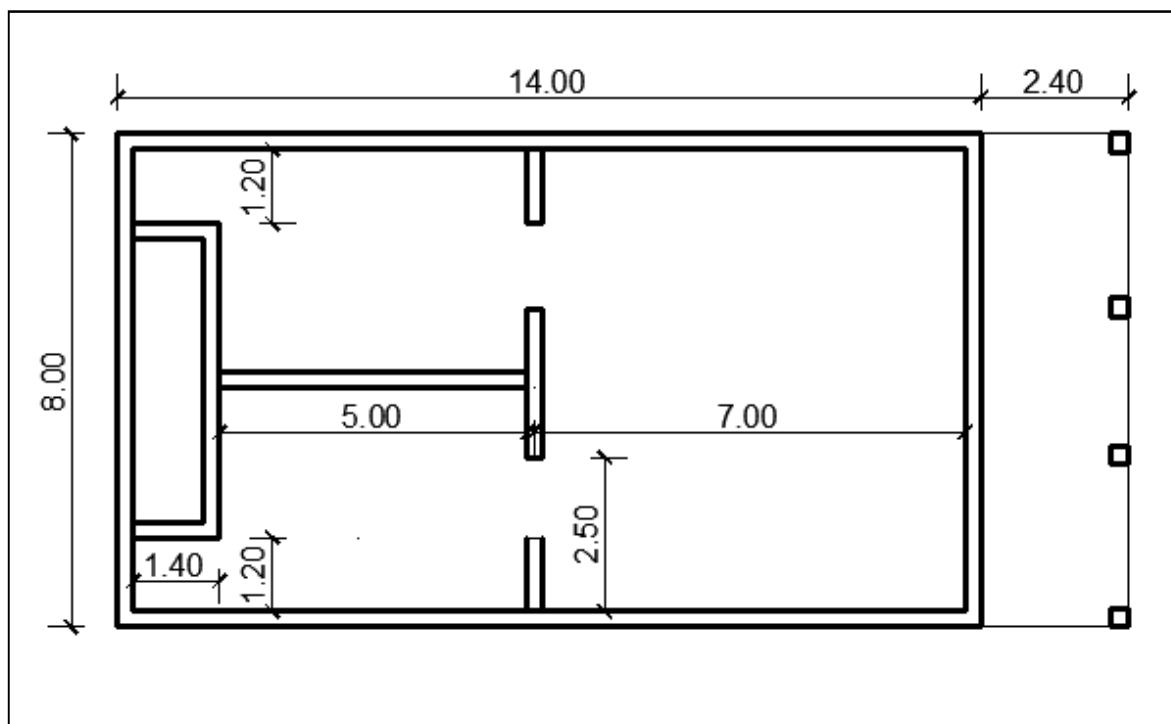
Figure 2 Plan Sketch Showing Key Structural Elements

The pavilion toilet is constructed on what is assumed to be a strip foundation. Both the perimeter and partition walls are constructed from 20 series concrete masonry. A timber framed roof is connected to the top beam on the walls. This roof is built from irregularly shaped trusses (Appendix A) spanning in the transverse direction. The trusses are spaced at 0.9 meter centres and provide the support for the metal sheet cladding. A 3m long canopy extends out of the buildings entire southern face forming a veranda.

Gravity roof loads are carried by timber purlins spanning in the longitudinal direction. Gravity loads are then transferred to the timber roof trusses which span the building in the transverse direction. Loads from the trusses are transferred to the concrete masonry walls to the foundation and into the ground.

In the transverse direction the connection of the purlins to roof trusses, which connect to the wall top plates provide, a rigid frame which transfers lateral roof loads to the walls in the plane of loading. The lateral loads are then resisted by the panel action of the concrete masonry walls and are passed to the foundation and finally to the ground.

In the longitudinal direction the lateral roof loads are transferred from the purlins, via the roof trusses to the walls in the plane of loading. Panel action is used by these walls to transfer the longitudinal loads into the foundation.

Despite the lack of bracing in the roof the metal sheet cladding and the timber roof provide nominal diaphragm action which helps to redistribute out of plane lateral loads to the in plane walls.

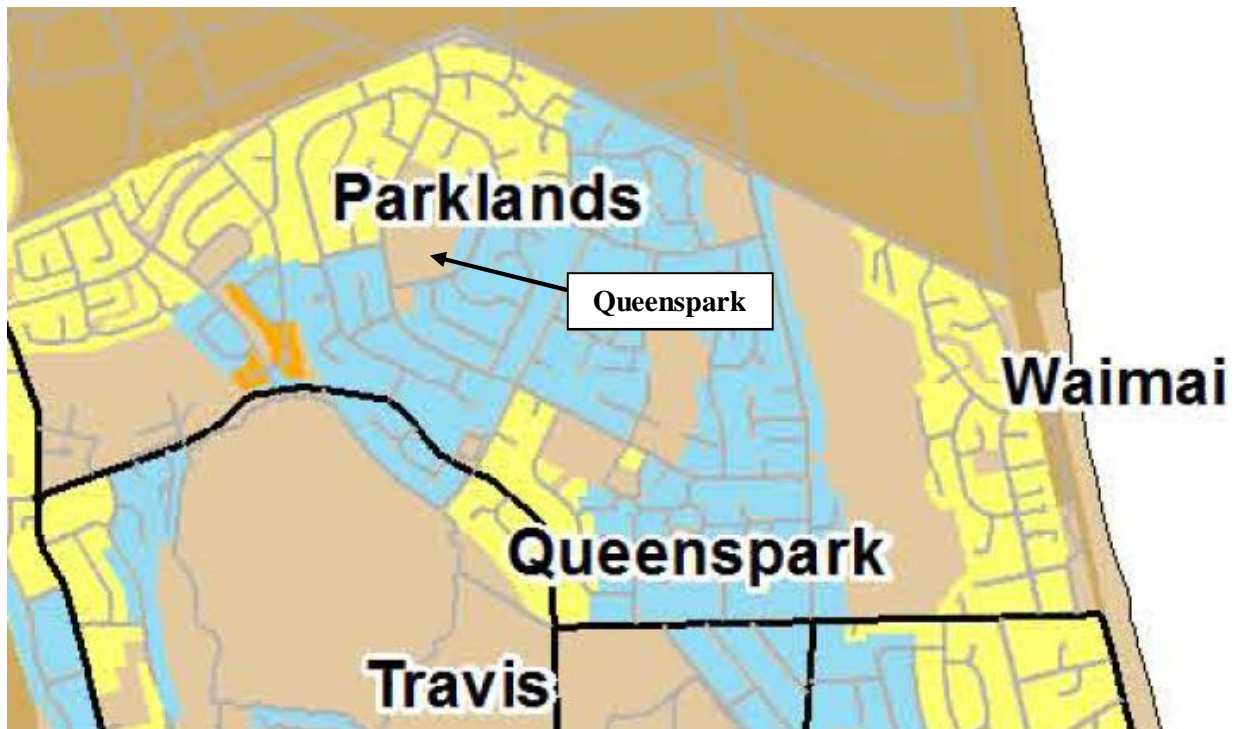
Figure 3 Map of Land Zoning Technical Categories ²

This site is categorised Technical Category Not Applicable, as the property is considered non-residential. However, as shown below in Figure 3, the site is located on the boundary of TC2 (yellow) and TC3 (blue).

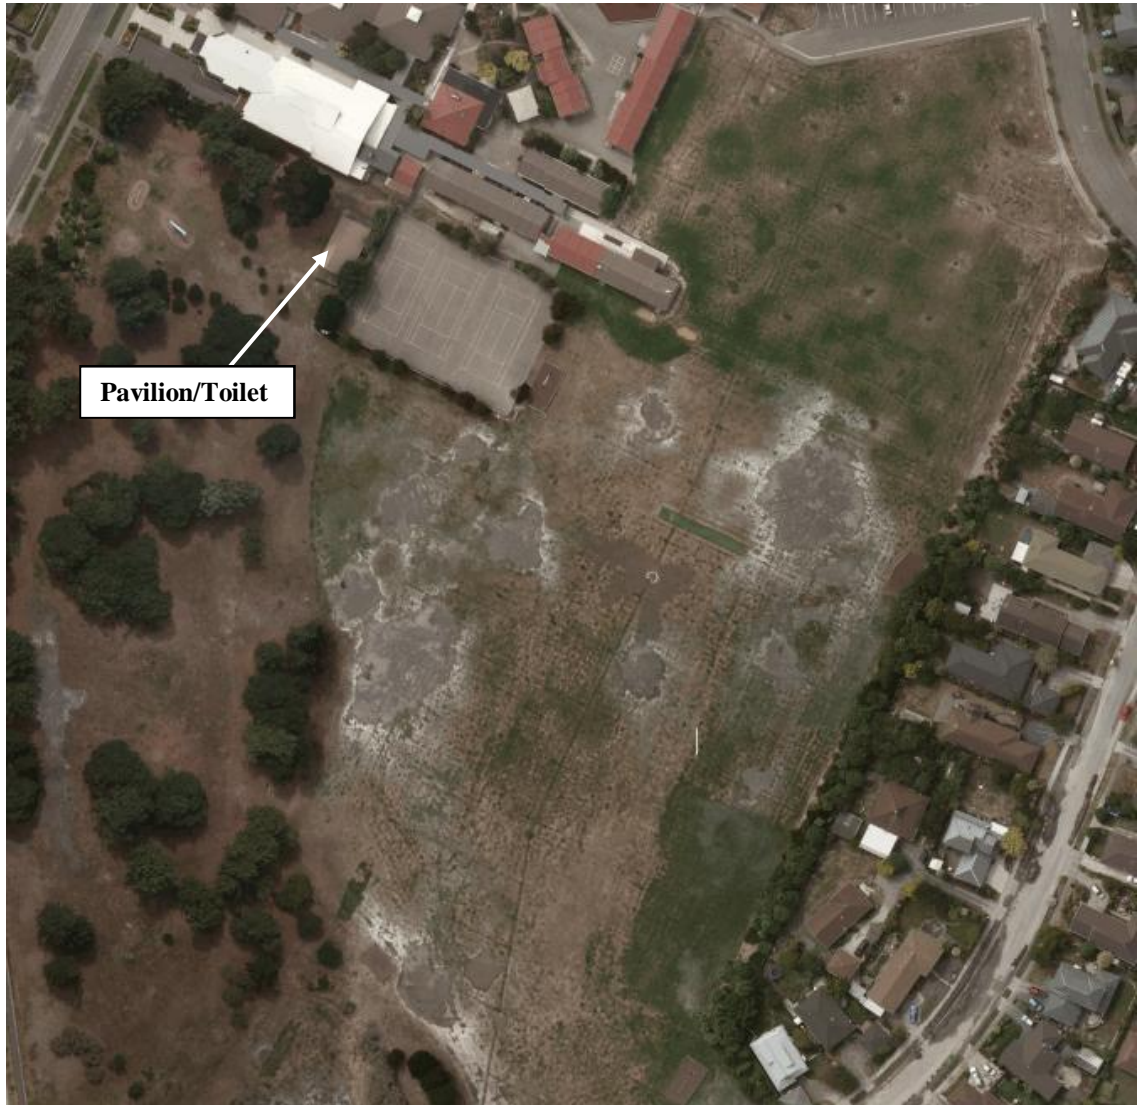
Figure 4 Post February 2011 Earthquake Aerial Photography³

Following the geotechnical appraisal it was found that the site has a high potential for liquefaction. For the purposes of the IEP assessment of the building and the determination of the %NBS score, the effects of soil liquefaction on the performance of the building has been assessed as a 'significant' site characteristic in accordance with the NZSEE guidelines.

Aerial photography taken within days following the 22 February 2011 earthquake shows significant signs of liquefaction throughout the reserve, particularly to the southeast of the buildings, as shown in Figure 4.

Given the site's anticipated susceptibility to liquefaction, it is recommended that intrusive investigation comprising at least one CPT should be conducted to target depth of 30m. This will allow a more detailed liquefaction assessment to be carried out.

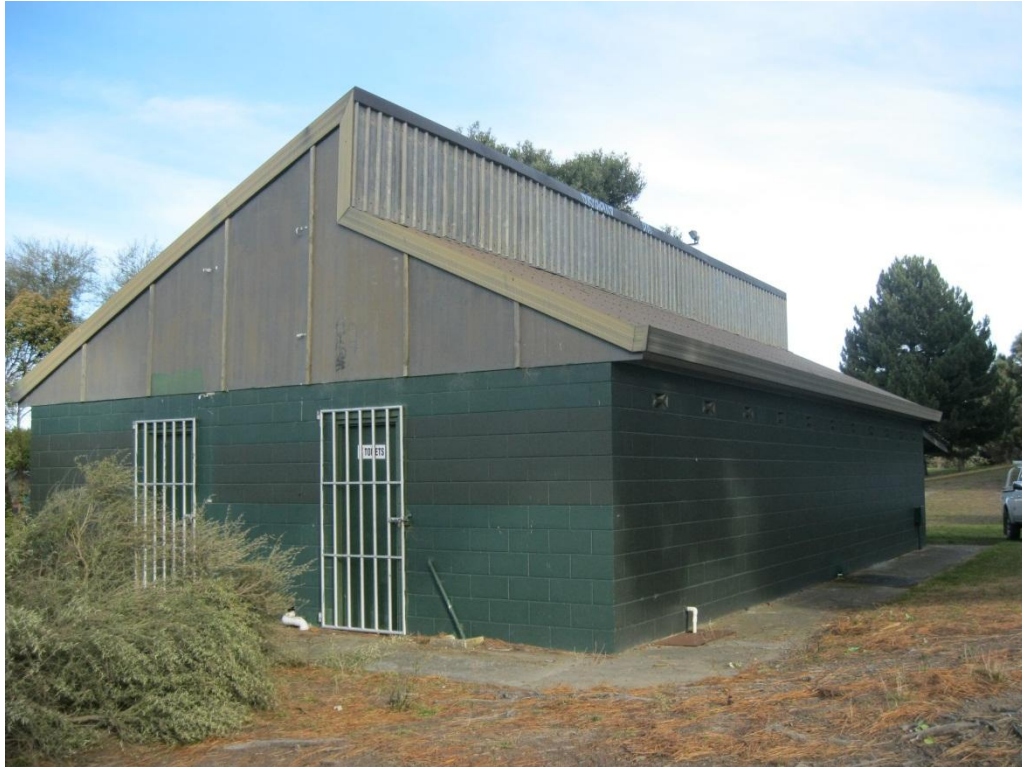
Photograph 1 View from the north.

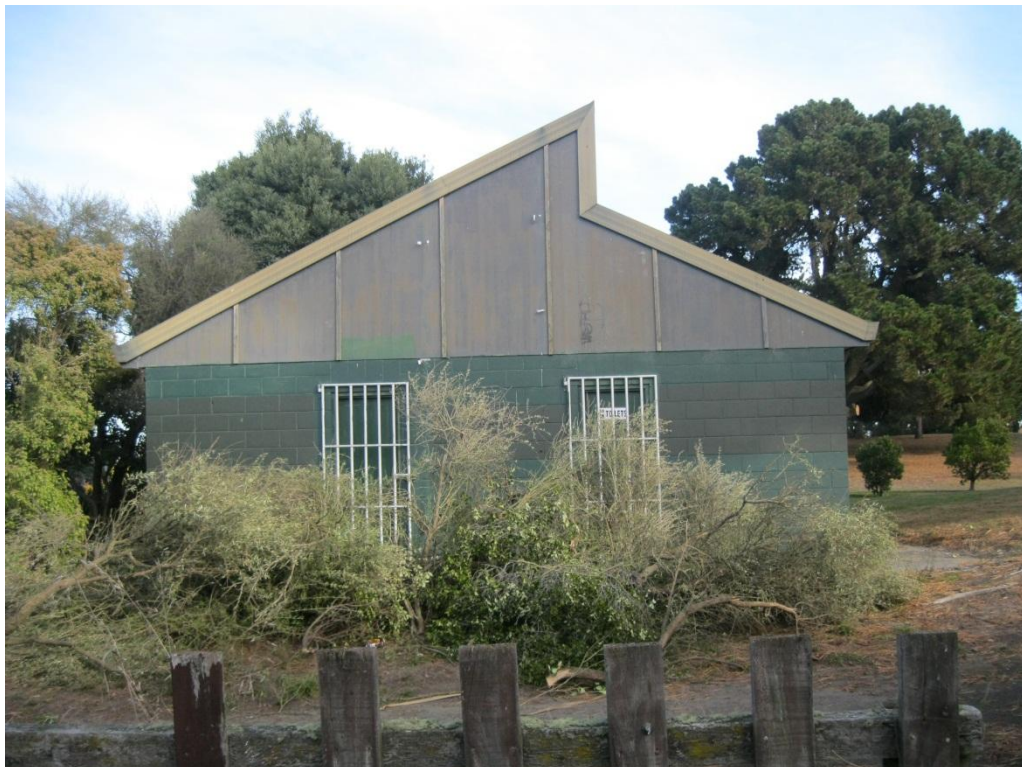
Photograph 2 Northern elevation.

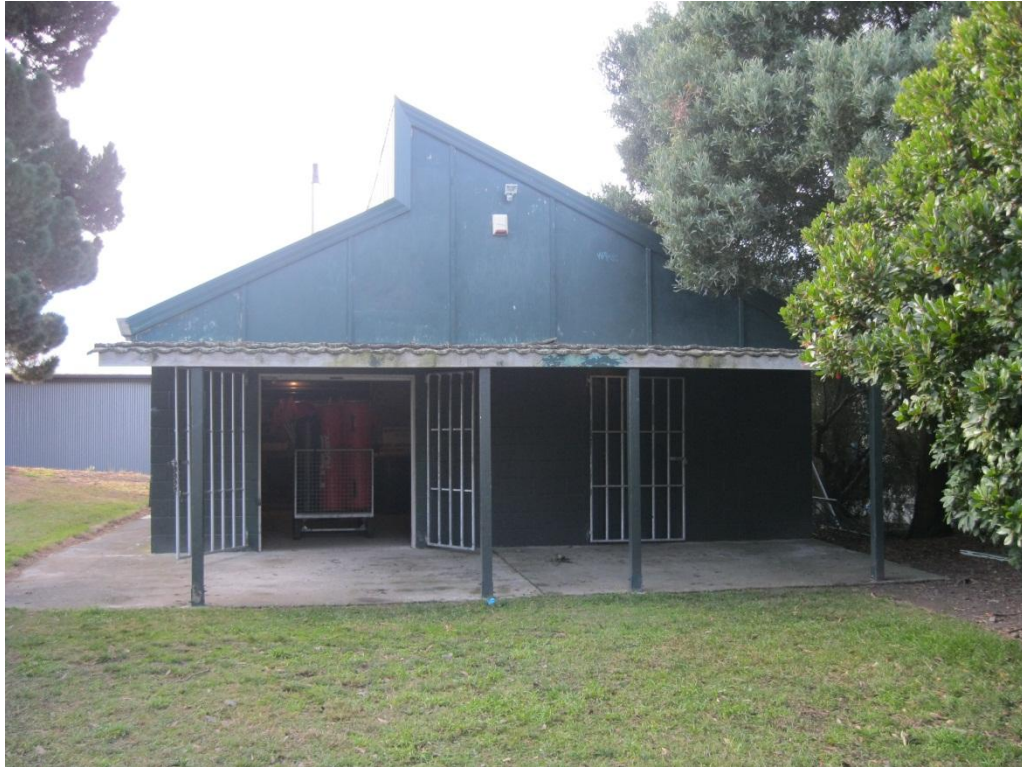
Photograph 3 Southern Elevation.

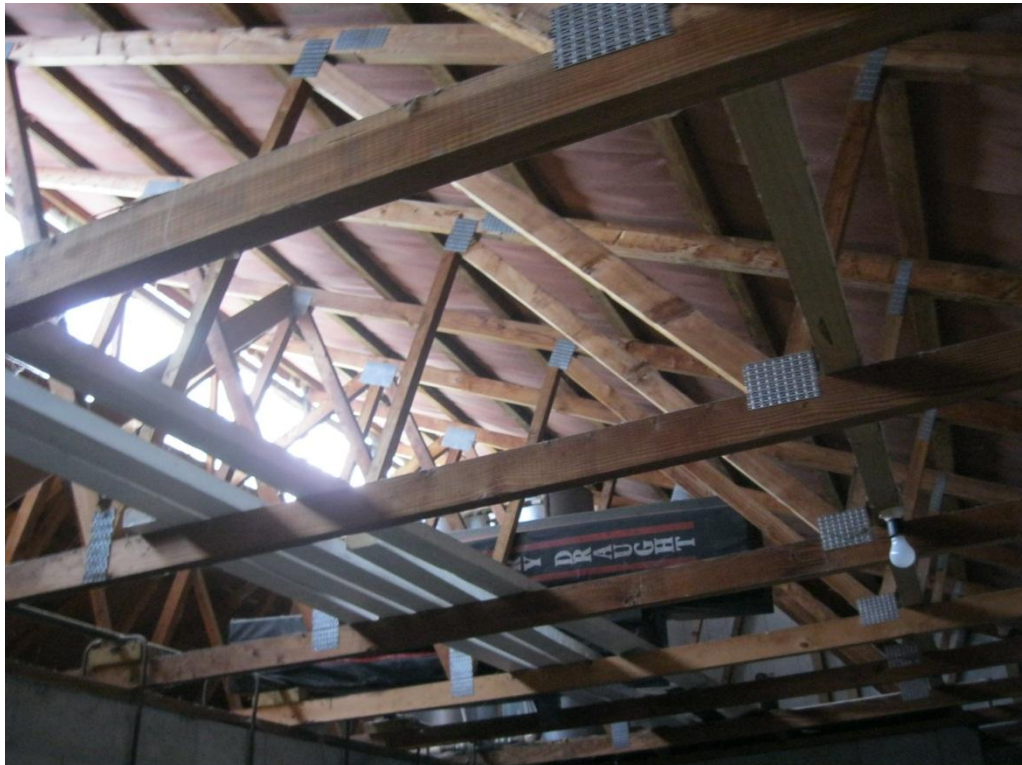
Photograph 4 Roof trusses.

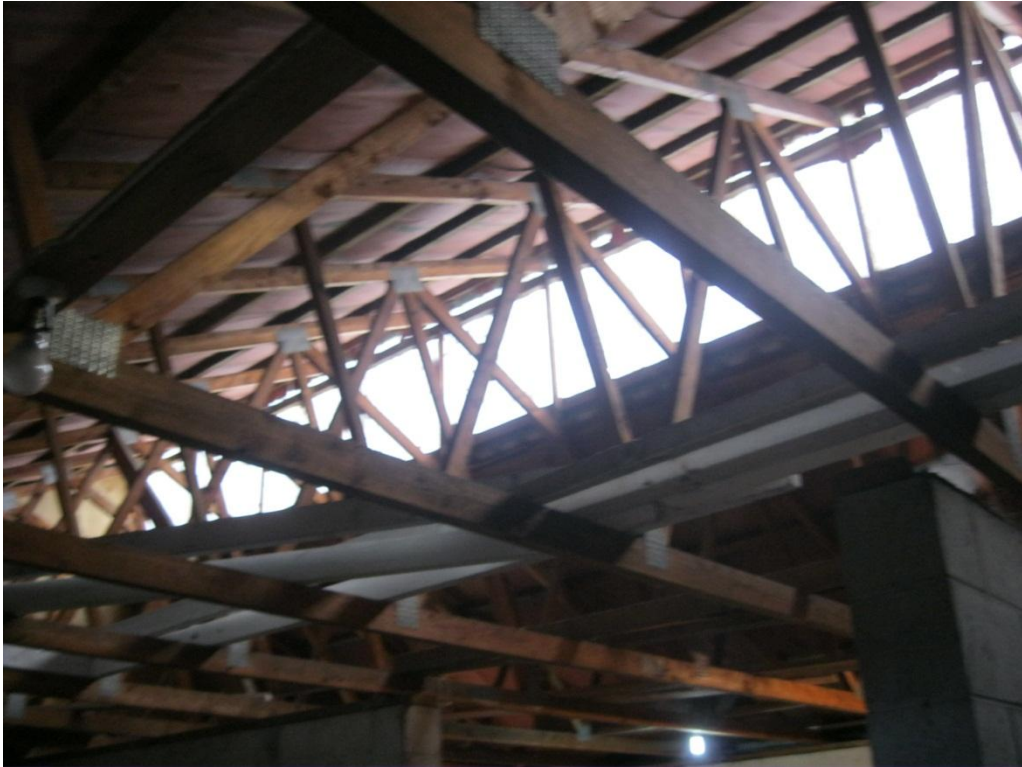
Photograph 5 Roof trussse.

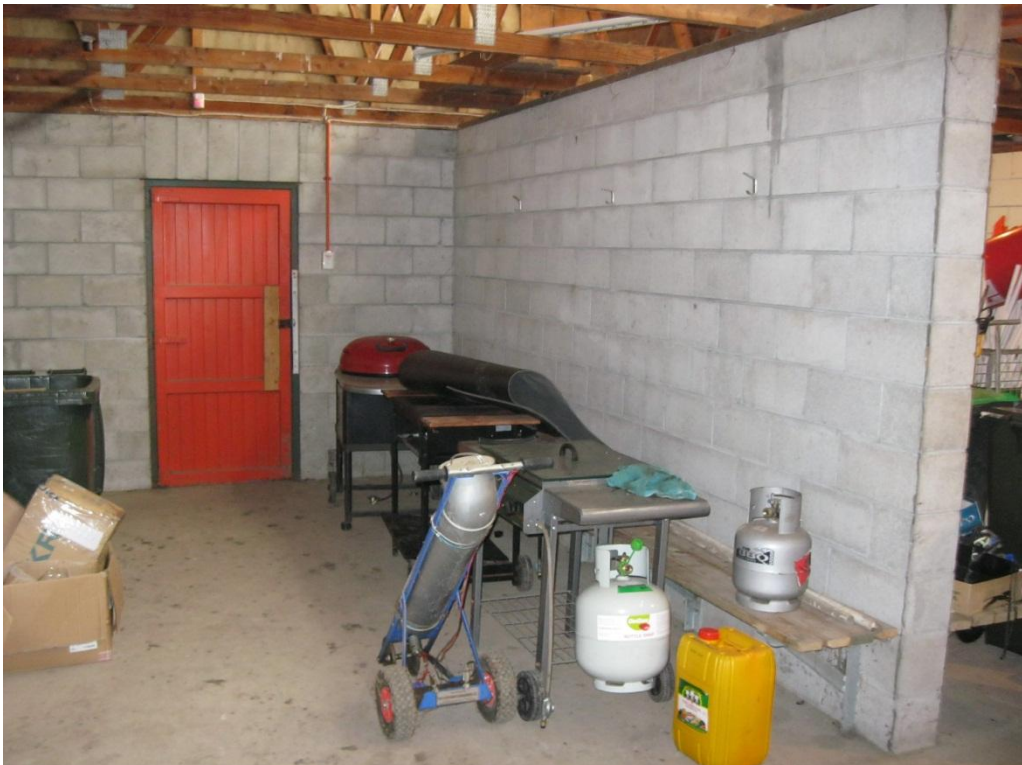
Photograph 6 Interior partition Wall.

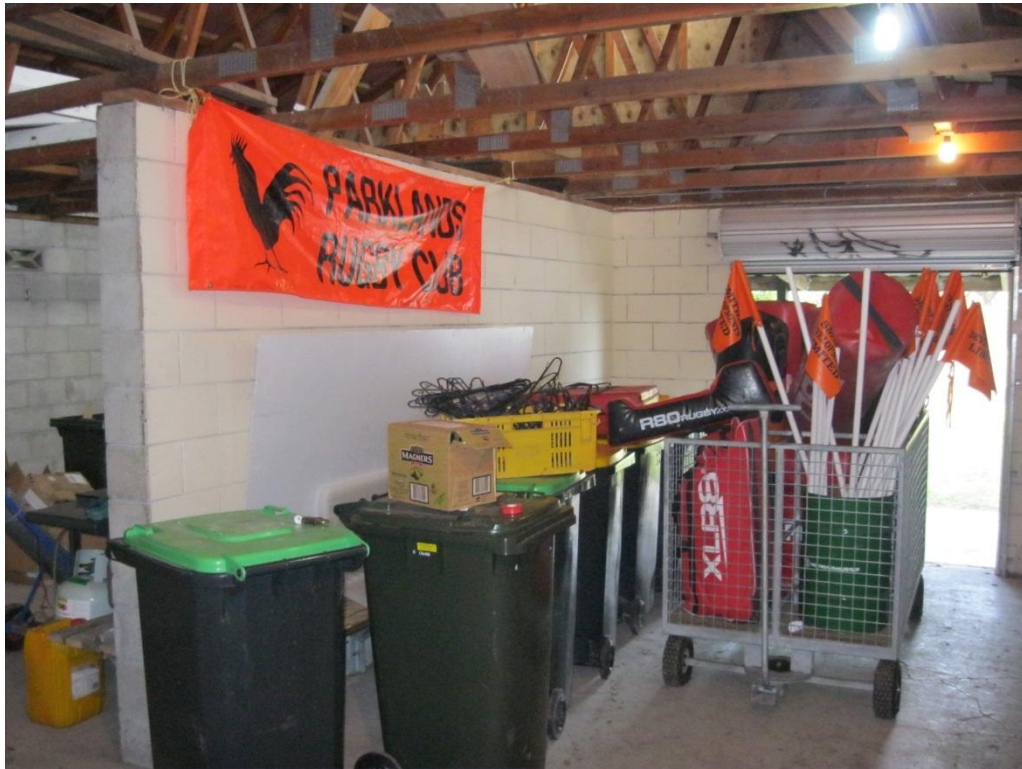
Photograph 7 Interior.
