**Raleigh/Newmark
Street
Housing Complex
PRO 0320**

**Detailed Engineering Evaluation
Quantitative Assessment Report**

Date: January 2014
Reference: 6-QC393.00
Status: Final

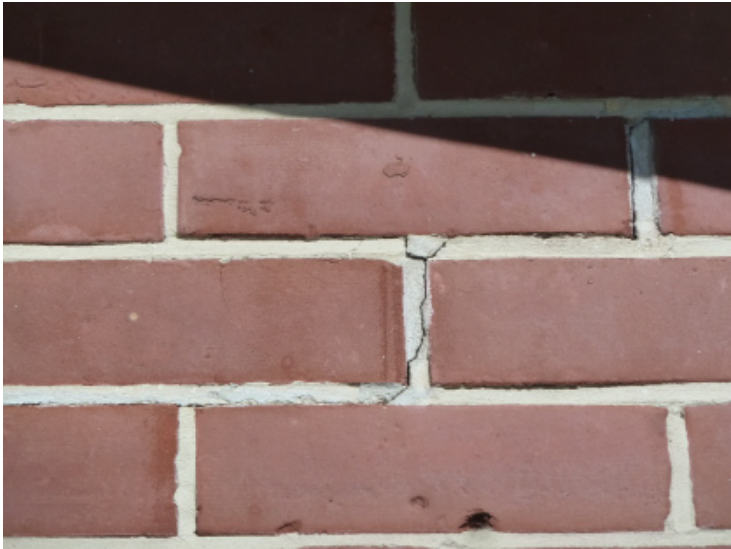
9.	Minor cracks in the brick veneer cladding, not believed to be earthquake related

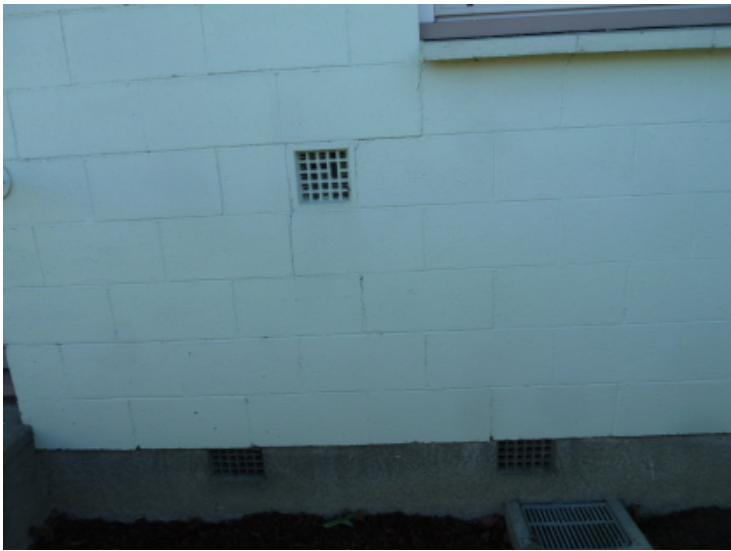
Minimal cracking of plasterboard ceiling diaphragms and wall linings was observed in the units. This form of damage is common throughout the units. Stepped cracking in the concrete block veneer mortar joints was observed on unit 3A (photo 10).

10.	Stepped cracking of blockwork at Unit 3A

- Veneer at height (gable ends) have the veneer ties checked.
- The concrete perimeter footings be repaired where cracking occurs.
- Cosmetic repairs be undertaken as required.
- Chimneys be removed to at least ceiling height.

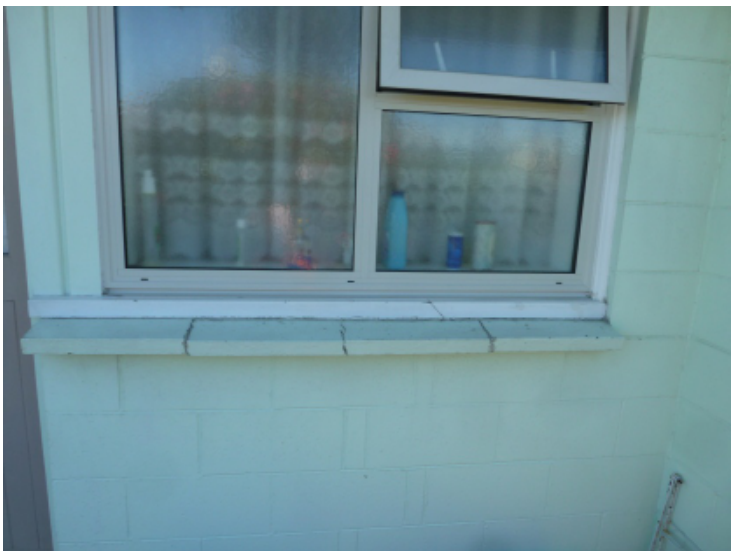
11.	One unit has cracking to the sill blocks

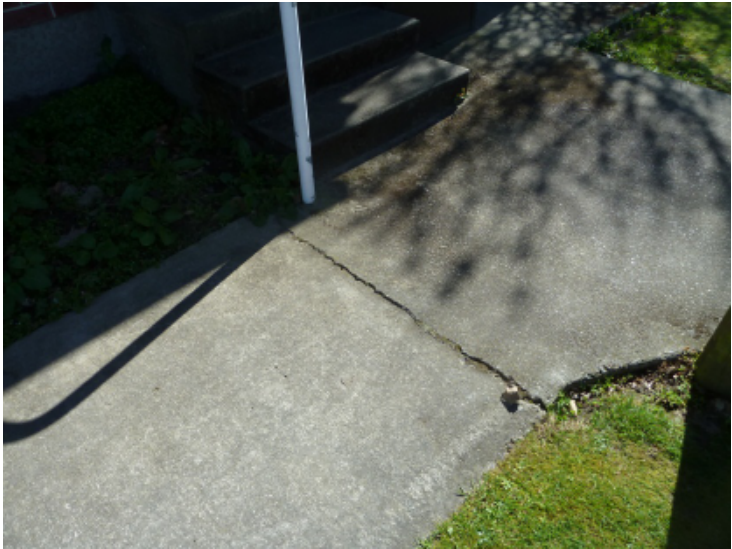
12.	Typical cracking of pavement

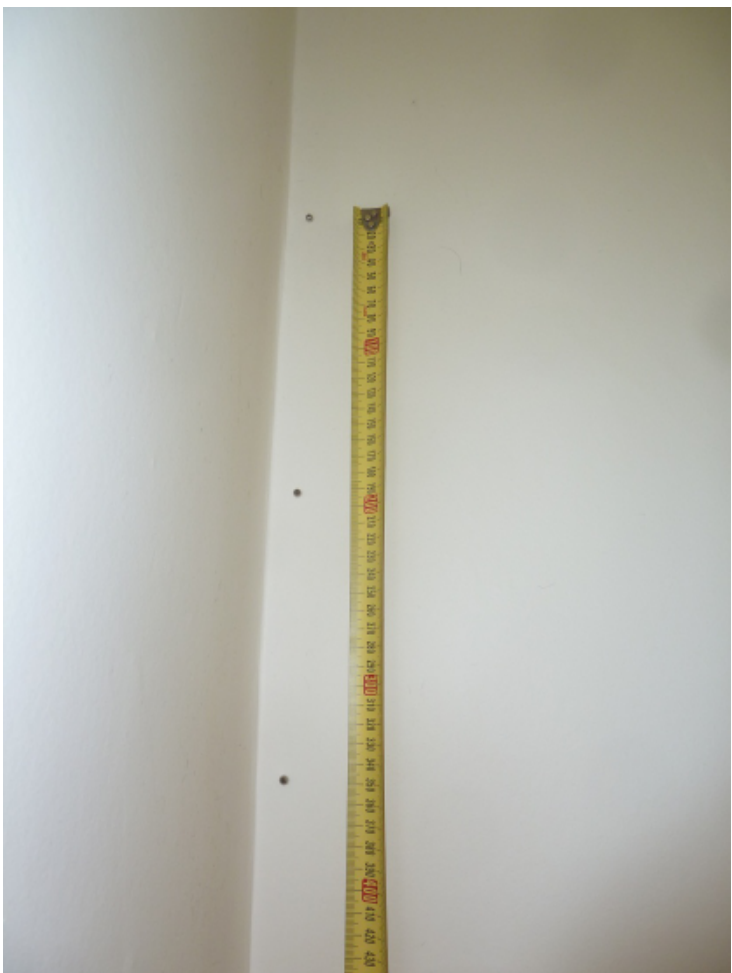
The internal lining nail spacings were measured on site to vary between 150-200mm.
