CHRISTCHURCH CITY COUNCIL
PRK_3558_BLDG_001 EQ2
Rapaki Wharf Toilet
7 Kina Road, Rapaki

QUALITATIVE ASSESSMENT REPORT

FINAL

- Rev B
- 23 May 2013

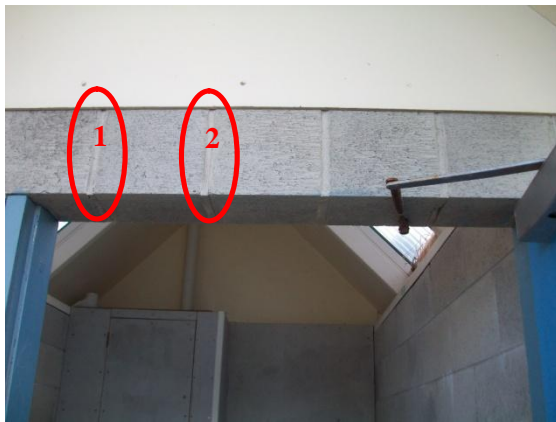
- 1) Minor cracking in the cement between masonry blocks centred above the doorway at a maximum of 0.3mm (refer to Photos 7 and 8).
- 2) Minor cracking in the cement between masonry at half-height of the western column at a maximum of 0.5mm (refer to Photo 9 and 10).
- 3) Some displacement between the masonry and timber in the columns (refer to Photos 11 and 12).
- 4) Some displacement between the feet of the columns and the concrete foundation (refer to Photos 13-16).
- 5) Cracking in the concrete foundation at the feet of the columns (refer to Photos 15 and 16).

Photo 7: Masonry above door way with minor cracking at two locations

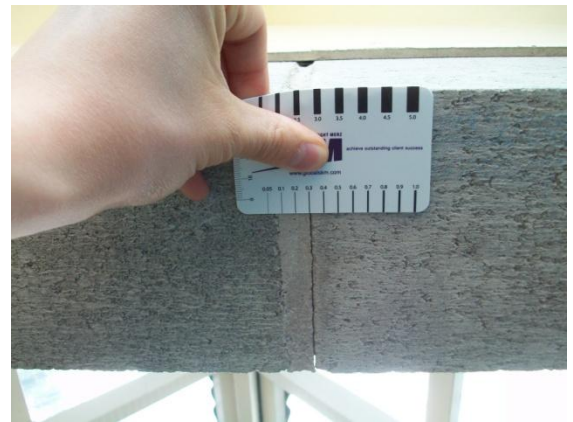
Photo 8: A maximum of 0.3mm cracking between masonry blocks above doorway (2)

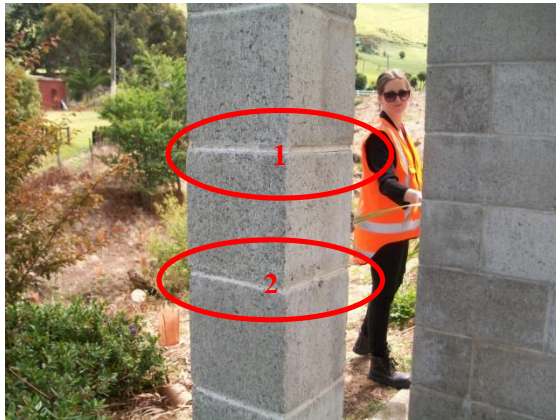
Photo 9: Western column masonry with minor cracking at two locations

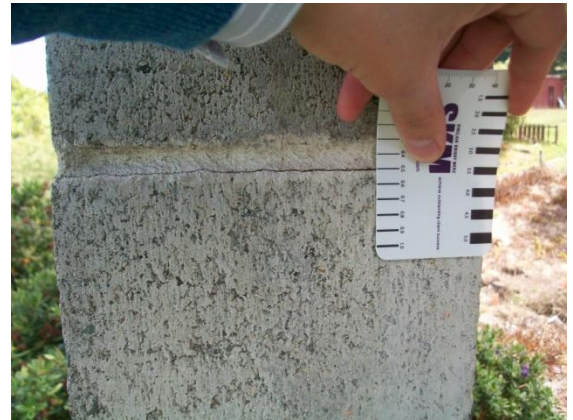
Photo 10: 0.5mm cracking between masonry blocks in the western column (1)

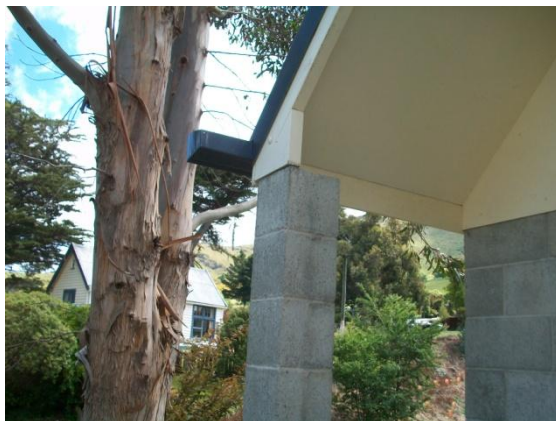
Photo 11: Displacement between columns and timber

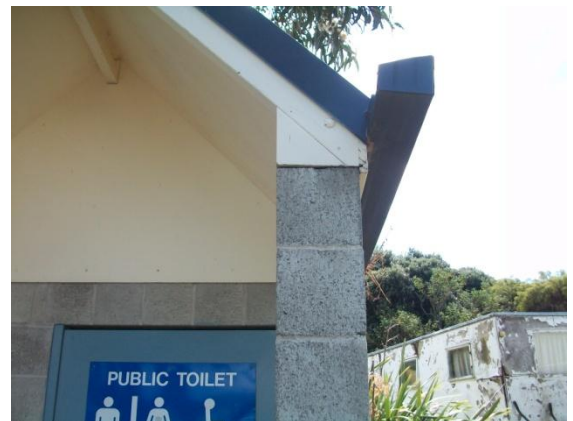
Photo 12: Displacement between columns and timber

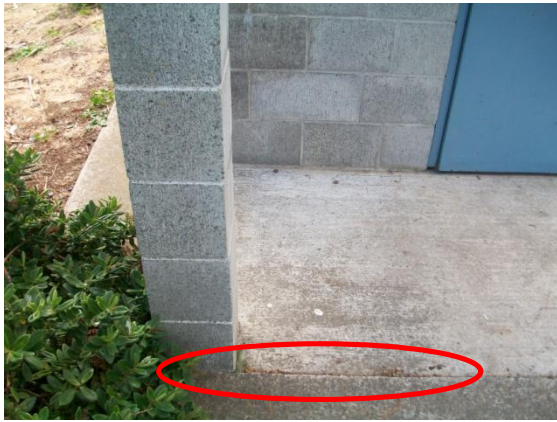
Photo 13: Displacement between foundation, column and pathway

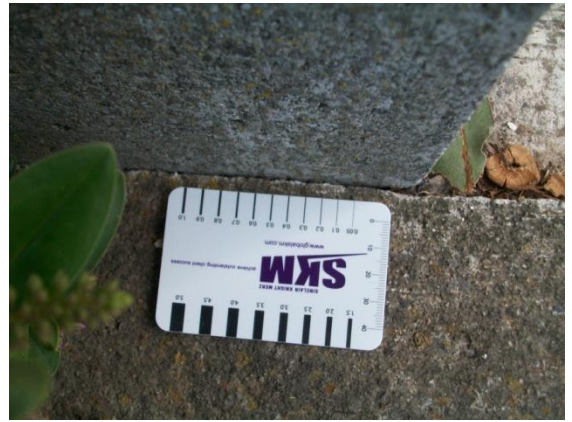
Photo 14: Size of displacement

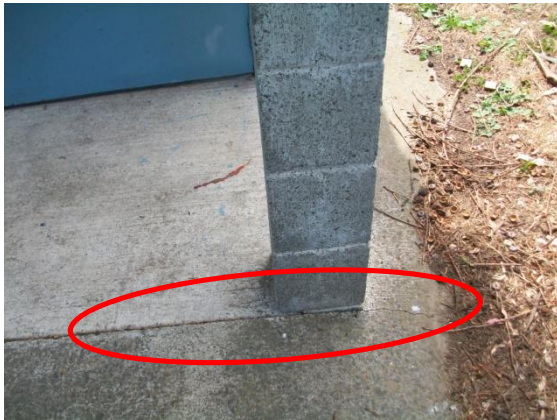
Photo 15: Displacement and cracking between foundation, column and pathway

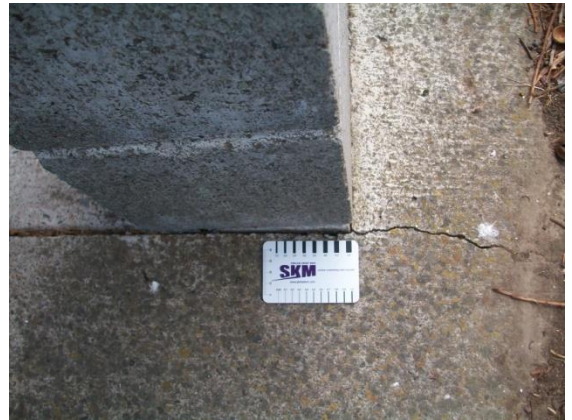
Photo 16: Size of displacement and cracking

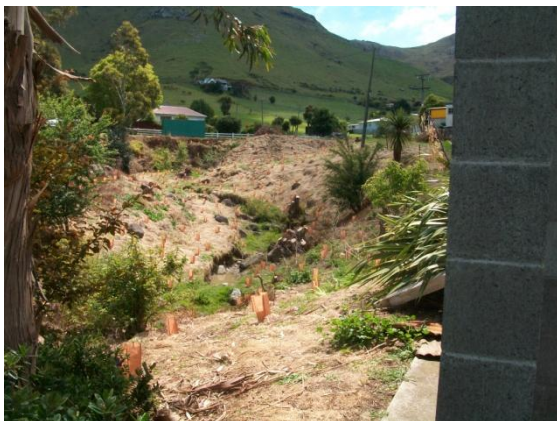
Photo 17: Slope and creek next to building
