Christchurch City Council
PRK_2004_BLDG_017 EQ2
Garage - Rawhiti Golf Course
35-37 Bowhill Rd

QUALITATIVE ASSESSMENT REPORT

FINAL

- Rev B
- 23 May 2013

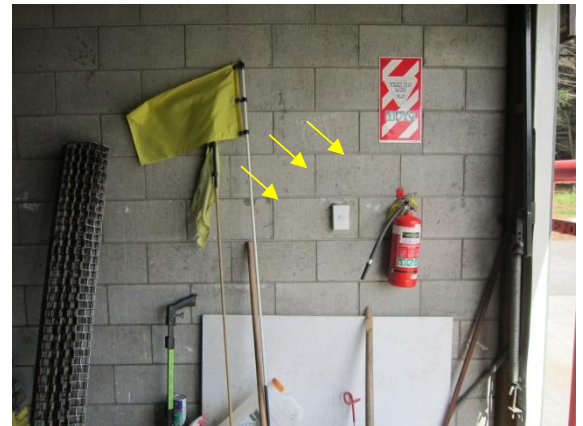
Photo 8: Close up view from photo 7

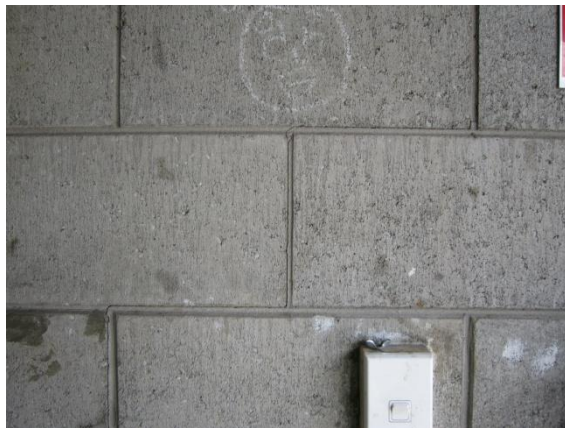
- 0.6mm step cracks through the masonry grout on the transverse walls close to the garage door openings

- 1) 0.5mm-0.6mm step cracks through the masonry grout on the transverse walls close to the garage door openings

Photo 9: Close up view from photo 8 showing 0.6mm step cracks through masonry grout.

Recommendations		
Level of repair/strengthening required: <input type="text" value="minor non-structural"/>		Describe: <input type="text" value="Mortar to be ground out, repointed and made good to match existing"/>
Building Consent required: <input type="text" value="no"/>		Describe: <input type="text"/>
Interim occupancy recommendations: <input type="text" value="full occupancy"/>		Describe: <input type="text"/>
Along	Assessed %NBS before: <input type="text" value="55%"/>	%NBS from IEP below
	Assessed %NBS after: <input type="text" value="55%"/>	
Across	Assessed %NBS before: <input type="text" value="55%"/>	%NBS from IEP below
	Assessed %NBS after: <input type="text" value="55%"/>	
		If IEP not used, please detail assessment methodology: <input type="text" value="Qualitative Assessment carried out, this includes the NZSEE IEP - refer to SKM report"/>

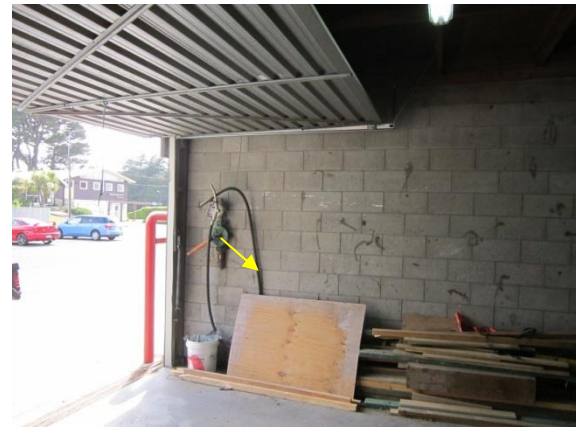
Photo 14: Masonry wall inside of 3 bay garage

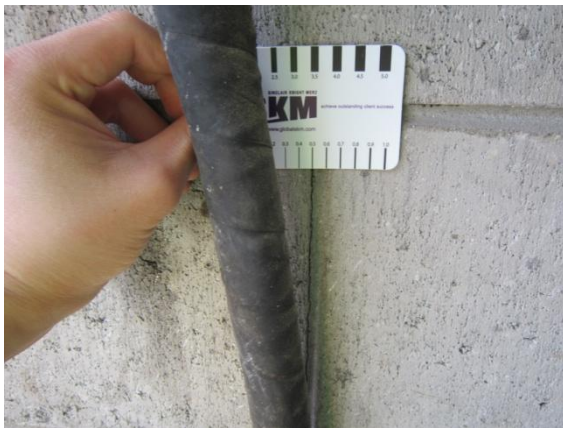
Photo 15: Close up view from photo 14 showing 0.5mm step cracks through masonry grout
