Christchurch City Council
PRK_2004_BLDG_018 EQ2
Rawhiti Domain - Silver Band Shed
35-37 Bowhill Road, New Brighton

QUANTITATIVE REPORT
FINAL

- Rev B
- 19 November 2013

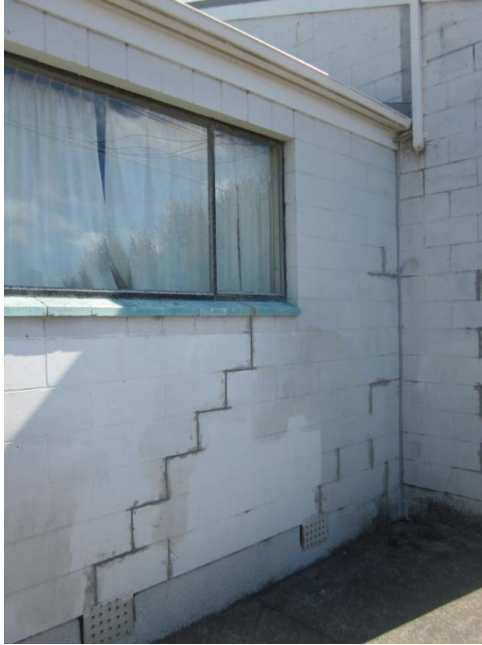
- 1) The building has sustained minor damage to the south west where cracking, approximately 1.5 mm wide, has occurred through the masonry block units below the library window. See Photo 21: Cracking beneath south west window
- 2) Cracking in the masonry blockwork mortar joints on the south east of the building which has since been repointed. See Photo 1: Repointed mortar joints on the Southeast amenities

Photo 1: Repointed mortar joints on the Southeast amenities block

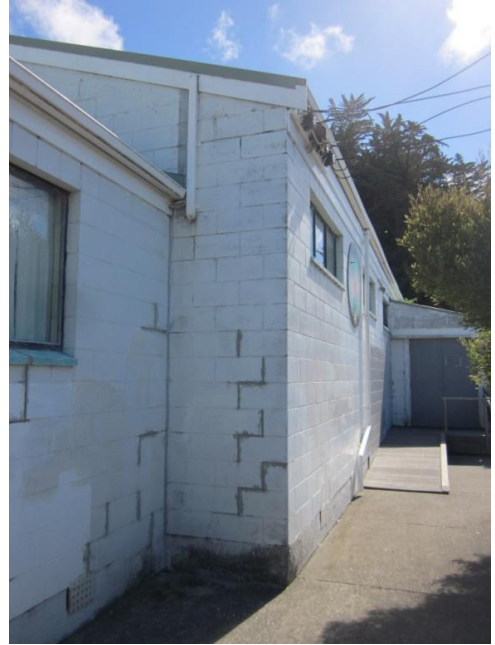
Photo 2: Repointed mortar joints on the Southeast amenities block

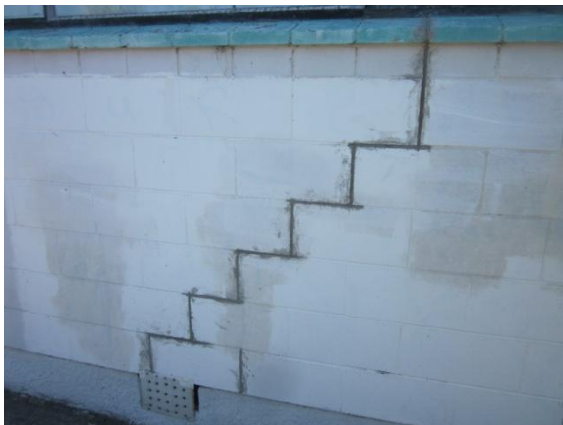
Photo 3: Stepped mortar joint cracking below the window from photo 1

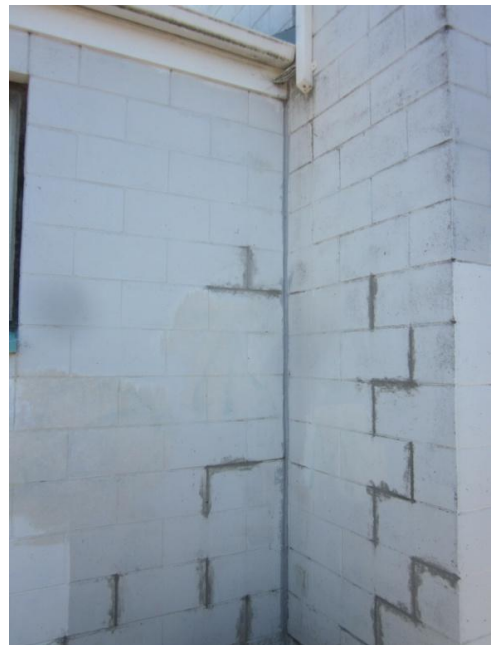
Photo 4: Mortar cracking around the building transition from amenities to main hall.

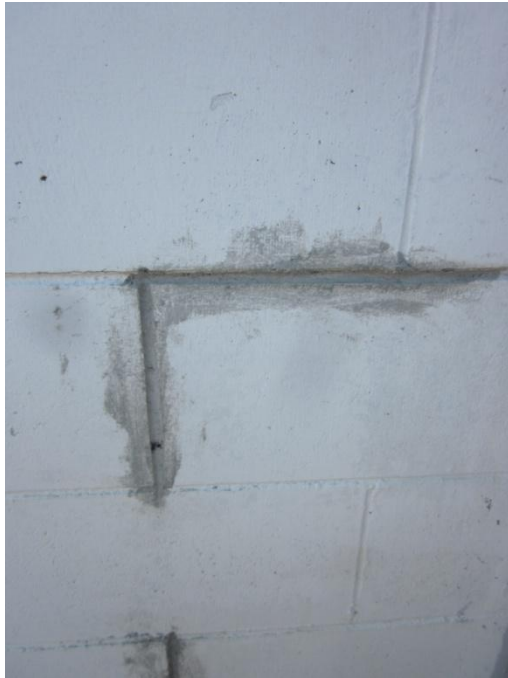
Photo 5: Repointed masonry, still to be painted

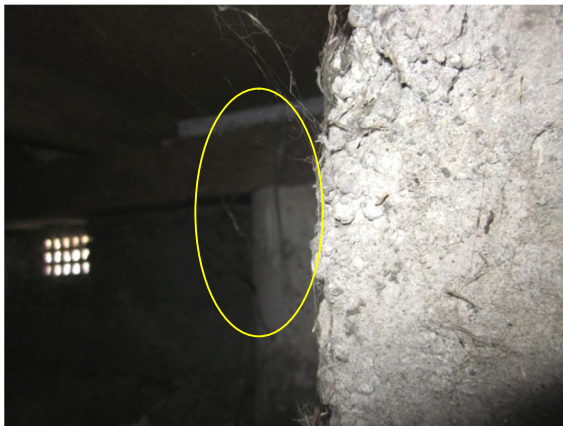
Photo 11: Bearers tied to concrete piles by wire

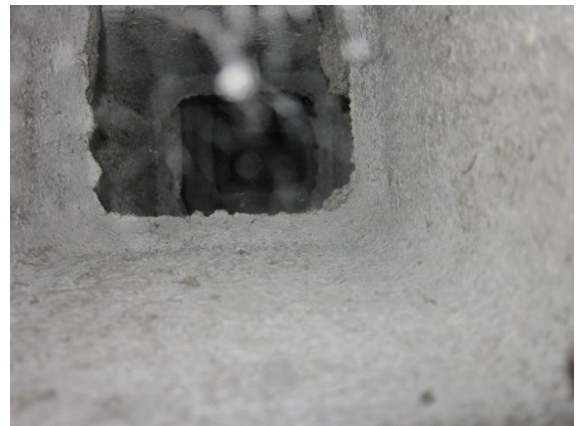
Photo 12: Photo up through the masonry block cell, above the ventilation point. Masonry walls partially filled

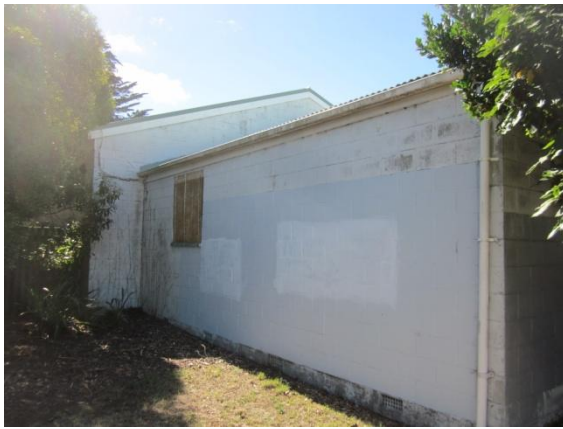
Photo 13: Southwest corner of the building with cracking below the window. See photos 14 and 21 to 23

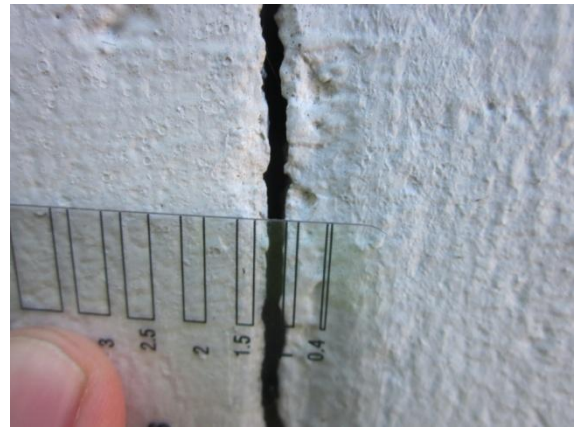
Photo 14: Block separation between masonry units

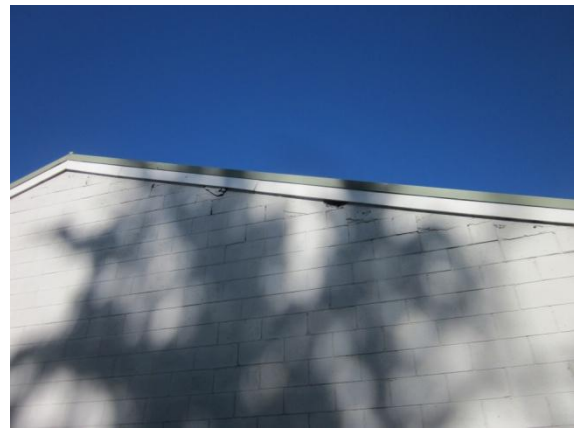
Photo 16: Spalling to the concrete infill along the gable end wall between blockwork and roof

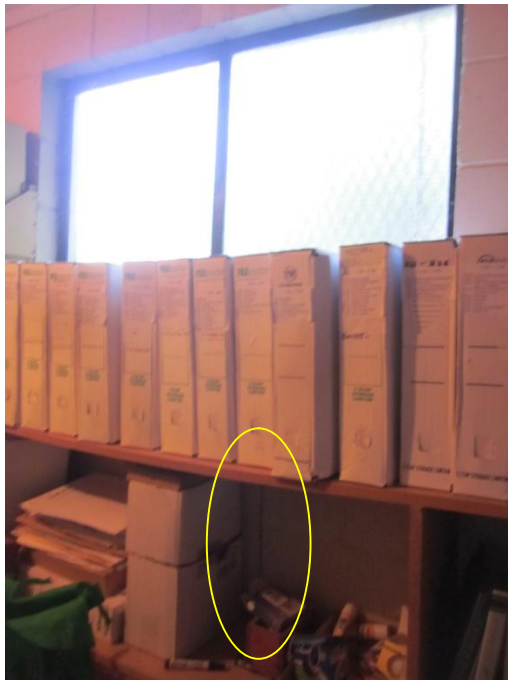
Photo 21: Cracking beneath south west window

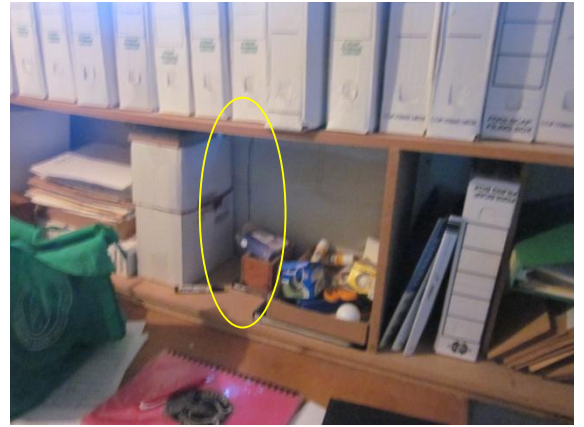
Photo 22: Cracking extends between masonry units and through blocks

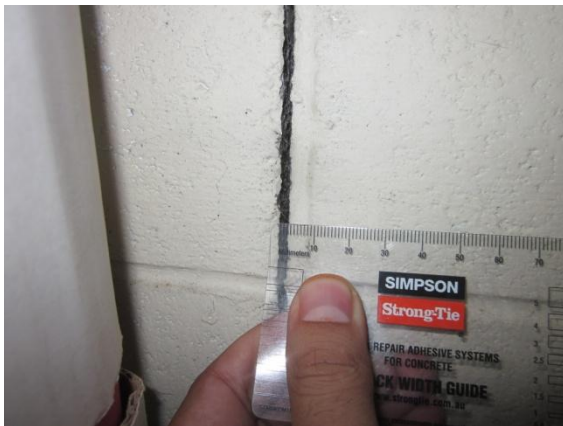
Photo 23: Cracking approximately 1.5 to 2mm in width

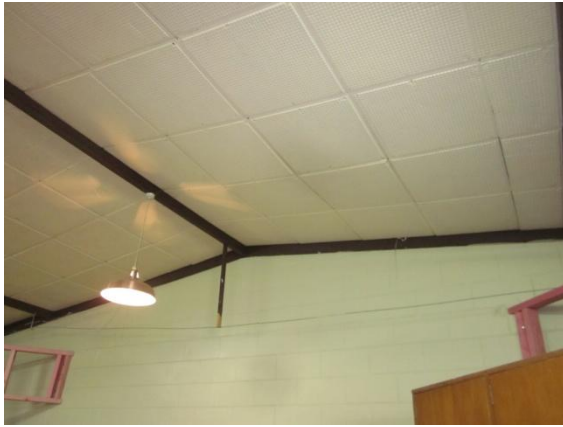
Photo 29: Structure of ceiling support unknown

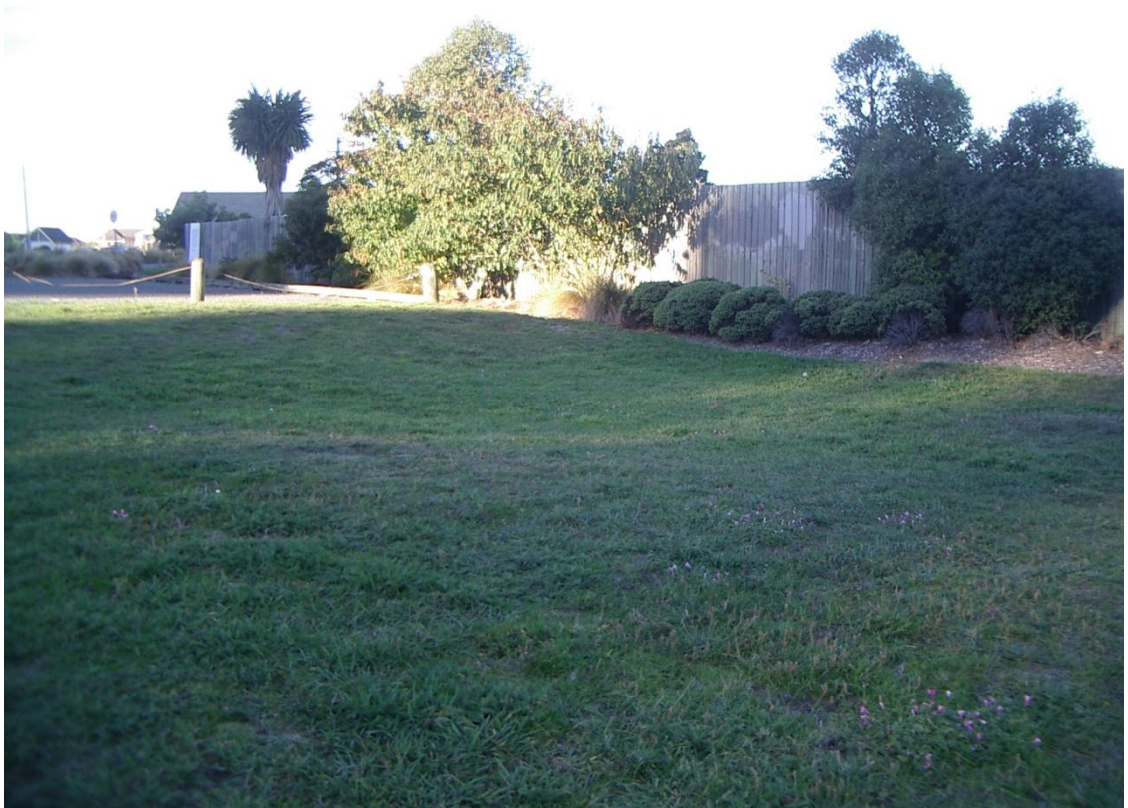
The building was noted to be a single storey masonry block building with a sheet metal roof. The foundation for the building was most likely a reinforced concrete slab on grade foundation. During the external site walkover no evidence of liquefaction or other land damage was observed. Any sand present on the surface was likely to be windblown sand from the nearby beach. There was undulating ground observed close to the site and through the car park but this could be due to tree roots or past sand dunes rather than due to liquefaction occurring on site.

■ **Figure 8 Observed undulating ground**
