CHRISTCHURCH CITY COUNCIL
BU 1316-017 EQ2
Former Radio Bldg-Rawhiti Golf Course
104 Shaw Ave, New Brighton

QUALITATIVE ASSESSMENT REPORT
FINAL

- Rev B
- 19 September 2012

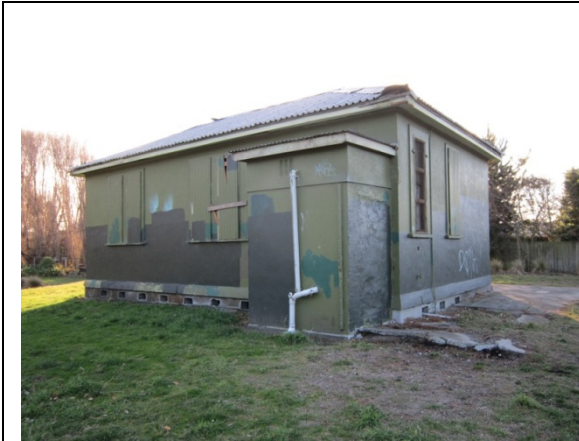
Photo 1: Southeast elevation

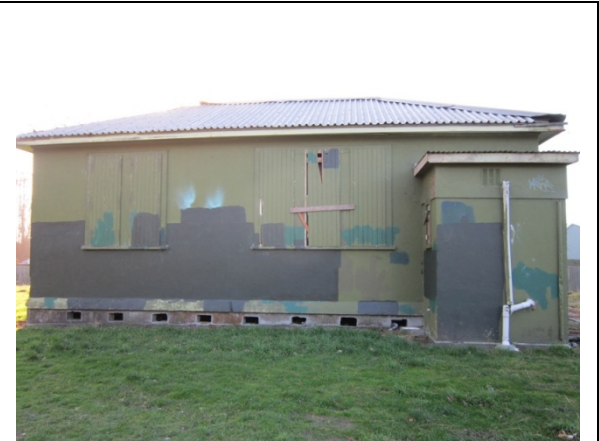
Photo 2: South elevation

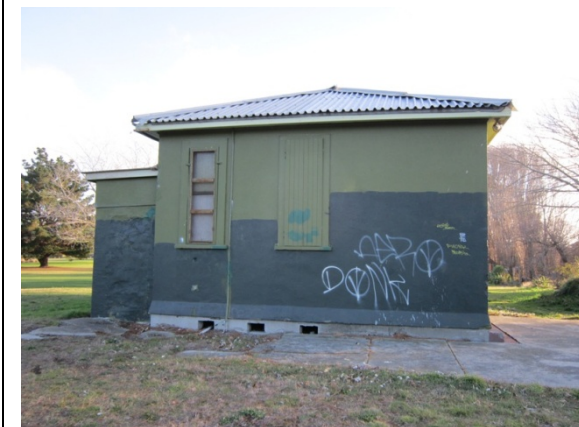
Photo 3: East elevation

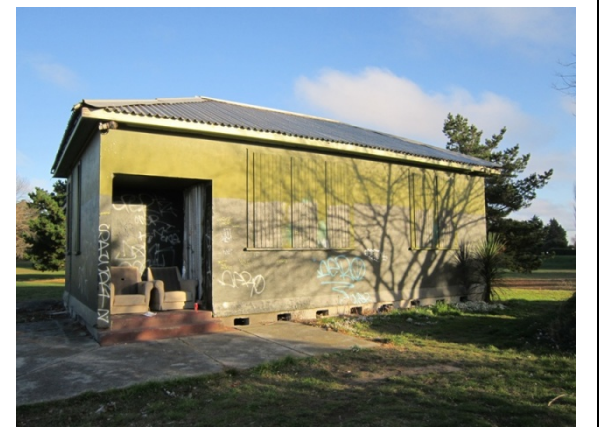
Photo 4: West elevation

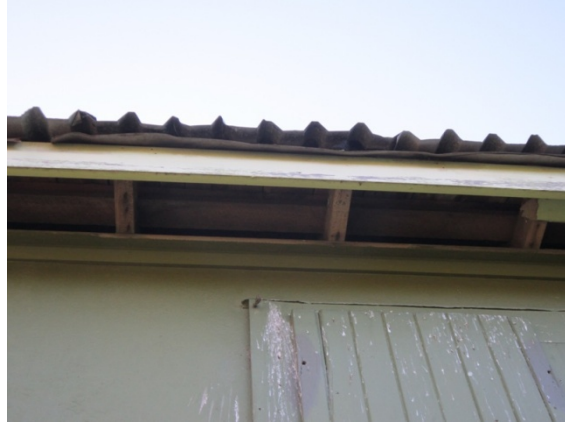
Photo 5: Soffit on south side with timber members missing.

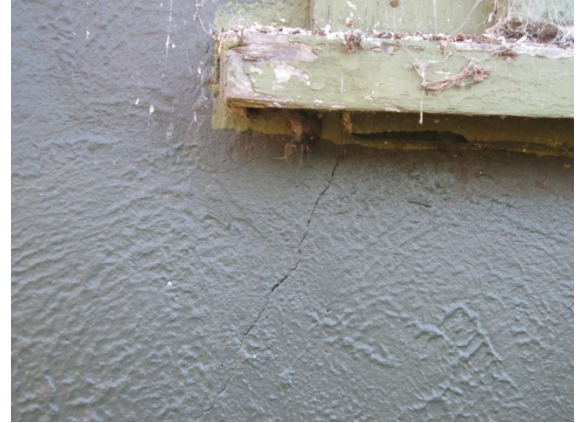
- 1) Cracking of the plaster on the walls throughout the building was noted. They appear to have been painted over, therefore this is not believed to be earthquake-related damage.

Photo 6: Crack in plaster on south concrete wall under timber windowsill has been painted over.

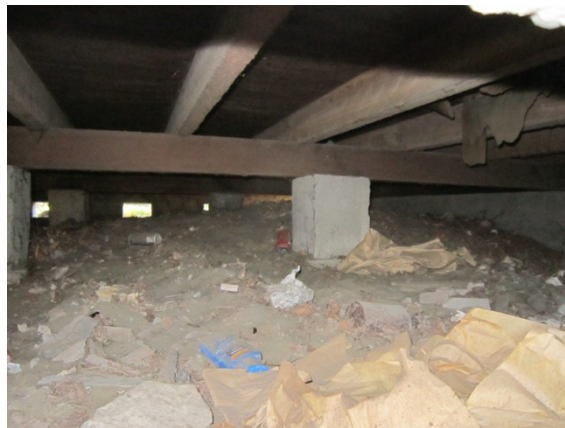
Photo 7: Timber floor supported by timber joists and bearers, resting on concrete blocks on ground.

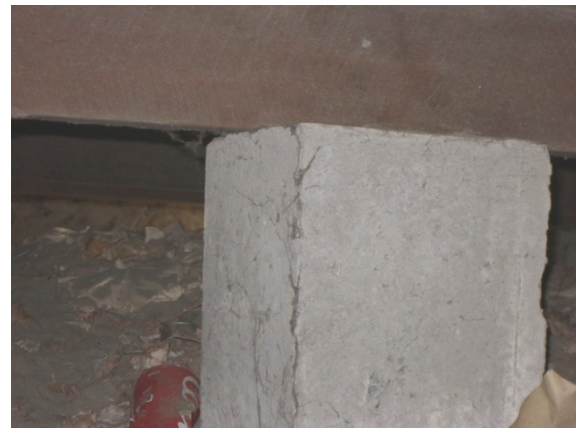
Photo 8: No visible connection between timber bearers and concrete block.

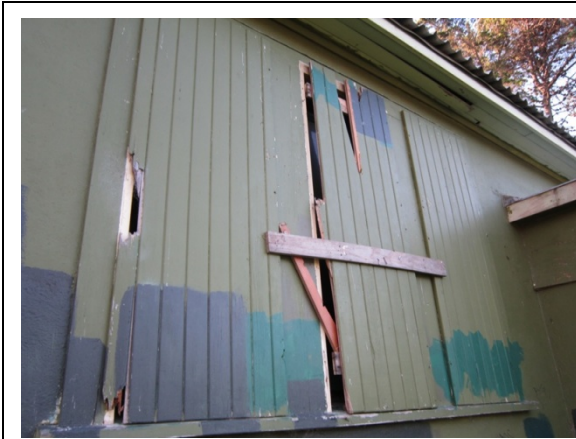
Photo 9: Boarded up window on south side.

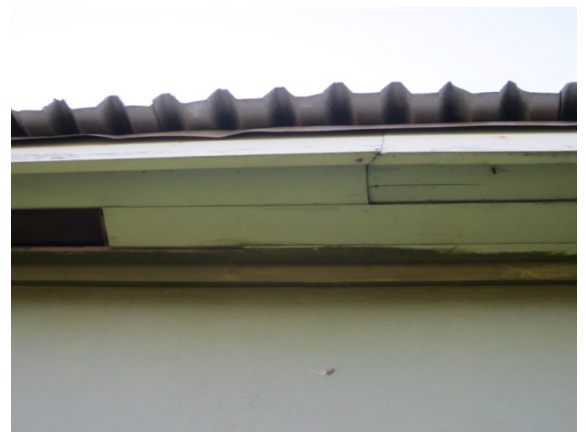
Photo 10: Soffit on south side.

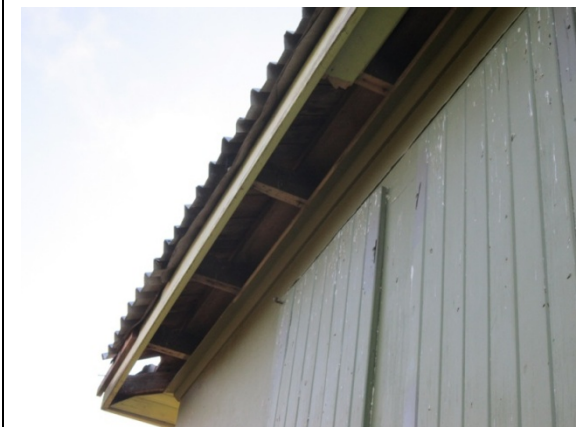
Photo 11: Soffit on south side.

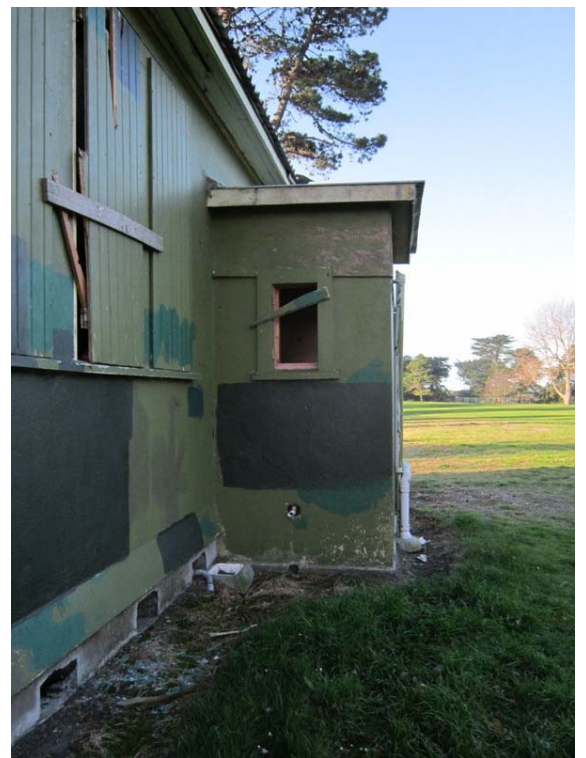
Photo 12: Lower section of building on southeast corner.

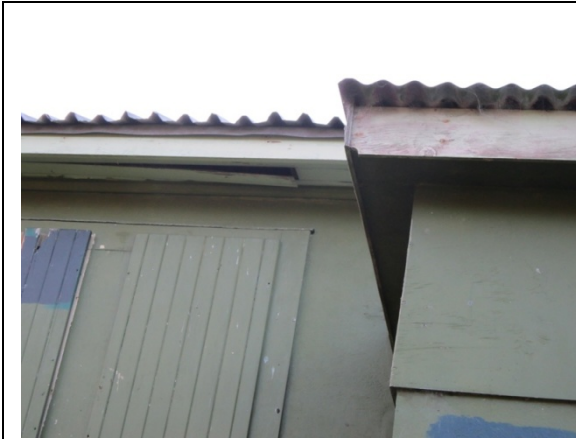
Photo 13: Timber edge beam on south side.

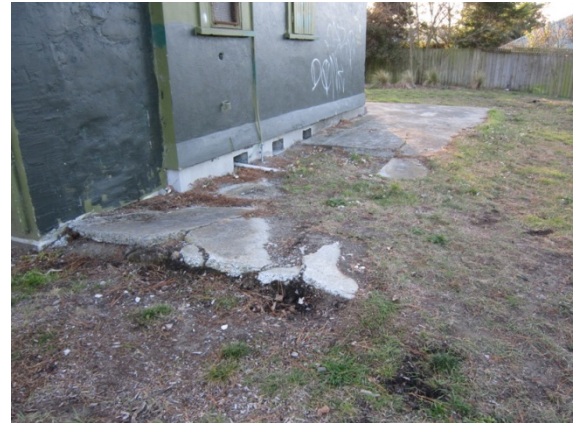
Photo 14: Concrete ground slab on east side.

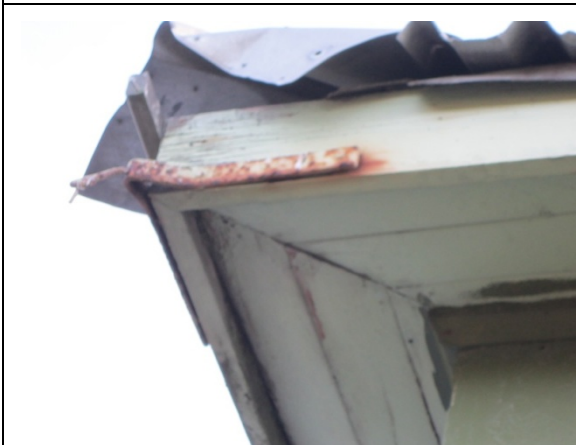
Photo 15: Rusted steel element on southeast corner of roof.

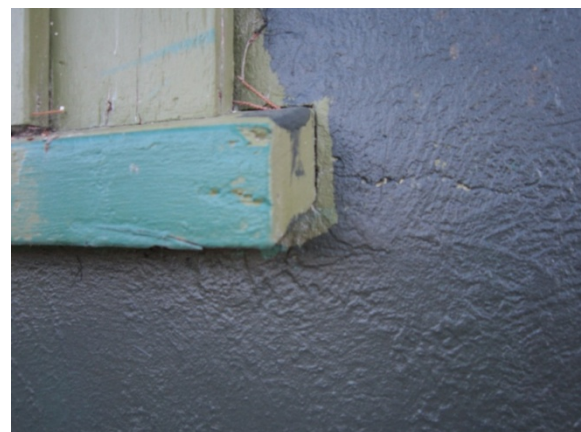
Photo 16: Crack in plaster on east wall by timber windowsill has been painted over.

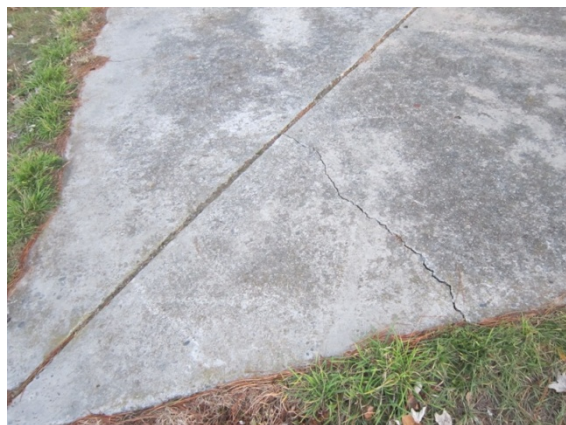
Photo 17: Crack in external ground concrete slab on northeast corner of building.

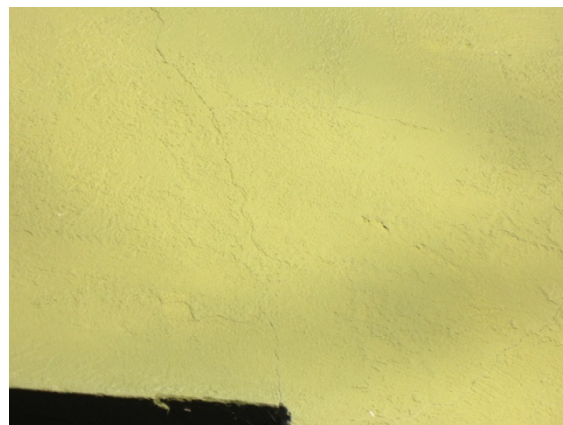
Photo 18: Crack in plaster on north wall has been painted over.

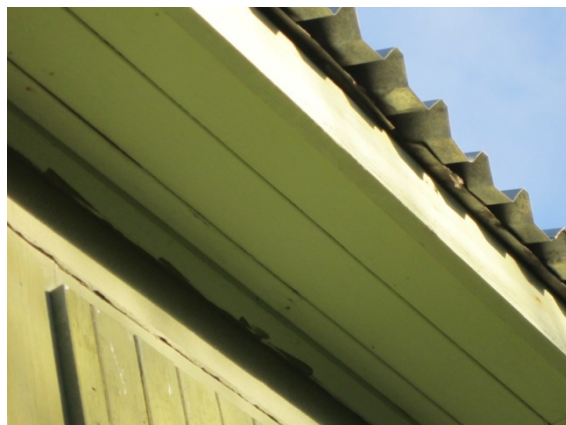
Photo 19: Soffit on north side.

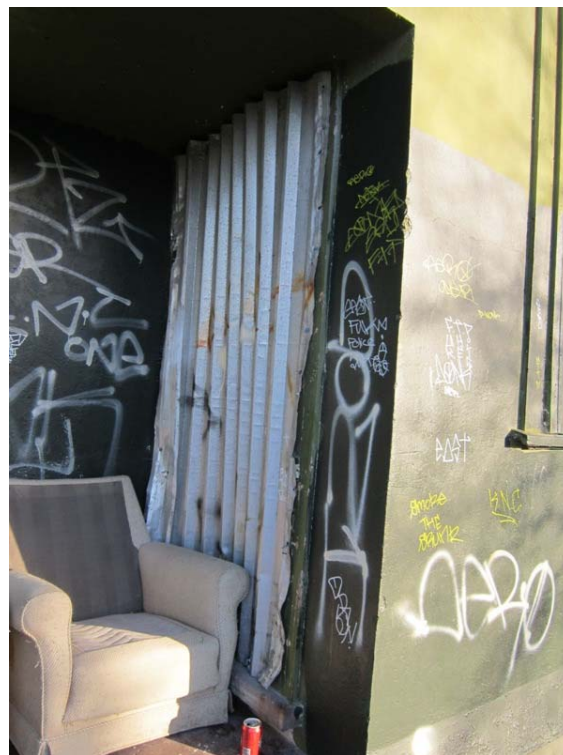
Photo 20: Entrance to building boarded up with corrugated metal sheeting.

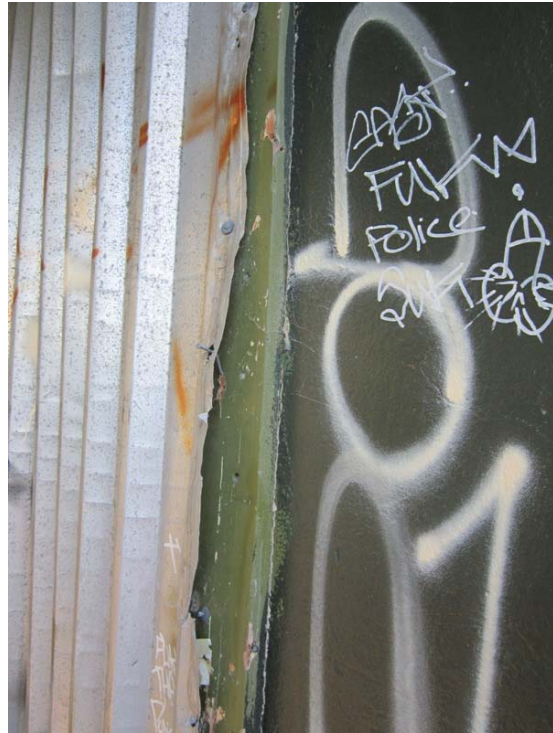
Photo 21: Corrugated metal sheeting over entrance secured with screws into timber doorframe.

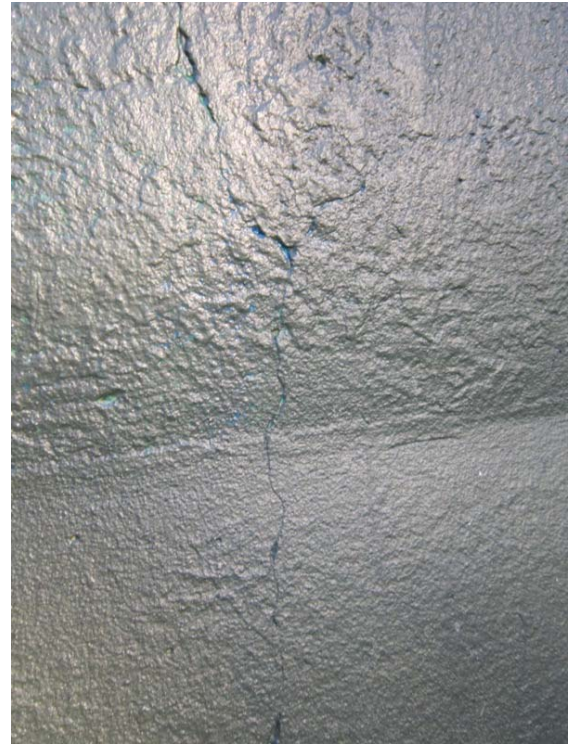
Photo 22: Crack in plaster on north wall has been painted over.

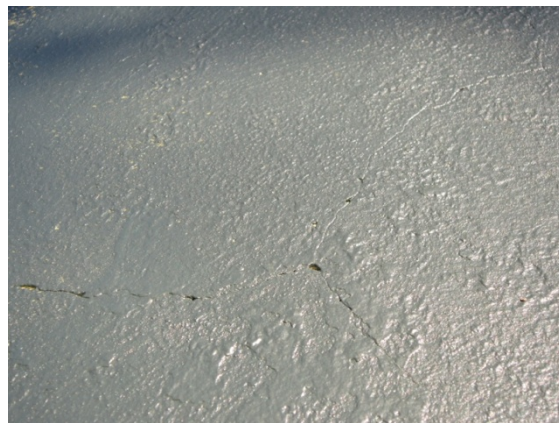
Photo 23: Crack in plaster on north wall has been painted over.

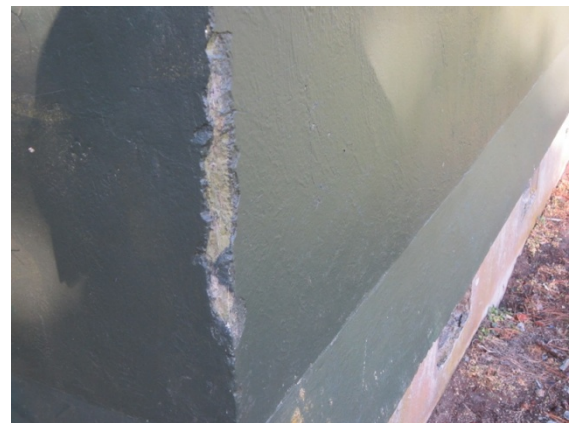
Photo 24: Existing impact damage to wall on northwest corner.

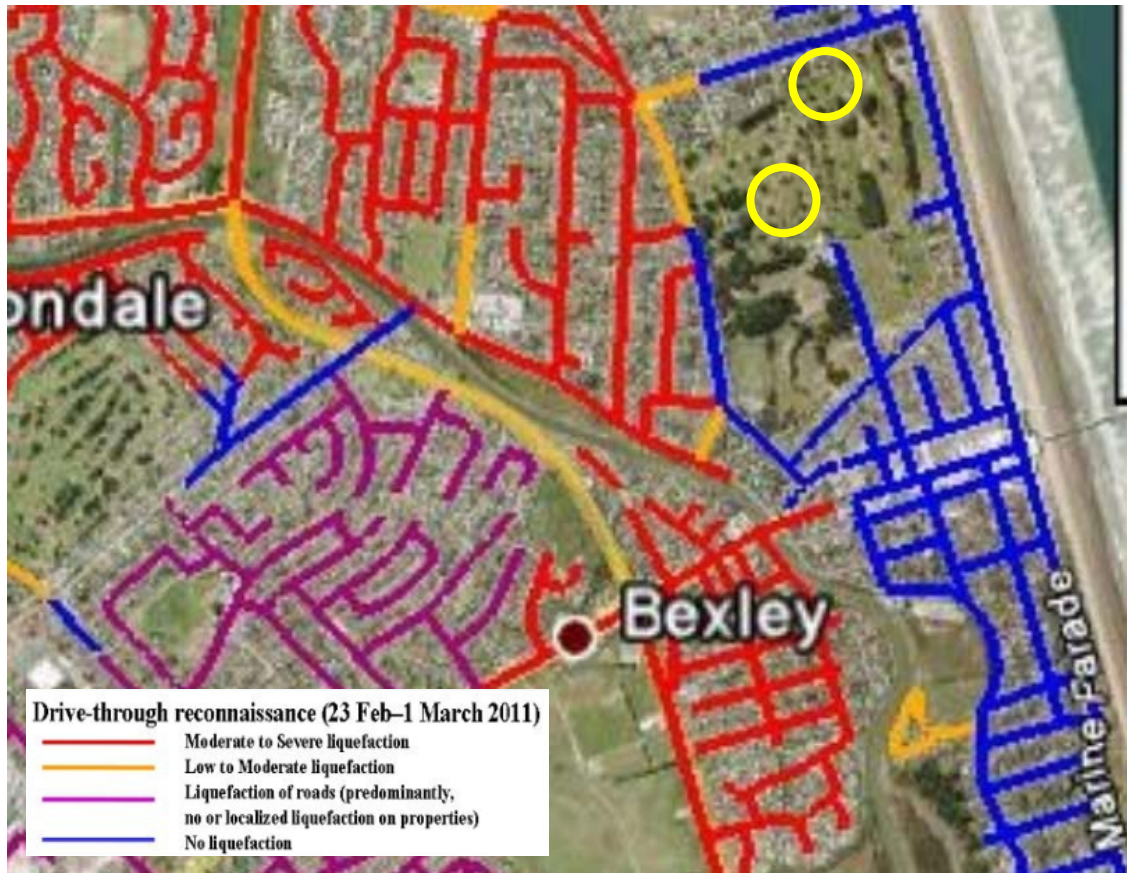
■ **Figure 4 – Liquefaction map (Cubrinovski & Taylor, 2011). Site marked in red.**

Following the 22 February 2011 event drive through reconnaissance was undertaken from 23 February until 1 March by M Cubrinovski and M Taylor of Canterbury University. Their findings show no liquefaction at this site.

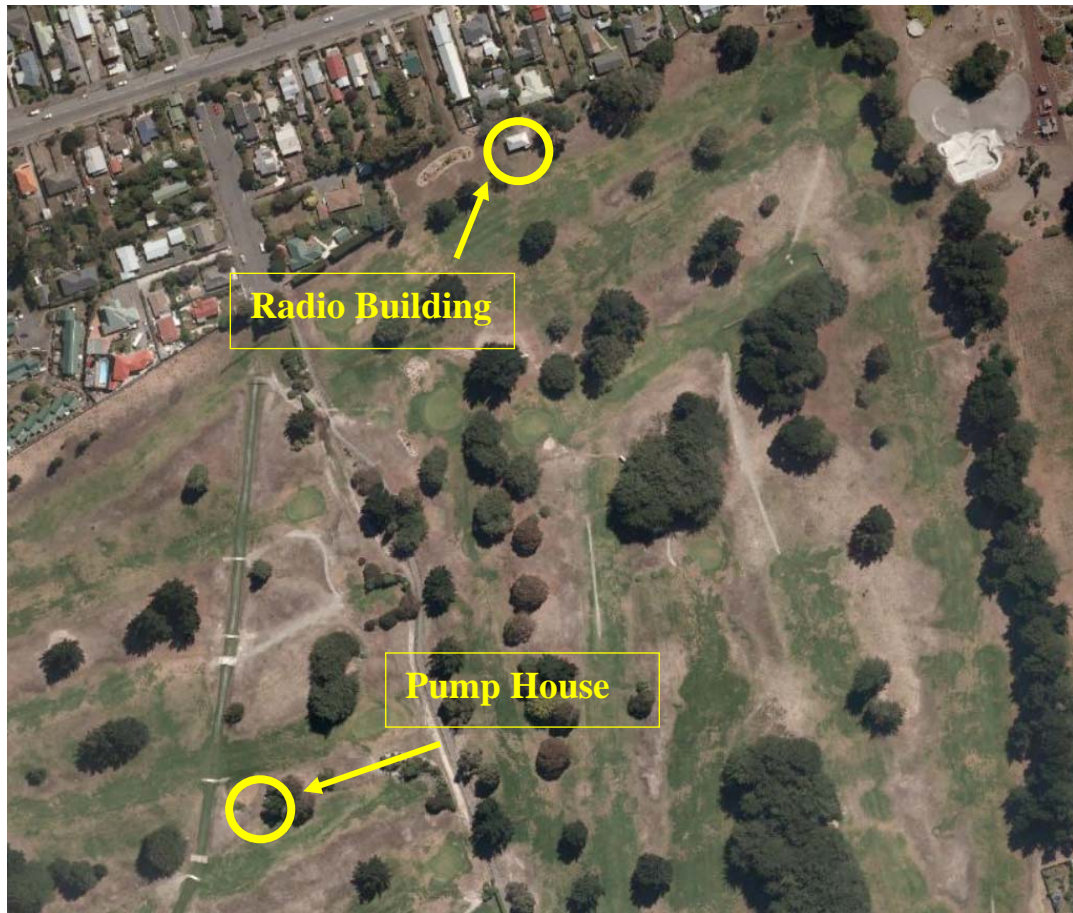
■ **Figure 5 – Aerial photography from 24 Feb 2011 (<http://viewers.geospatial.govt.nz/>)**

No significant evidence of liquefaction or land damage is visible from the aerial photographs. The site is very close to the beach and the patches are likely to be windblown sand or dune sand exposed by lack of vegetation.

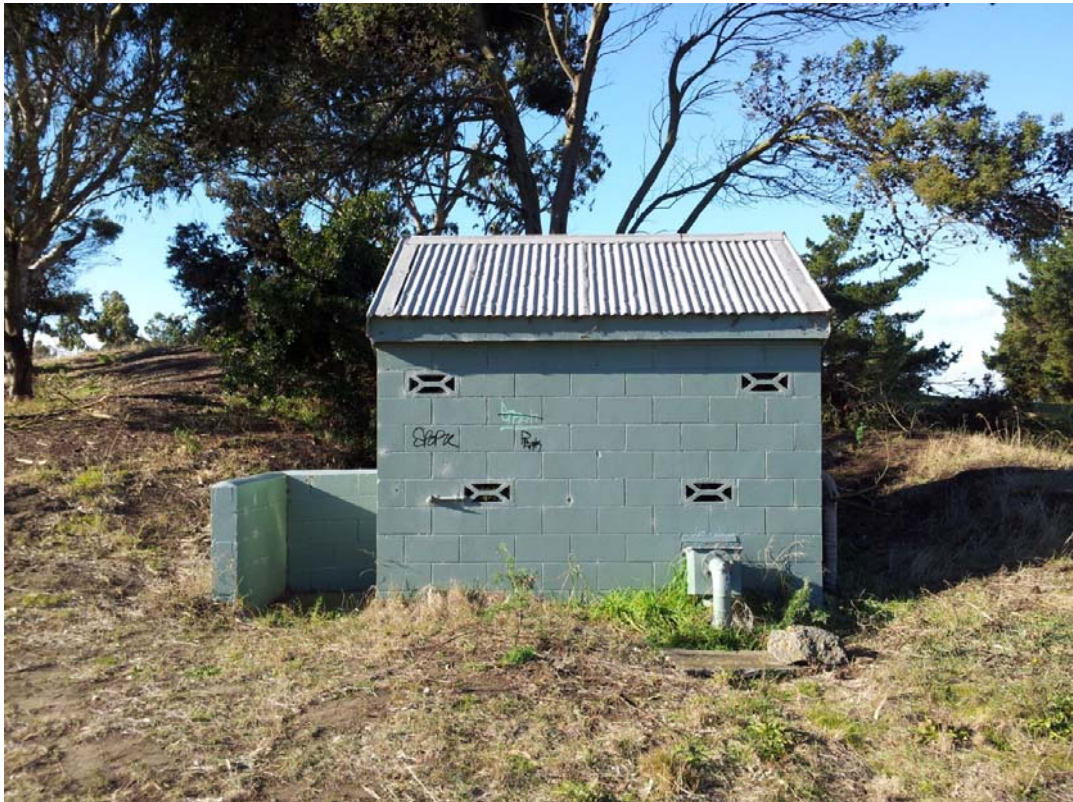
The building was noted to be a masonry block construction with sheet metal roof and slab on grade foundations. There was an upward slope of approximately 20-30 degrees from the eastern side of the building. Minor step cracking was noted in masonry blocks from the external inspection. No apparent evidence of liquefaction or land damage was noted in the surrounding vicinity. Any sand present on the surface was likely to be windblown sand from the nearby beach.

- **Figure 7 - Overview of the building (western elevation)**

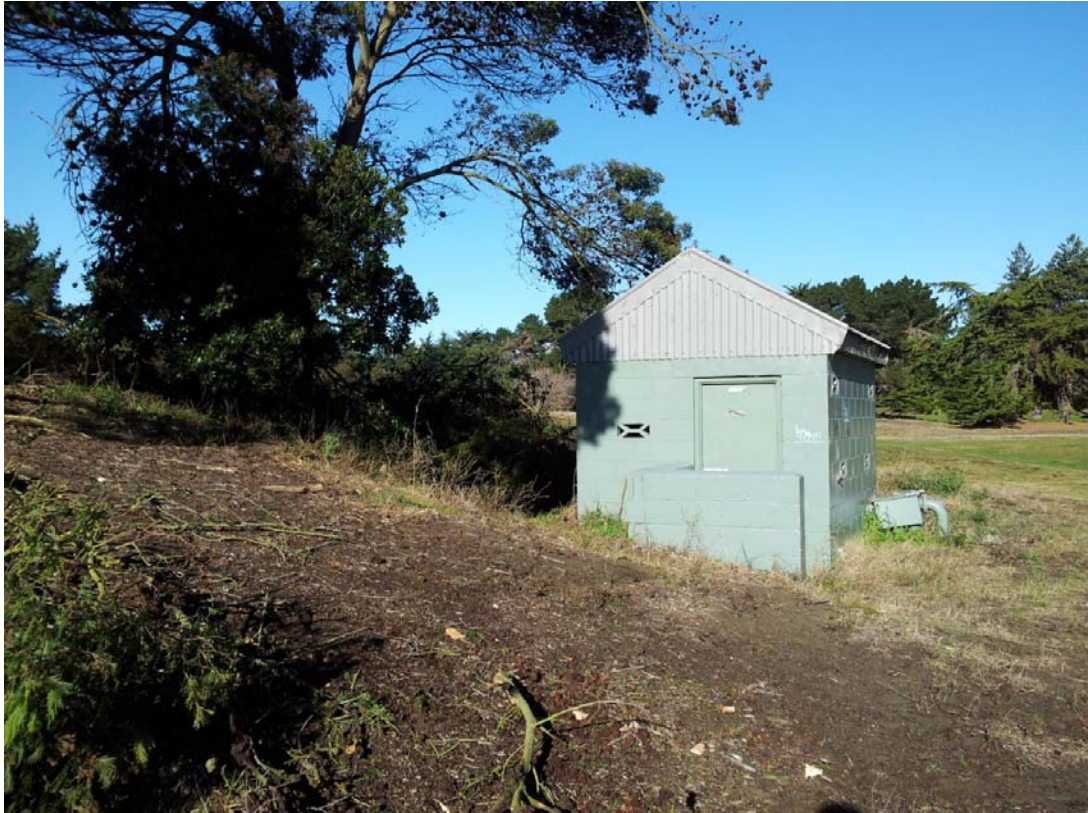
■ **Figure 8 - Overview of the building (northern elevation)**

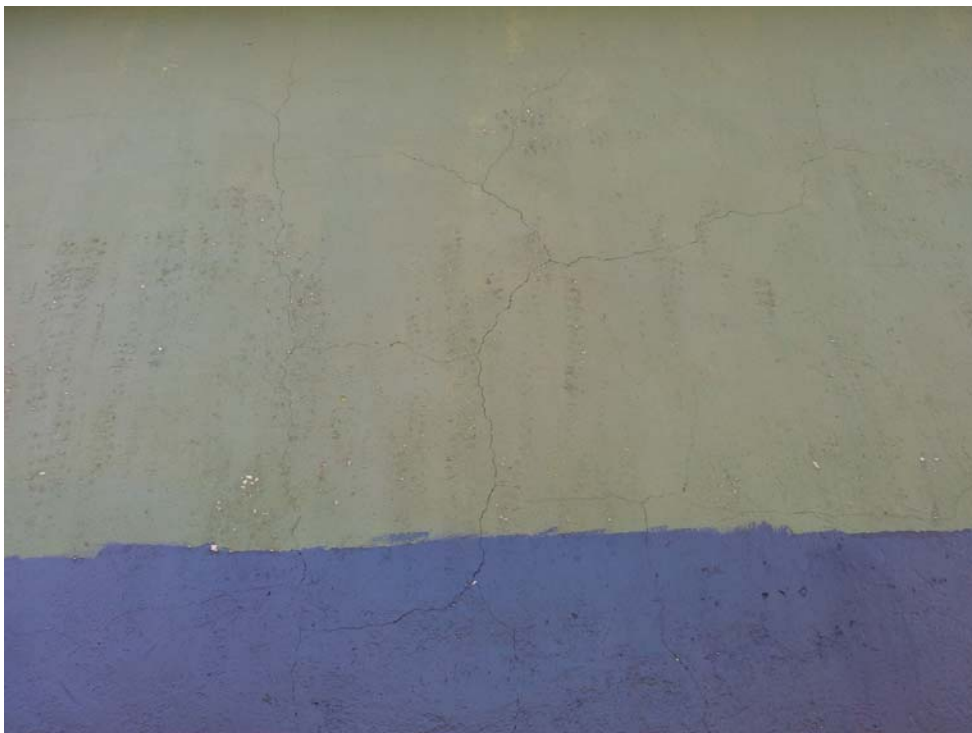
■ **Figure 10 - Observed cracks in the wall**

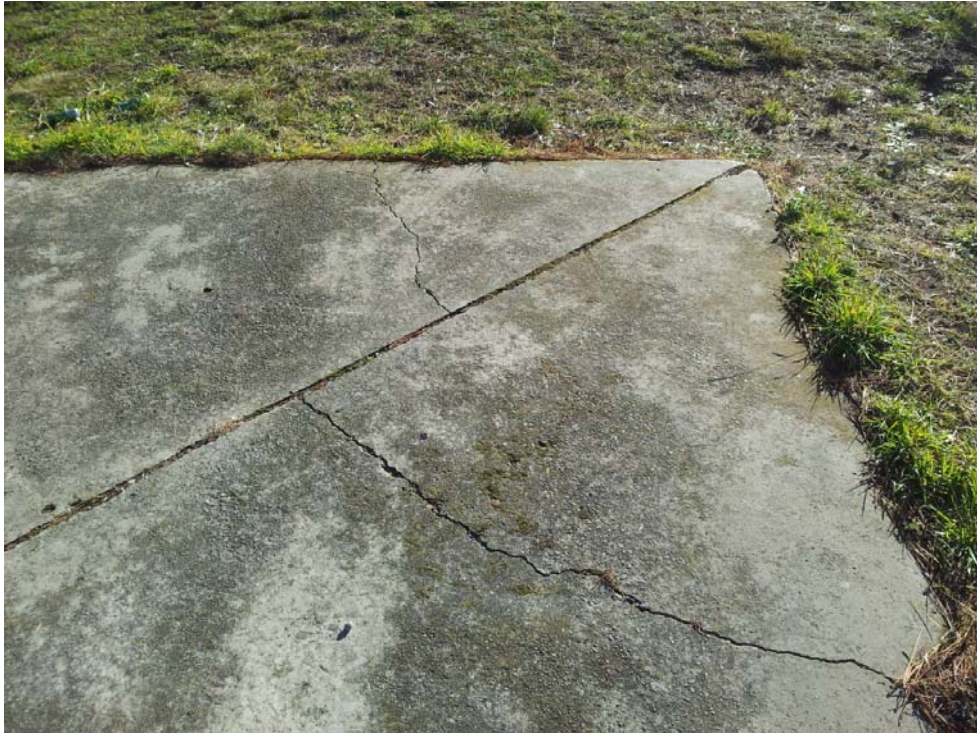
■ **Figure 11 - Cracking in external concrete ground slab**

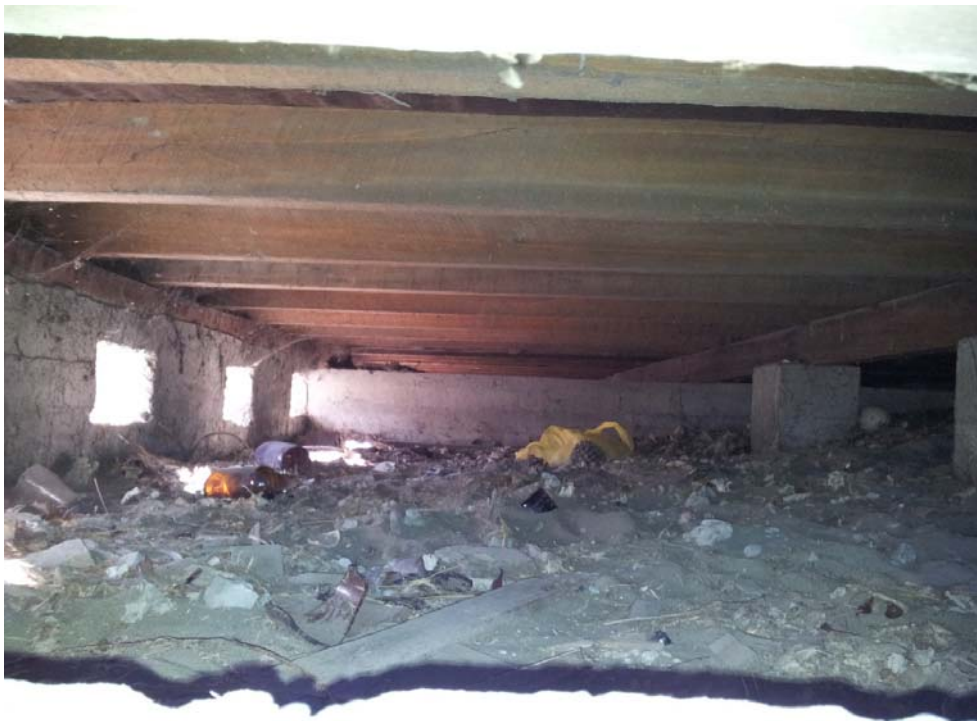
■ **Figure 12 - Foundation details**
