Toilet Rawhiti Golf Course – 6th Fairway
PRK 2004 BLDG 016
Detailed Engineering Evaluation
Qualitative Report
Version Final

35 – 37 Bowhill Road

Christchurch City Council

Date
17th May 2013

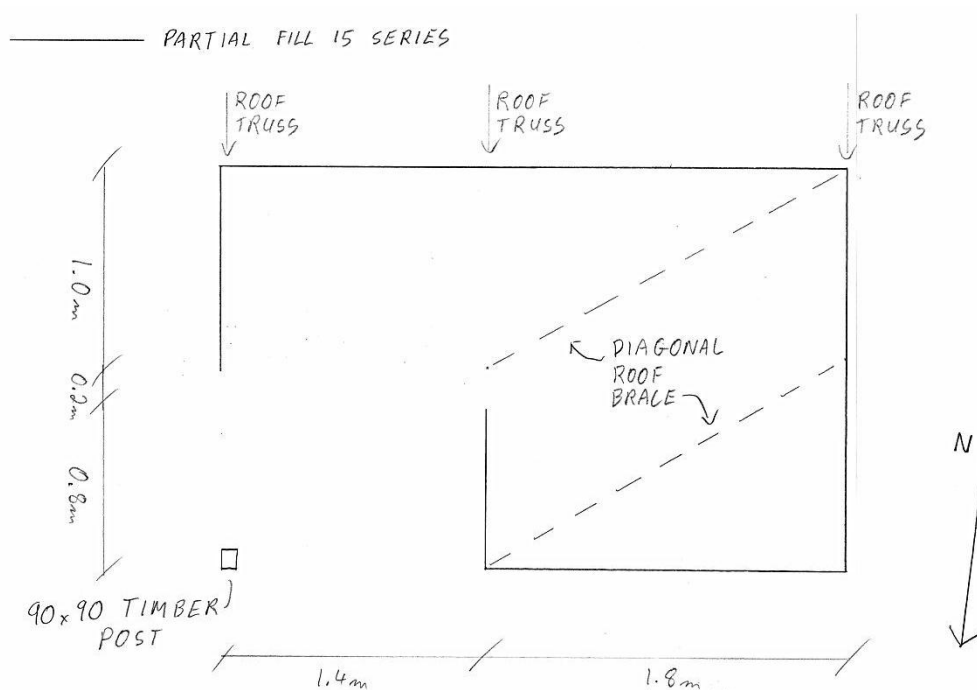
Figure 2 Plan Sketch Showing Key Structural Elements

Gravity roof loads are transferred through roof trusses to the masonry walls and a corner timber post. These elements transmit the loads to the slab on grade.

In the longitudinal direction(E-W), lateral roof loads are transferred via 2 diagonal braces in the roof plane to walls in the plane of loading, which in turn transfer these loads to the ground by panel action. In the transverse direction(N-S), lateral roof loads are transferred from the purlins to the roof trusses which in turn transfer the load to walls in the plane of loading. These walls resist these loads by panel action of the masonry and transfer the loads to the ground.

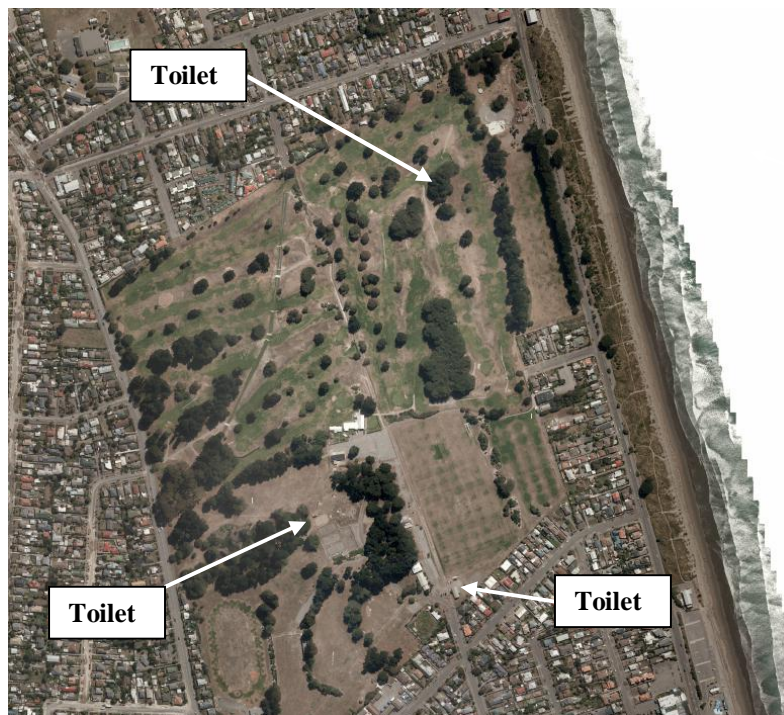
Figure 3 Post February 2011 Earthquake Aerial Photography ²

Aerial photography taken following the 22 February 2011 earthquake shows no signs of liquefaction outside the building footprint or adjacent to the site, as shown in Figure 3.

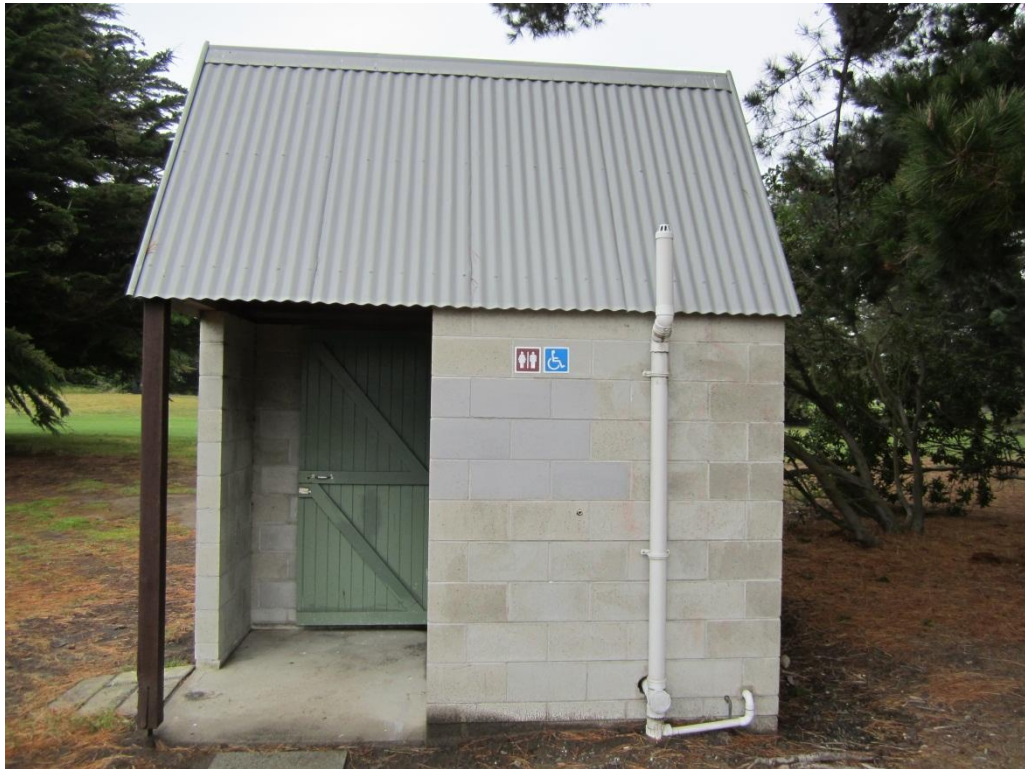
Photograph 1 North elevation.

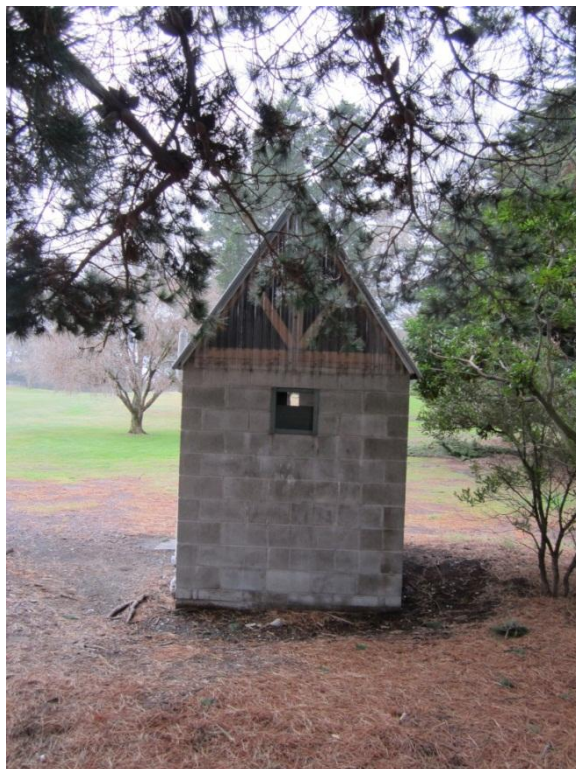
Photograph 2 View of the toilet from the south.

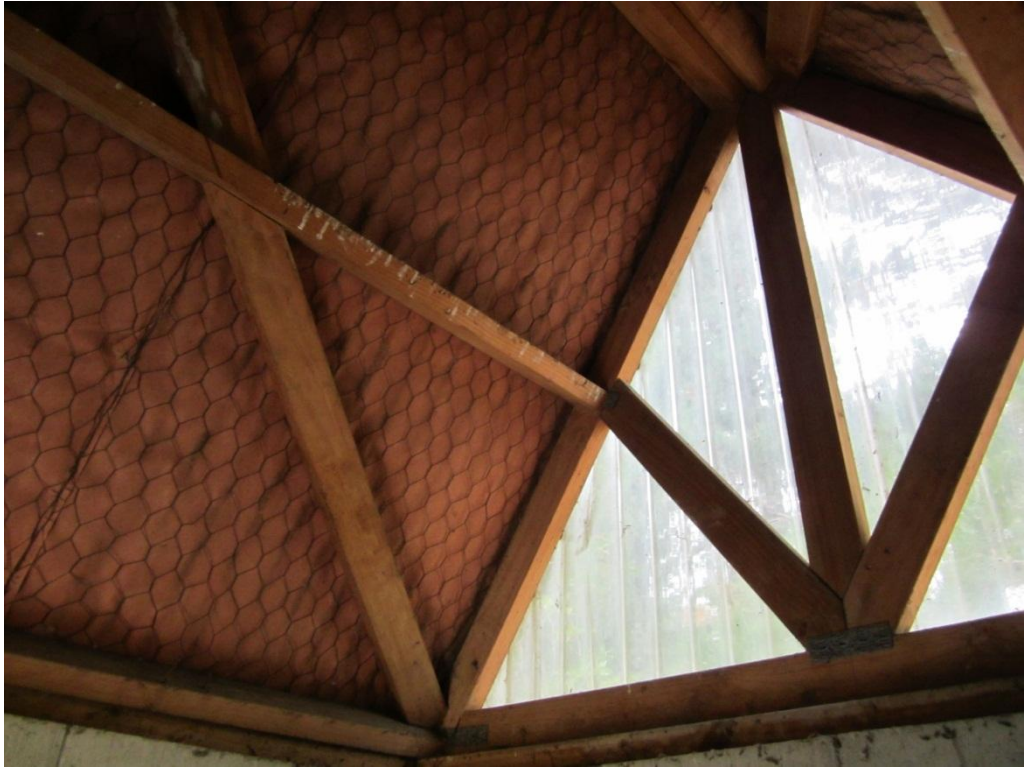
Roof bracing is present in the form of diagonal timber members.

Photograph 3 Roof structure showing truss, purlins and diagonal brace.

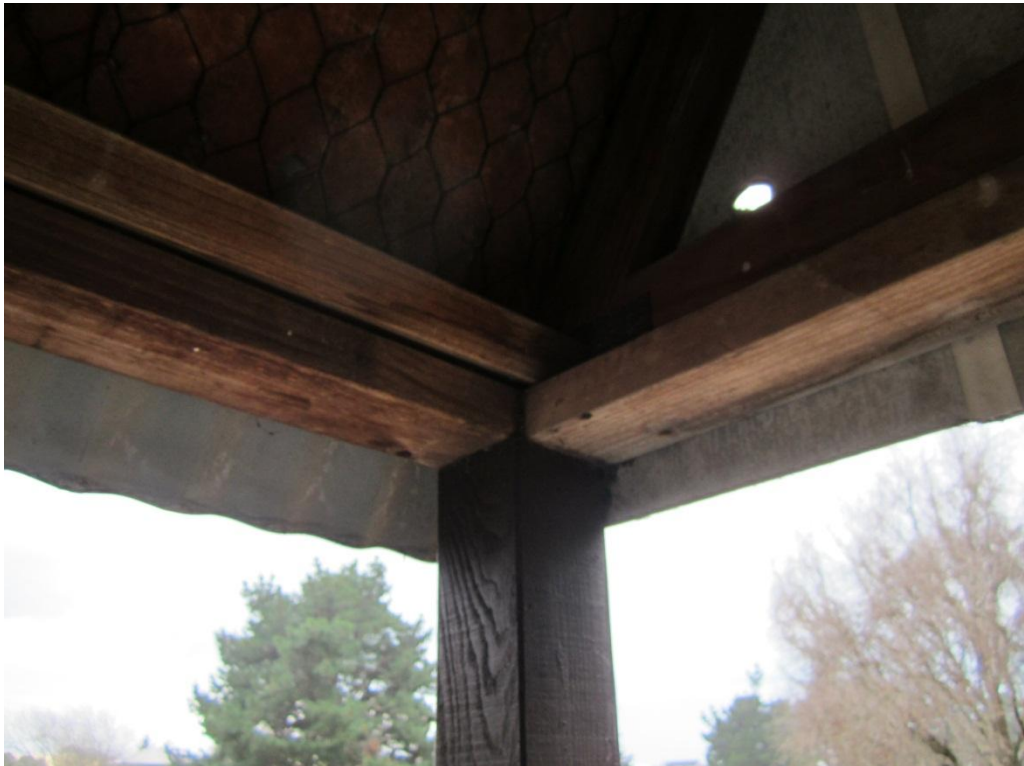
Photograph 4 90mm x 90mm timber post supporting roof truss.
