Christchurch City Council
PRK_2179_BLDG_004 EQ2
Toilets – Redwood Park (Main North Road)
339 Main North Road

QUALITATIVE ASSESSMENT REPORT
FINAL

- Rev B
- 23 May 2013

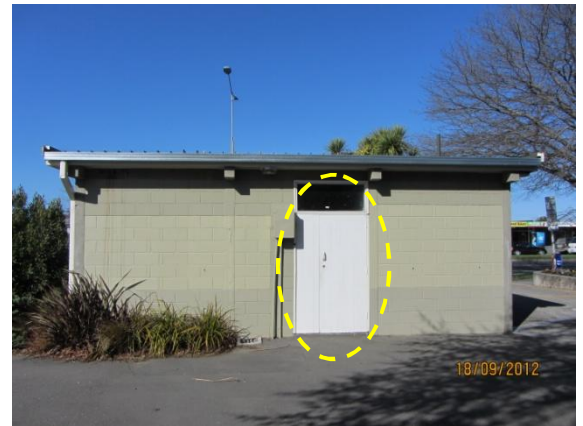
Photo 4: West Elevation, showing service doorway that could not be entered during the visual inspections

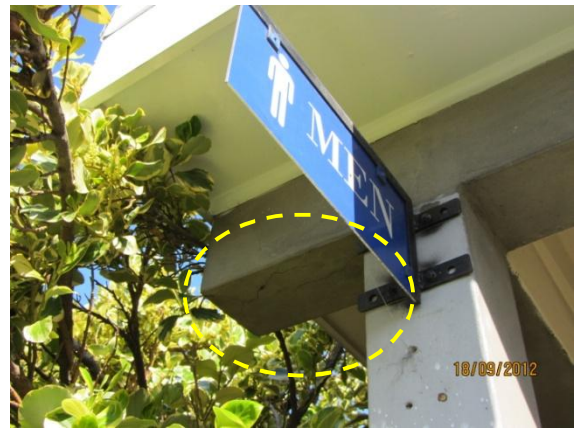
This damage is unlikely to be a result of the earthquakes and appears to be non-structural damage. It appears the damage is most likely due to a weak bond between the concrete render material and the main concrete elements, attributed to poor workmanship at the time of construction.

Photo 12: View of cracking on the underside of the cantilever concrete beam (1)

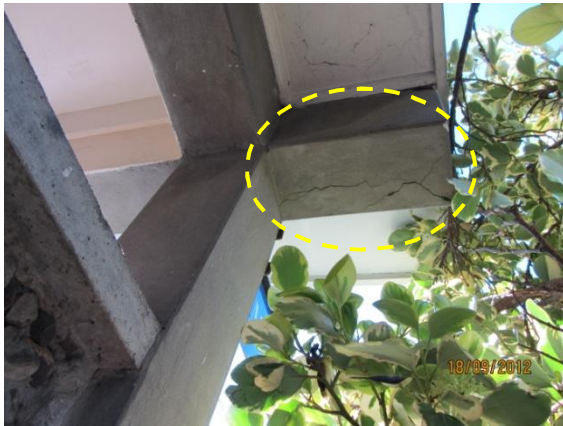
Photo 13: View of cracking on the underside of the cantilever concrete beam (2)

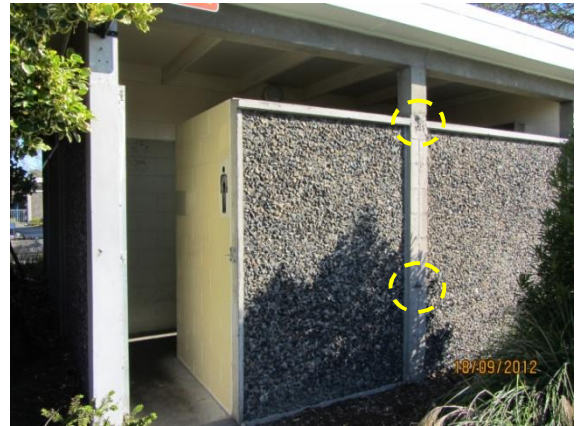
Photo 14: Mens toilet wall showing centre column with damage

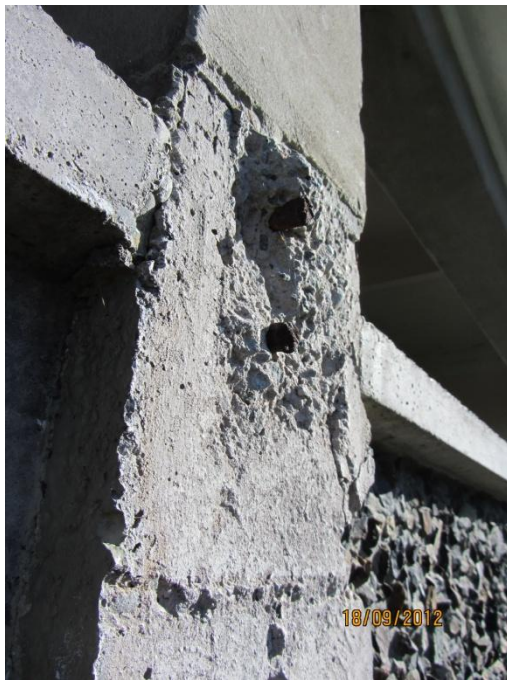
Photo 15: Close up view from photo 14 showing the exposed reinforcing at the top of the column

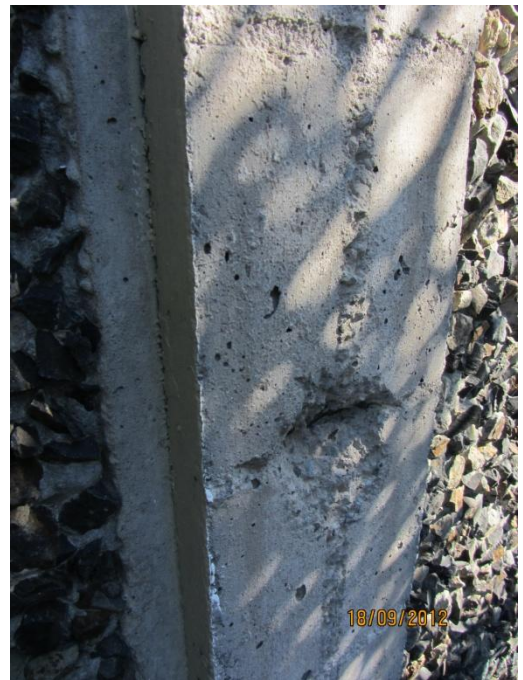
Photo 16: Close up view from photo 14 showing damage near the bottom of the column

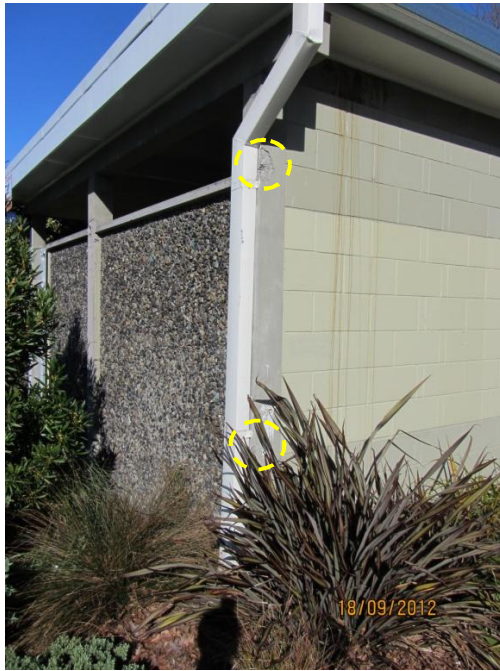
- 1) No visual evidence of settlement was noted at this site. Therefore a level survey is not required at this stage of assessment.
- 2) Cracks on the underside of the cantilever concrete roof beam on the northeast corner of the building (photo 12 and 13).
- 3) Outer surface of centre concrete column on north side of building has spalled nearly the entire height, exposing reinforcing near the top of the column (photo 14, 15 and 16).
- 4) Outer surface of concrete column on the northwest corner has spalled near the top and the bottom of the column (photo 17, 18 and 19).

Photo 17: View of concrete column on the northwest corner, showing locations of damage

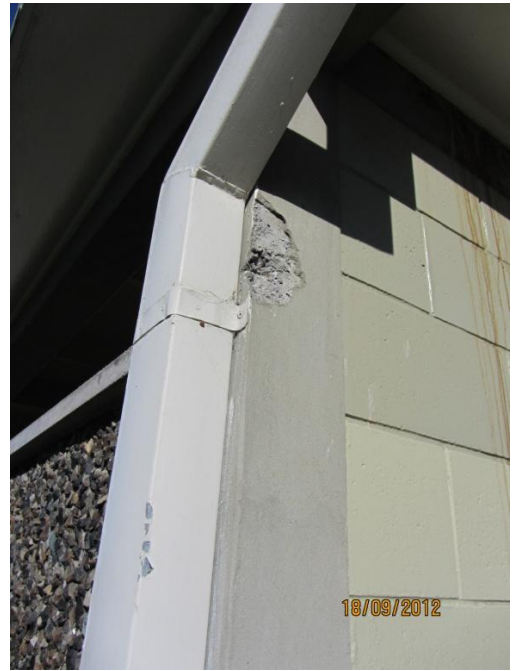
Photo 18: Close up view from photo 17 showing spalled grout near the top of the column

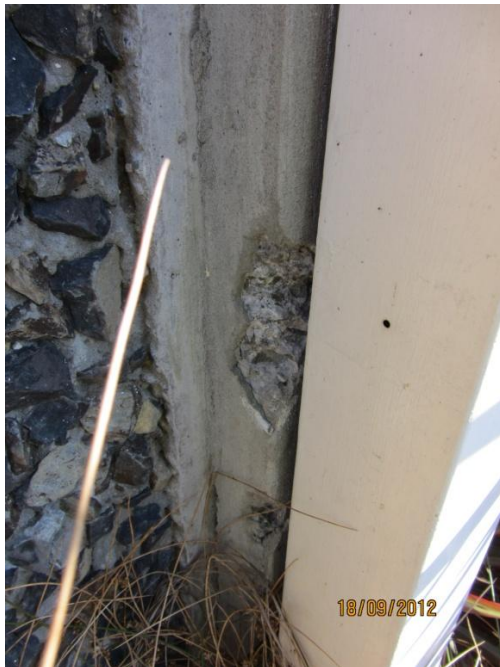
Photo 19: Close up view from photo 17 showing spalled grout near the bottom of the column
