**Reg Adams Courts  
Housing Complex  
PRO 0583**

**Detailed Engineering Evaluation  
Quantitative Assessment Report**

**445 Papanui Road, Strowan,**

Date: February 2014  
Reference: 6-QC394.00  
Status: Final

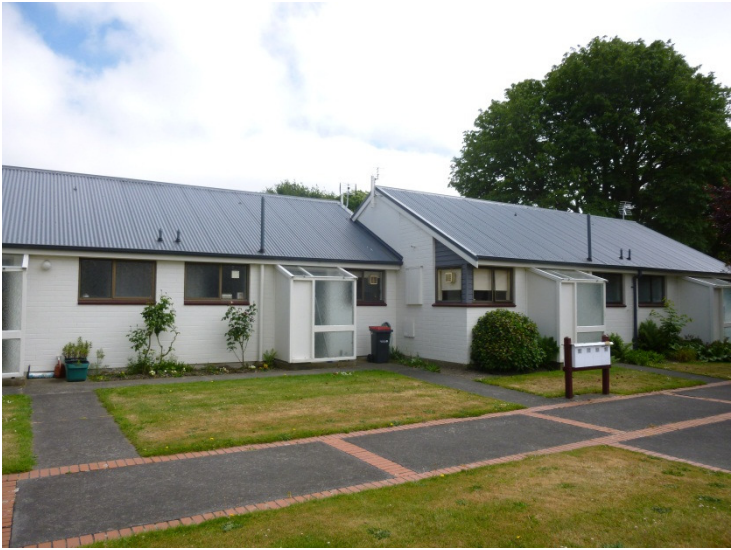
Reg Adams Courts Housing Complex		
1.	Typical exterior elevation (back)

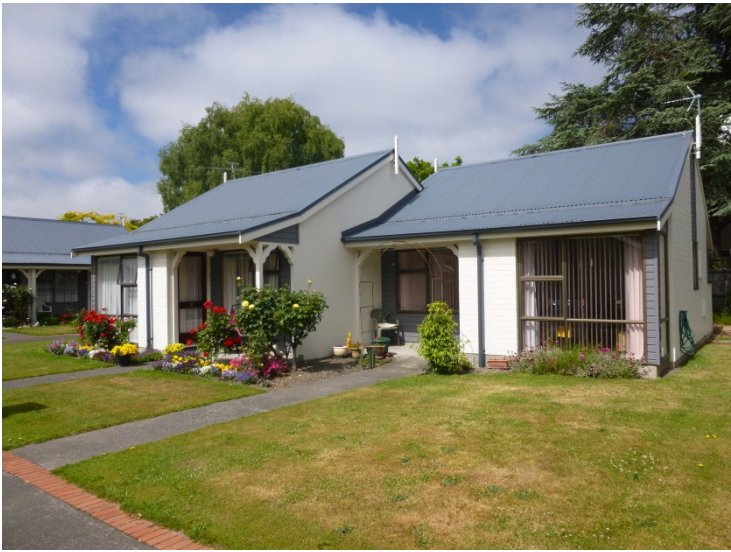
2.	Typical exterior elevation (front)

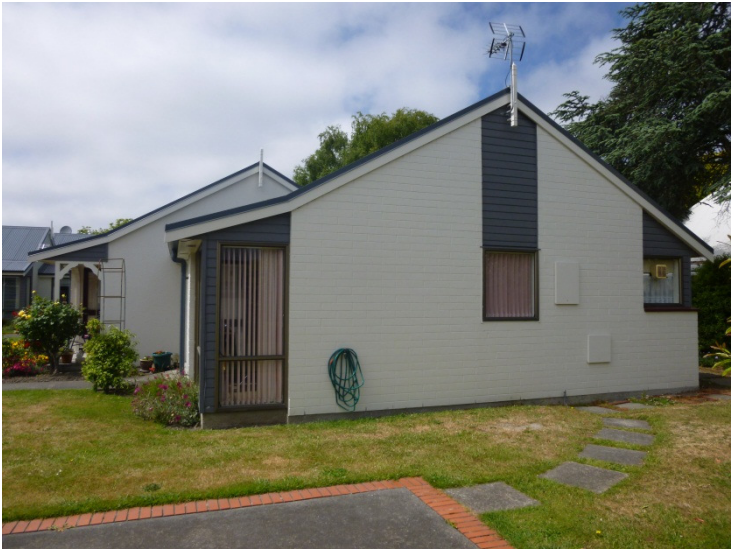
3.	Typical exterior elevation (side)

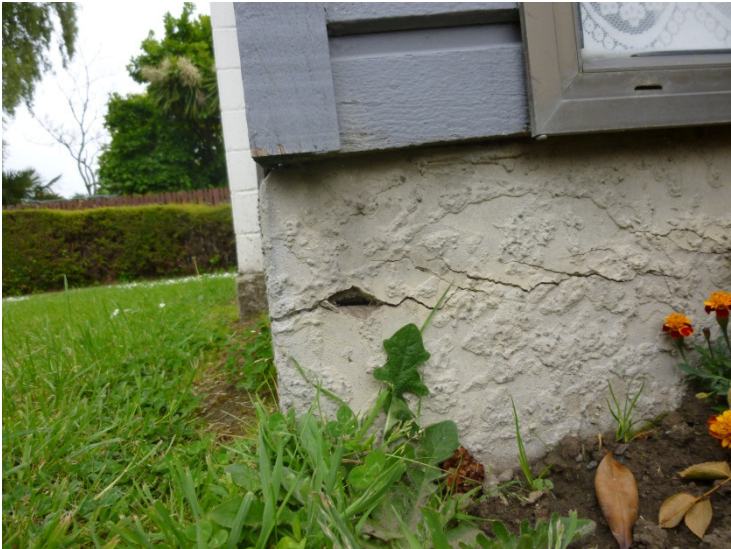
Horizontal cracking was observed in the render on the foundations of all units (photo 8). This was most significant in Units 9 and 10.

<p>8.</p>	<p>Horizontal foundation cracking (all units, most severe in Units 9 and 10)</p>

- Veneer at height (gable ends) have the veneer ties checked.
- Repair render on the foundation.
- Cosmetic repairs be undertaken as required.
- Strengthening schemes be developed to increase the seismic capacity of Blocks A – D to at least 67%NBS.

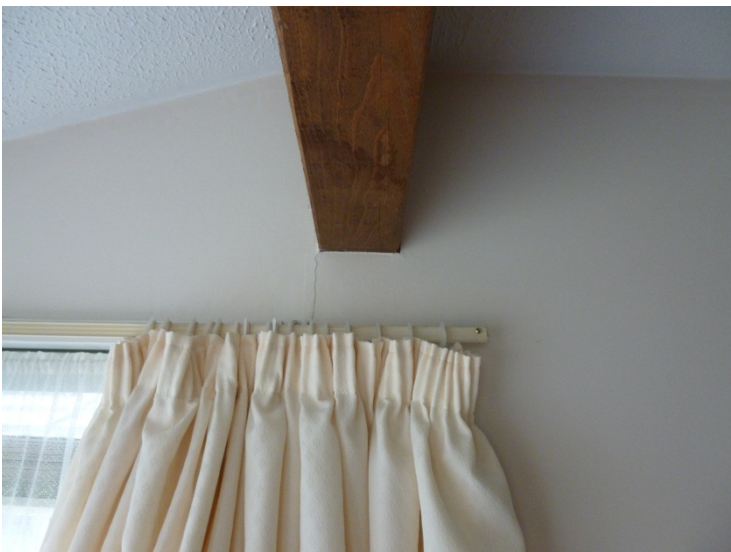
Minor damage to the interior wall linings was observed in all units, in particular the crack in the plasterboard linings at either end of the ceiling beam (photo 9) in the living room of each unit.

A photograph showing the exterior of a building. The wall is made of light-colored stucco. There is a window with a grey frame above the wall. Below the window, there is a horizontal crack in the stucco. The ground in front of the building is covered with green grass and some weeds.
<p>9.</p>	<p>Cracking to interior linings from beam (all units)</p>
