Regal Courts Housing Complex  
Qualitative Engineering Evaluation

**Reference:** 233415

**Prepared for:**  
Christchurch City Council

**Address:** 146 King Street

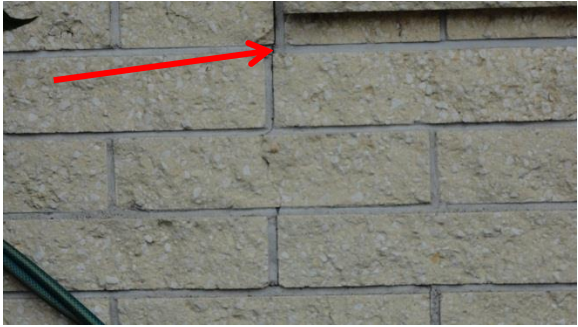
#1.	Cracking in the exterior brickwork of unit 4, Block A at Regal Courts Housing Complex.

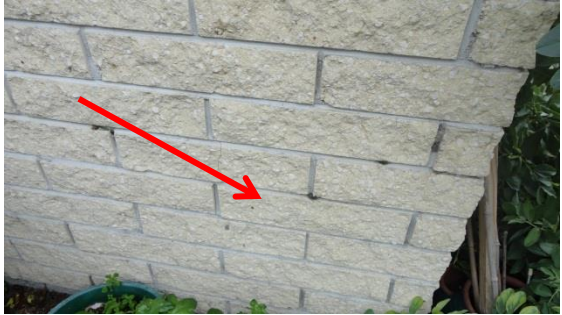
#2.	Cracking in the exterior brickwork of unit 6, Block B at Regal Courts Housing Complex.

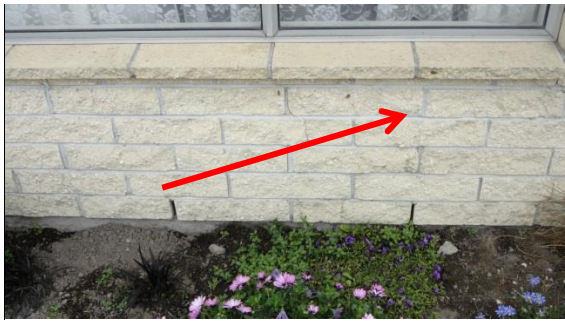
#3.	Cracking in the exterior brickwork of unit 11, Block C at Regal Courts Housing Complex.

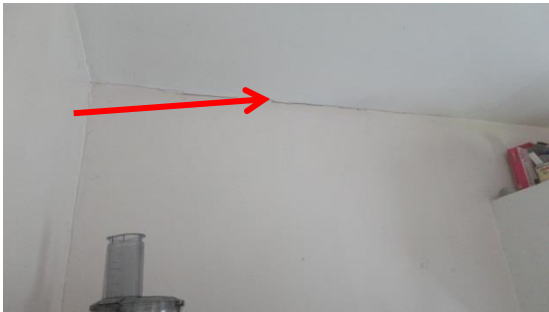
#4.	Cracking in the interior lining inside unit 12, Block C.

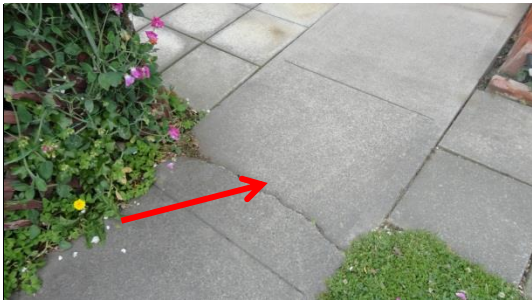
#5.	Crack in the exterior patio slab close to unit 13, Block C.

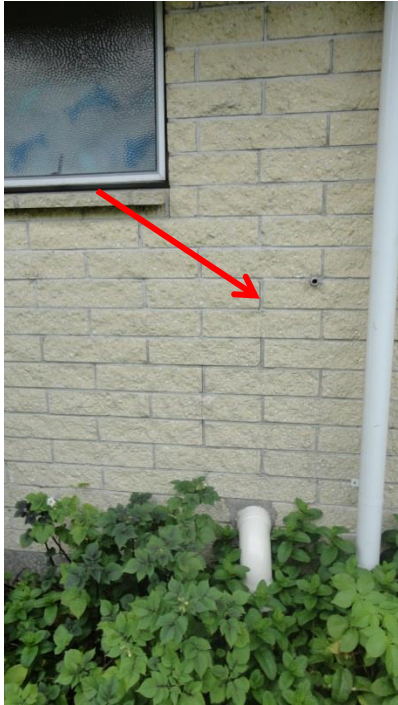
<p>#6.</p>	<p>Cracking in the exterior brickwork of unit 15, Block C at Regal Courts Housing Complex.</p>

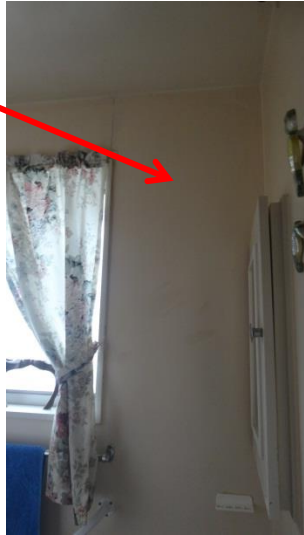
<p>#7.</p>	<p>Cracking in the interior lining inside unit 18, Block C.</p>

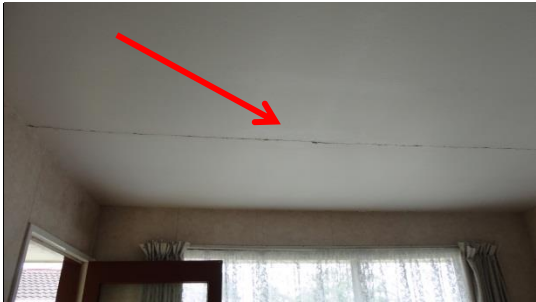
<p>#8.</p>	<p>Cracking in the ceiling lining inside unit 20, Block C.</p>
