**Riccarton
Community Centre
PRO 0537-002**

**Detailed Engineering Evaluation
Quantitative Assessment Report**

Date: August 2013
Reference: 6-QUCCC.11
Status: Final R2

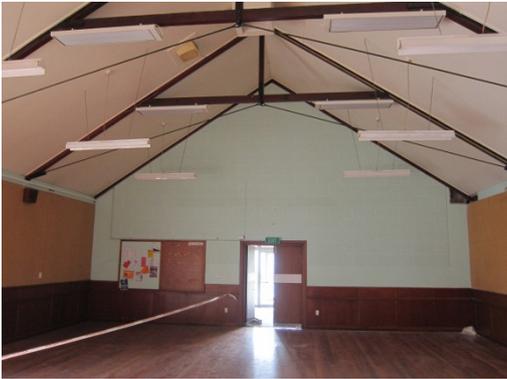
2.	The interior of the original building.

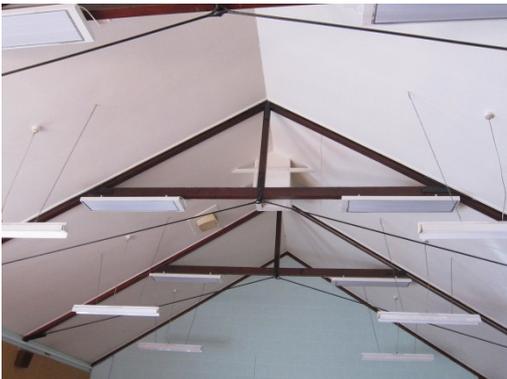
3.	Scissor trusses in the original building.

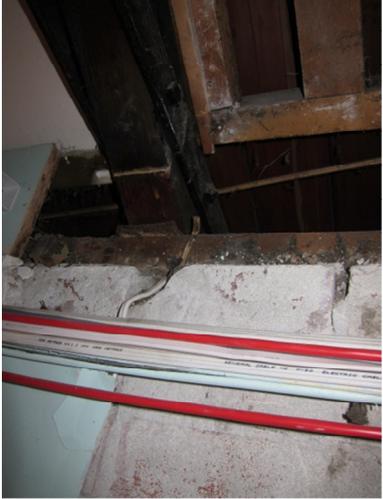
- d) The top plate which the scissor trusses affix to is not bolted to the masonry walls. Shear transfer is currently provided by friction between the top plate and the wall. High roof accelerations could cause the roof to lose bearing and collapse.

<p>4.</p>	<p>Connection of the scissor truss to the top plate on the masonry wall.</p>

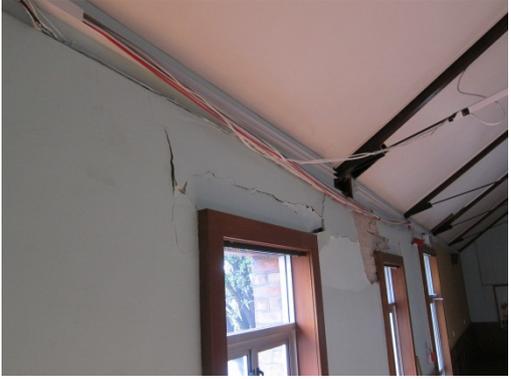
A close-up photograph showing the connection of a dark metal scissor truss member to a masonry wall. The truss is supported by a horizontal top plate. Below the wall, there are several horizontal pipes, some with red and blue markings.
<p>5.</p>	<p>North wall of the original building.</p>

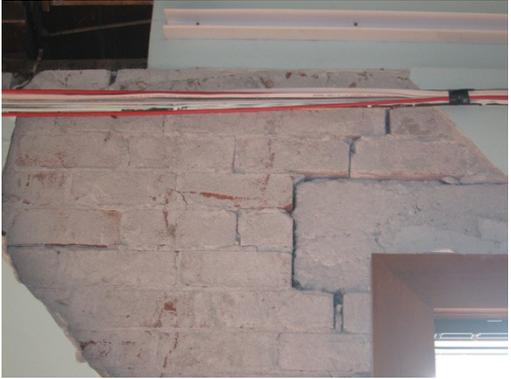
The brick (3 layers) cavity walls on the northern and southern sides of the hall (above the internal windows) sustained moderate cracking of the plaster and possibly brick work. The wall and pilaster columns (external) appear to be out of plumb by approximately 20mm. The cracking appears to be caused by rotation of the concrete lintel at the lintel seat in the masonry wall.

A photograph of the north wall of the original building. The wall is light-colored and shows signs of wear and cracking. A window with a wooden frame is visible on the right side. The ceiling above the wall has exposed wooden beams and pipes.
<p>6.</p>	<p>Cracking in masonry wall and plaster at the concrete lintel seat on the north wall of the original building.</p>

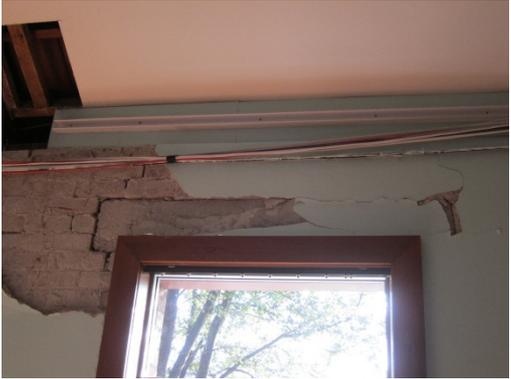
<p>7.</p>	<p>Cracking in masonry wall and plaster at the concrete lintel seat on the north wall of the original building.</p>

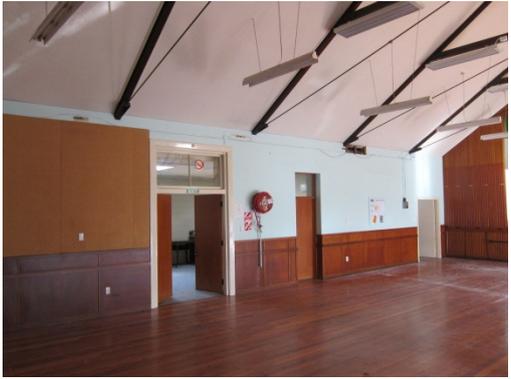
<p>8.</p>	<p>South wall of the original building.</p>

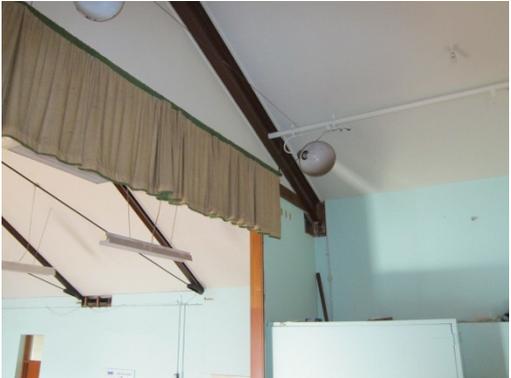
<p>9.</p>	<p>Interface of the 1960 addition with the original building.</p>

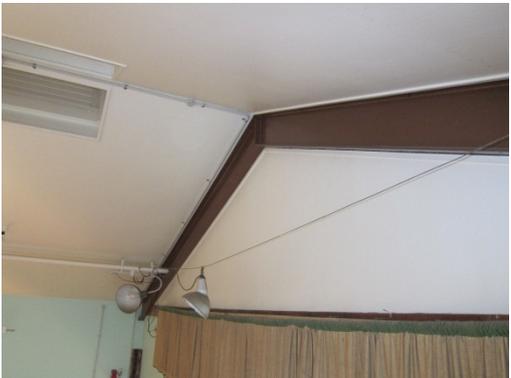
<p>10.</p>	<p>Easternmost portal frame of the 1960 addition.</p>

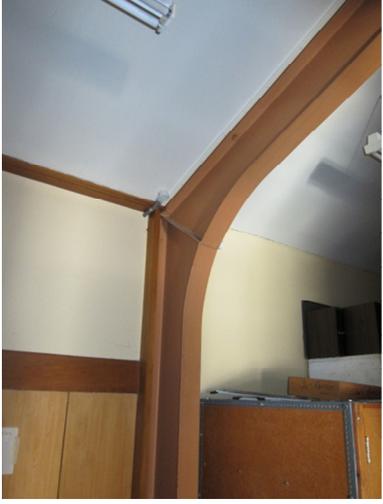
<p>11.</p>	<p>Portal frame knee in the 1960 addition.</p>

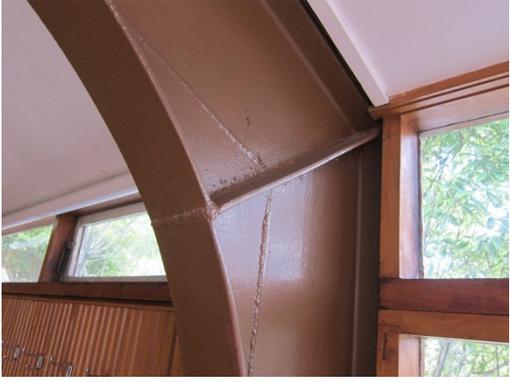
<p>12.</p>	<p>Portal frame knee connection in the 1960 addition.</p>

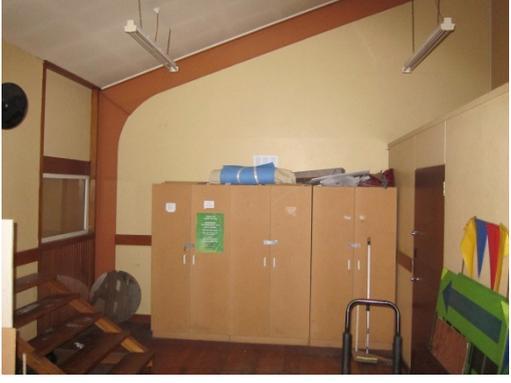
<p>13.</p>	<p>Portal frame in the 1960 addition.</p>

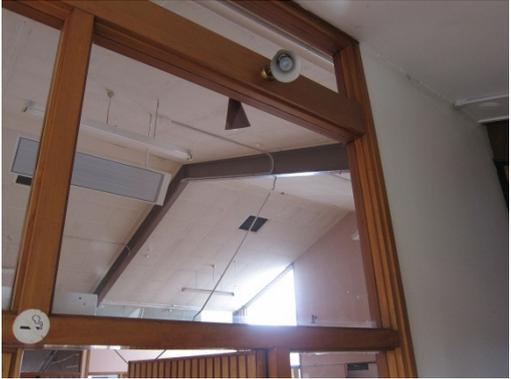
<p>14.</p>	<p>Portal frame in the 1960 addition.</p>

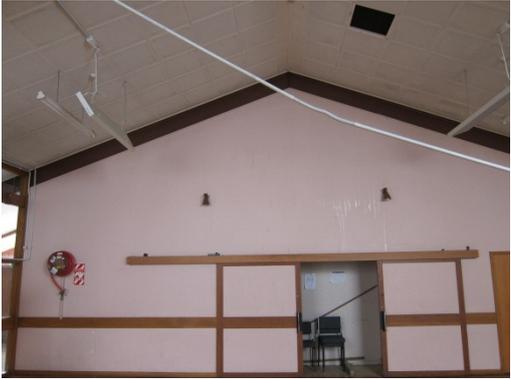
<p>15.</p>	<p>Portal frame in the 1960 addition.</p>

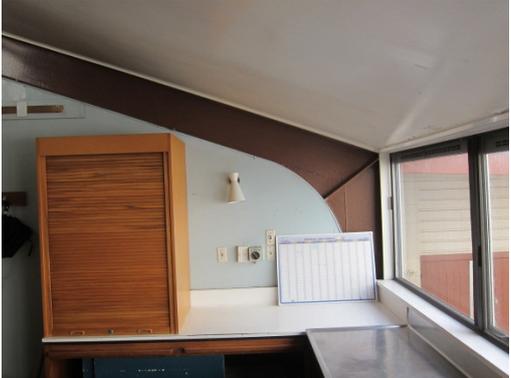
<p>16.</p>	<p>Portal frame knee connection in the 1960 addition.</p>

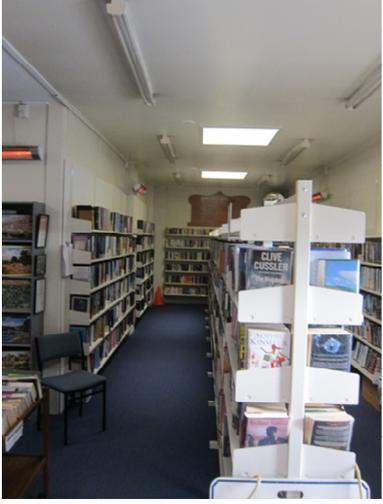
<p>17.</p>	<p>North wing of the 1968 addition.</p>

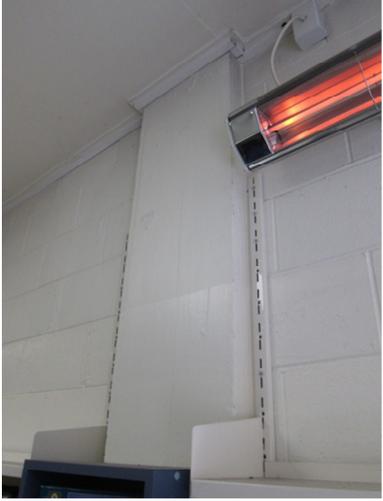
<p>18.</p>	<p>Concrete column with block infill in the 1968 addition.</p>

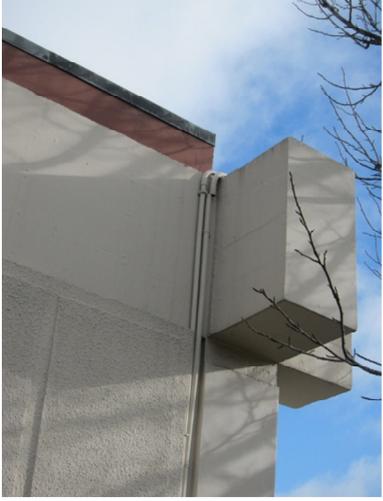
<p>19.</p>	<p>Northeast corner beam-column connection of the 1968 addition.</p>

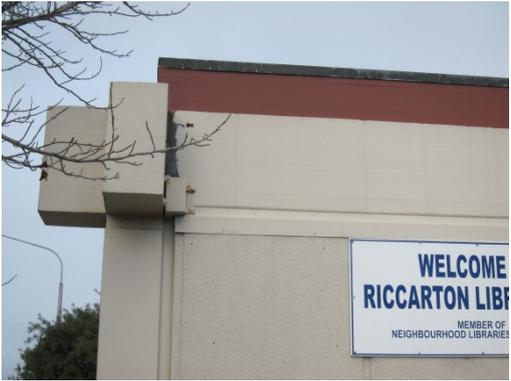
<p>20.</p>	<p>Northeast corner beam-column connection of the 1968 addition.</p>

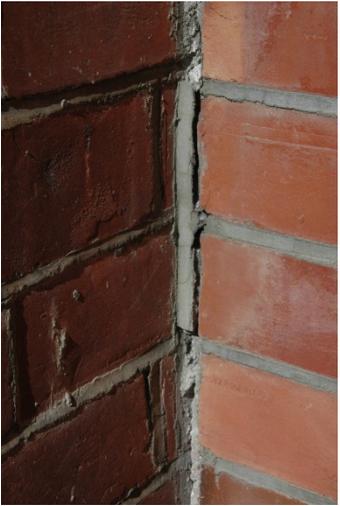
<p>23.</p>	<p>Cracking at the interface of the masonry walls of the original building with the veneer of the 1960 addition.</p>

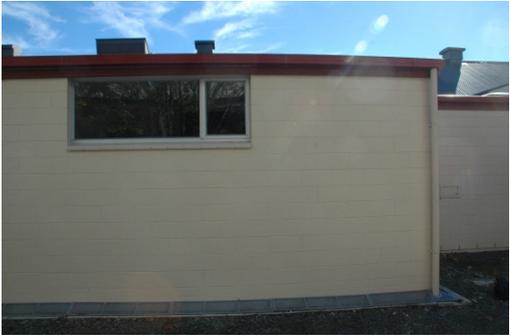
<p>24.</p>	<p>South face of the 1986 addition.</p>

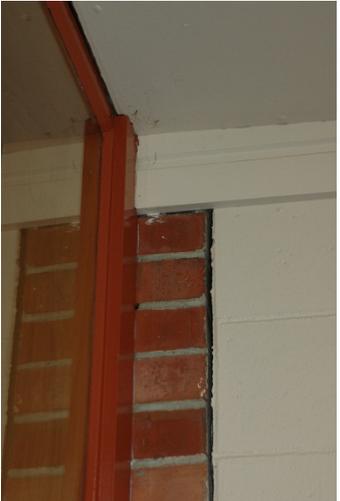
<p>25.</p>	<p>Interface of the veneer of the 1960 addition with the walls of the 1986 addition.</p>

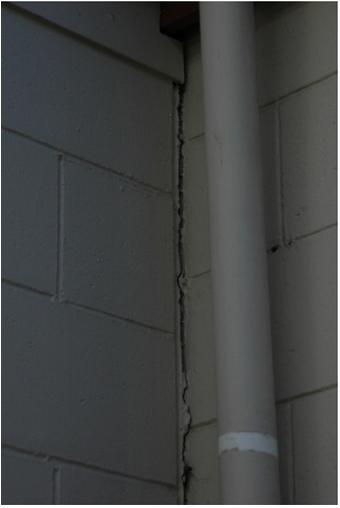
<p>26.</p>	<p>Interface of the wall of the 1986 addition with the walls of the 1968 addition.</p>

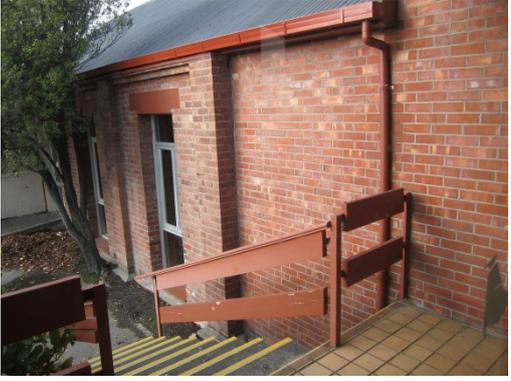
<p>27.</p>	<p>North wall of the original building and part of the 1960 addition.</p>
