Riccarton House

Detailed Engineering Evaluation Report

14th February 2012

Re: Riccarton House Detailed Engineering Evaluation

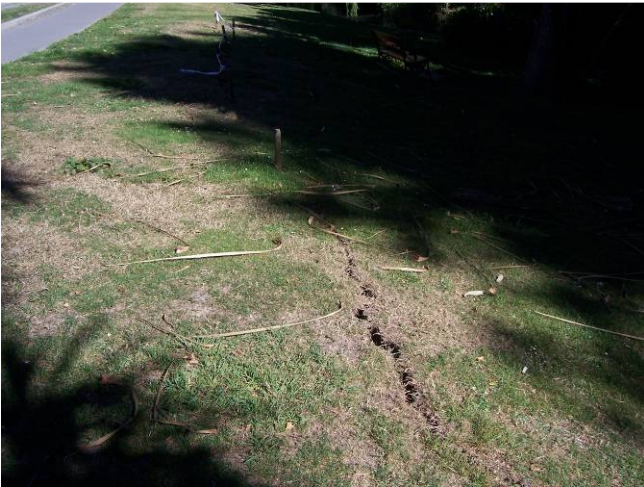
Ground cracking is the result of lateral spreading towards the nearby Avon Stream, which is to be expected near such waterways.

Ground cracking between path and stream

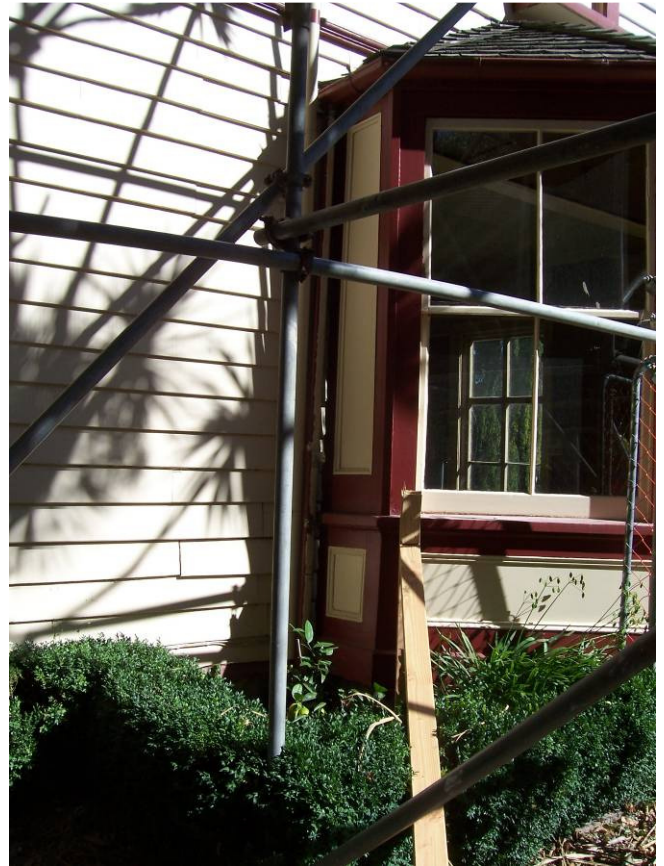
- Rear porch framing has displaced relative to its concrete landing.
- 1-3mm ground crack extending under morning room bay window. This bay window has also pulled away from the main building, which appears to be the result of differential settlement.

Morning room bay window pulled away from main building

Repair to morning room bay window:

- Deconstruct morning room bay window. Prior to demolition, take photographic records of original construction as directed by the council heritage team.
- Excavate for new strip foundation.
- Lay compacted hardfill, sand binding, DPM and cast new reinforced strip foundations. Tie new foundations into existing foundations.
- Reconstruct bay window to match original.

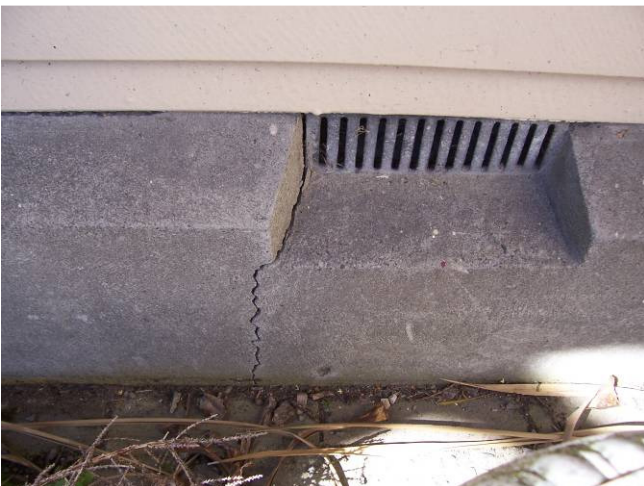
Minor isolated cracking to foundation wall

- Seal cracks to perimeter concrete foundation wall using a pressure injected epoxy. Install as per manufacturers specification.

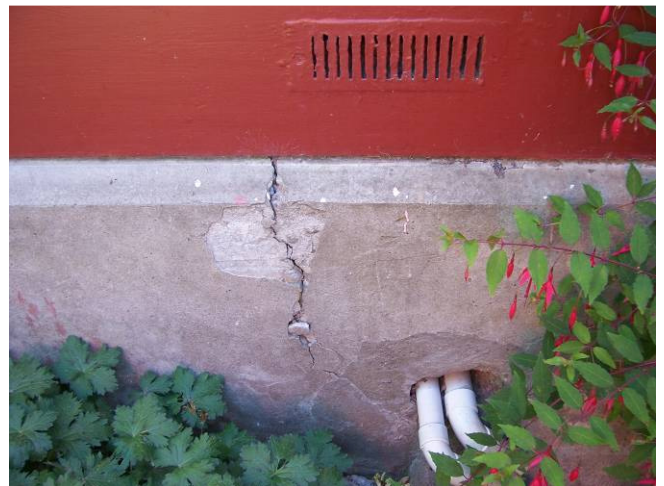
Minor isolated cracking to foundation wall

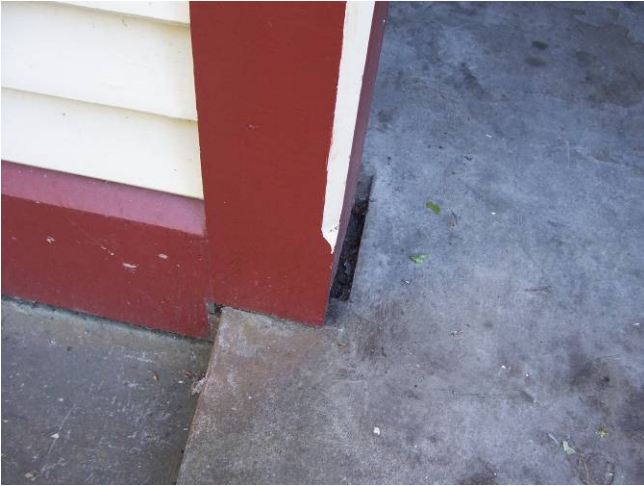
Rear porch framing displaced from concrete landing

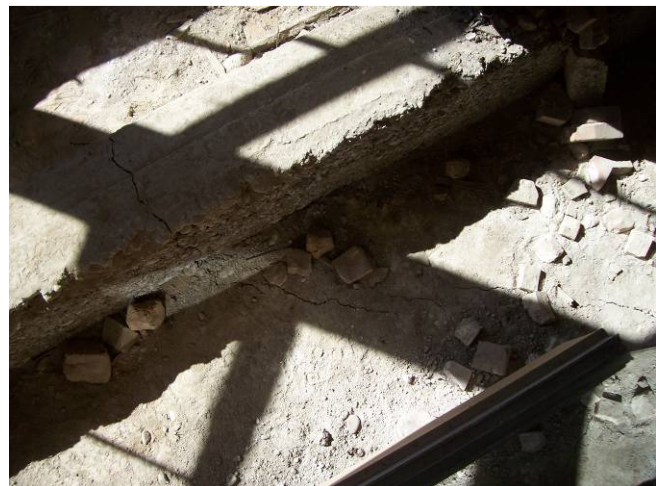
Ground crack extending under morning room bay window

- Excavate to base of ground crack. Relay compacted hardfill. We recommend utilising geotextile reinforcement.

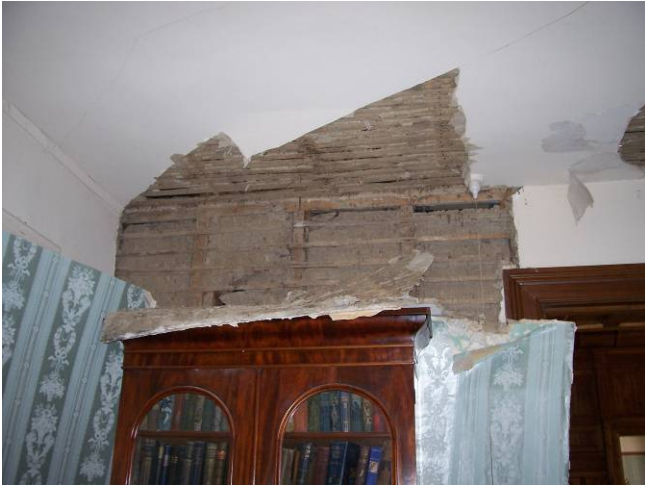
The ground floor study in the 1856 building suffered severe damage with wall and ceiling linings delaminating completely from timber framing. This could be attributed to the lack of bracing in the adjacent morning room. The morning room had much of its lath and plaster wall linings removed to expose brick insulation as an exhibit of historic construction. This essentially removes much of the bracing to this room, overloading the adjacent study.

Lath and plaster wall and ceiling delamination in study

- Lath and plaster linings which have crushed plaster at bottom corners or have delaminated will required replacement with 12mm plywood and 13mm standard GIB.

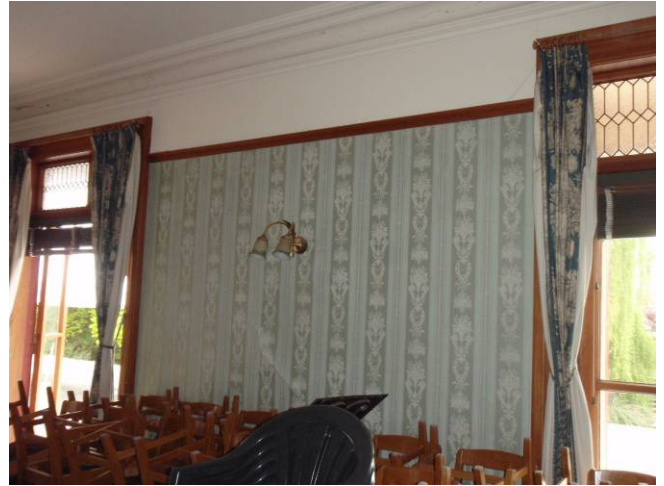
Diagonal cracking to lath and plaster wall in drawing room

- For larger cracks/fractures to plaster linings, remove and replace with GIB in accordance with GIB literature. As existing lath and plaster is 25mm thick, we suggest lining with 12mm plywood and 13mm standard GIB. Alternatively, engage specialist tradesperson to break-out cracked plaster to expose timber laths locally, re-fix laths to timber framing, and re-plaster over.

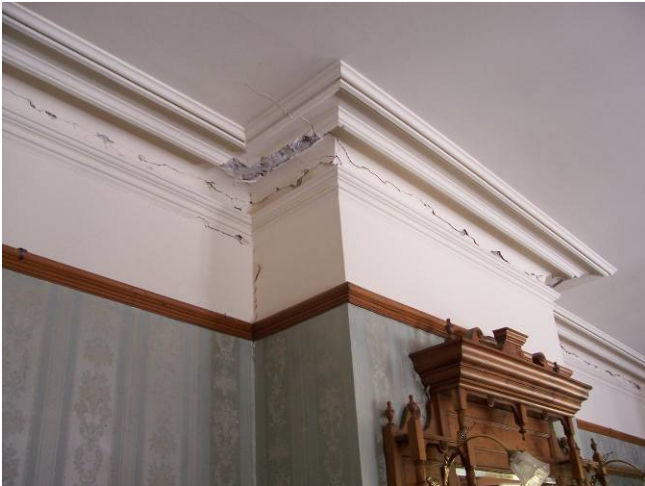
Cracking to drawing room scotia

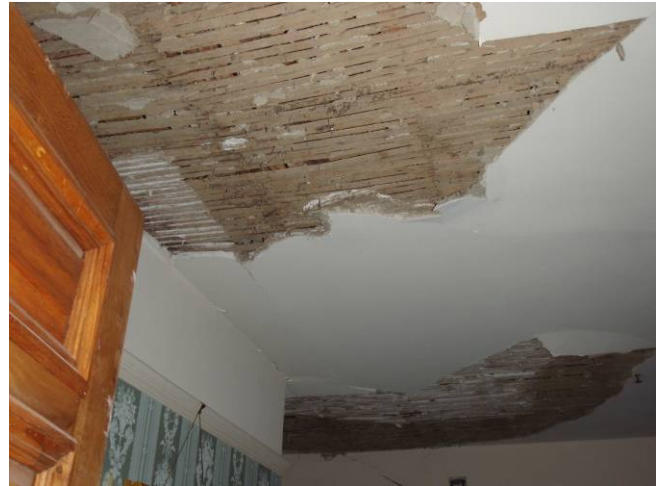
Lath and plaster ceiling delamination in study

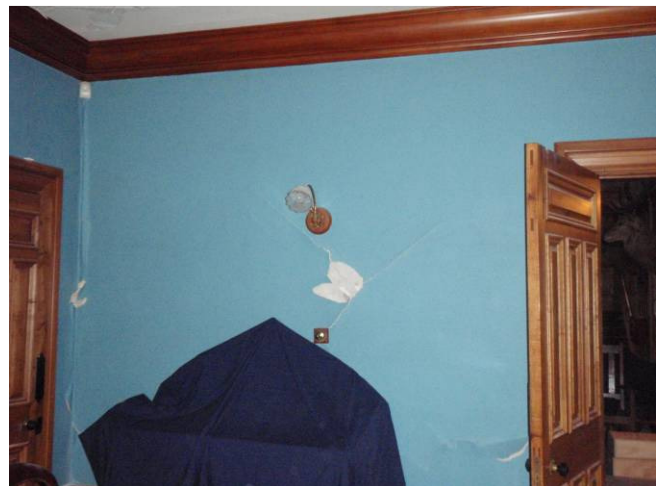
Diagonal cracking to lath and plaster wall in dining room

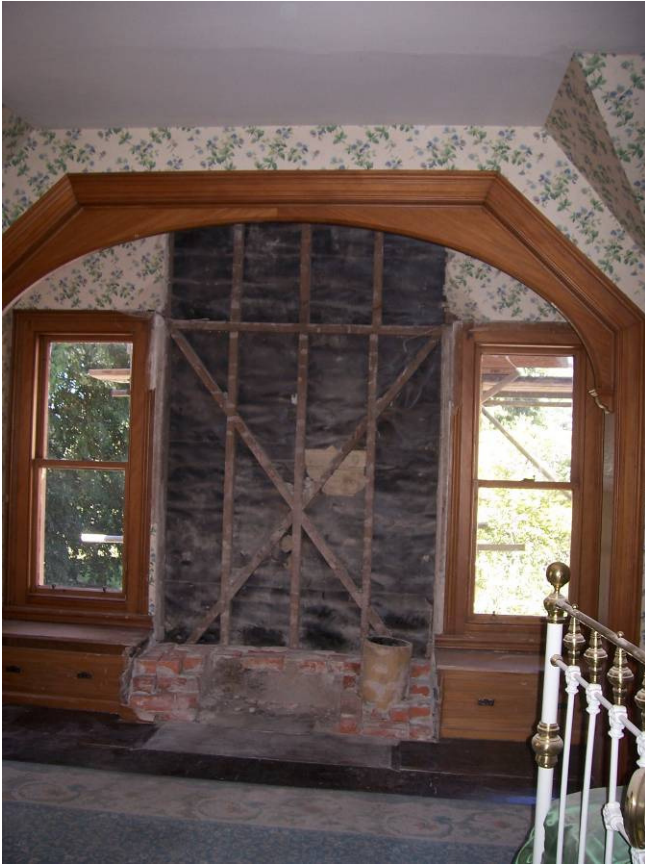
- 30-50mm ground cracking to lawn between Avon Stream and footpath. One 2-3mm ground crack passed under the morning room bay window.
- Severe damage to all chimneys, except chimney 6, following the 4th September 2011 earthquake. These were subsequently deconstructed to first floor ceiling level. Chimney 6 suffered severe damage following the 22nd February earthquake 2011, and was then also deconstructed to first floor ceiling level. We understand the first floor chimney breast of chimney 2 collapsed during the 22nd February earthquake.

Collapse of chimney 2 breast at first floor

- Due to damage to internal brick flues and fireplaces, we recommend chimneys 2, 3, 4, 6 and 7 be deconstructed to the top of the ground floor fireplace. Prior to demolition, take photographic records of original construction as directed by the council heritage team. Retain ground floor fireplaces for re-use.
- We recommend replacement chimneys and breasts be strengthened versions such as a brick veneer on lightweight steel braced framing. Refer next section regarding strengthening.

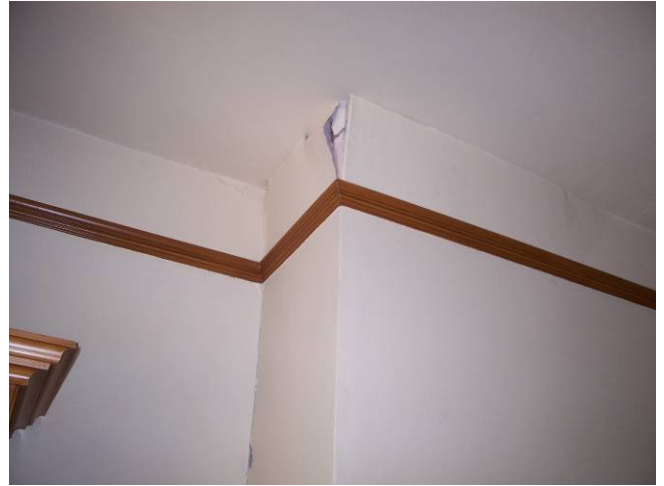
Damage to chimney 6 breast at first floor

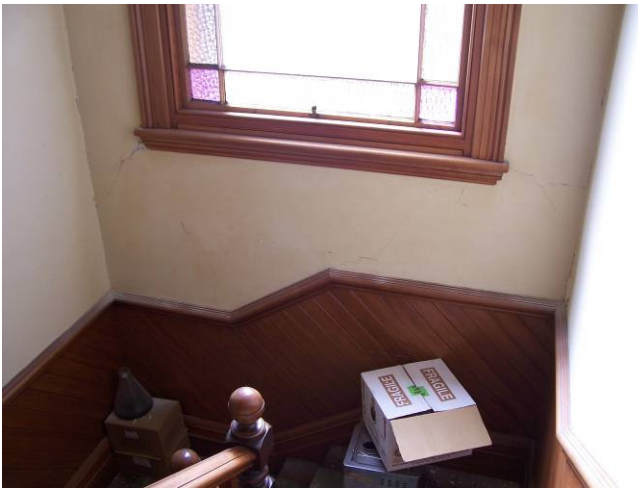
Cracking to lath and plaster walls at rear stair well

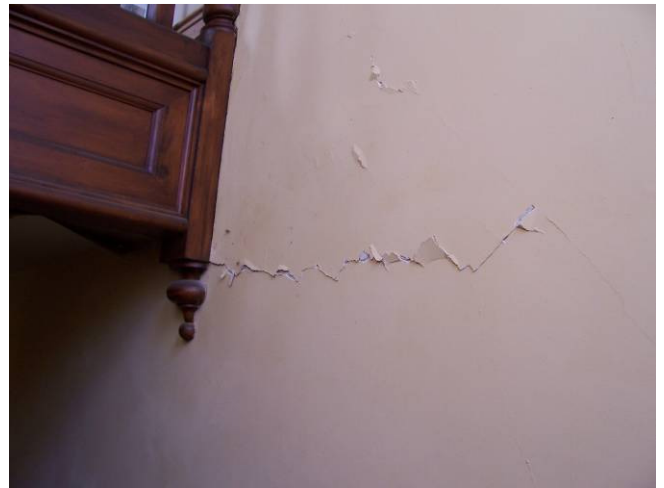
Cracking to lath and plaster walls at rear stair well

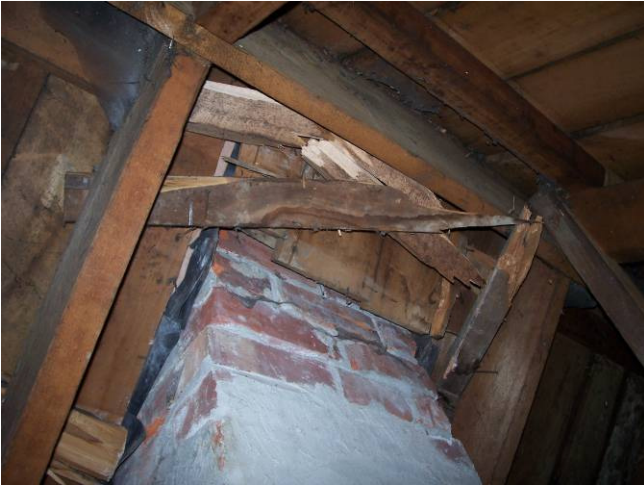
Localised damage to roof framing from chimney

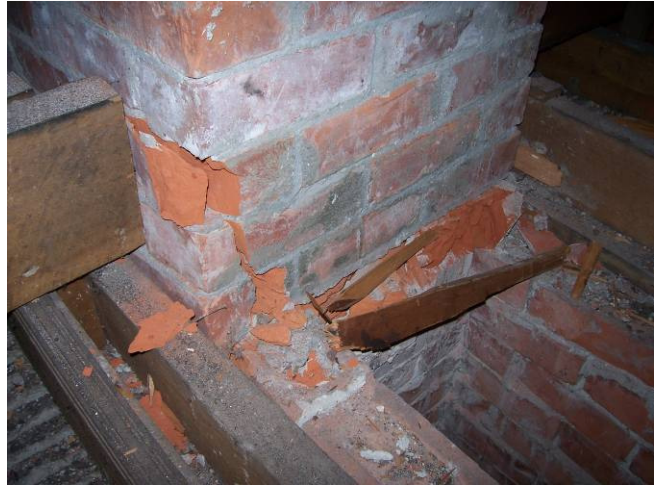
Damage to base of chimney 6

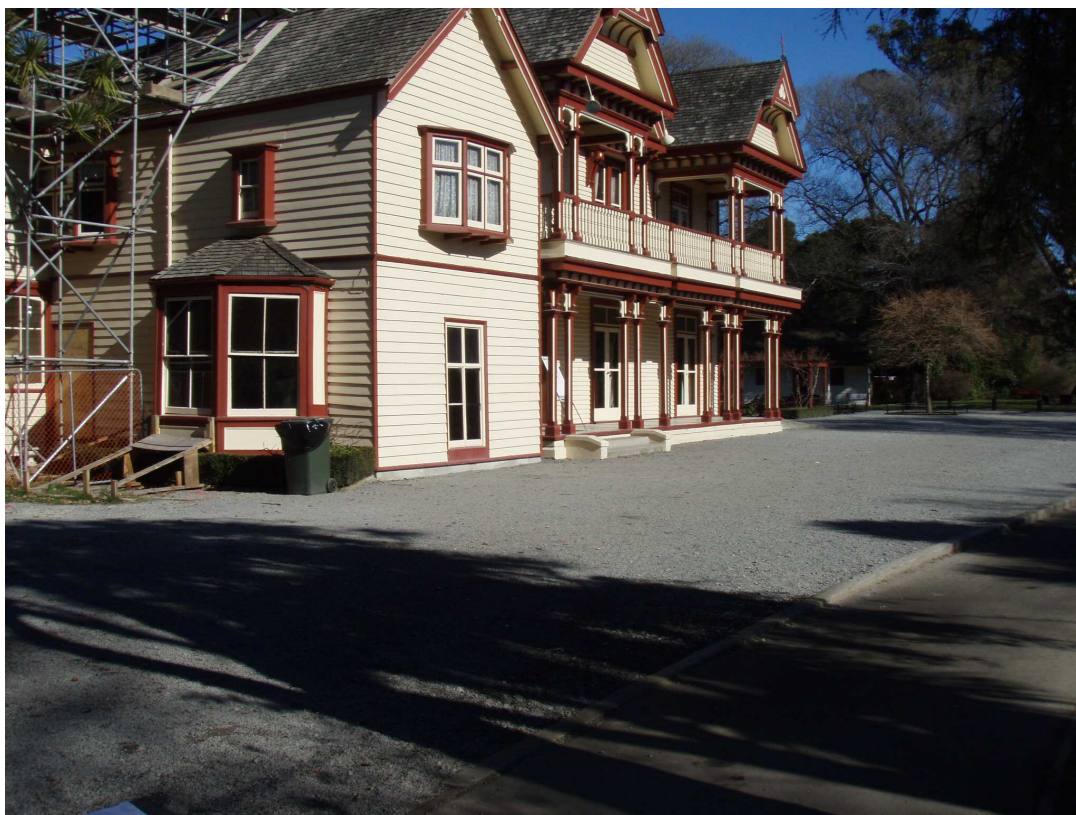
Figure 1: Northern side of Riccarton House. Damaged bay window in left of view.

The remedial work is expected to comprise of the replacement of the bay window footing.

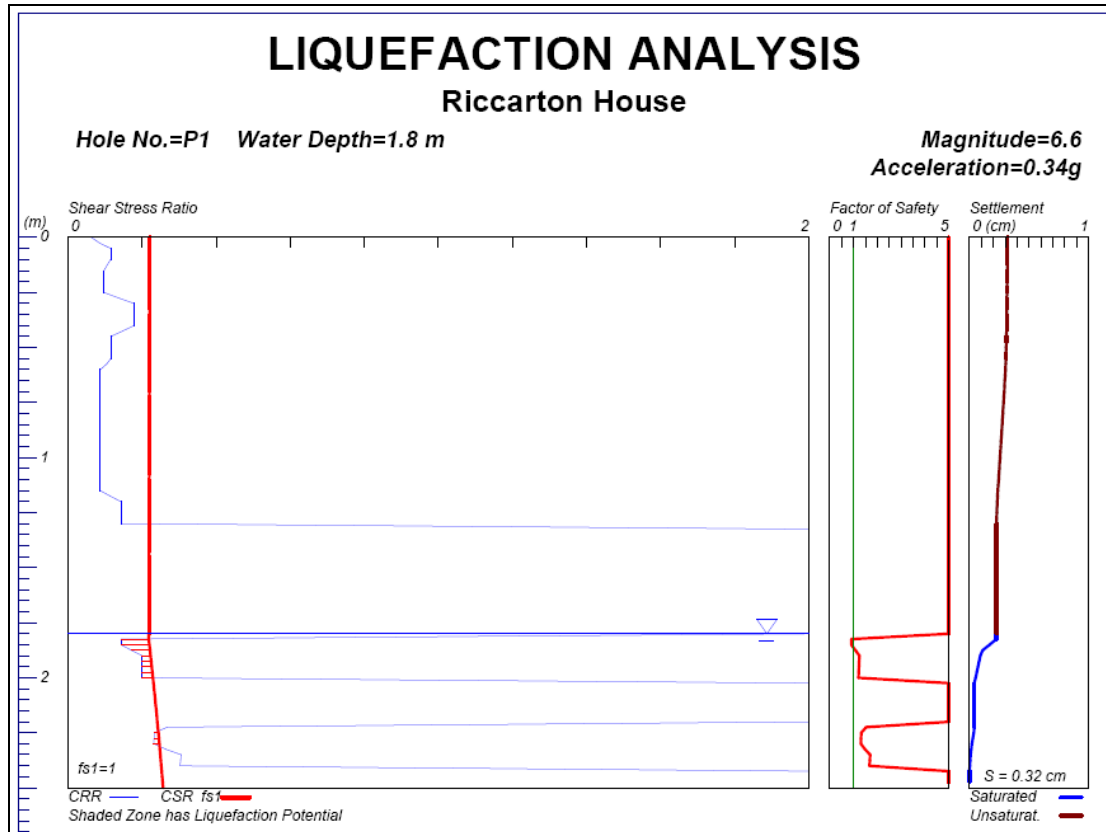
The analyses show that a layer of loose silty sand immediately below the water table and above the very dense sand layer are likely to liquefy during a ULS earthquake (Figure 4). This is expected to be the layer that liquefied during the February 22 event.

Figure 4: Liquefaction potential of the near surface soils beneath bay window area (ULS model).
