Robbies on Riccarton
Quantitative Engineering
Evaluation

Reference: 227676
Prepared for:
Christchurch City Council

Address: 199 – 205 Clarence Street, Riccarton

Revision: 2
Date: 24 June 2013

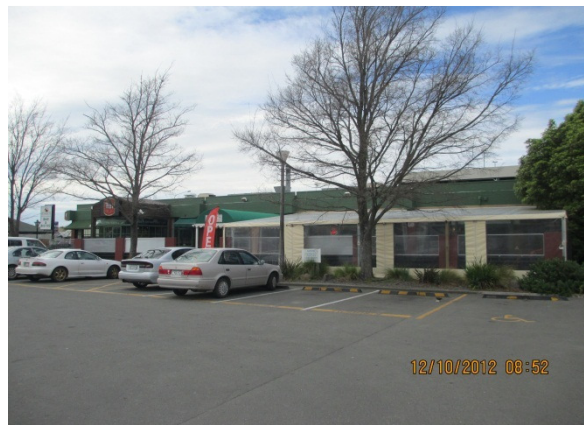
Northern view of the building.

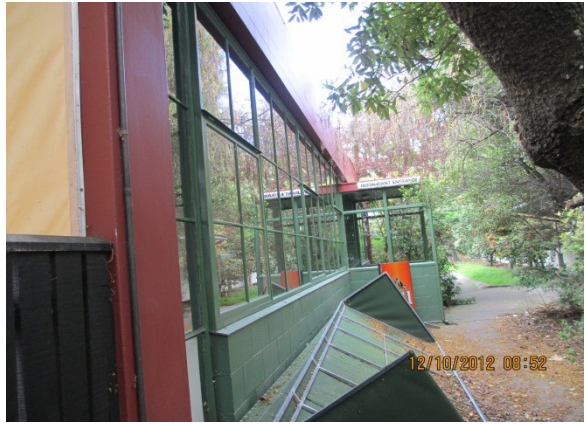
Western view of the building.

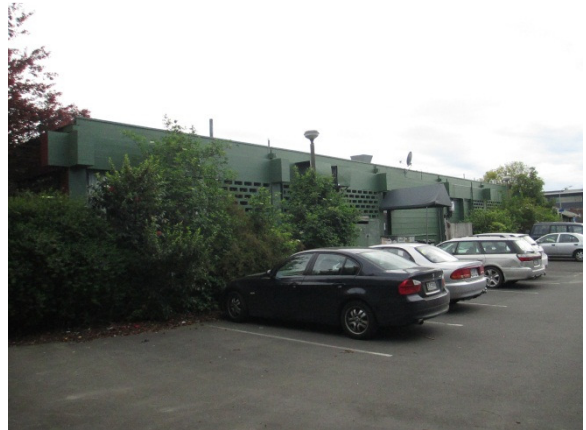
Southern view of the building.

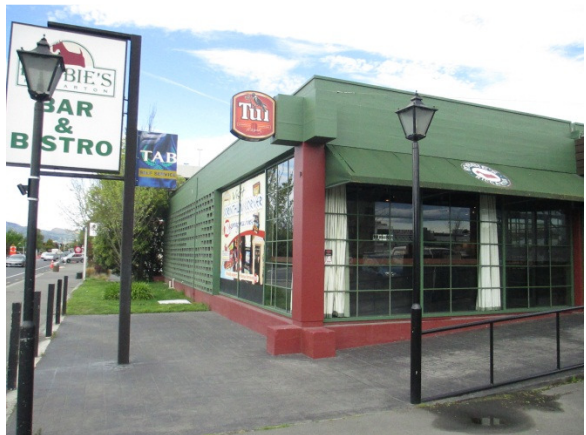
Northeast view of the building.

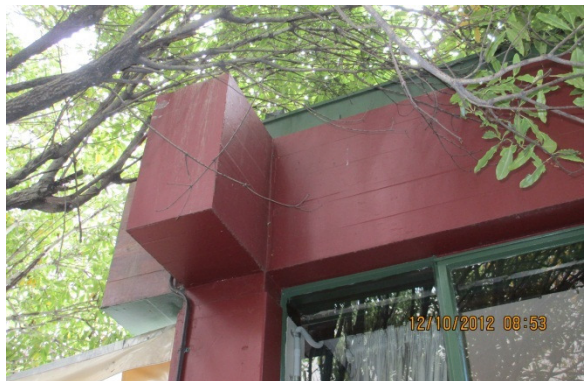
Typical view of the top external concrete beam at the corner of the building.

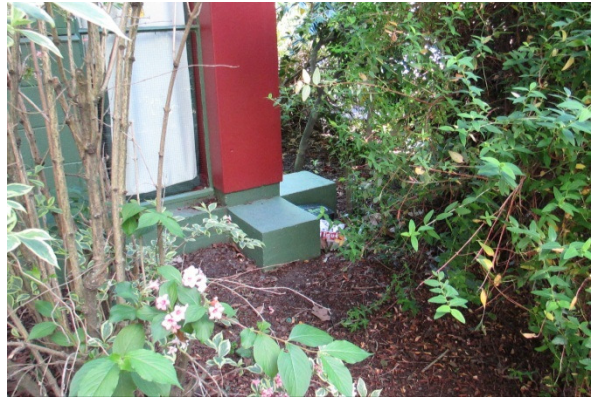
Typical view of the bottom external concrete beam at the corner of the building.

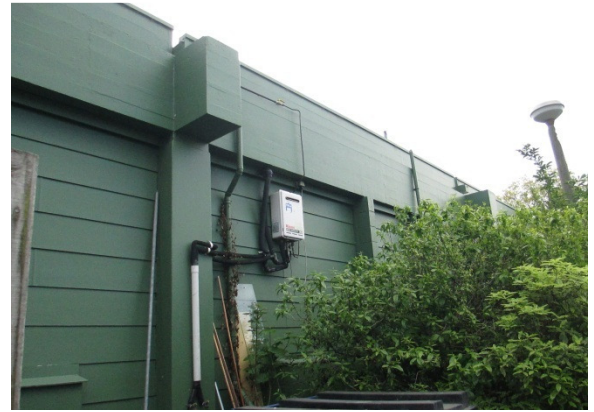
View of the top external concrete beam in the south central part of the building.

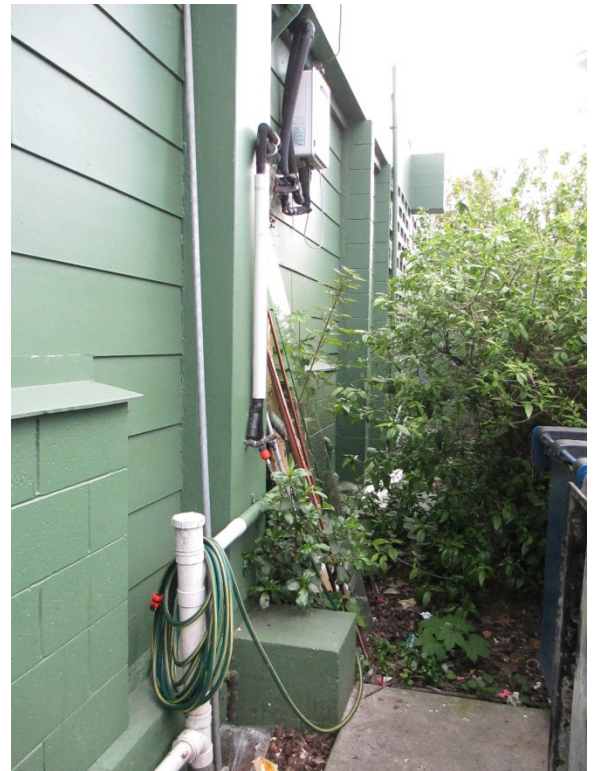
View of the bottom external concrete beam in the south central part of the building.

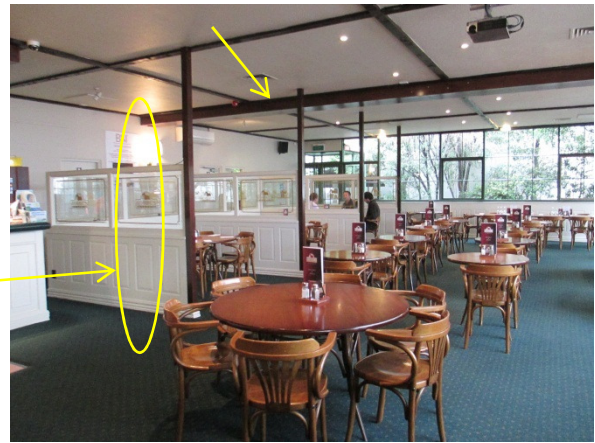
Internal southern view of one of the internal beams in the transverse direction.

400mm square reinforced concrete column supports this beam

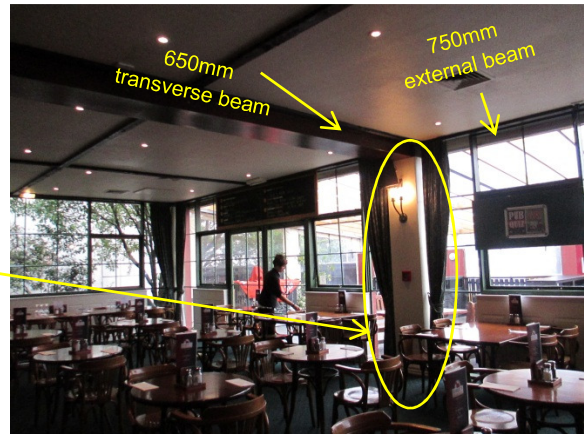
Internal northern view of one of the internal beams in the transverse direction.

400mm square reinforced concrete column supports this beam

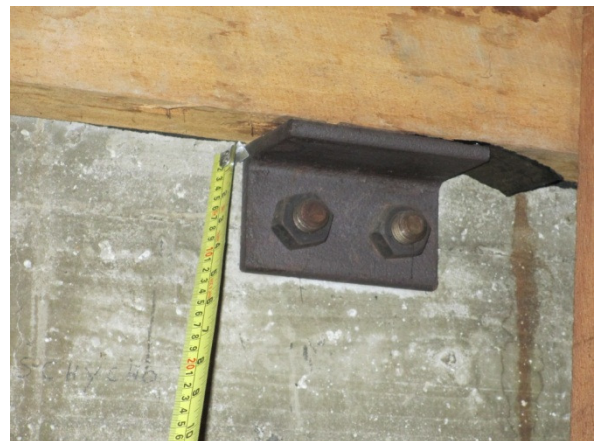
100mm angle metal cleat supporting the timber joist.

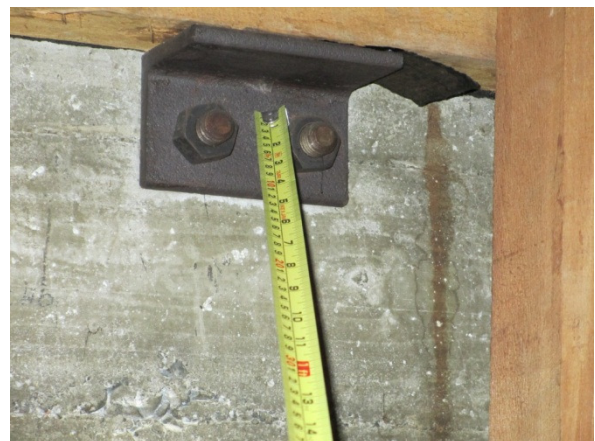
Timber joist is supported by angle metal cleat that is bolted to the external concrete beam by two M24 bolts.

Note: There are 7 angle cleats per 6.60m span.

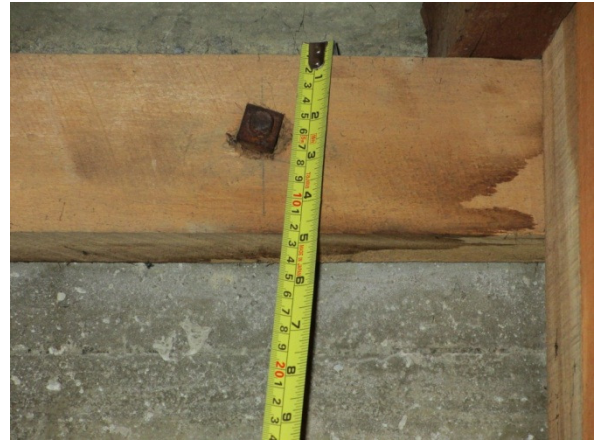
Additional M12 bolts have been placed in between the angle metal cleats.

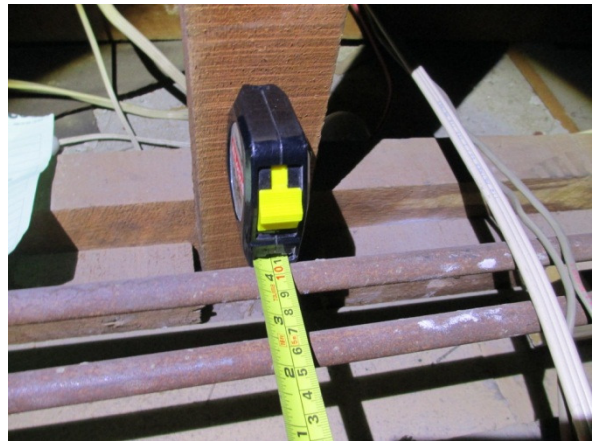
Concrete masonry wall has R16 horizontal reinforcement bars.

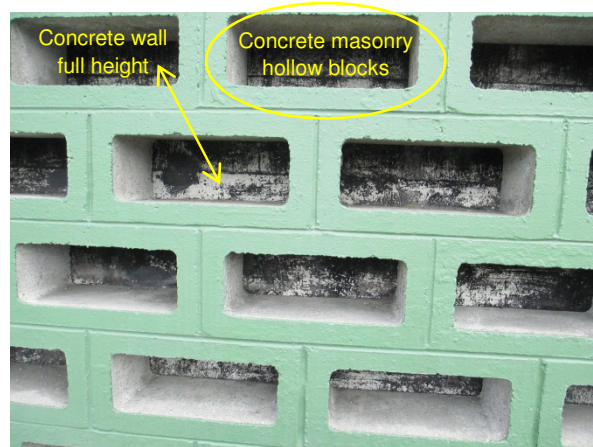
The building has a combination of steel framed window glazing and concrete masonry hollow blocks which are laid in a staggered pattern and placed on top of the original external wall. Only the southern core (cold store) has full height concrete wall.

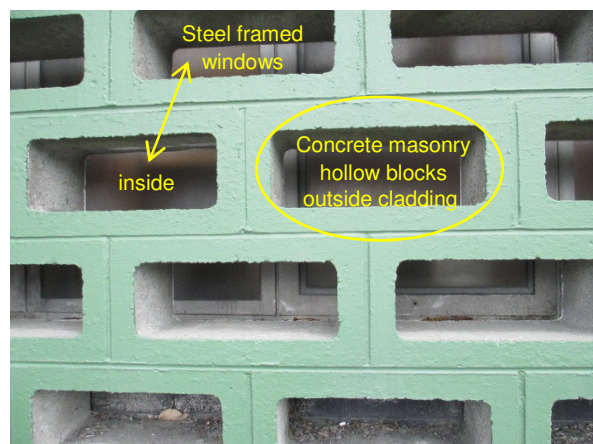
The building has a combination of steel framed window glazing and concrete masonry hollow blocks which are laid in a staggered pattern and placed on top of the original external wall.

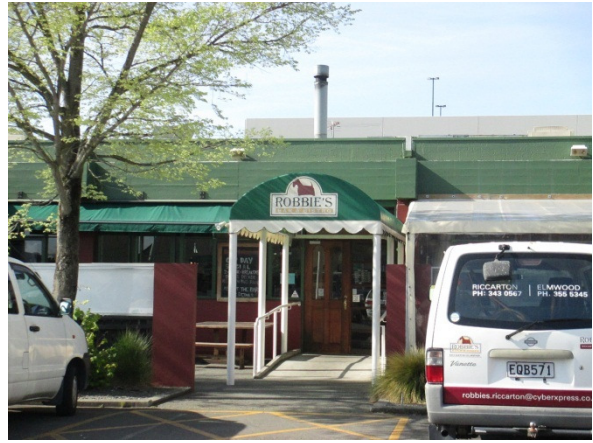
Standalone circular steel framed canopy in the north facing entrance. This lightweight canopy is supported by the cantilevered circular hollow section.

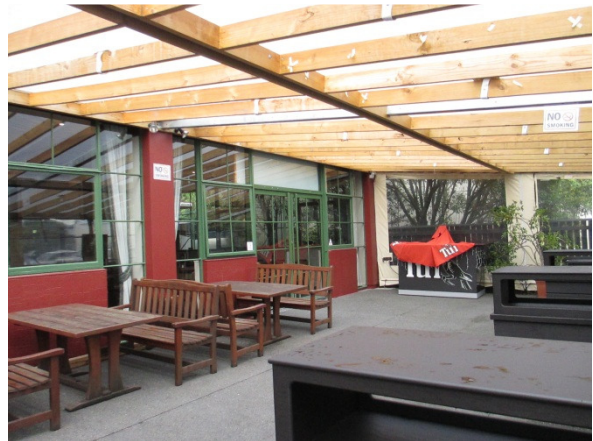
100mm galvanised square hollow section acts as the main steel frame. Transverse beams have a span of 6.15m and are supported by columns bolted into the ground.

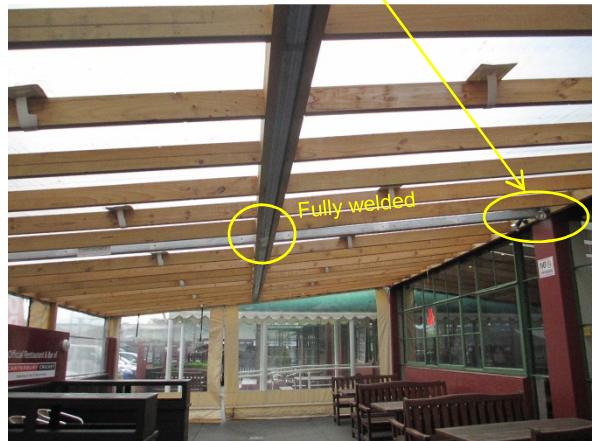
Longitudinal beams spans at 6.60m over 2 bays. It is fully welded at both ends and supported by the transverse beams.

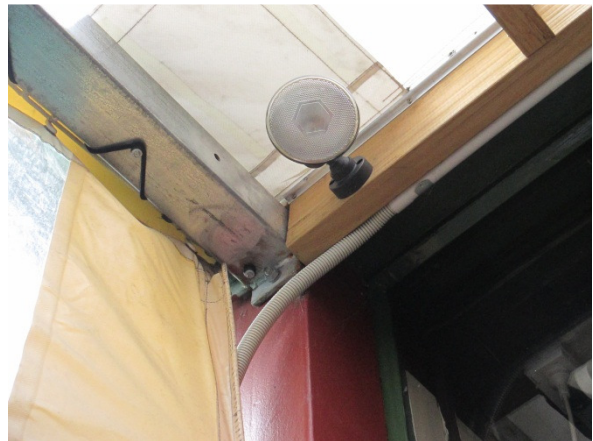
The steel frame is bolted to the concrete columns on the north side of the building.

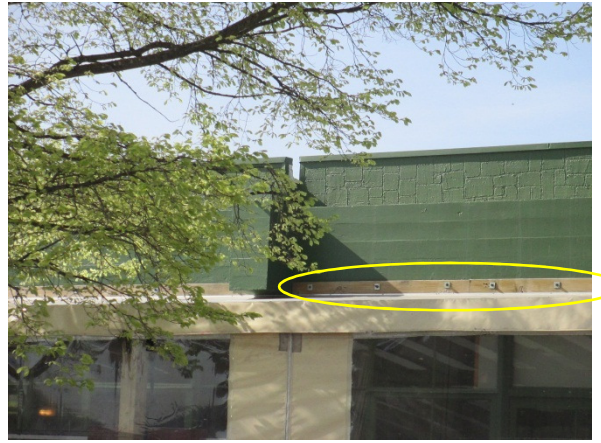
The timber joists are bolted to the external concrete beams to support the timber rafters.
