Ruru Lawn Cemetery Garage
PRK_0895_BLDG_009 EQ2
Detailed Engineering Evaluation
Qualitative Report
Version Final

63 Ruru Road
Bromley

Christchurch City Council

Date
18th September 2012

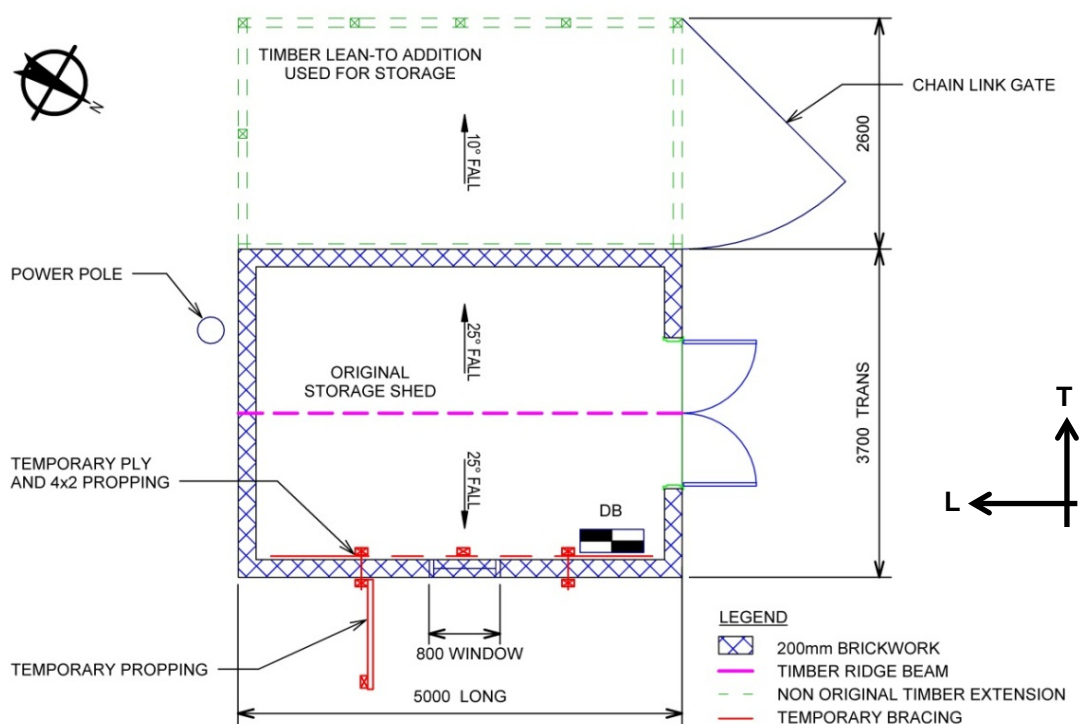
Figure 2 Plan Sketch Showing Key Structural Elements

The building is approximately 5.0m in length by 6.3m in width with a height of 3.0m. The building occupies a footprint of approximately 31.5m² and is over 10m from the nearest structure, a shed occupying the same site. The site is relatively flat at approximately 10m above mean sea level. It is approximately 2.5km west of Avon River, 2.5km north of the Heathcote River, and 4km west of the coast (Pegasus Bay). No plans are available for the structure.

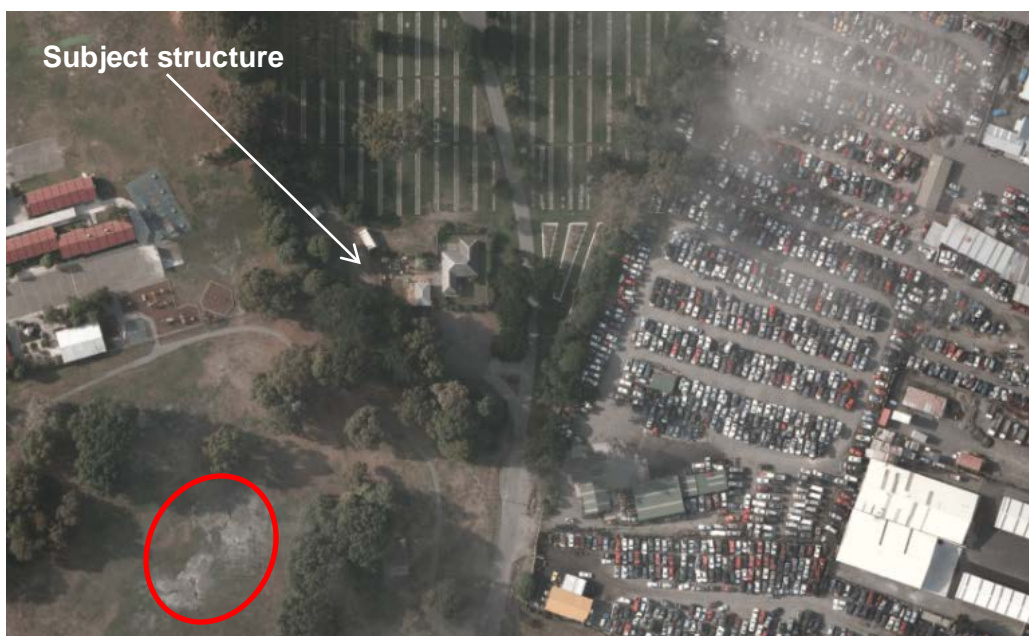
Figure 3 Post February 2011 Earthquake Aerial Photography³

Aerial photography taken following the 22 February 2011 earthquake shows signs of liquefaction close to the site, as shown in Figure 3.

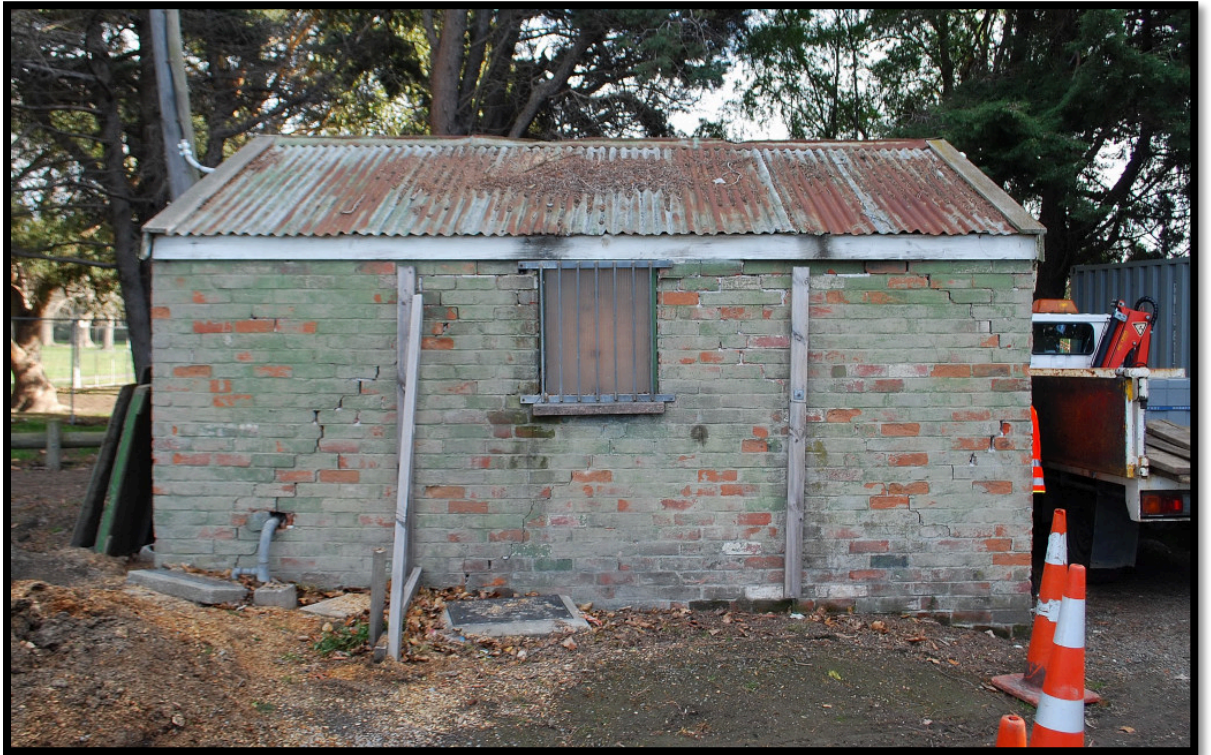
Cracking was noted to the exterior brick wall in several locations throughout the building. See photographs 1,4,5,7 and 8. These cracks are considered to be significant.

Photograph 1 Northeast elevation.

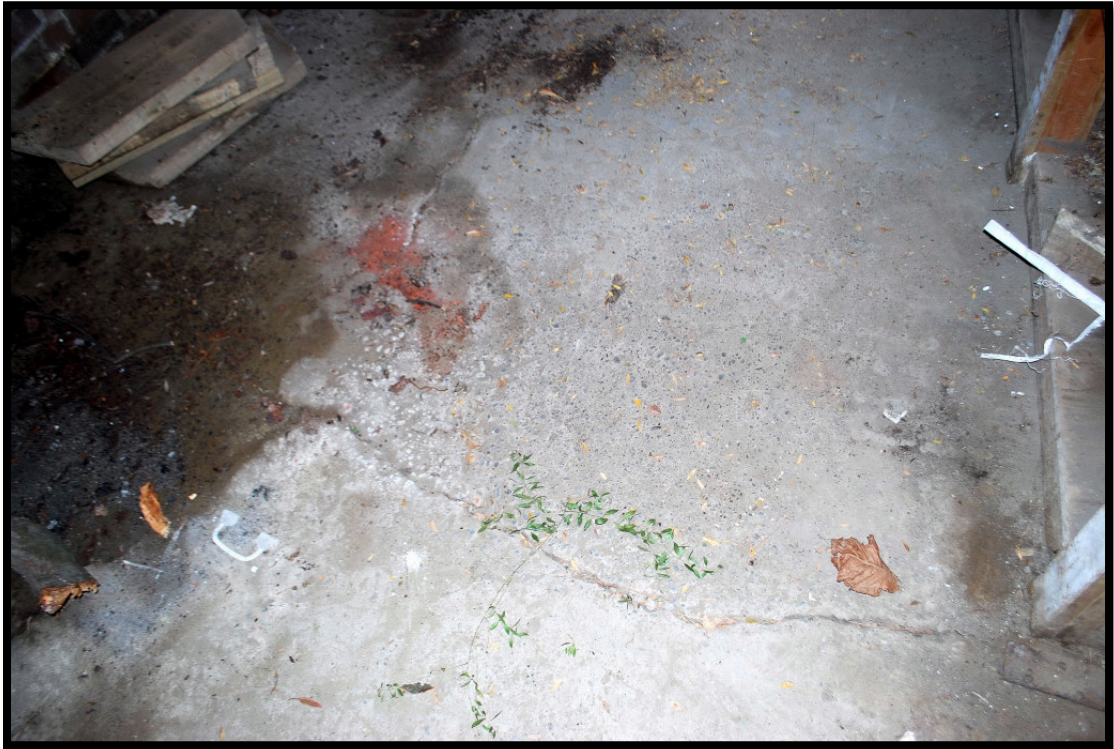
Cracking was also noted to the foundations; however these probably existed before the Christchurch earthquake. See photograph 3.

Photograph 3 Cracks in original structure's slab.

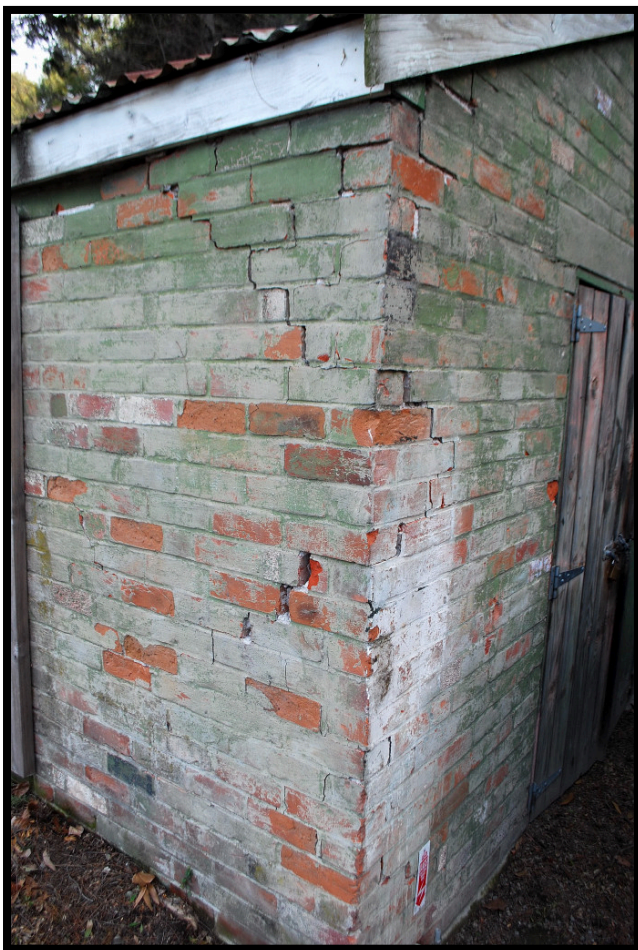
Photograph 4 North corner of building showing vertical and horizontal cracking along brickwork joints.

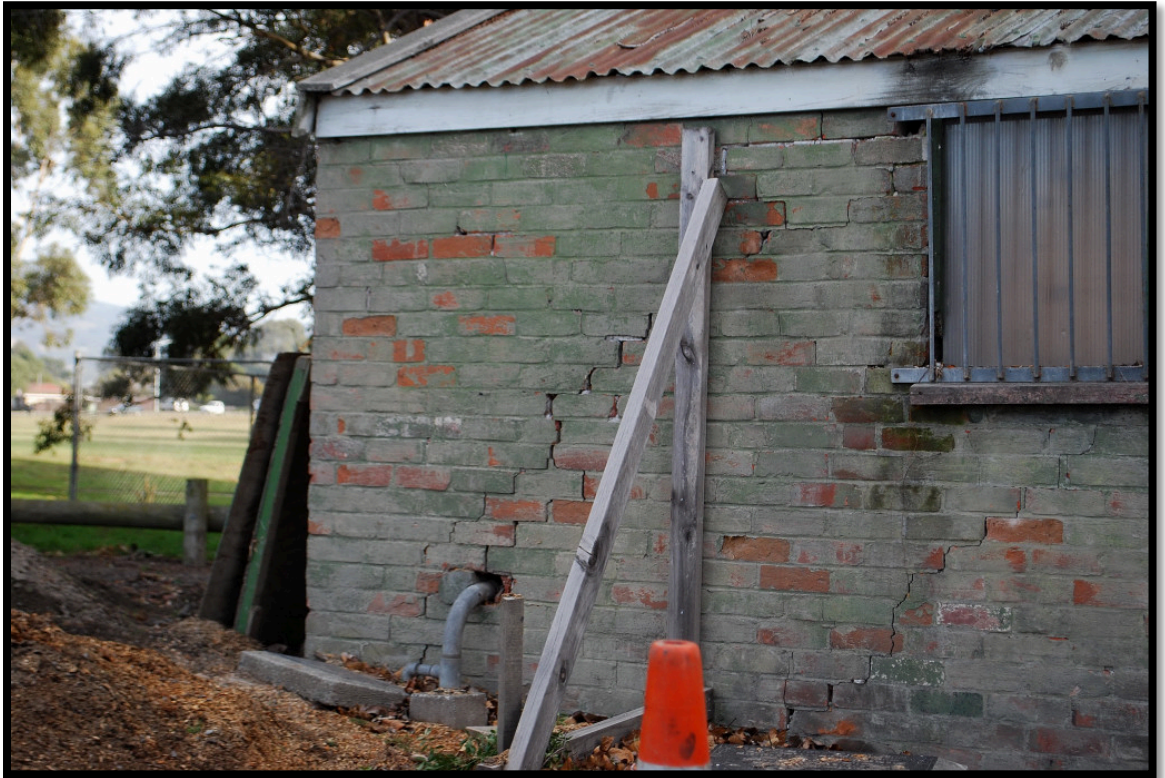
Photograph 5 Northeast corner of building showing extensive vertical and horizontal cracking along brickwork joints.

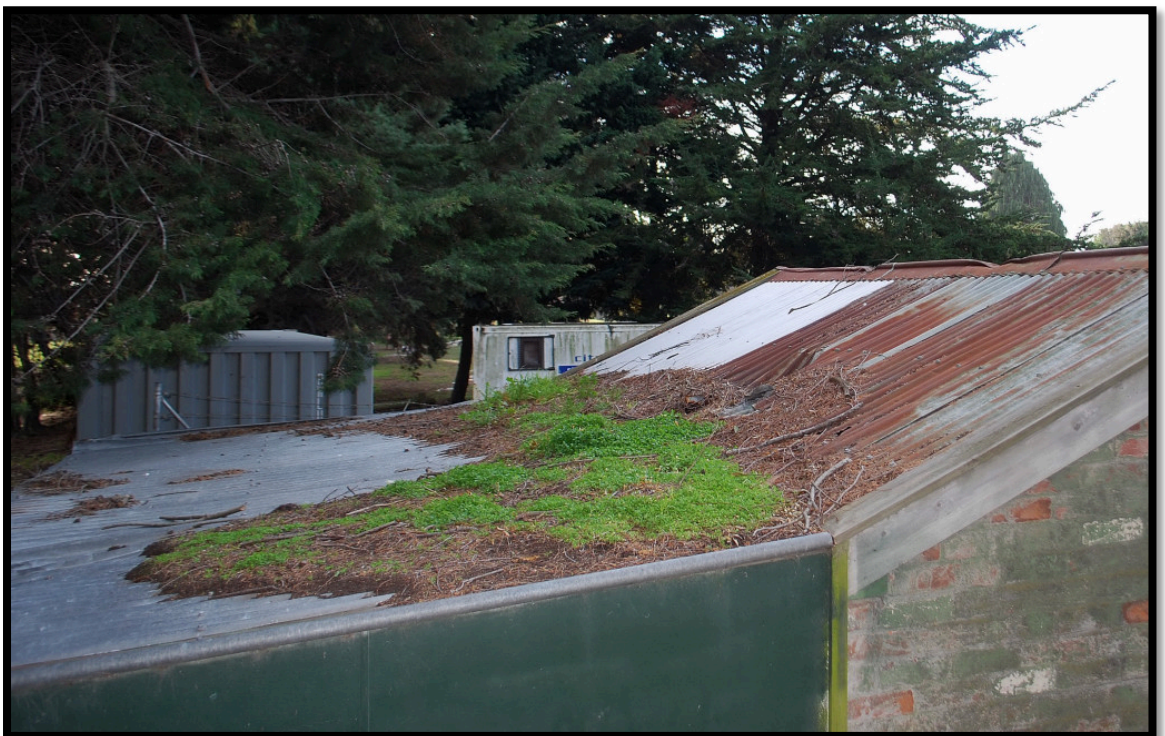
Photograph 6 View of Rooftop showing original structure to the right and added lean-to on the left. Note debris build-up and collapsed section on the original iron roof.

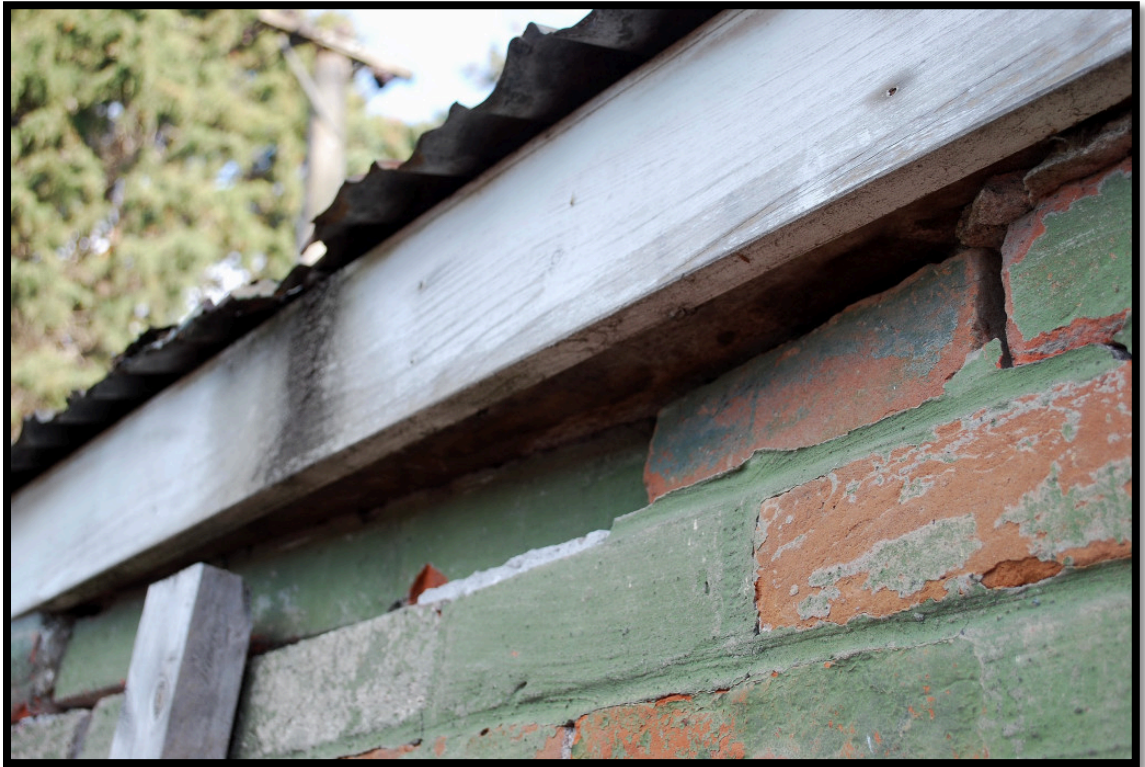
Photograph 7 Northeast walls top row of bricks separating.

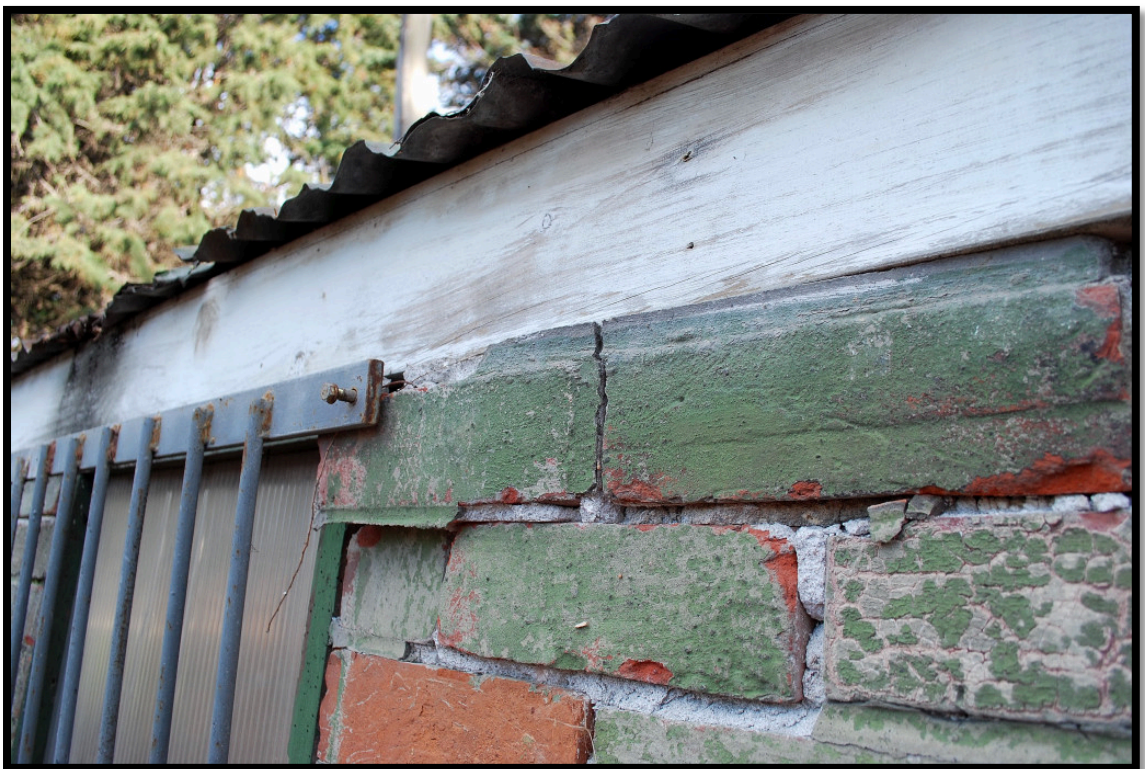
Photograph 8 Northeast walls top row of bricks separating at window.

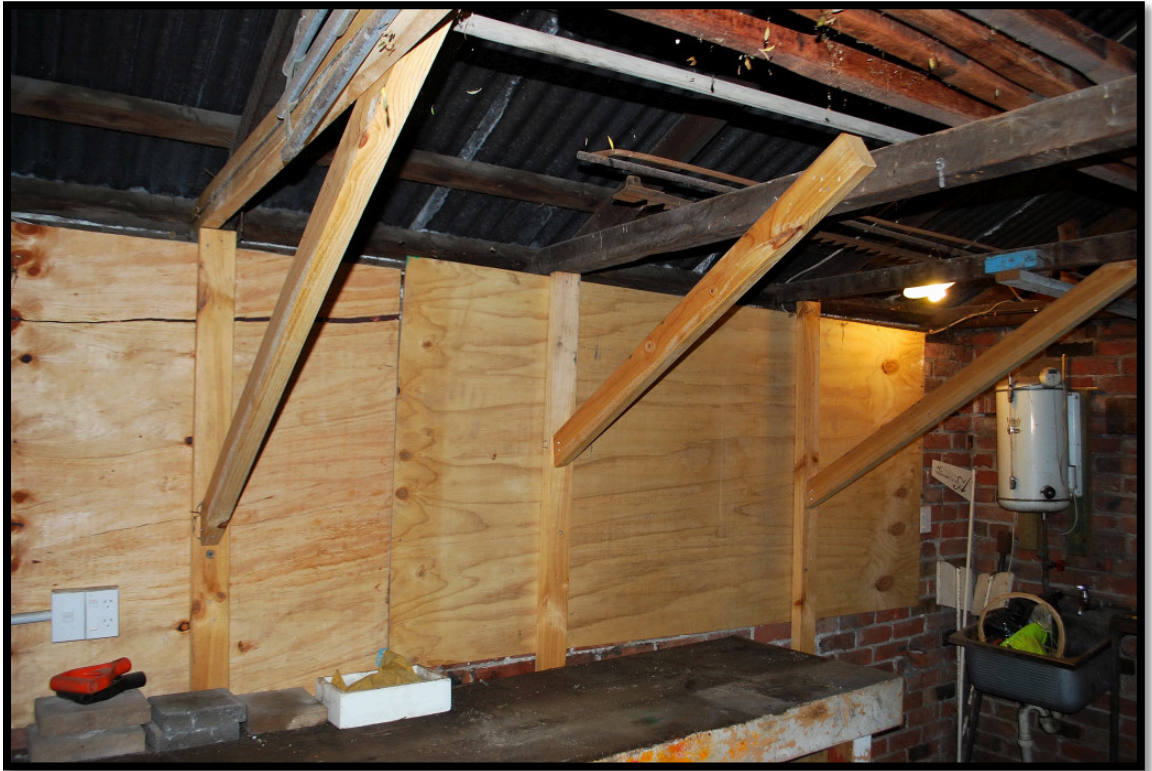
Photograph 9 Temporary prop strengthening on the inside of the building with Ply and 4x2 timber.

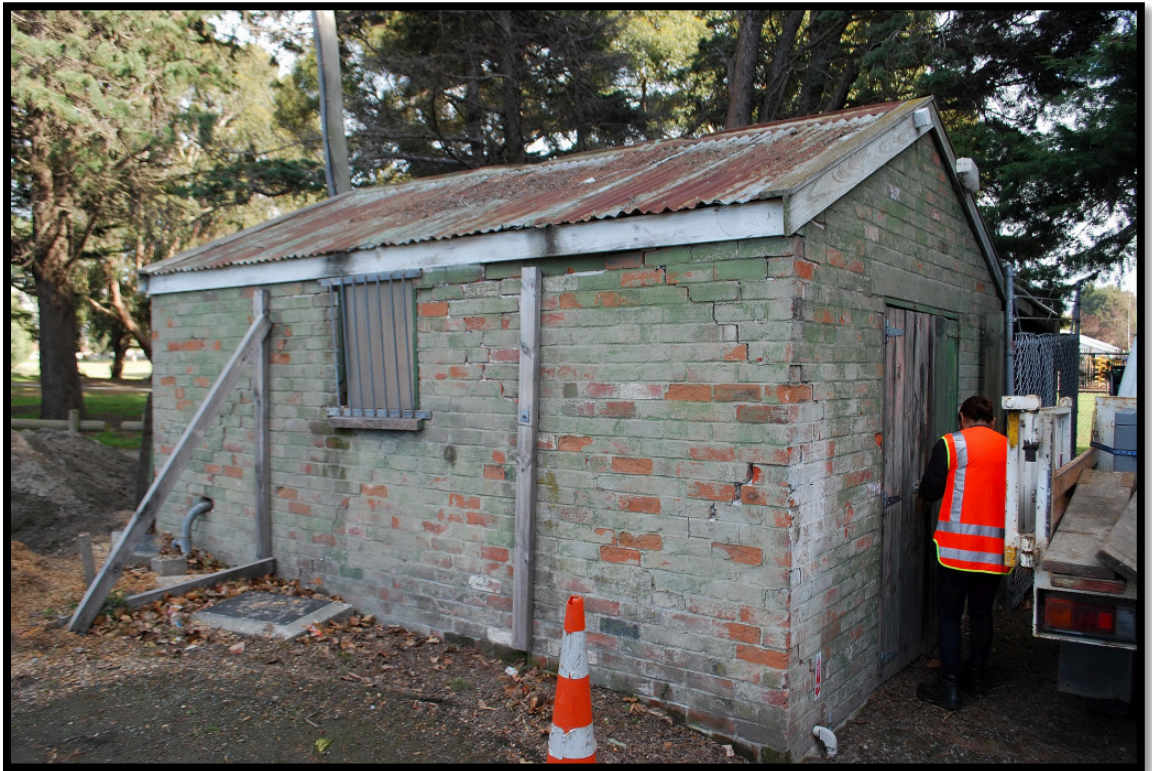
Photograph 10 Temporary prop strengthening on outside of the building.
