CHRISTCHURCH CITY COUNCIL
PRK_0895_BLDG_006 EQ2
Ruru Lawn Cemetery – Portacom Office
Raymond Road, Bromley

QUALITATIVE ASSESSMENT REPORT

- Rev B
- 23 November 2012

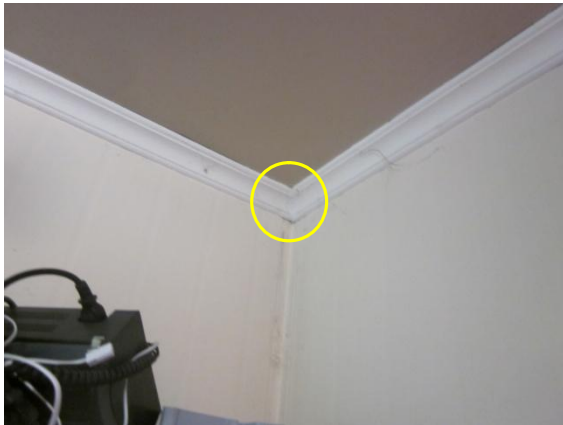
- 1) Minor hairline cracking to the scotia practically at the joints was present (PHOTO 3, 4 & 5)
- 2) No visual evidence of settlement was noted at this site. Therefore a level survey is not required at this stage of assessment.

Photo 3: Hairline Cracking at Scotia Joints

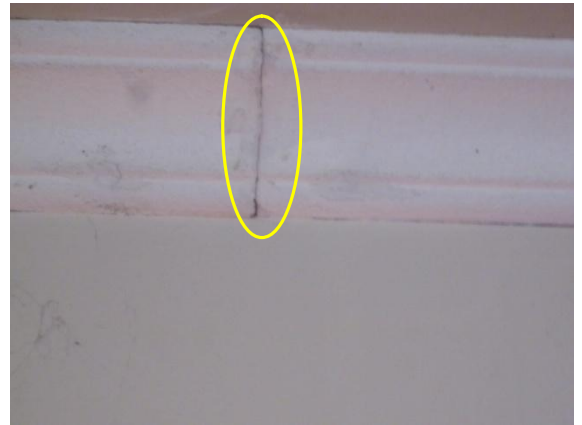
Photo 4: Hairline Cracking at Scotia Joints

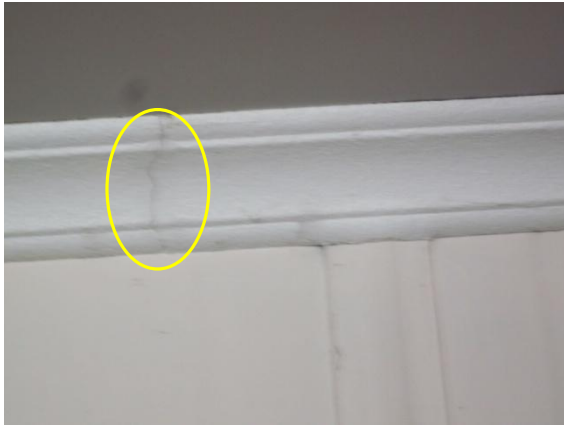
Photo 5: Hairline Cracking to Scotia

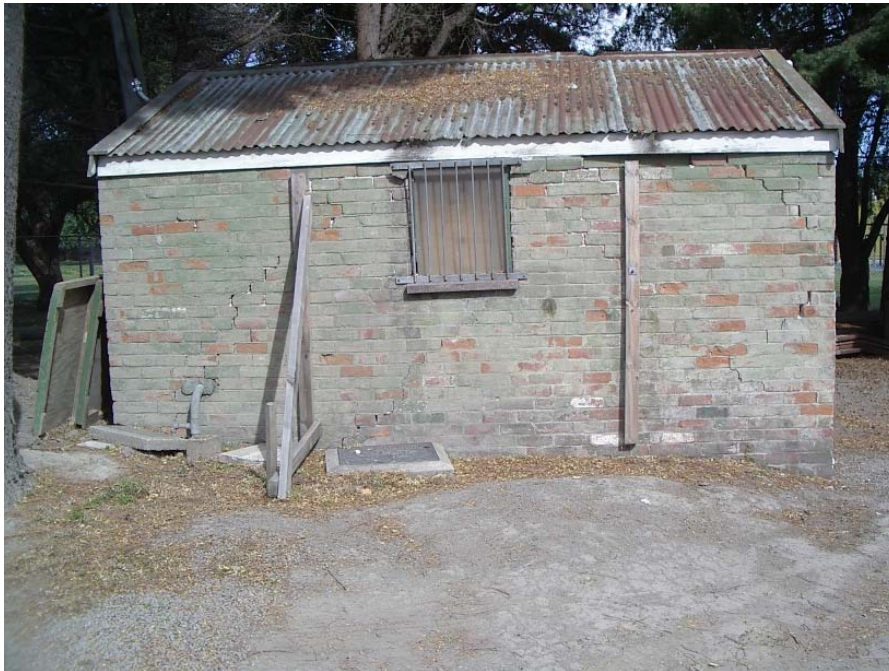
The toolshed was the only building on the site with any noticeable structural damage. The main damage observed was the cracking of the bricks.

■ **Figure 8 Visible damage to the tool shed**

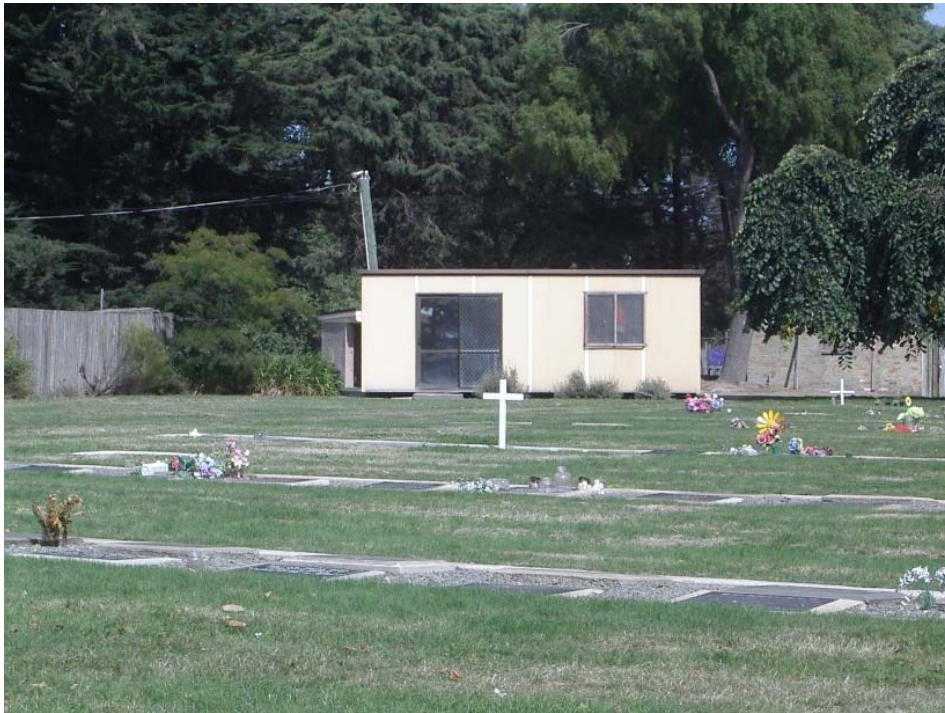
■ **Figure 9 No visible damage to land or the building**

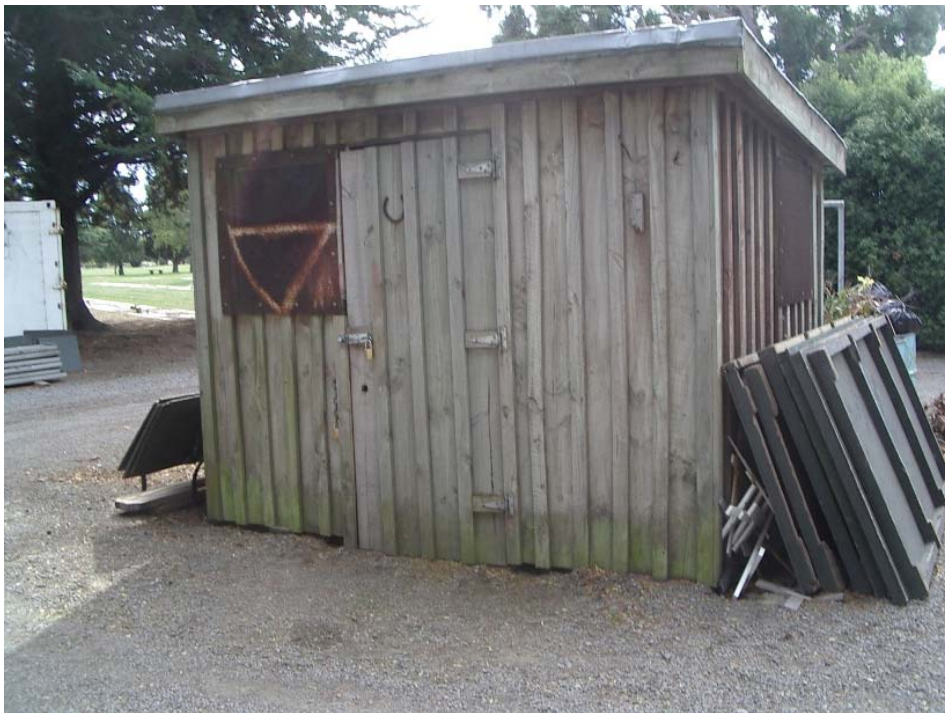
■ **Figure 10 No visible damage to the pump house**
