CHRISTCHURCH CITY COUNCIL
PRK_2389_BLDG_001 EQ2
Scarborough Farm Park Woolshed
190 Summit Road, Sumner

QUALITATIVE ASSESSMENT REPORT
FINAL

- Rev B
- 23 May 2013

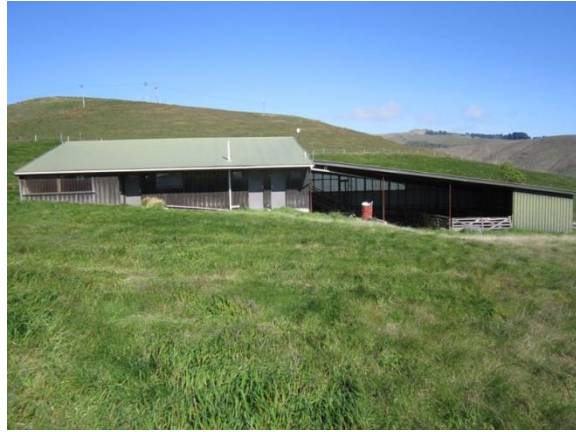
Photo 1: North elevation

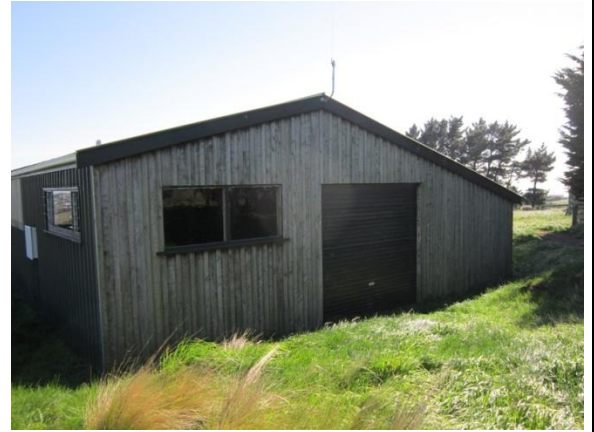
Photo 2: East elevation

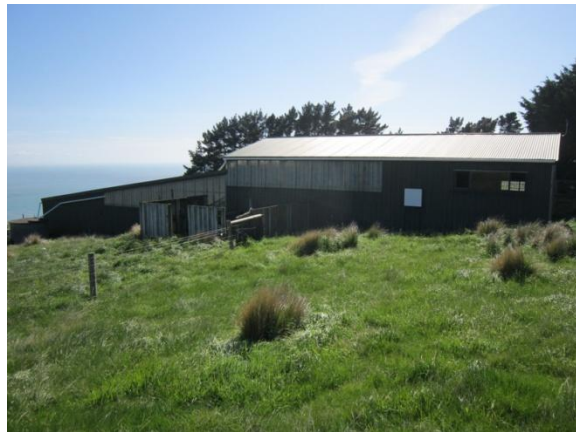
Photo 3: South elevation

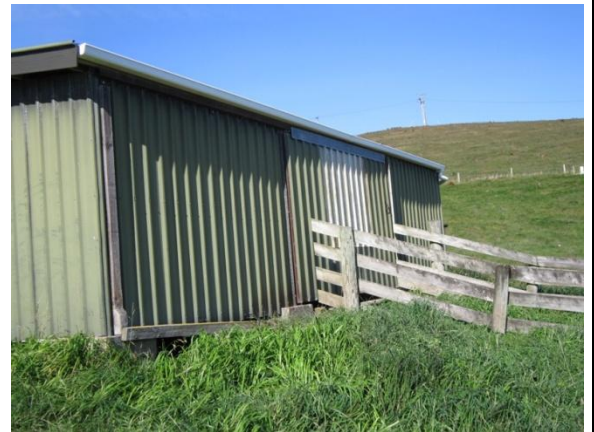
Photo 4: West elevation

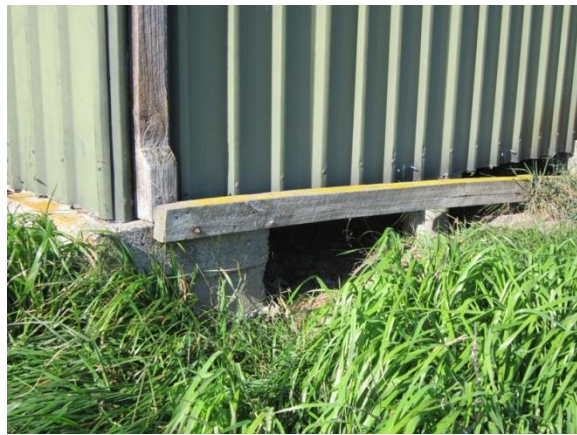
Photo 5: Concrete footing and timber pile on northwest corner of three-walled structure

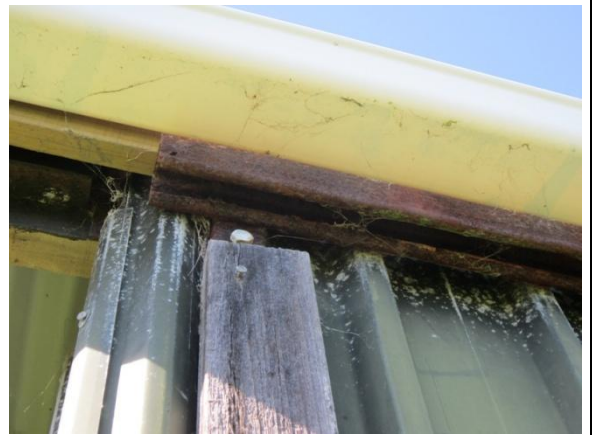
- 1) No earthquake-related damage was observed during our site inspection.
- 2) Splitting of timber elements along the grain throughout the building. This is not believed to be earthquake-related damage.
- 3) Rusting of non-structural steel elements throughout the building. This is not earthquake-related damage.

Photo 6: Rusted steel element (typical)

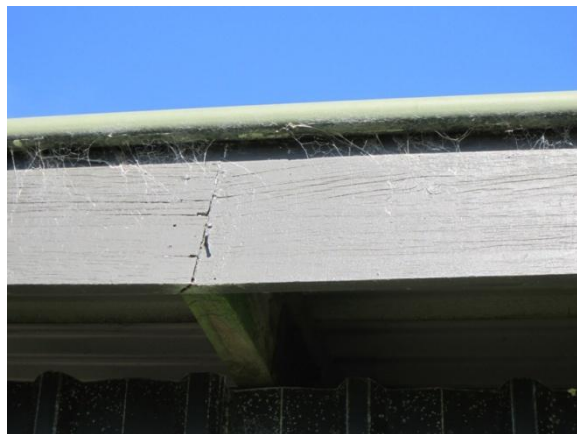
Photo 7: Splitting of timber element along the grain (typical)

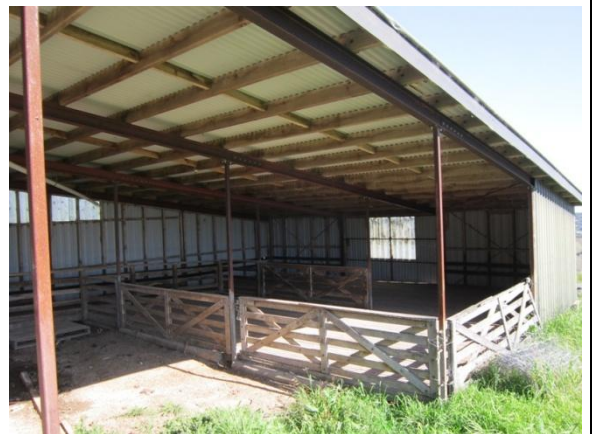
Photo 8: Steel beams and posts spanning longitudinally in three-walled structure

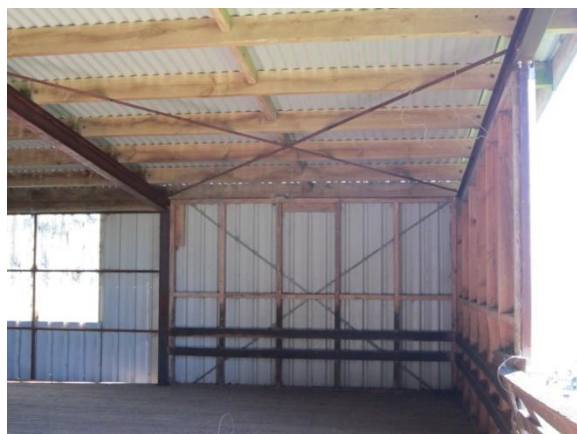
Photo 9: Steel cross-bracing in the walls and

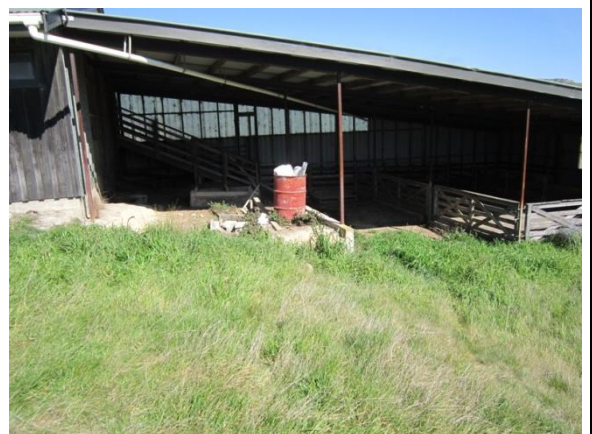
As the separation between the enclosed and lean-to structures is less than 0.005 times the height of the building, there is potential for pounding to occur in the longitudinal direction. This can have a severe effect on structural performance. However, if pounding occurred, it would likely have a greater effect on the capacity of the lean-to structure as opposed to the enclosed structure, due to the difference in construction and mass.

Photo 10: Sloping ground causing height

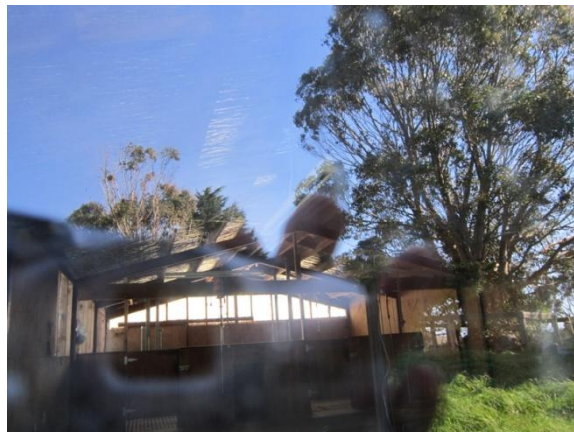
Photo 15: Timber rafters with steel posts along roof apex with exposed internal timber framing

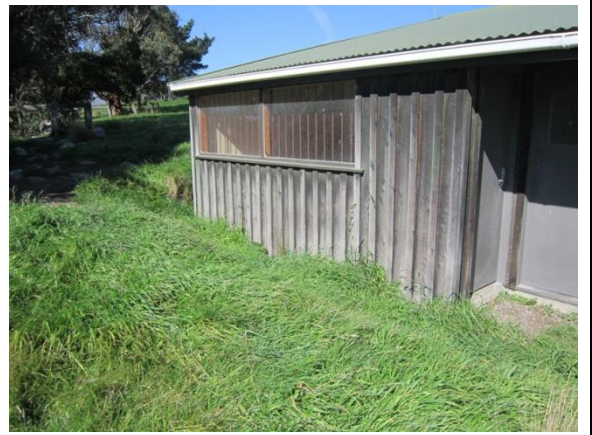
Photo 16: Trench created around eastern end of enclosed structure
