CHRISTCHURCH CITY COUNCIL
PRK_1474_BLDG_002 EQ2
Scarborough Jet Boat Shed
2 Scarborough Beach

QUANTITATIVE ASSESSMENT REPORT
FINAL

- Rev B
- 26 February 2013

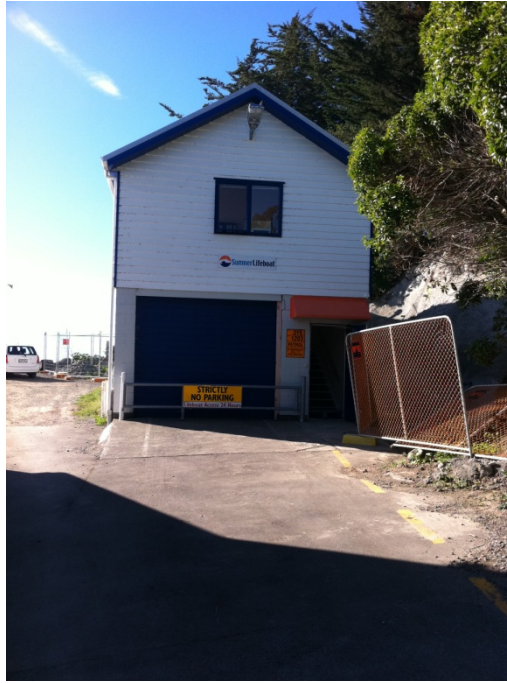
Photo 1: South Elevation. No bracing wall at ground floor level

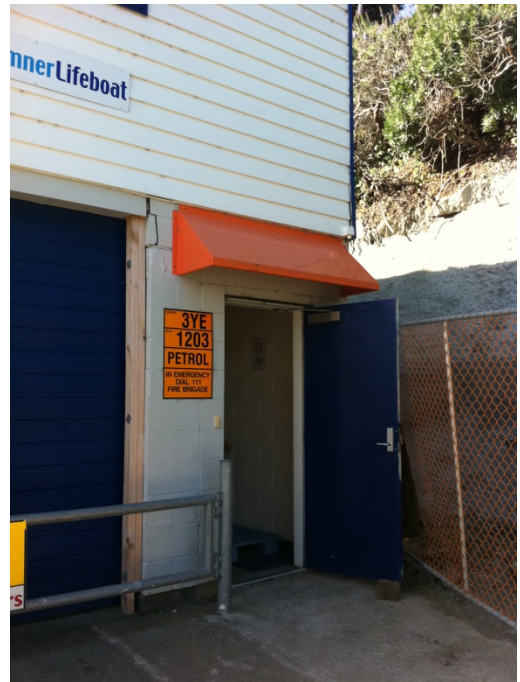
- 1) The following damage was observed on the south wall: -
 - Top course block located on the east side of the roller door has cracked right through the face (PHOTO 4 & 5).

Photo 4: Cracking to Block Work Near Roller Door

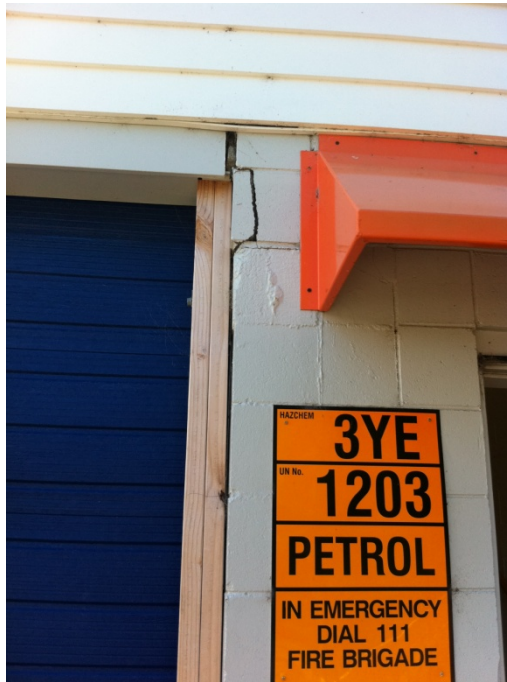
Photo 5: Close up of Photo 6

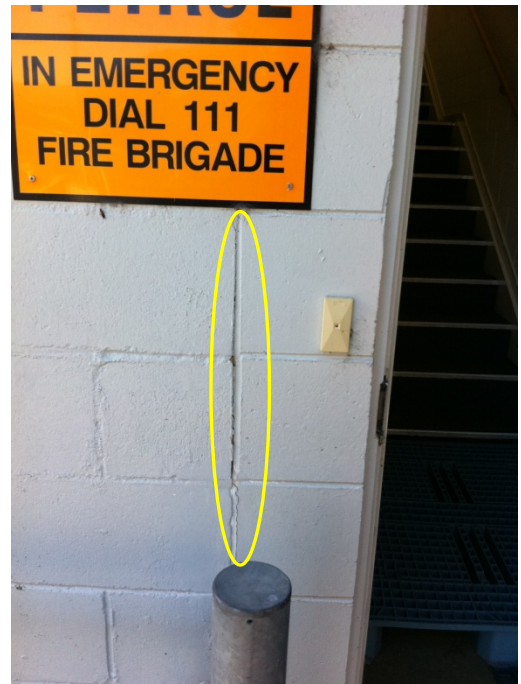
- Minor cracking to block wall mortar joints near entrance door in the south-east corner (PHOTO 6 & 7). This cracking may be the result of drying shrinkage movement rather than earthquake damage.

Photo 6: Minor Cracking to Block Wall Mortar Joints Near SE Corner

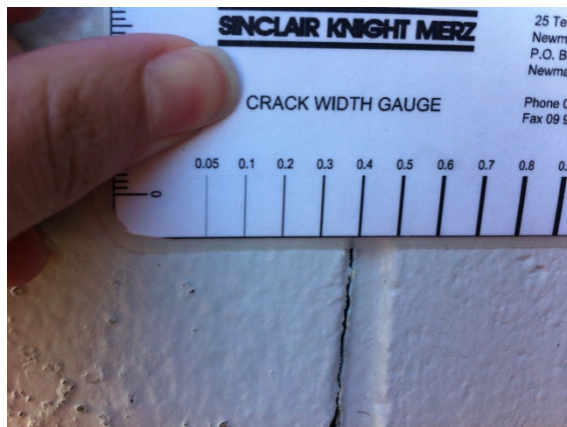
Photo 7: Close up of Photo 6

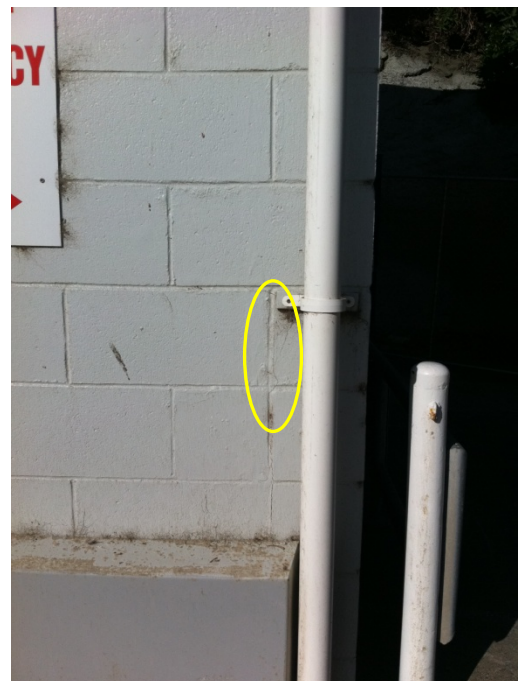
- Hairline cracking through mortar joints and face of the block work in the south-west corner (PHOTO 8 & 9).
- Spalling to the block faces to the top course of the blocks in the north-west corner (PHOTO 10).

Photo 8: Minor Cracking to Block Wall Mortar Joints Near SW Corner

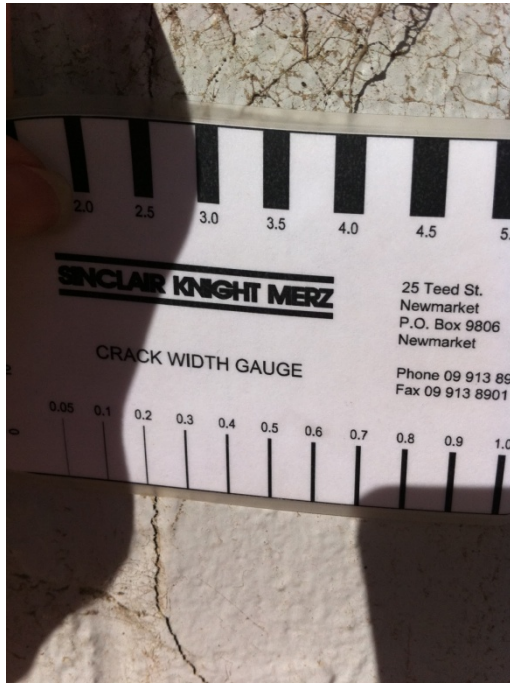
Photo 9: Close up of Photo 8

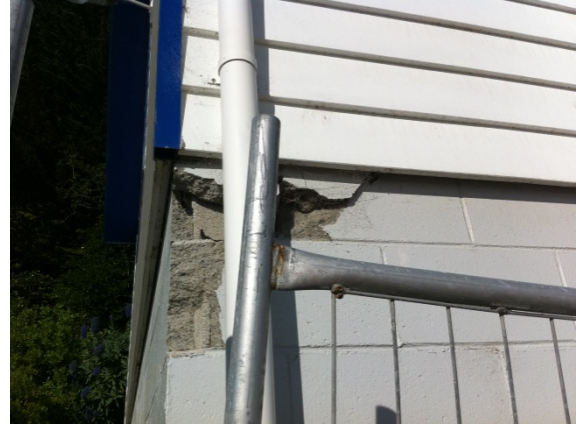
Photo 10: Spalling to Block Face in NW Corner

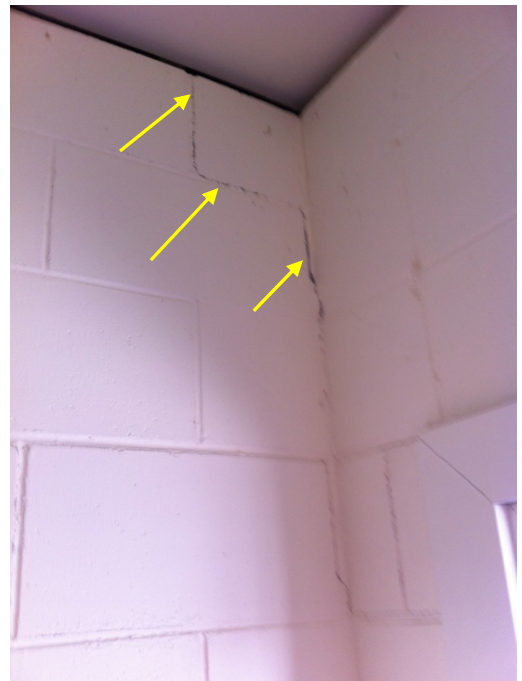
- Step cracking present along the block wall mortar joints on the east and south walls (PHOTO 12, 13 & 14).
- Hairline crack present between the block wall and timber wall joint in the south-west corner (PHOTO 15 & 16).
- Hairline cracking present in wall lining joints on the west wall (PHOTO 16 & 17).
- Cracking present between the timber stair stringer and the wall lining joint (PHOTO 19). Timber stair skirting damaged at the base of the stair as well as mid way up the stair (PHOTO 18 & 20). Stringer plate also appears to have separated from the eastern wall.
- Horizontal crack present in wall lining at the top of the stair (PHOTO 21).
- Cracking present along the block wall and timber infill wall joint (PHOTO 22 & 23).
- Horizontal hairline crack present at the wall lining joint on the north wall at the top of the stair (PHOTO 24 & 25).

Photo 12: Minor Cracking to Block Wall Mortar Joints in SE Corner

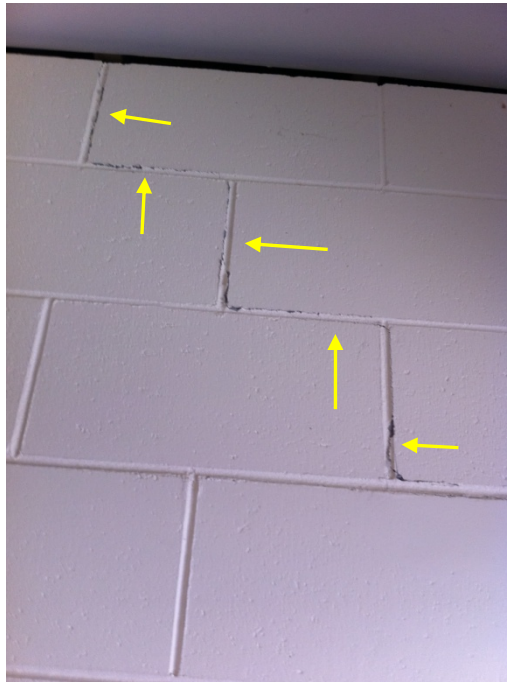
Photo 13: Minor Cracking to Block Wall Mortar Joints on East Wall of East Stair

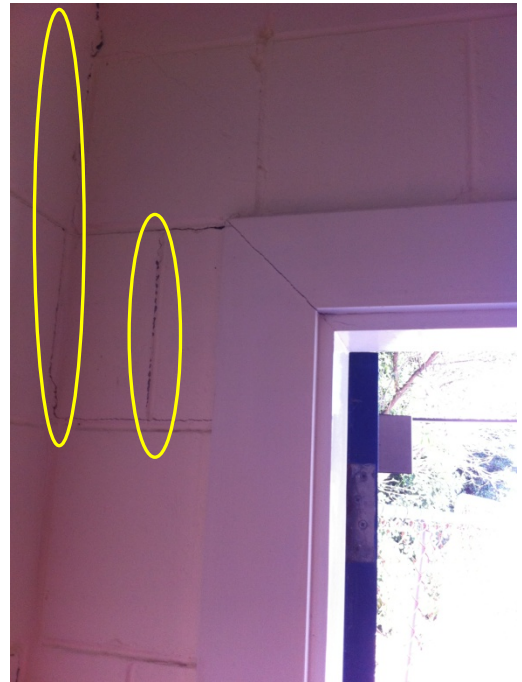
Photo 14: Minor Cracking to Block Wall Mortar Joints in SE Corner of East Stair

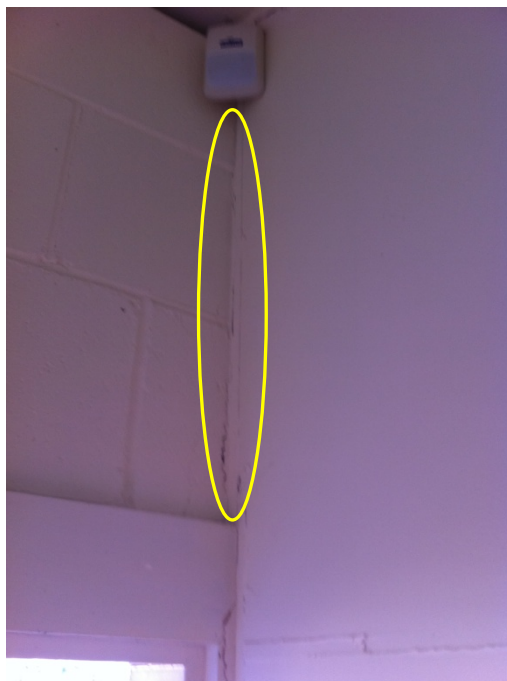
Photo 15: Hairline Cracking between Block and Timber Wall Joint in SW Corner of East Stair

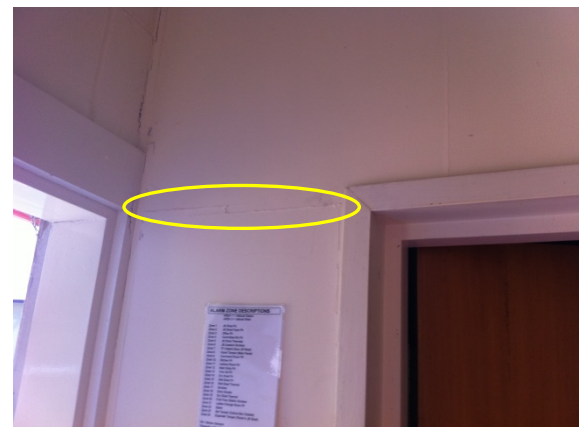
Photo 16: Hairline Cracking at Wall Lining Joints on West Wall of East Stair

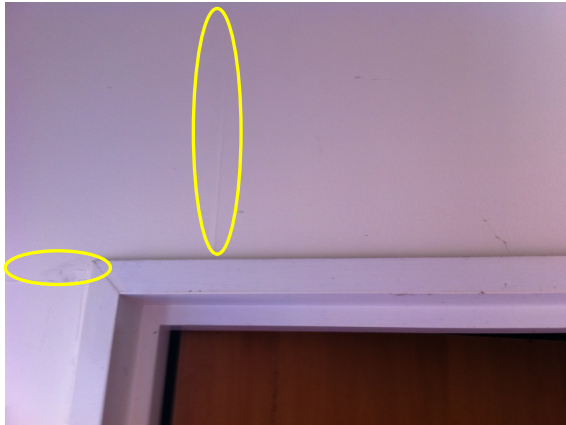
Photo 17: Close up of Photo

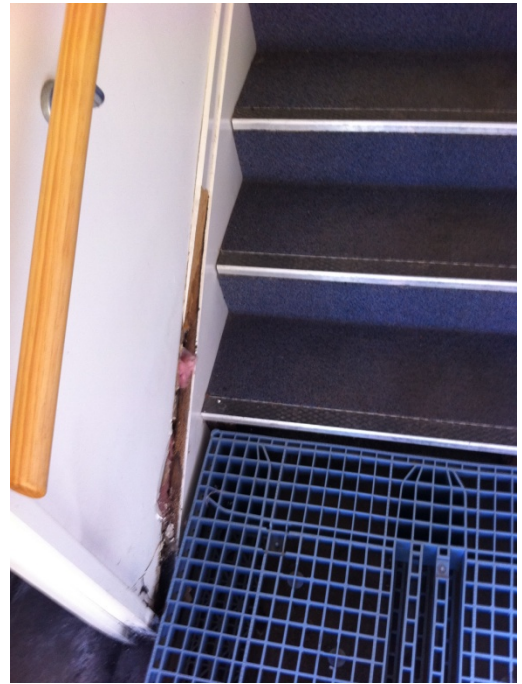
Photo 18: Damage to Timber Stair Skirting

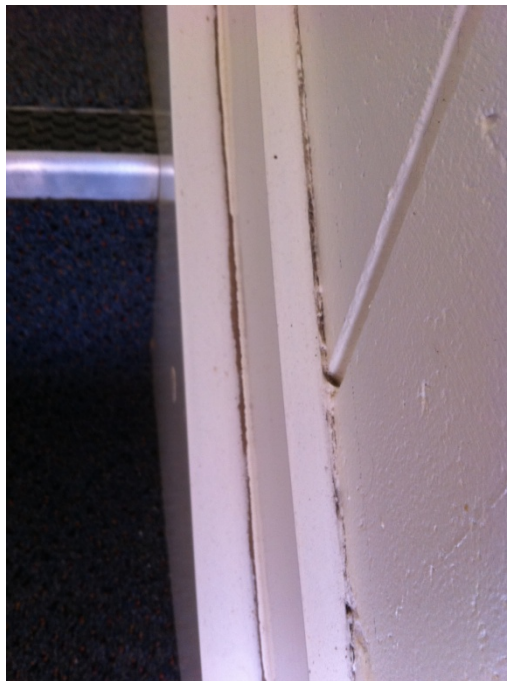
Photo 19: Cracking along Timber Stair Skirting Joints

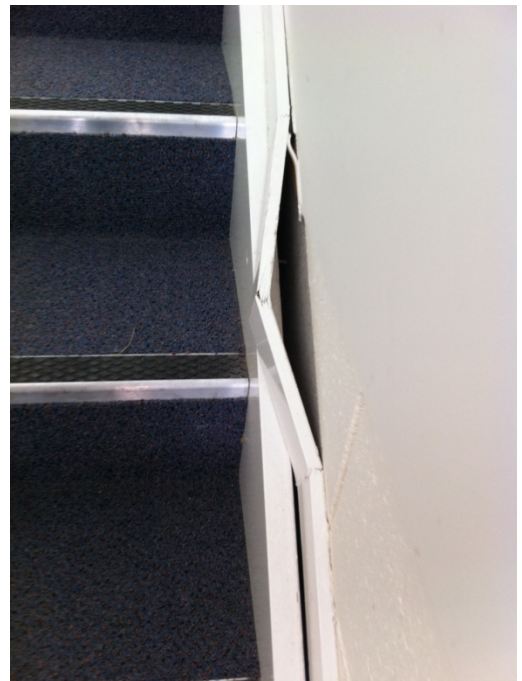
Photo 20: Damage to Timber Stair Skirting – East Wall

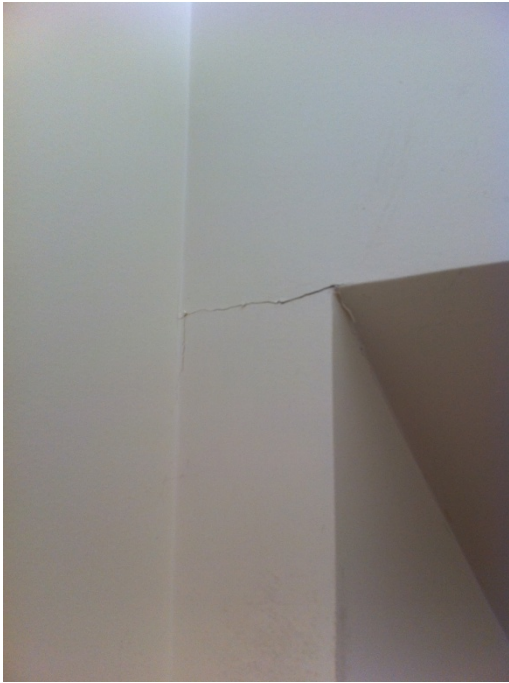
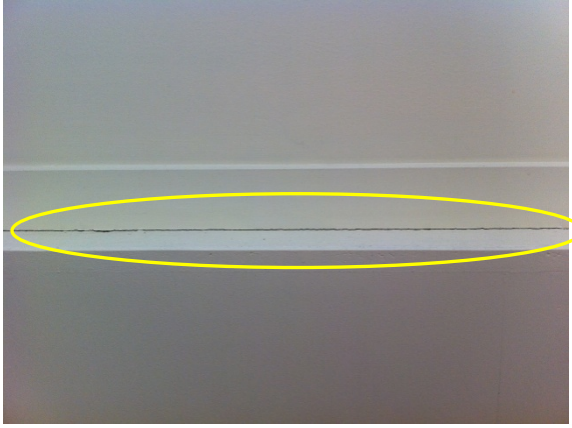
<p>Photo 21: Cracking to Wall Linings at the Top of the East Stair</p>	<p>Photo 22: Hairline Cracking along the Block Wall and Timber Infill Wall Joint</p>

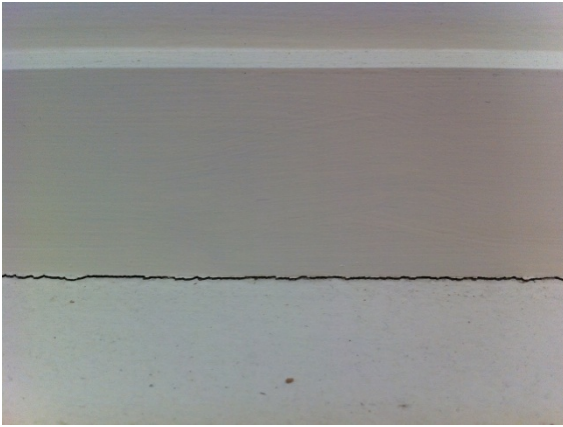
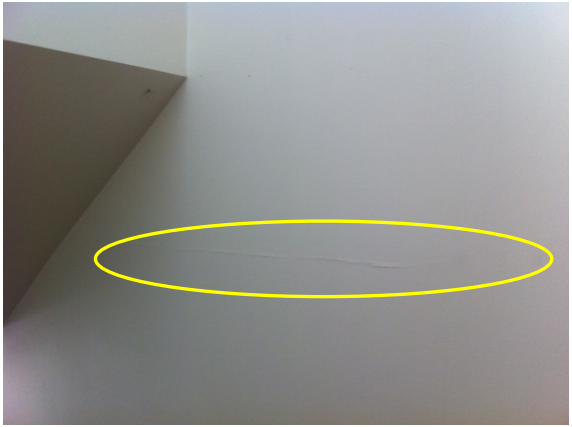
<p>Photo 23: Close up of Photo 26</p>	<p>Photo 24: Horizontal Hairline Crack at Wall Lining Joint at the Top of the East Stair – West Wall</p>

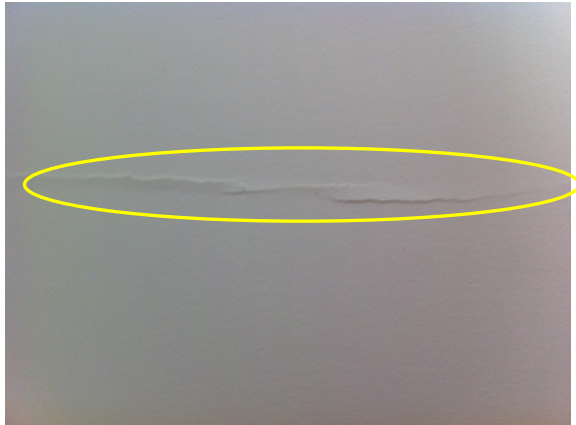
Photo 25: Close up of Photo 27

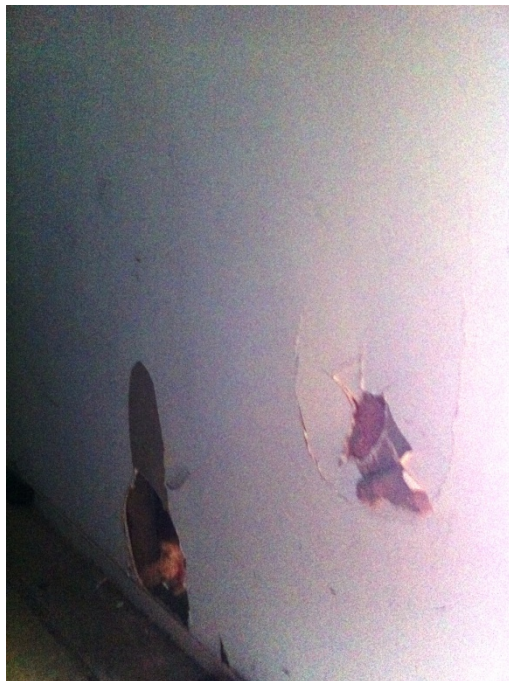
- Damage present to the wall lining on the east wall. This damage appears to be caused by impact forces and therefore is not earthquake related (PHOTO 27).
- Vertical hairline crack present in the wall lining above the personnel door on the east wall (PHOTO 28).
- Horizontal crack present in wall lining in the south-east corner (PHOTO 29).

Photo 27: Damage to East Wall of Garage – Not EQ Damage

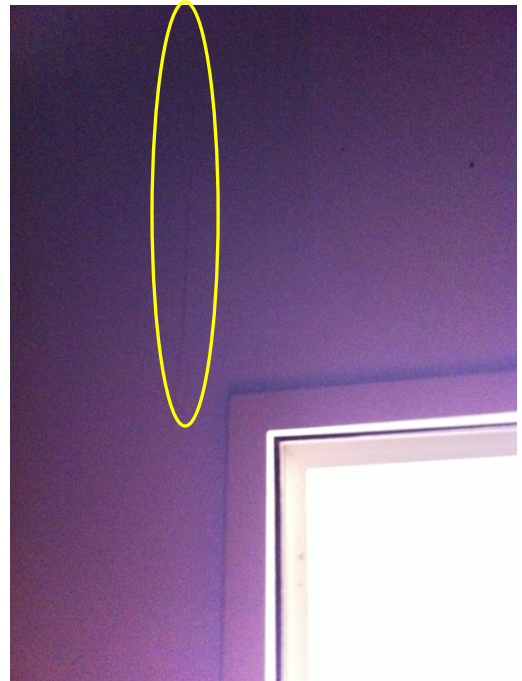
Photo 28: Vertical Hairline Crack above Personnel Door on the East Wall of Garage

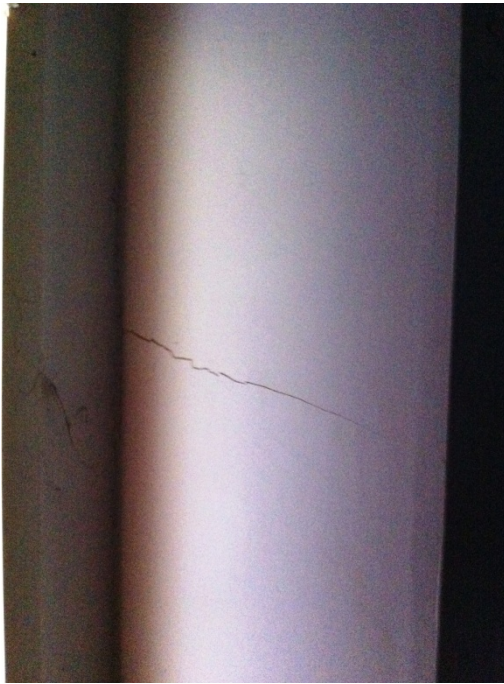
Photo 29: Cracking to Wall Lining in the SE Corner of the Garage

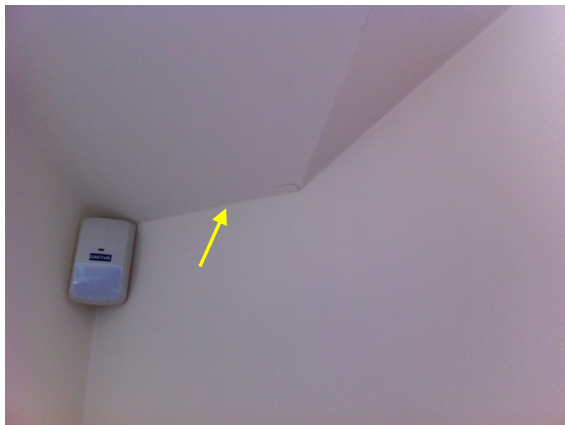
- Main Room: - Cracking present between the wall lining and ceiling lining joint in the south-east corner (PHOTO 31).
- Main Room: - Hairline cracking present between the full height window architrave and the wall lining joint (window located on the north wall) (PHOTO 32 & 33).
- Southern Office: - Hairline cracking in wall lining above south corner of doorway.

Photo 31: Cracking Between Wall Lining and Ceiling Lining Joint

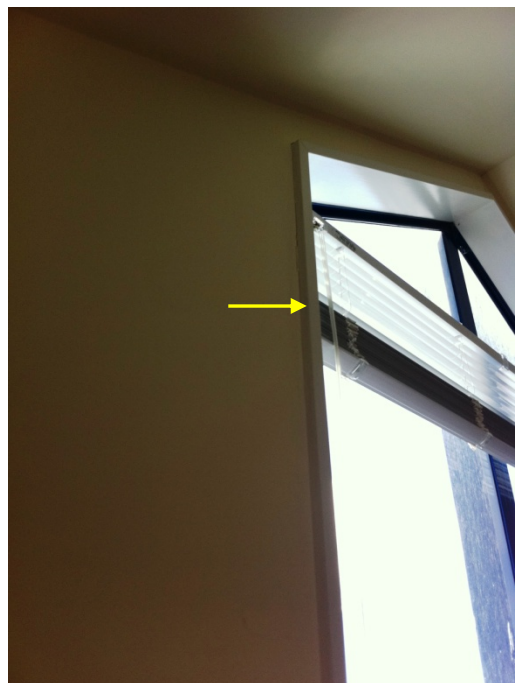
Photo 32: Hairline Cracking Between the Window Architrave and the Wall Lining Joint

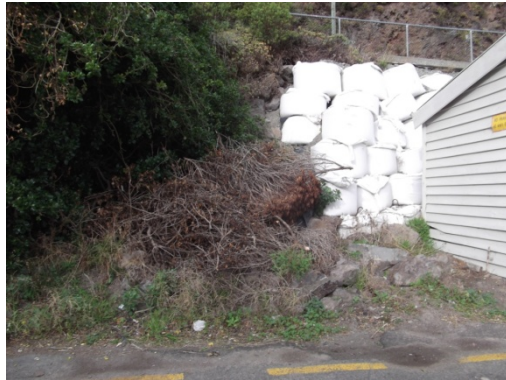
Photo 3 – Sand bags supporting dry stacked boulder wall that collapsed behind historic boat shed. Wall to right is still standing.

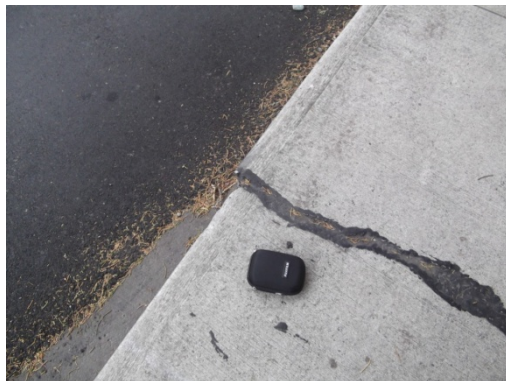
The road above at hairpin looks to have moved approximately 15mm (see Appendix B, Photos 5 and 6) northwest as shown by the crack in the footpath. This is likely to be related to movement of fill or damage of underground services and not an indication of large scale rock movement.

Photo 5 – 15mm offset in footpath due to movement of the cantilevered road section.

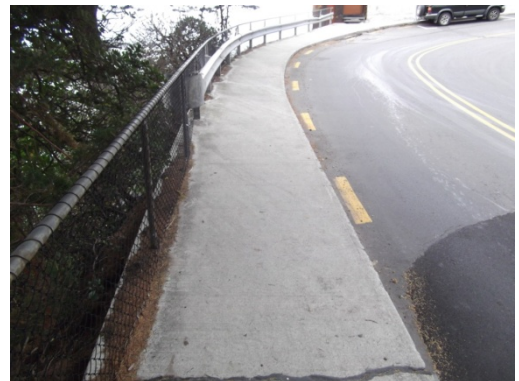
Photo 6 – Section of road which has moved approximately 15mm (looking north).
