Seafield Park – Barntype Shed
Qualitative Engineering Evaluation

Reference: 230550
Prepared for:
Christchurch City Council

Functional Location ID: PRK 0138 BLDG 009

Date: 2 July 2013

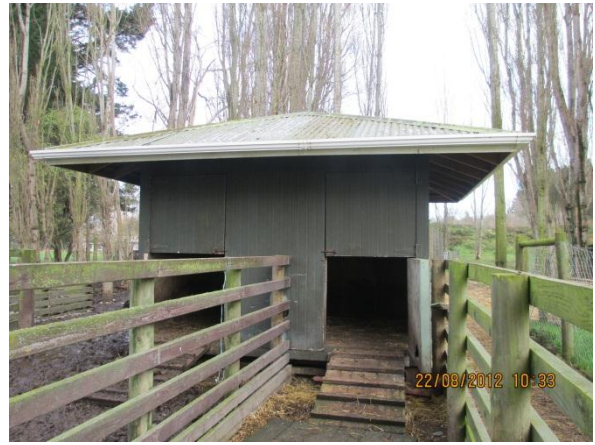
Northeast view of the building.

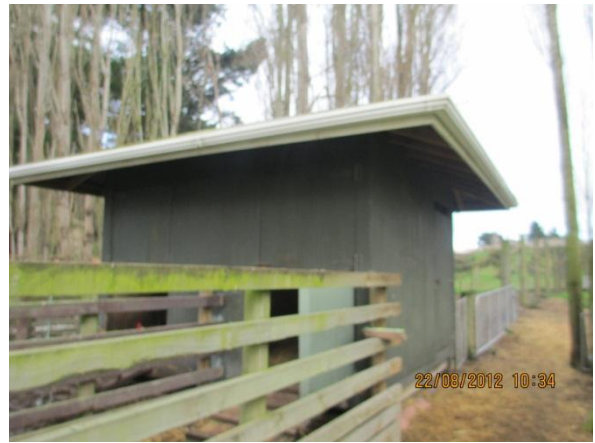
Southeast view of the building.
