Seafield Park – Main Stores Shed
Qualitative Engineering Evaluation

Reference: 230546
Prepared for:
Christchurch City Council

Functional Location ID: PRK 0138 BLDG 005 EQ2

Date: 16 October 2012

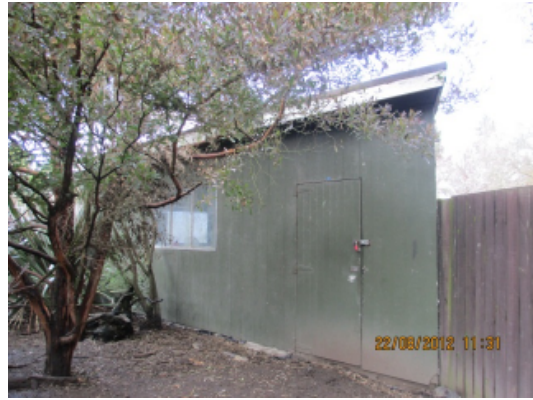
Southwest view of the building.

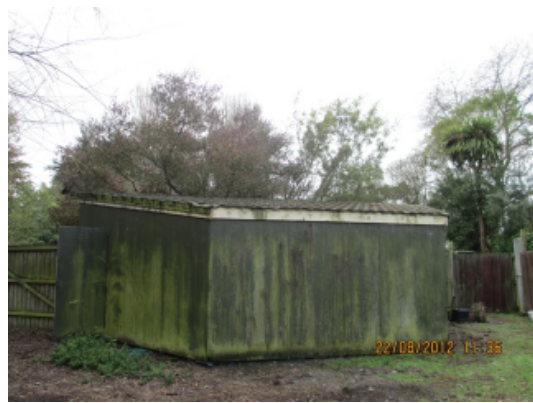
Southeast view of the building.

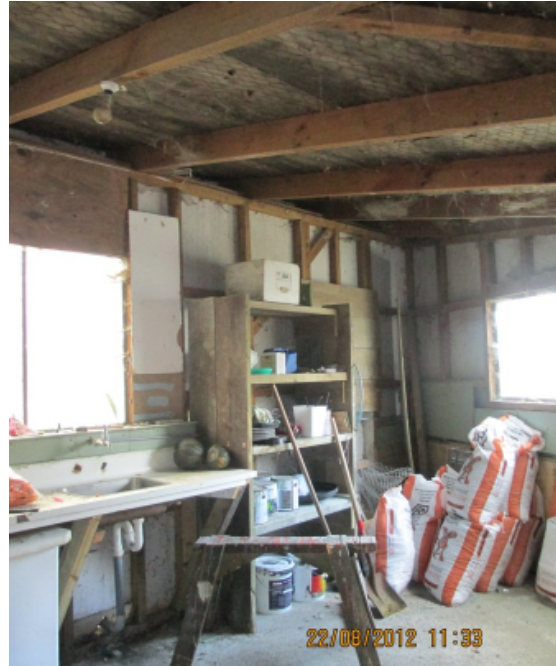
Internal view of the southwest wall.
