Seafield Park – Multi-Aviary  
Building  
Qualitative Engineering Evaluation

**Reference:** 230552  
**Prepared for:**  
Christchurch City Council

Functional Location ID: PRK 0138 BLDG 011

**Date:** 2 July 2013

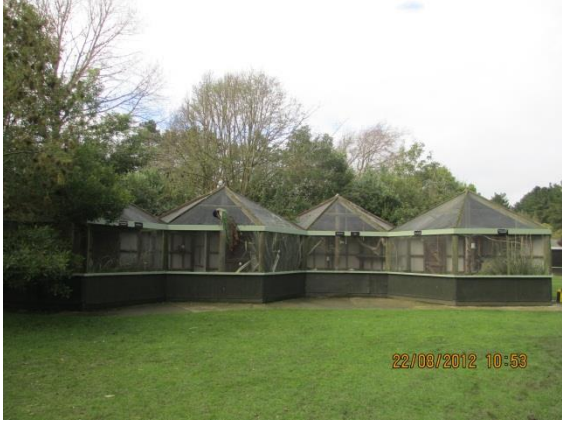
<p>Southern end of the building.</p> <p>west side of the building has concrete floor slab on grade</p>

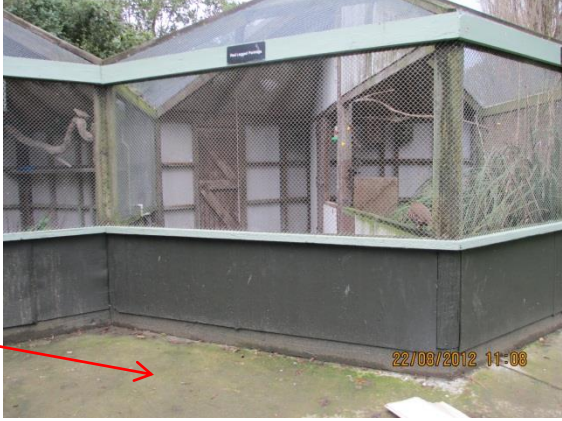
<p>Back view of the last aviary on the southern end of the building.</p> <p>east side of the building sits directly on the ground</p>

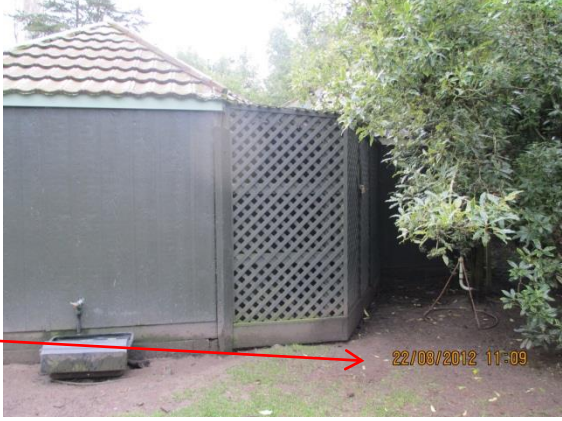
<p>Back view of the first two aviaries on the northern end of the building.</p>

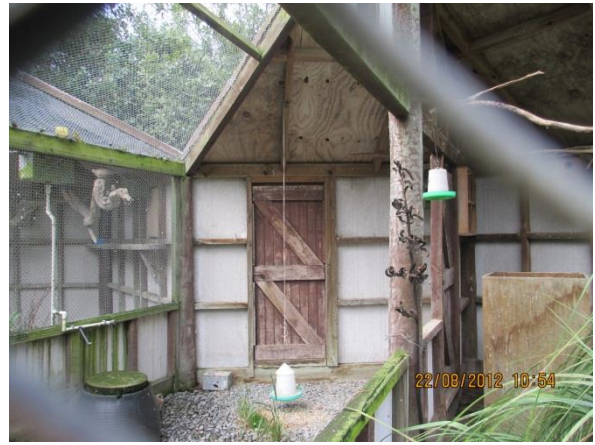
Internal view of one of the aviaries.
