Sheldon Park - Cricket Shed  
Qualitative Engineering Evaluation

**Reference:** 229622  
**Prepared for:**  
Christchurch City Council

**Date:** 11 October 2013

14 September 2012 – Sheldon Park - Cricket Shed Site Photographs

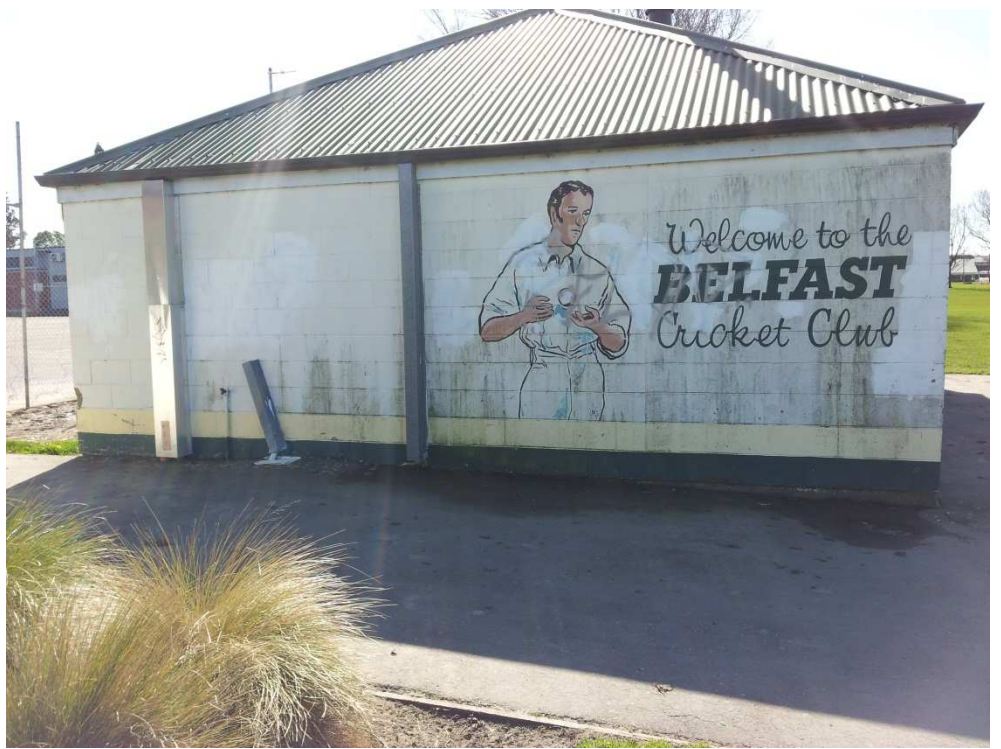
Building southern elevation.

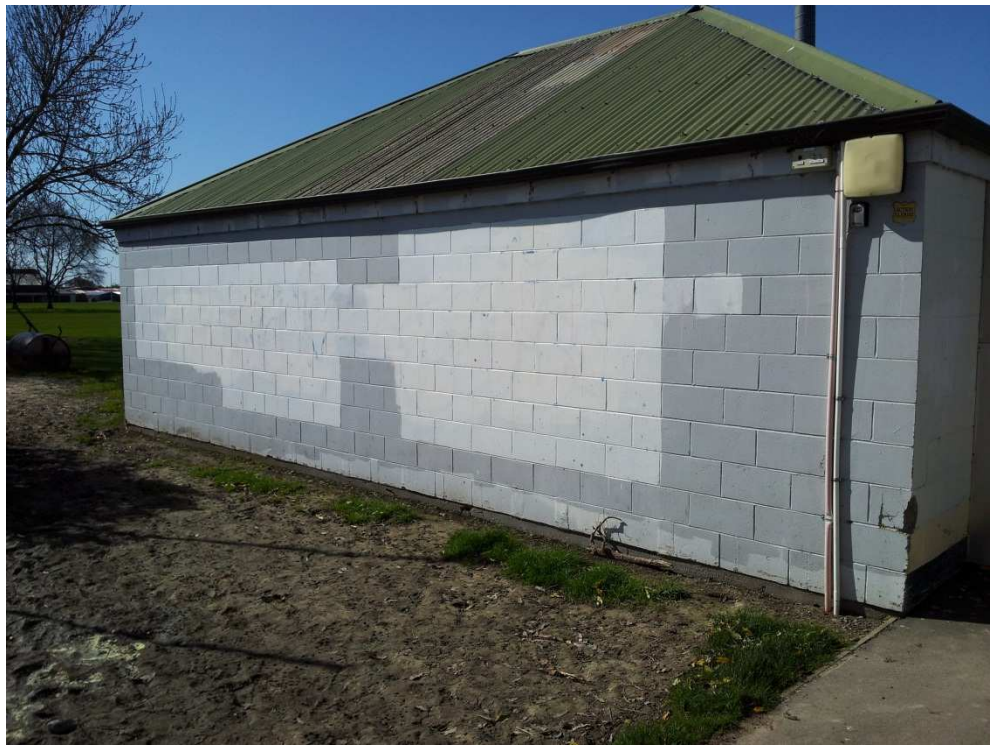
Building western elevation.

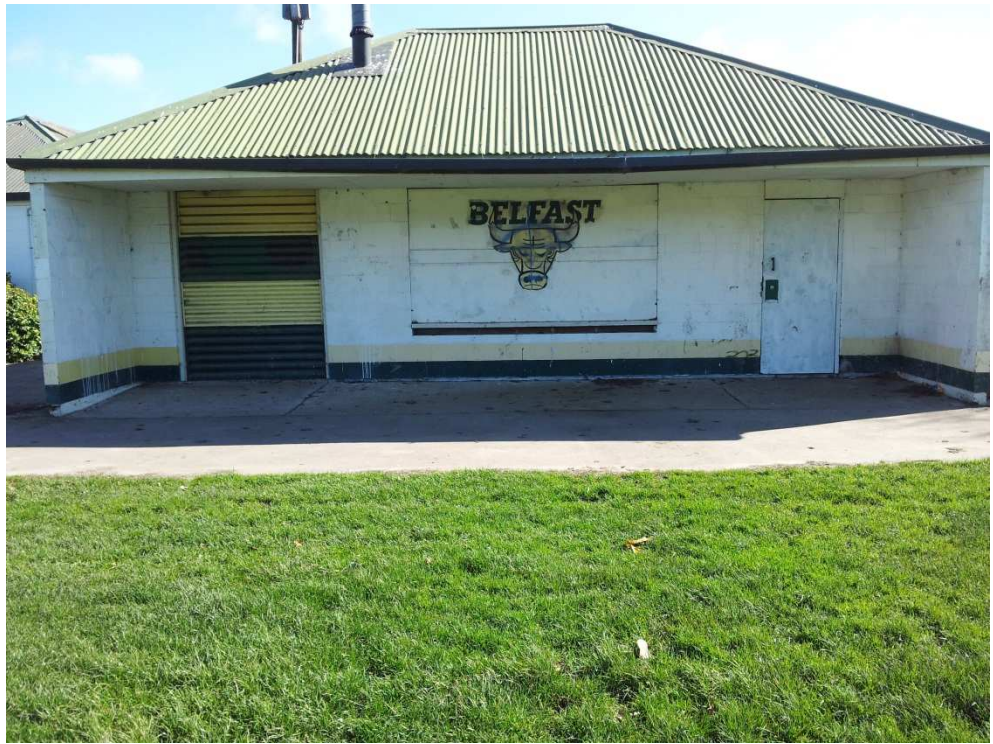
Building eastern elevation.

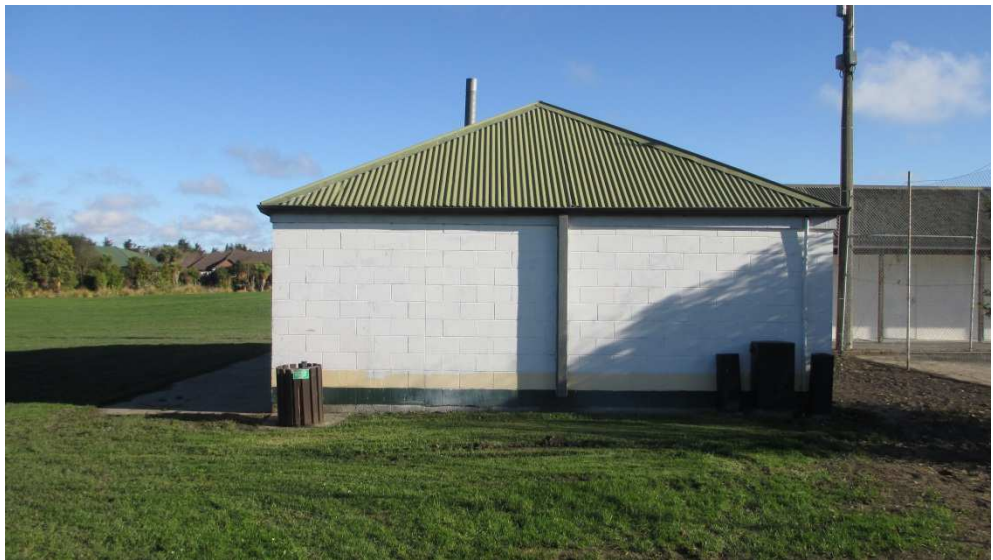
Building northern elevation.

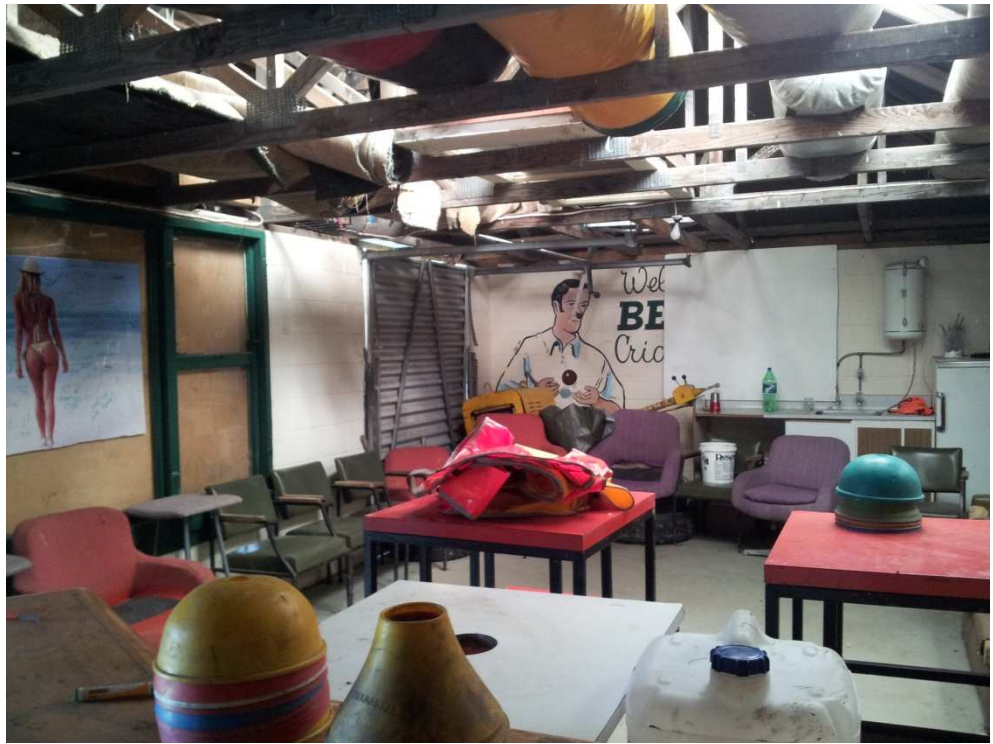
Internal view.

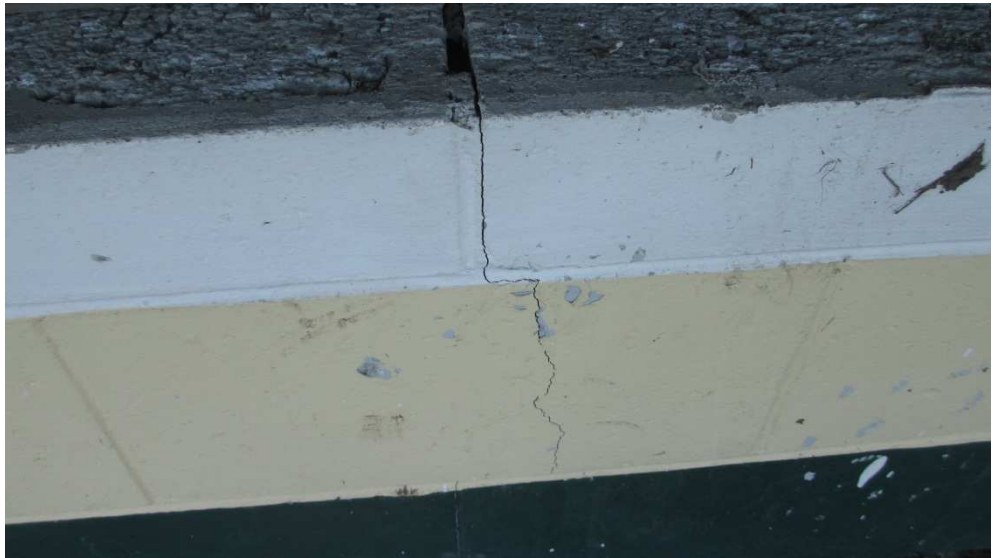
The Sheldon Park - Cricket Shed is currently in use and was occupied at the time the damage assessment was carried out. The Sheldon Park - Cricket Shed has performed well but has suffered damage to the walls consisting of several minor cracks running along the mortar and through the blockwork. Some spalling is evident on one of the blocks.

Cracking to blockwork.

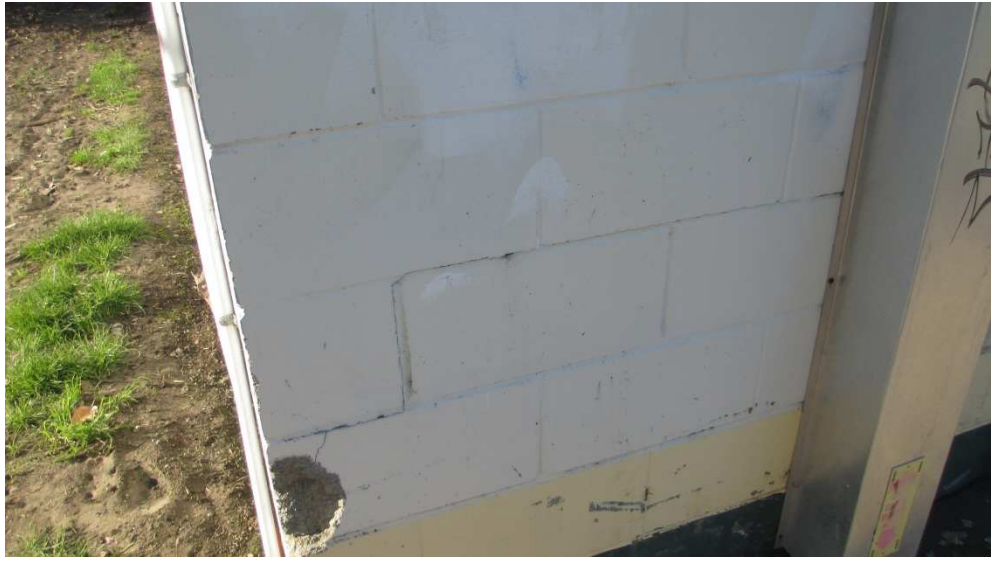
Spalling of  
blockwork.

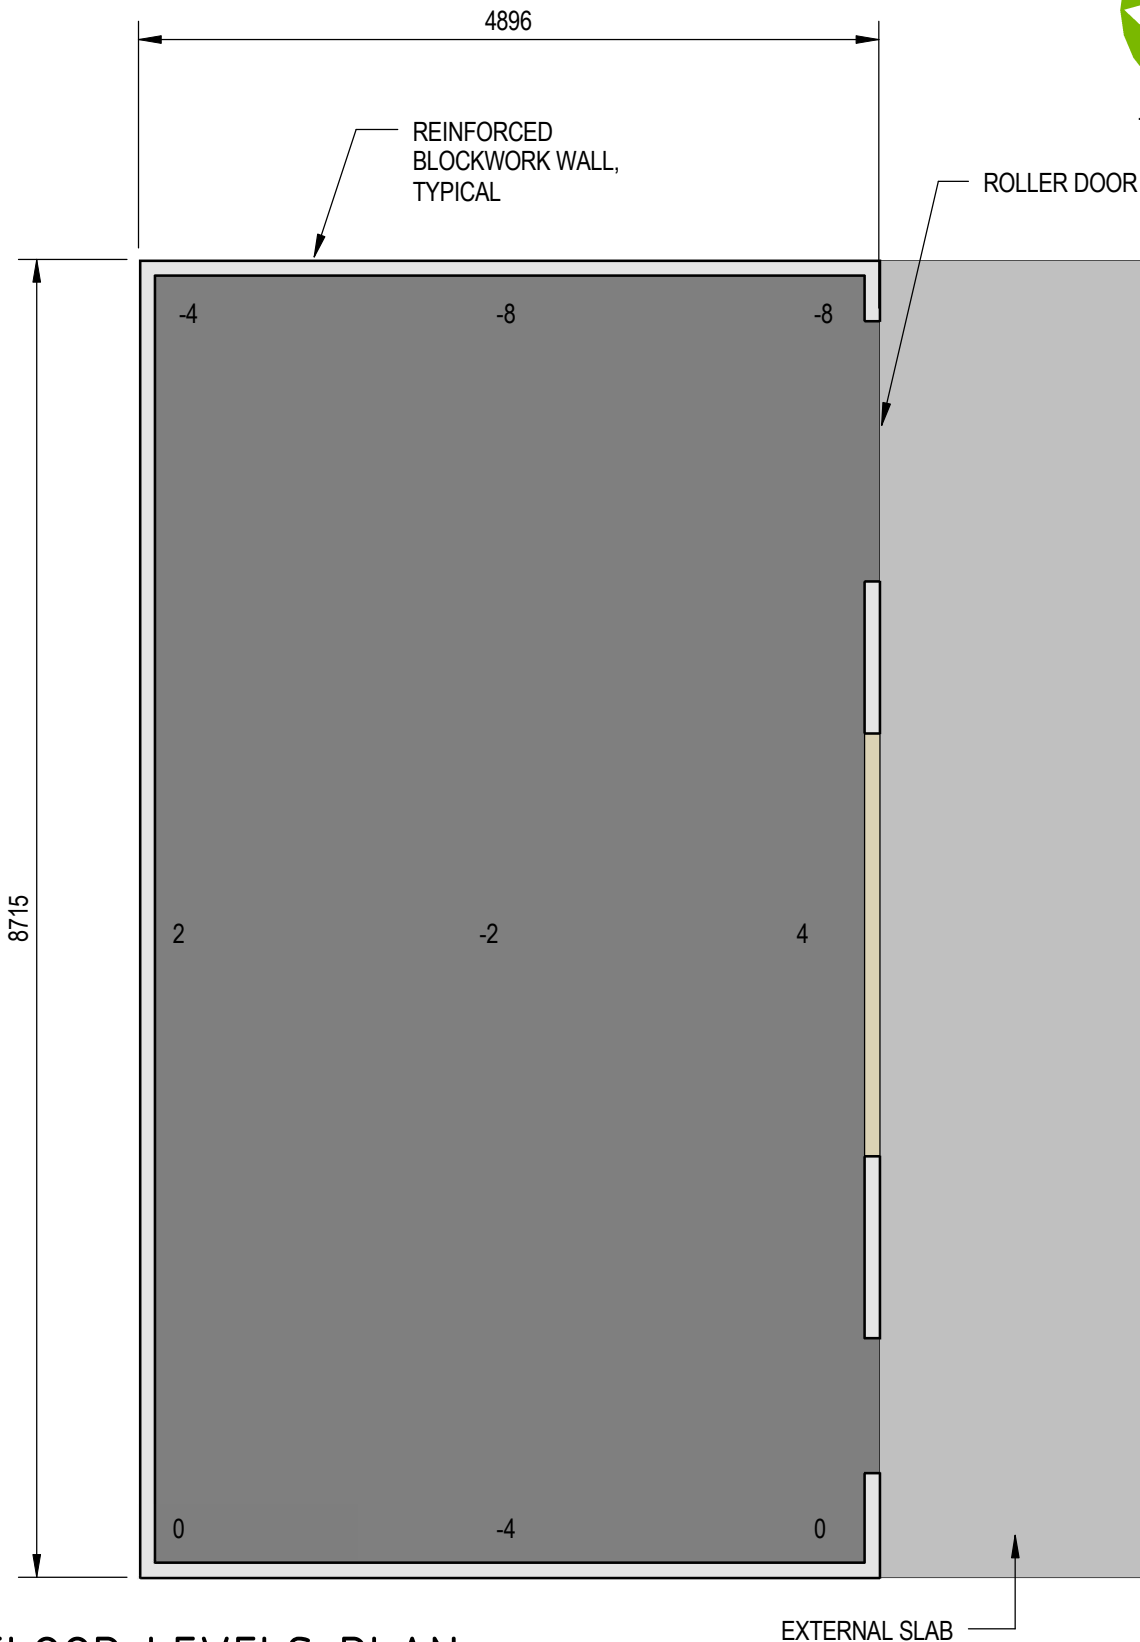
# FLOOR LEVELS PLAN

A floor level survey was undertaken to establish the level of unevenness across the floors. The results of the survey are presented on the attached sketch in Appendix A. All of the levels were taken on top of the existing floor coverings which may have introduced some margin of error.

The floor levels for the Sheldon Park - Cricket Shed were found to be within the recommended tolerances.
