**Sheldon Park Changing  
Sheds and Toilets  
PRK 0370 BLDG 003 EQ2**

**Detailed Engineering Evaluation**

**Quantitative Assessment Report**

Date: November 2012  
Reference: 6-QUCC1.47  
Status: Final

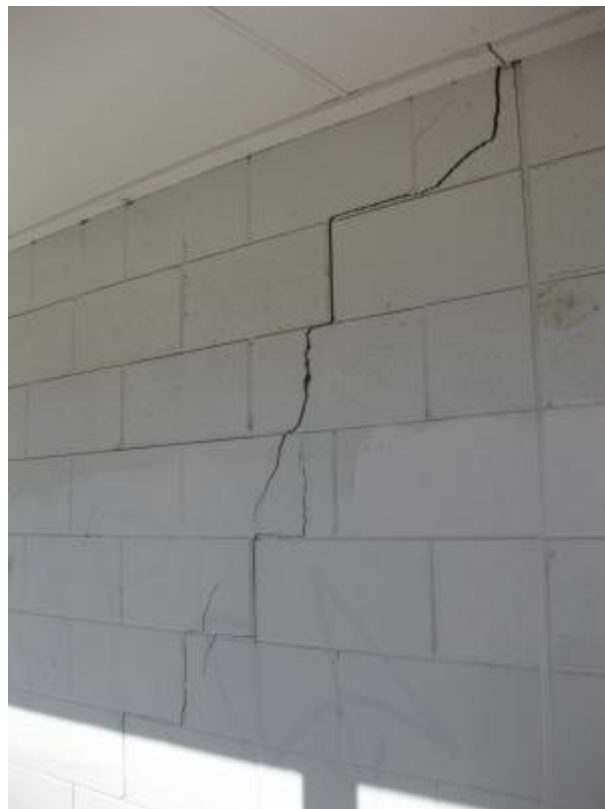
There are moderate wall cracks and opening up of the wall joints in both the front and rear external walls at the joints created by the extensions to the building. The opening of the joint is wider at the top indicating that differential foundation settlement has occurred at the ends of the building.

The masonry walls and foundations of the extensions are likely connected to the original building with steel dowels. Building rotation due to foundation settlement and bonding of the dowels is the likely cause of the cracking adjacent these joints. The cracking and opening of the joint has not significantly affected the wall strength and only minor repairs are required.

**Photo 6: Crack in the front wall**

- (a) Remedial repair work to cracked wall and open wall joints.
- (b) Strengthening works be undertaken to increase the seismic capacity of the building to at least 67%NBS.

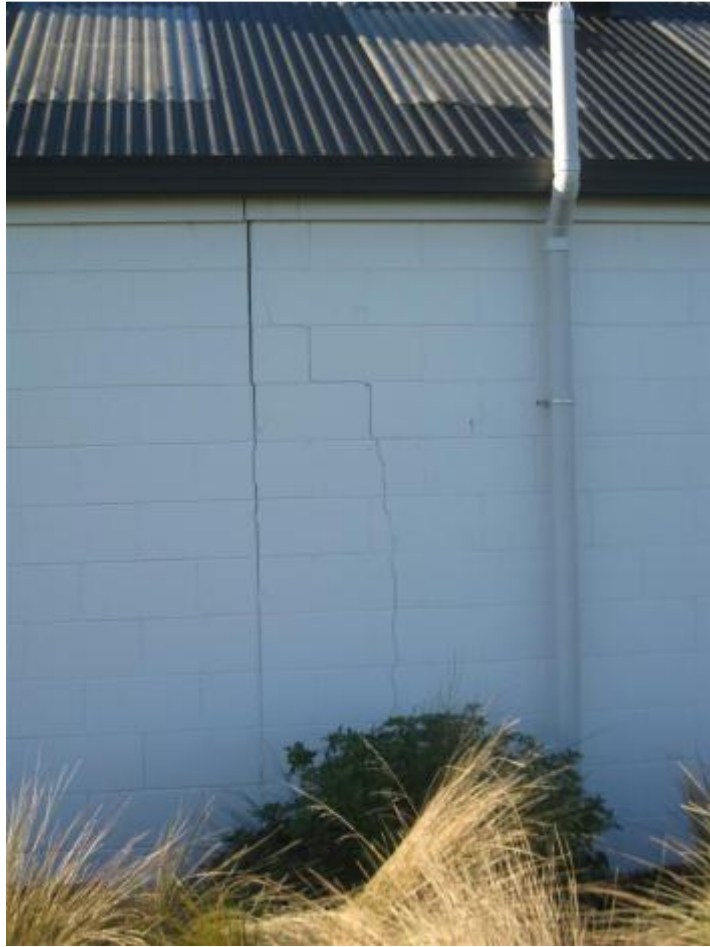
**Photo 7: Crack in the rear wall**

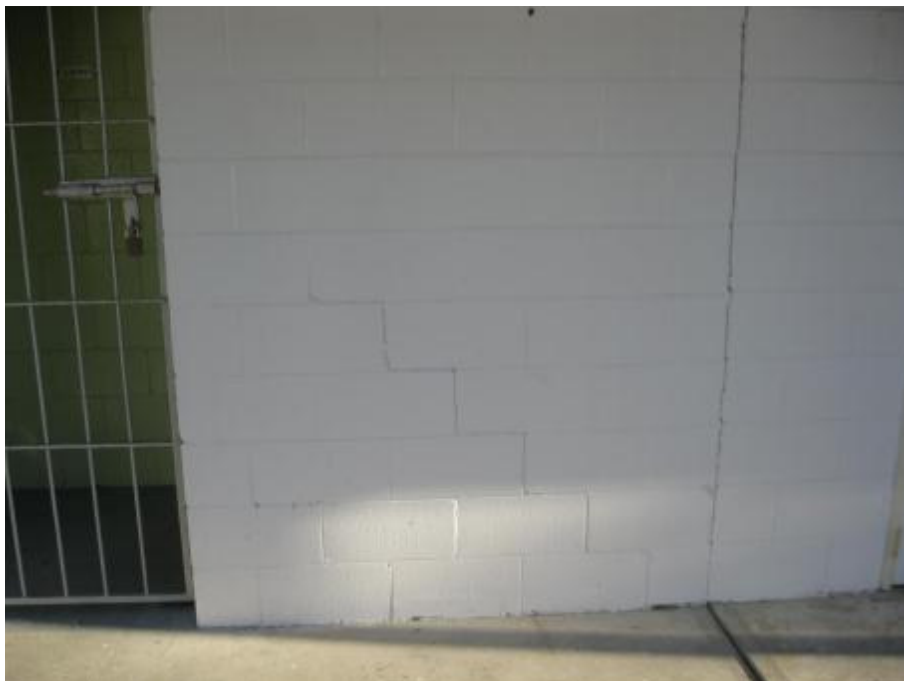
**Photo 8: Diagonal crack in the front wall**

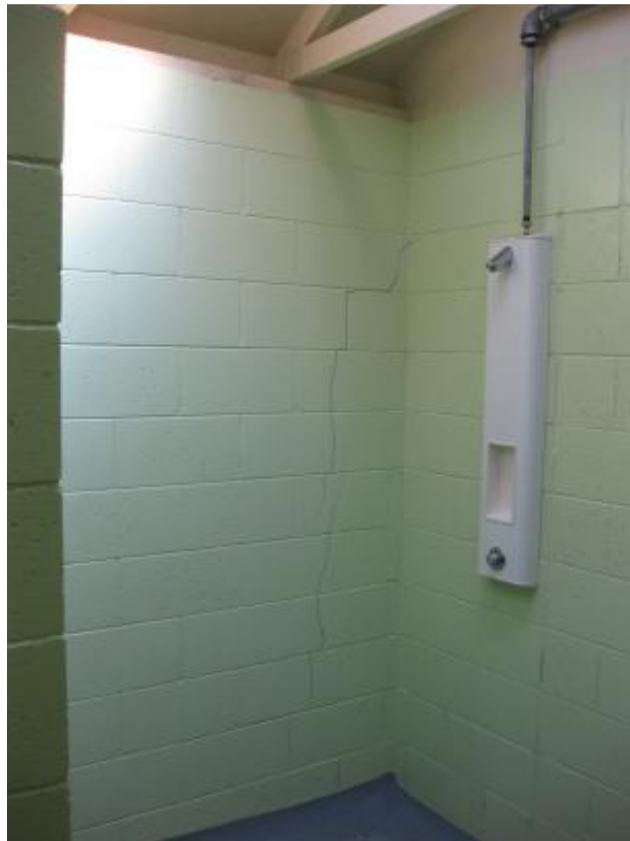
**Photo 10: Diagonal crack in the back side wall from inside**
