**Sign of the Kiwi - Toilet Block**  
**PRK 1823 BLDG 004**  
Detailed Engineering Evaluation  
Quantitative Report  
Version FINAL

561 Dyers Pass Road

Christchurch City Council

**Date**  
22<sup>nd</sup> May 2013

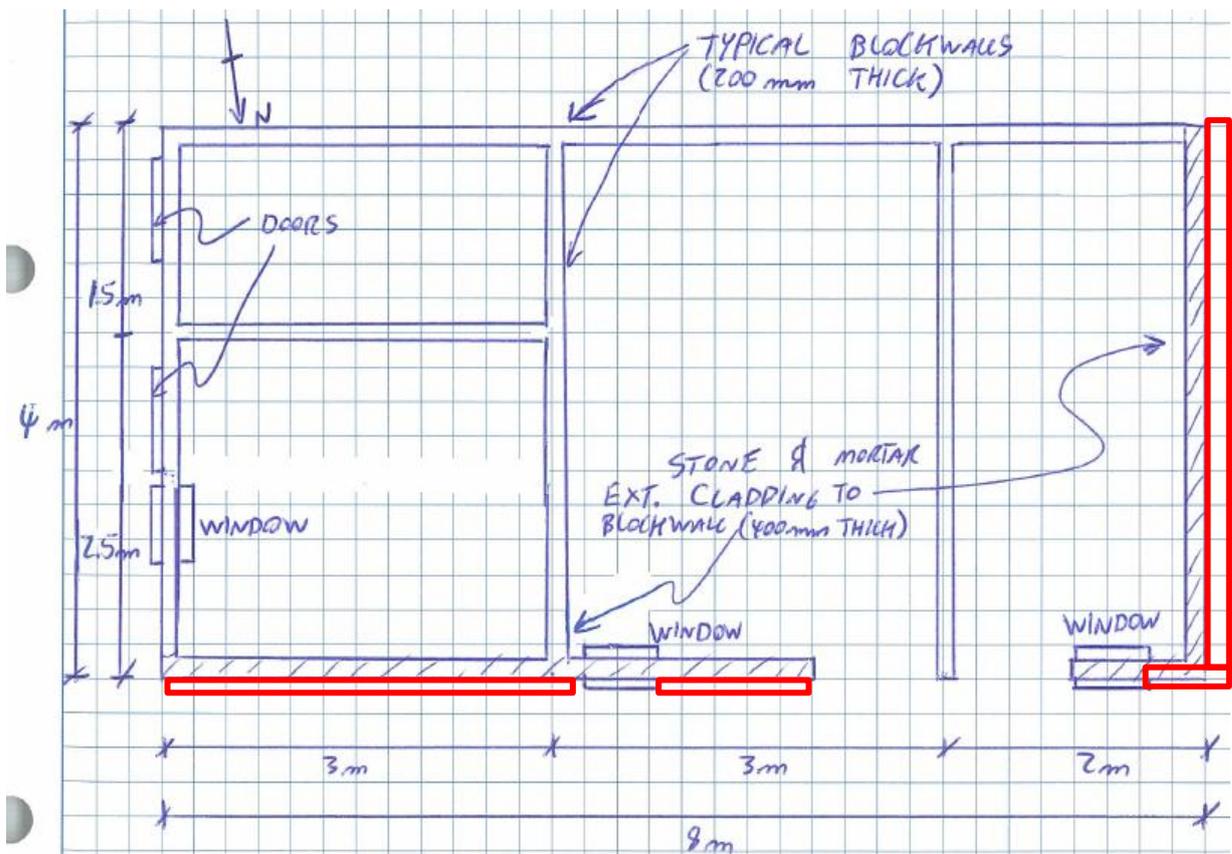
Figure 2 Plan Sketch Showing Key Structural Elements

Due to the plasterboard ceiling the roofs interior was unable to be observed; it is assumed timber trusses brace the roof structure and form a connection with the top of the concrete masonry block walls. The roof is clad with corrugated steel cladding.

All of the walls are load bearing 200 series concrete masonry block. All internal walls are lined with plasterboard. Externally, the northern and western facing block walls are clad with 200mm thick heavyweight stone and mortar to the external face. The southern and eastern block walls are clad with fibre cement sheeting.

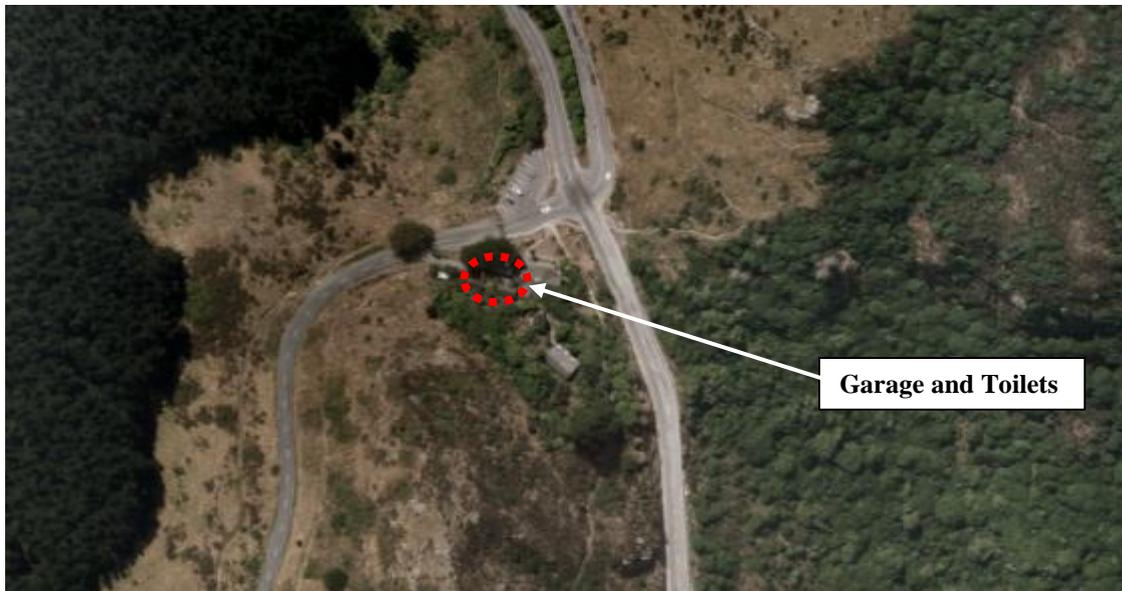
**Figure 3 Post February 2011 Earthquake Aerial Photography**<sup>2</sup>

Aerial photography taken following the 22 February 2011 earthquake shows no signs of liquefaction outside the building footprint or adjacent to the site, as shown in Figure 3.

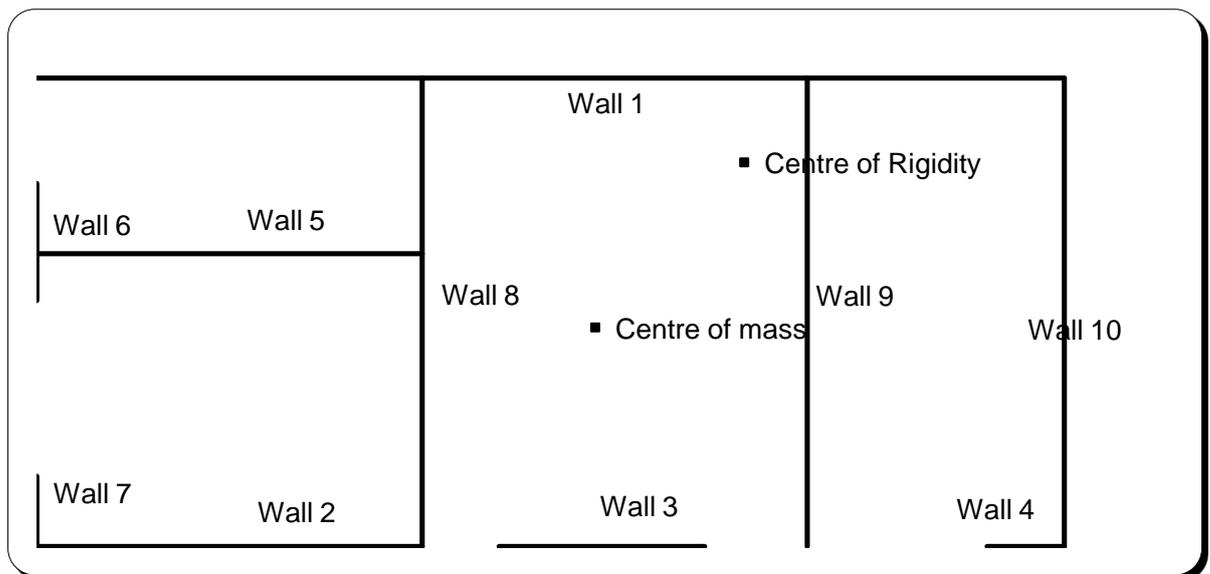
**Figure 4 Plan Details and Wall Locations**

The position of each wall is indicated in the plans below and each wall is named accordingly.

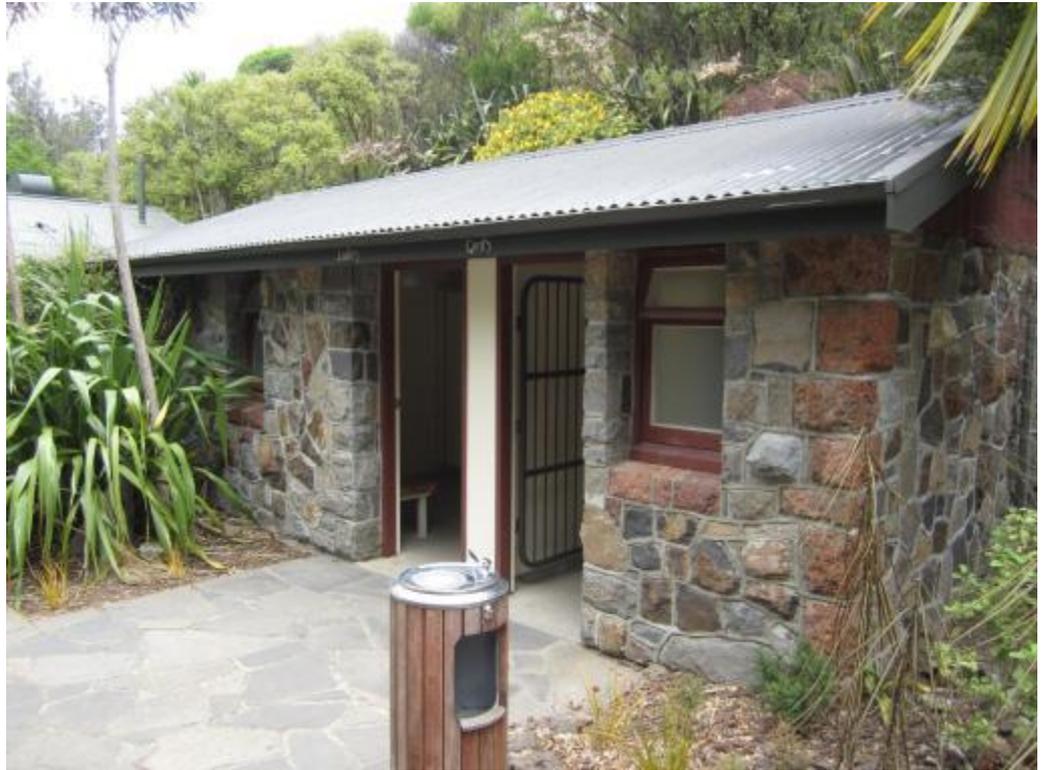
**Photograph 1 North elevation.**

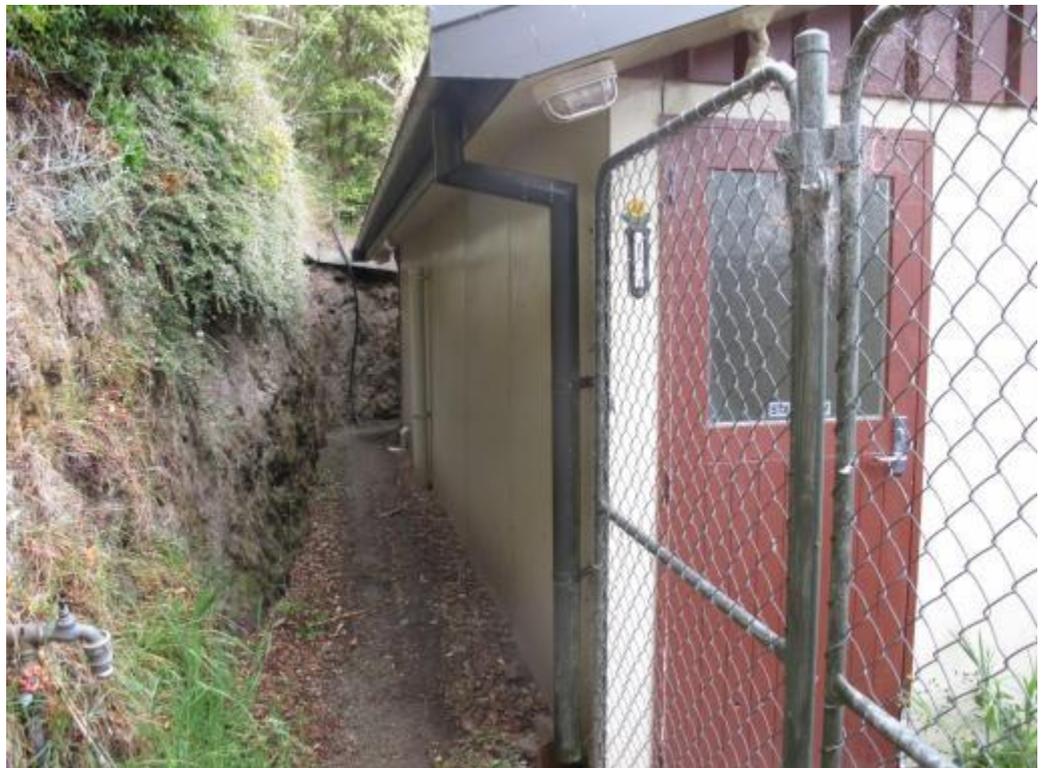
**Photograph 2 View of the toilet block from the south east.**

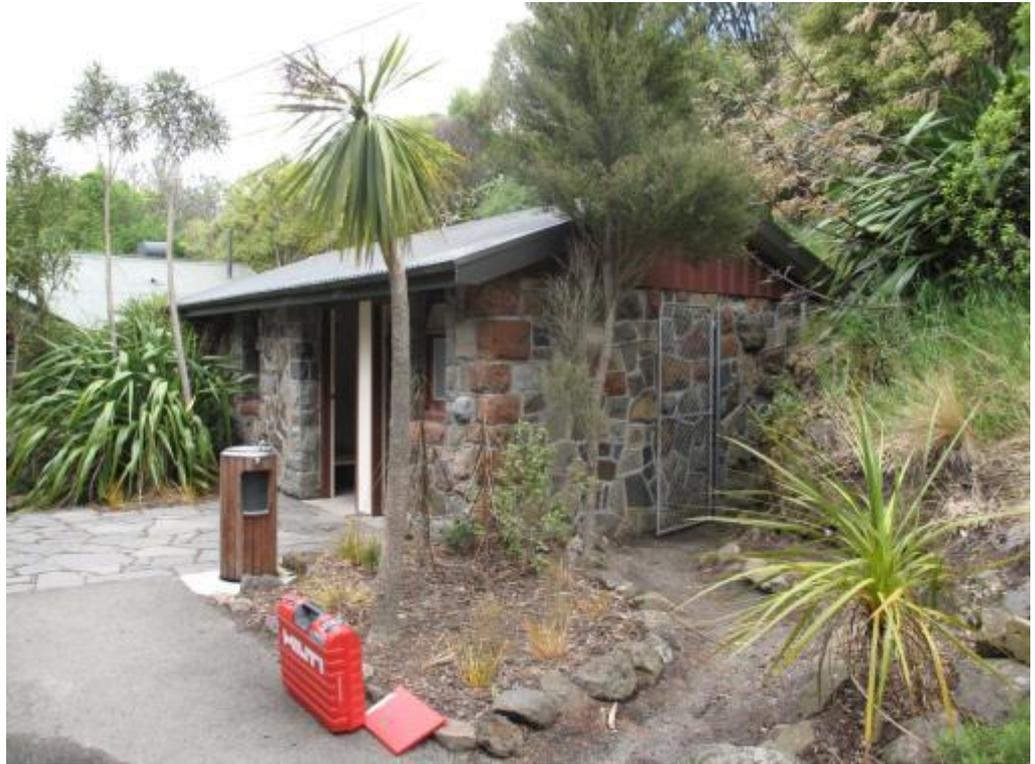
**Photograph 3 View of the toilet block from the west.**

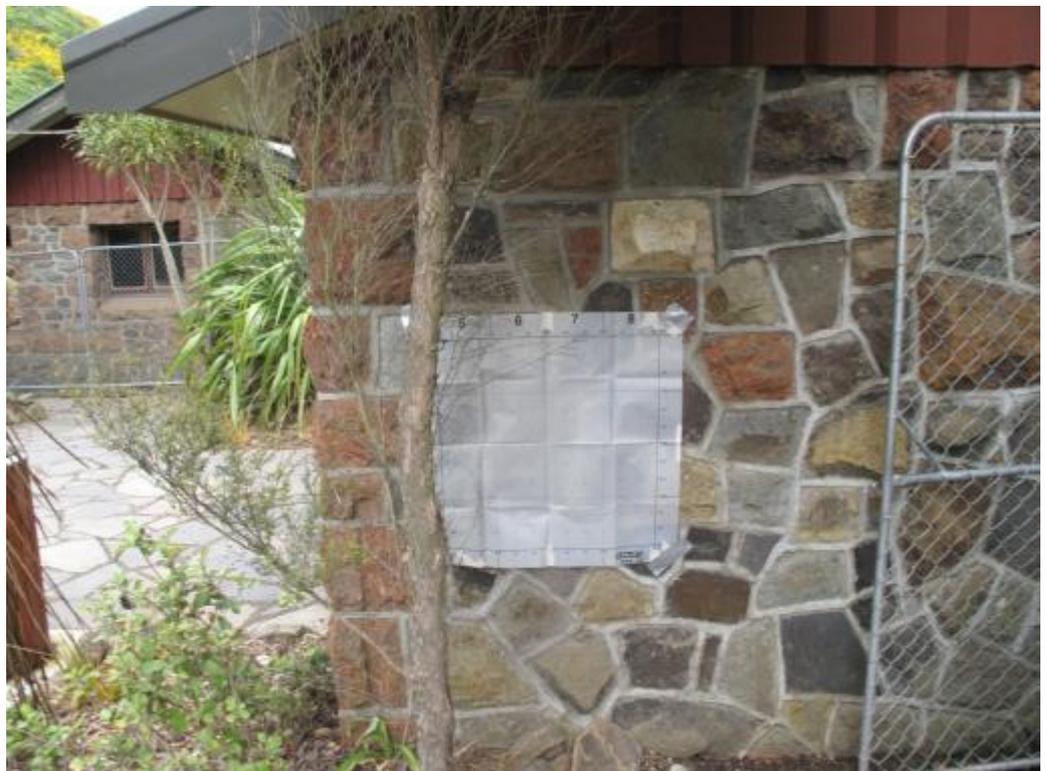
Electromagnetic scans have been carried out on site to ascertain the extent of the reinforcement in the masonry walls.

**Photograph 4 One of the two areas where wall reinforcement was checked.**

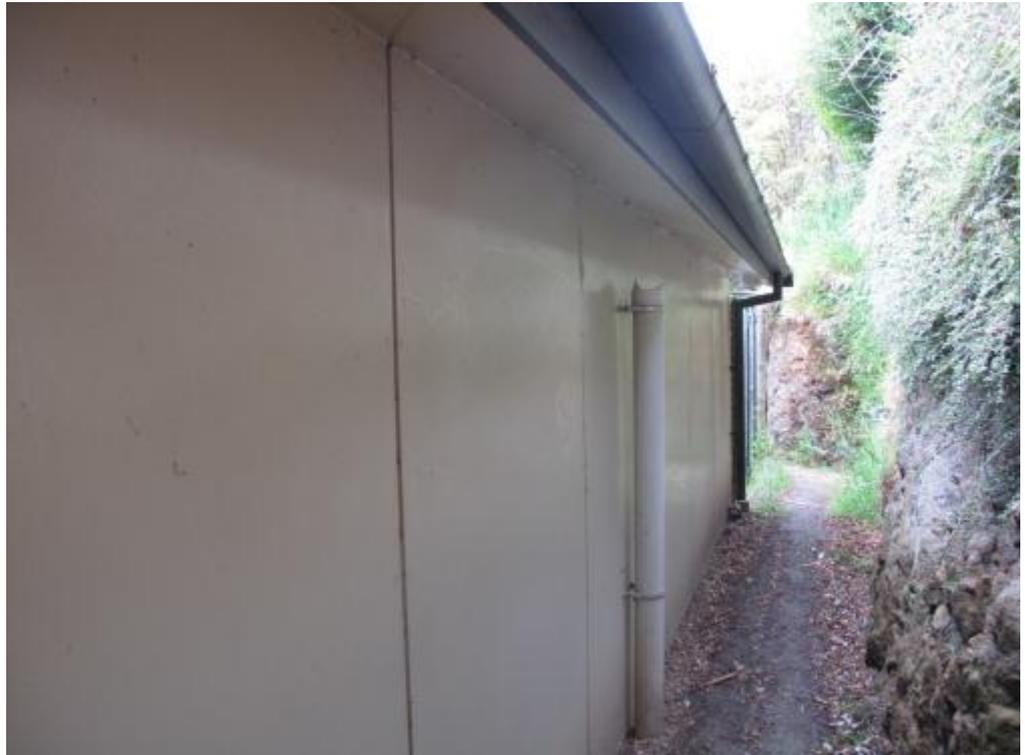
**Photograph 5 Southern side of block does not have stone and mortar veneer.**

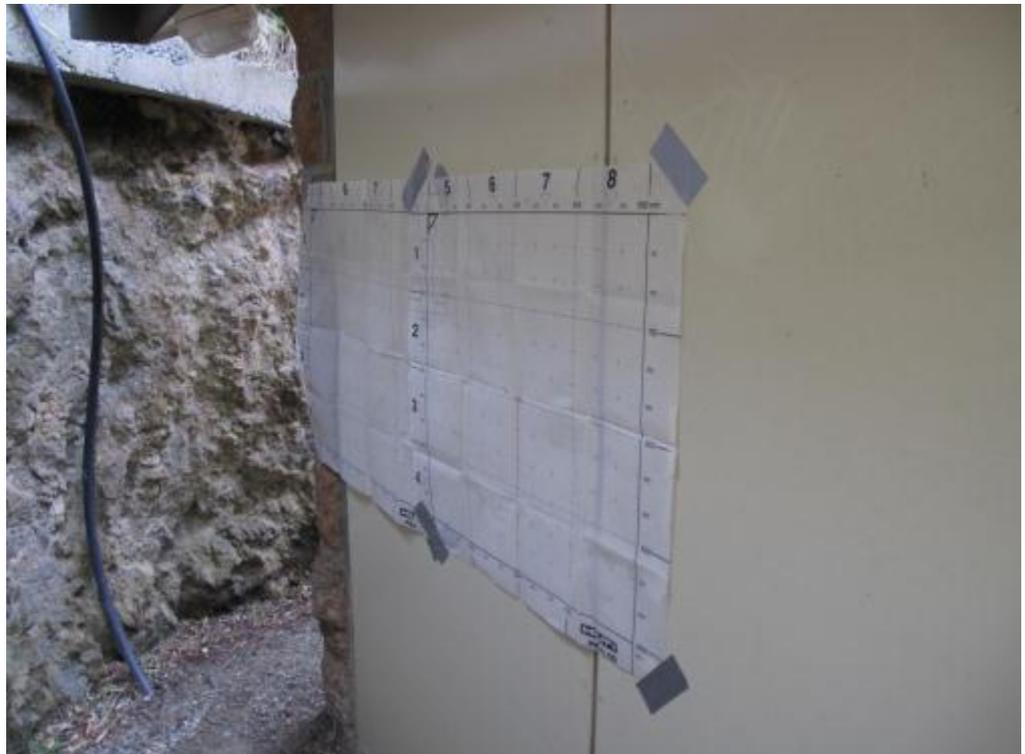
**Photograph 6 Area on south side of building where reinforcement was checked.**

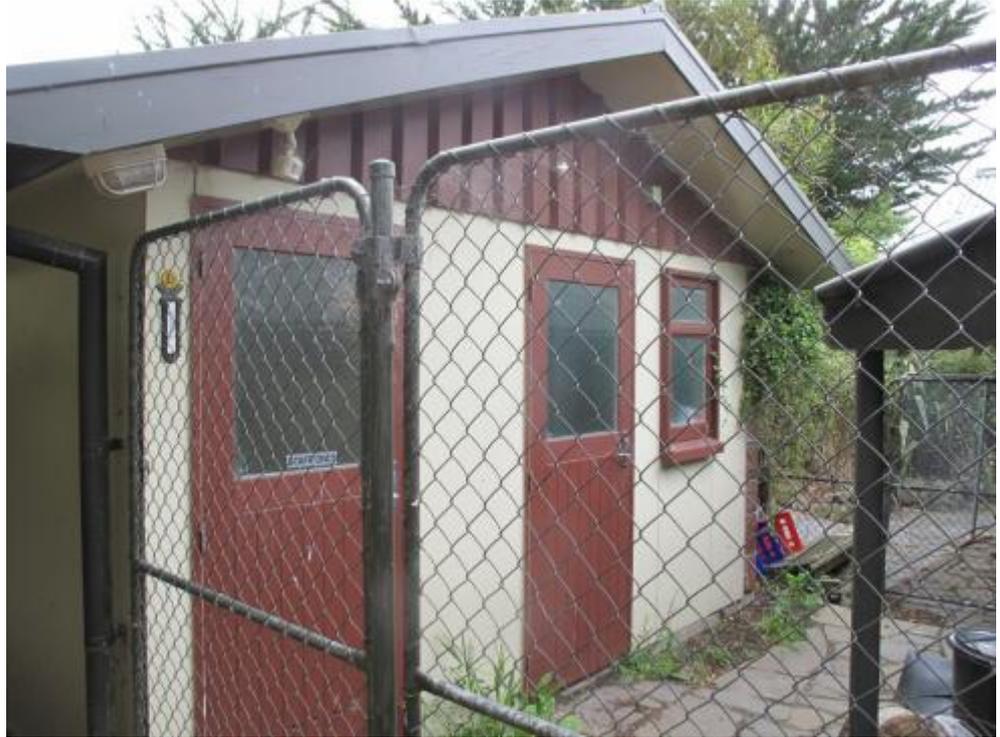
**Photograph 7 Rooms on the eastern end of the building were not accessible.**

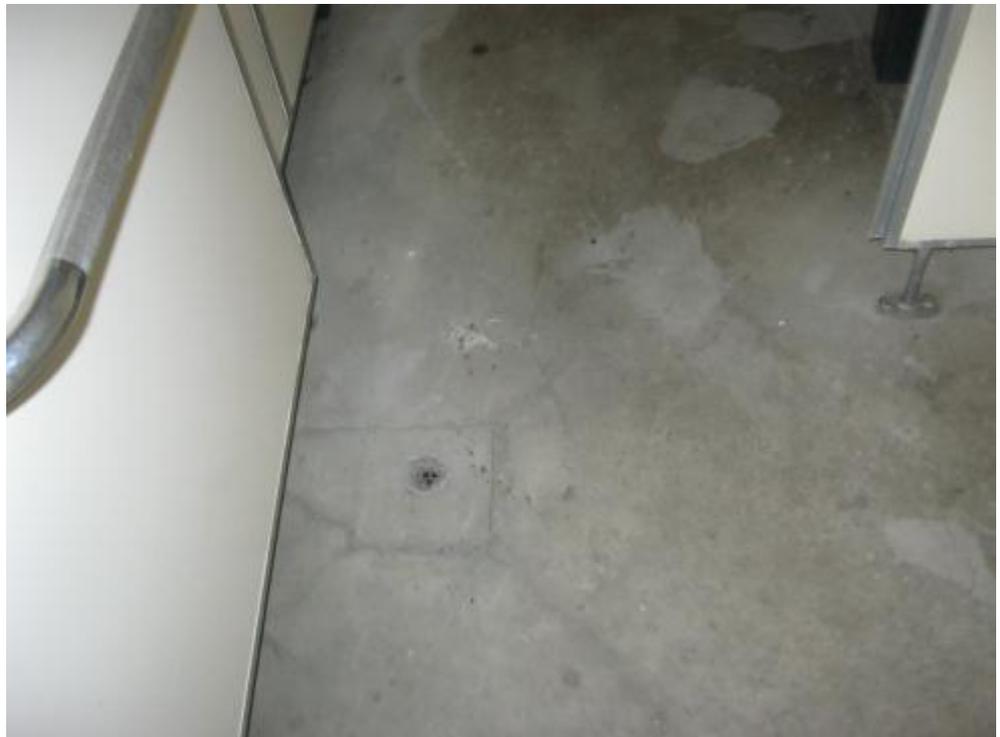
Minor cracks were visible in the slab on grade floors, but do not appear to be significant (See photograph 8).

**Photograph 8 Minor cracking in the concrete slab on grade floor.**

Along	Damage ratio: <input type="text"/>	0%	Describe how damage ratio arrived at: <input type="text"/>
	Describe (summary):	Cracking in floor slab	
Across	Damage ratio: <input type="text"/>	0%	
	Describe (summary):	Cracking in floor slab

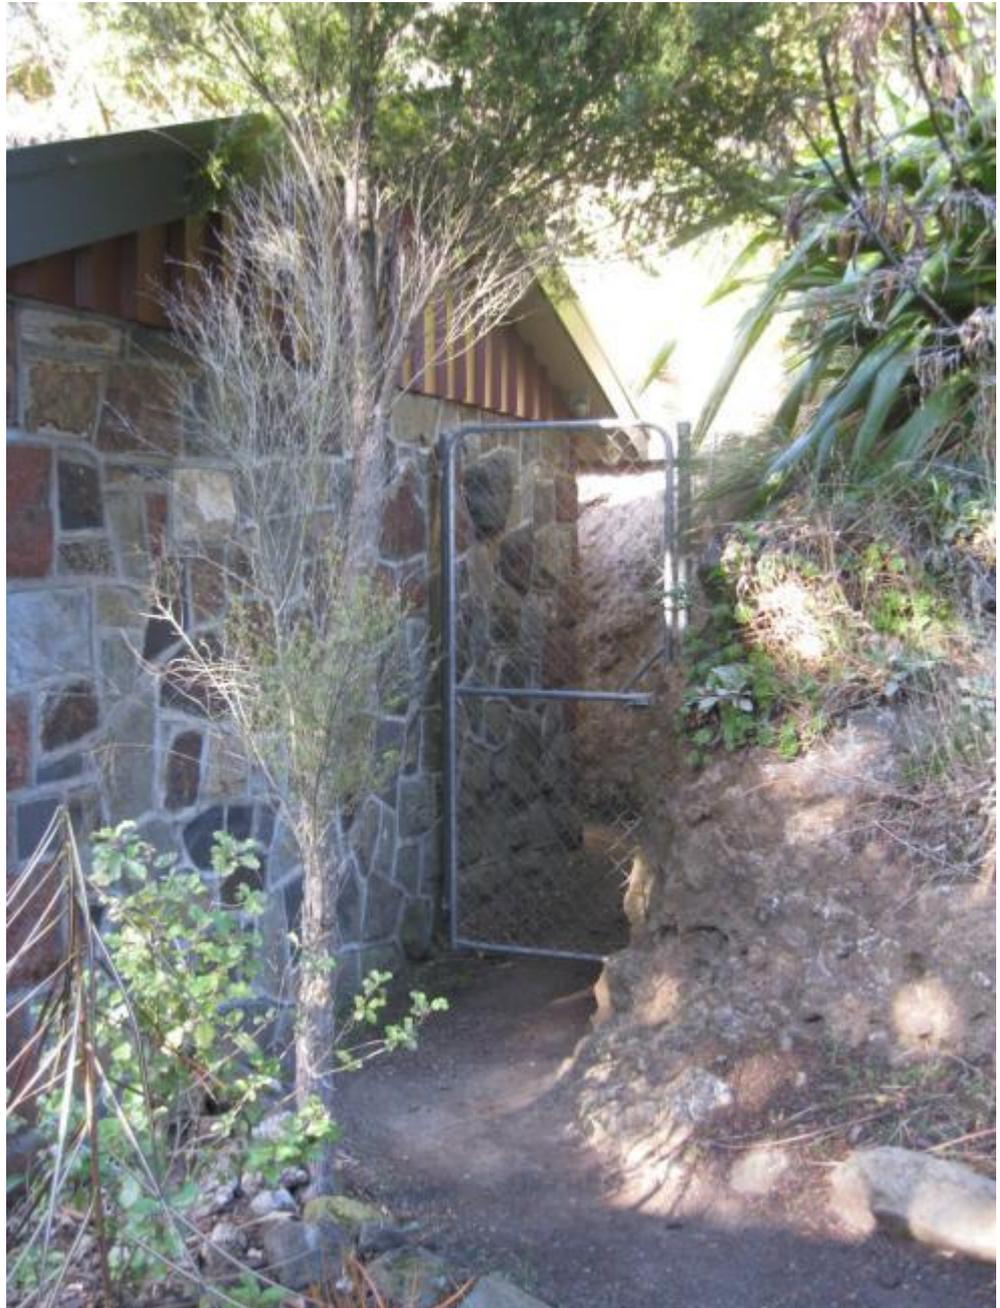
The site has been excavated into the side of a steep slope. There is an unsupported cut into the slope 1m to 1.5m from the southern face of the toilet.

The topography of the site and presence of discontinuous bluffs above create a potential rock fall hazard. Several fallen boulders have been mapped on the hillside above the site. Established vegetation between the subject structures and the rock bluff are likely to mitigate the rockfall potential.

**Photograph 9 The hillside behind the toilet block is unsupported.**
