BU 1564-007 EQ2

Sockburn Recreation Centre - BBQ Shelter

134 Main South Road, Sockburn

QUALITATIVE ASSESSMENT REPORT

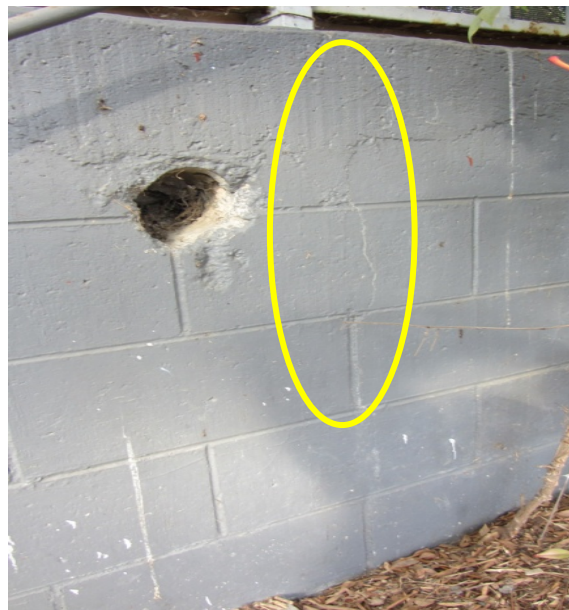
- 1) 1 mm vertical crack in the masonry wall
- 2) 100 mm diameter hole in the masonry wall. (defect which appears to have been drilled sometime in the past and not as a result of the recent earthquakes)
- 3) Moss, cracks and loose timber joints in the roof. (defect which appears to be as a result of general wear and tear and not as a result of the recent earthquakes)

Photo 14: Masonry retaining wall with 100mm diameter hole, and vertical crack alongside.

Recommendations		Level of repair/strengthening required: minor non-structural	Describe: Grouting of crack
Building Consent required: no		Interim occupancy recommendations: full occupancy	Describe: _____
Along	Assessed %NBS before: 100%	%NBS from IEP below	Qualitative Assessment carried out, this includes the NZSEE IEP - refer to SKM report
	Assessed %NBS after: 100%	If IEP not used, please detail assessment methodology: _____	
Across	Assessed %NBS before: 100%	%NBS from IEP below	
	Assessed %NBS after: 100%

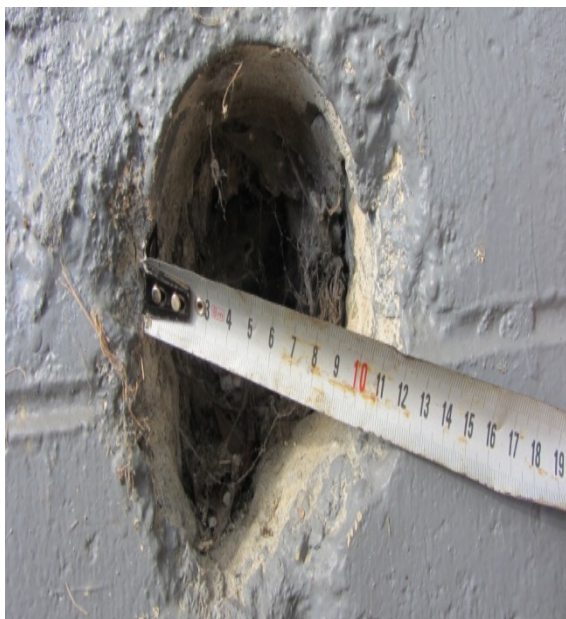
Photo 15: Close up view of 100mm diameter hole

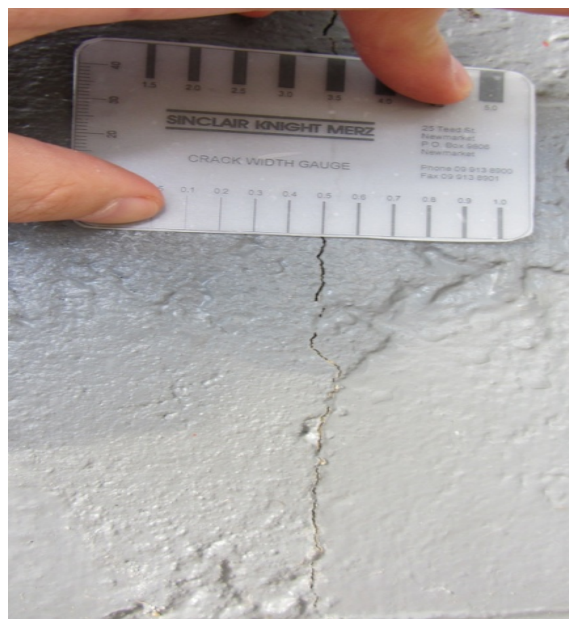
Photo 16: Close up view of vertical crack

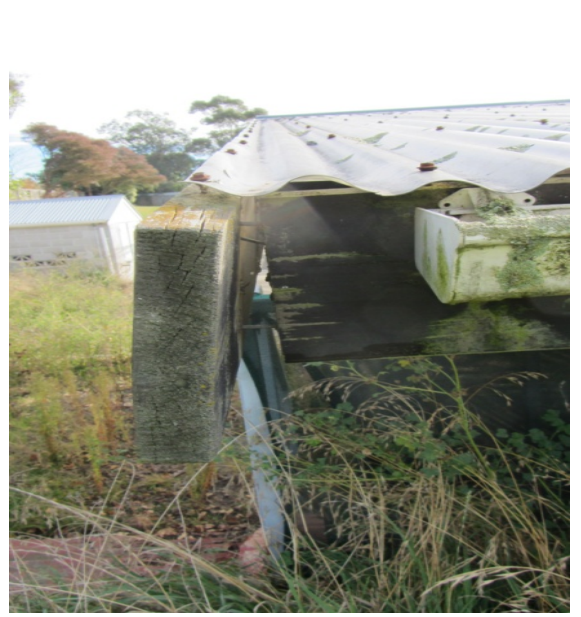
Photo 18: loose timber connection in roof framing

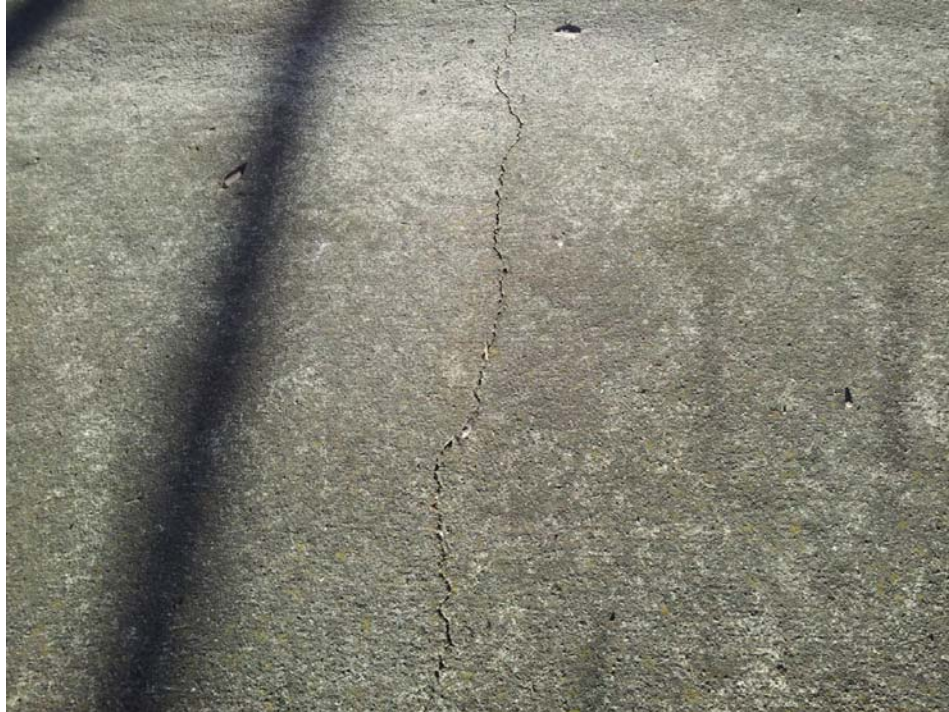
■ **Figure 8 - Cracking in external concrete slab**

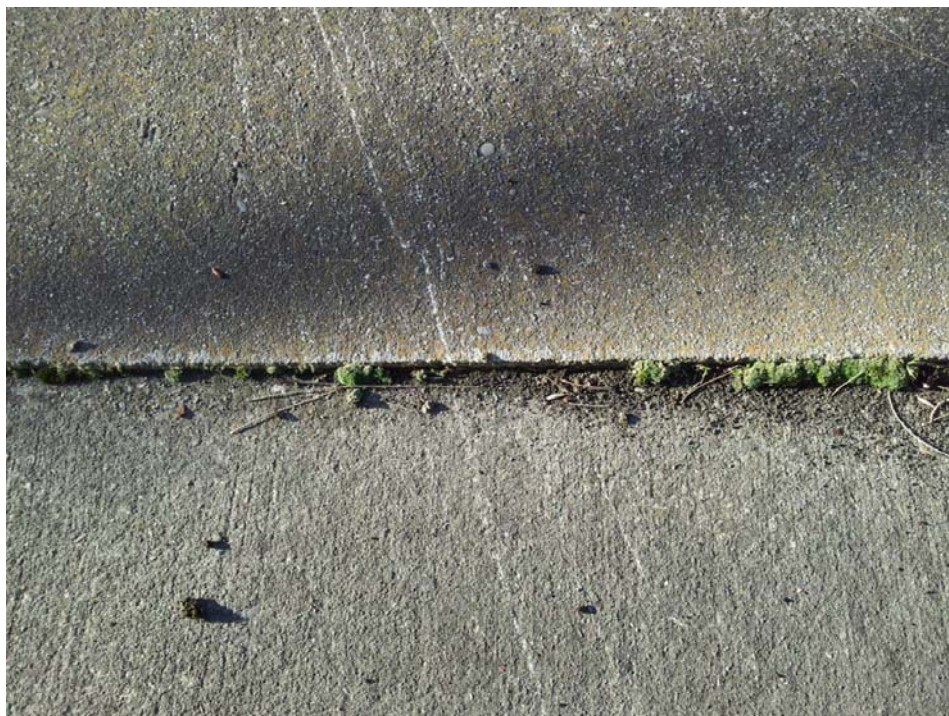
inspection. There was slight differential settlement of external concrete slabs within the site. There was no evidence of surface expression of liquefaction or any land damage around the site. No stability issues related to the slope were noted. Site photographs are shown below:

■ **Figure 9 – Observed differential settlement of external concrete slabs**
