CLIENTS | PEOPLE | PERFORMANCE

Sockburn Squash Centre
BU 1564-003 EQ2
Detailed Engineering Evaluation
Quantitative Report
Version FINAL-11/4/13

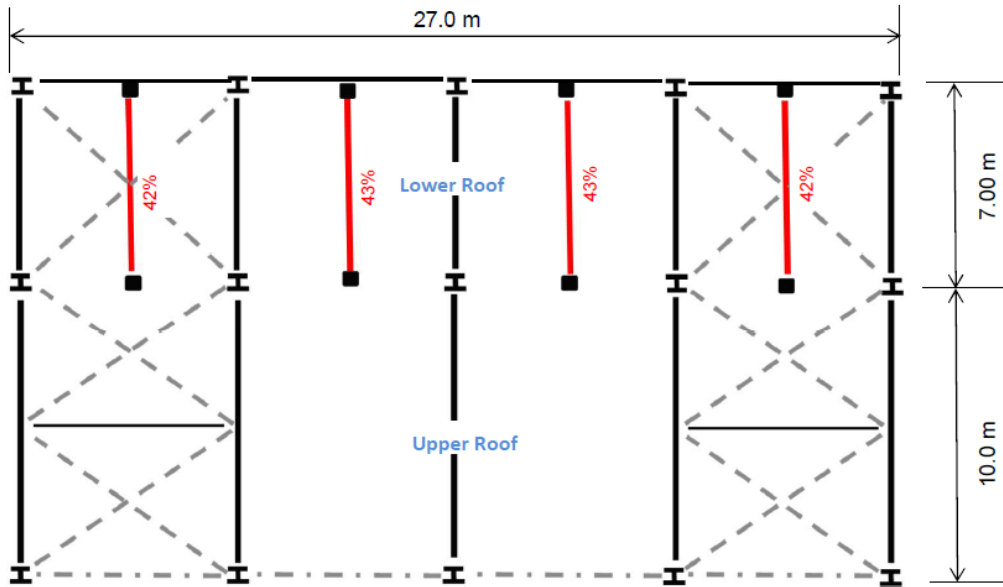
Reinforced Concrete Masonry Walls

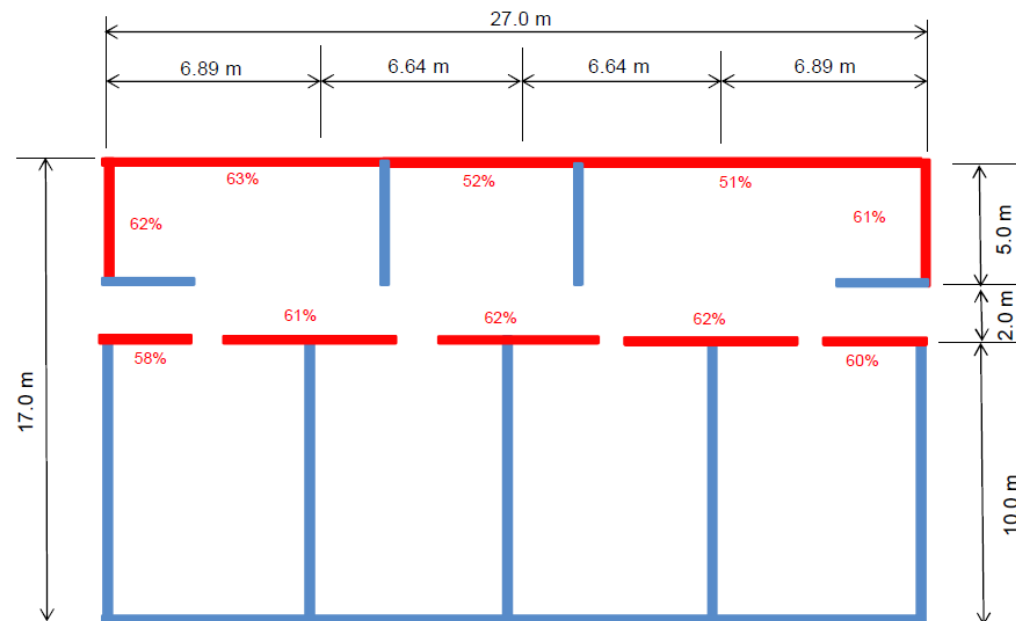
Reinforced Concrete Masonry Bond Beam (Out of Plane Bending)

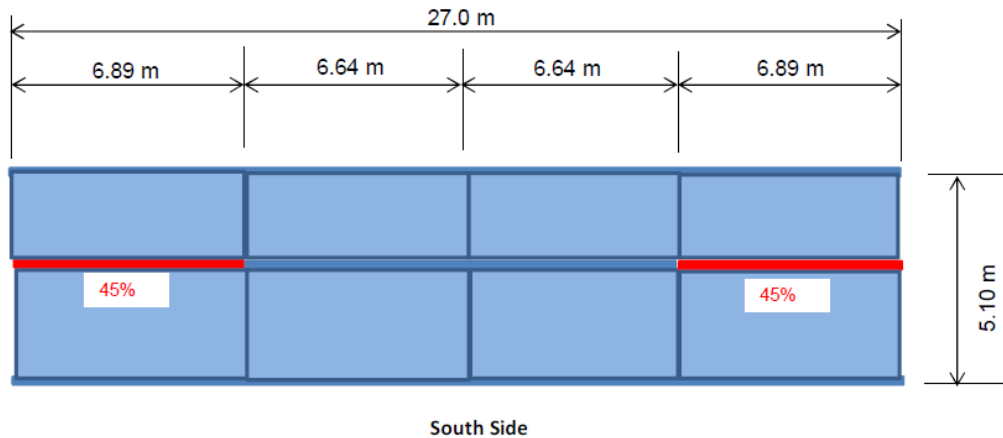
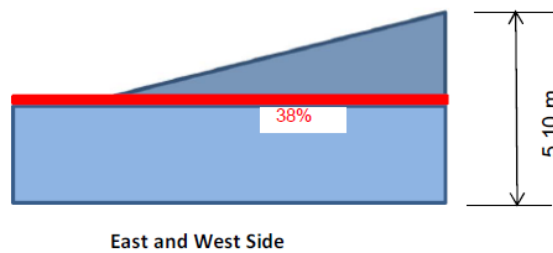
Lateral Seismic Drift

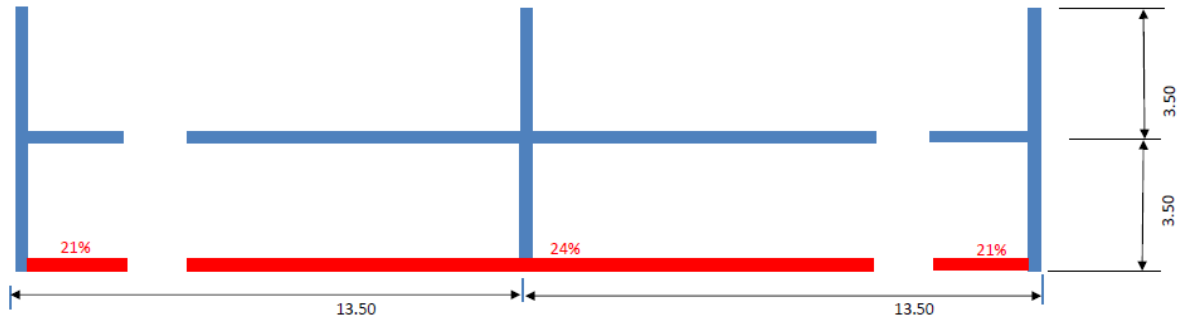
9.4 Discussion of Results

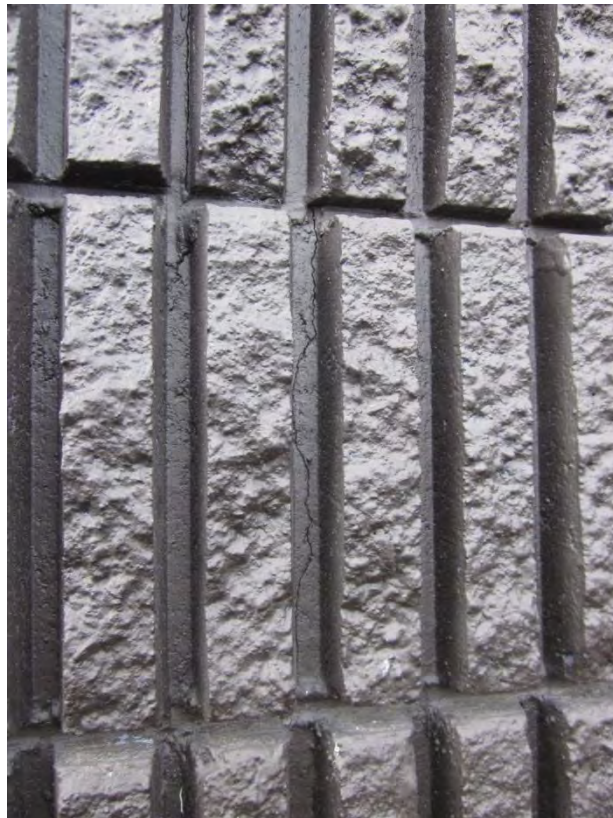
Photograph 3 **View of building from Takaro Avenue**

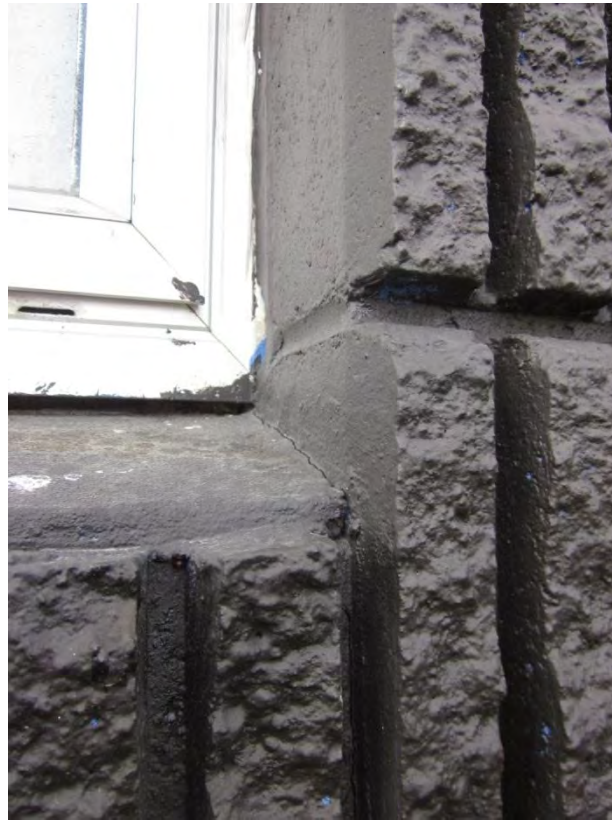
Photograph 5 Cracking at the edge of the window between the column and concrete masonry wall on the front face of the building

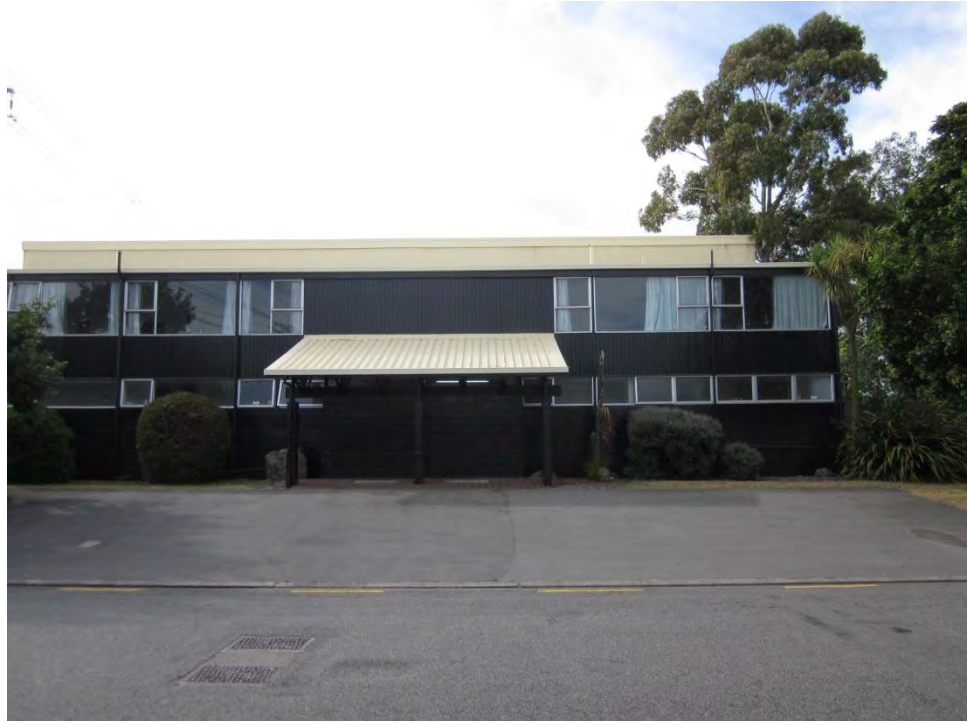
Photograph 6 View from Takaro Avenue

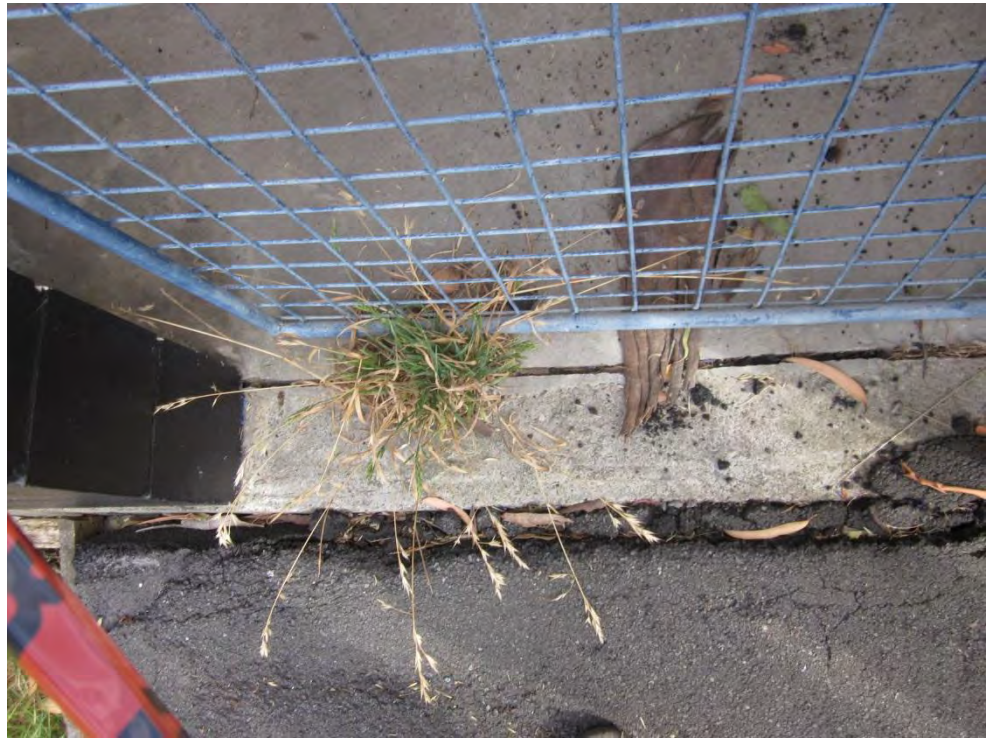
Photograph 12 Cracking of asphalt footpath where ground appears to have slumped

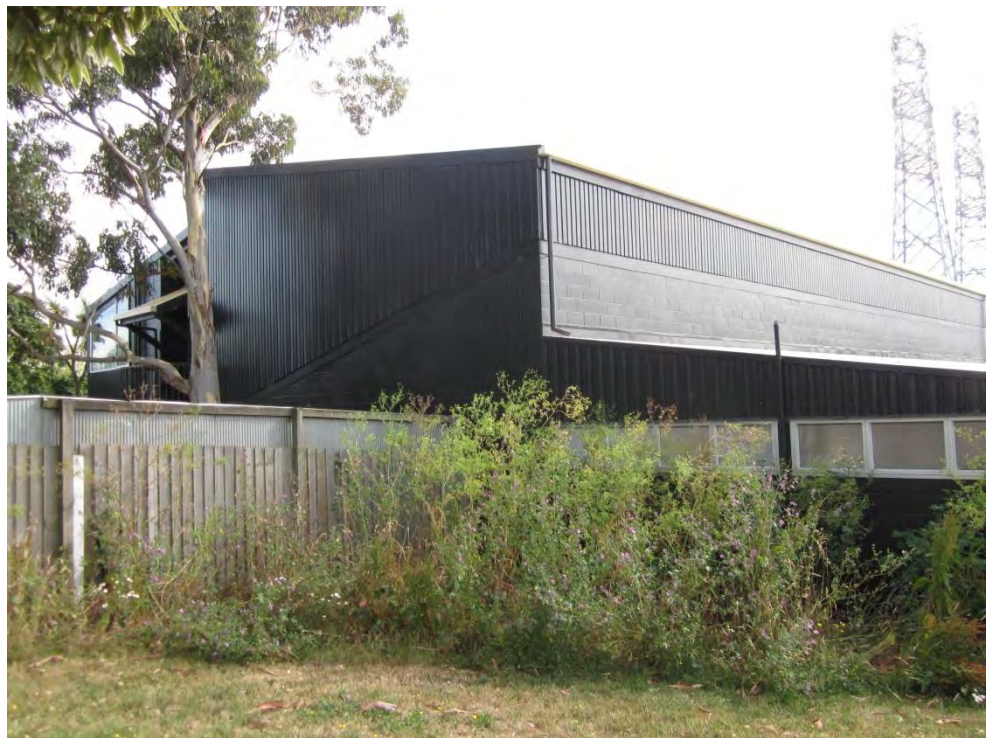
Photograph 13 View from the south

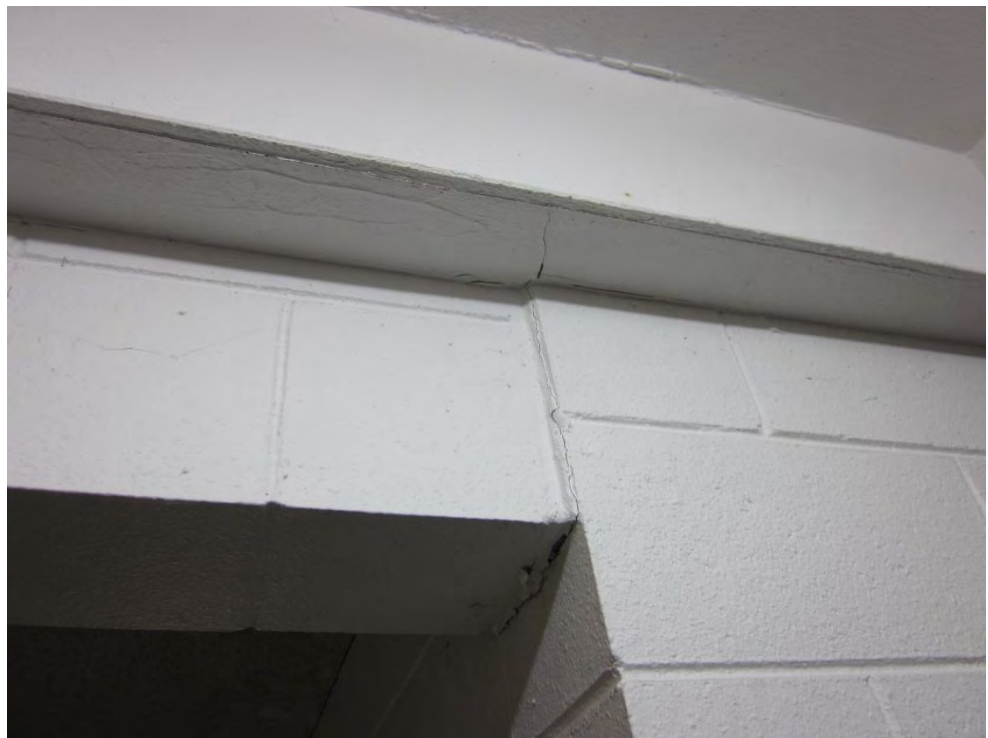
Photograph 19 Cracking around doorway in internal corridor

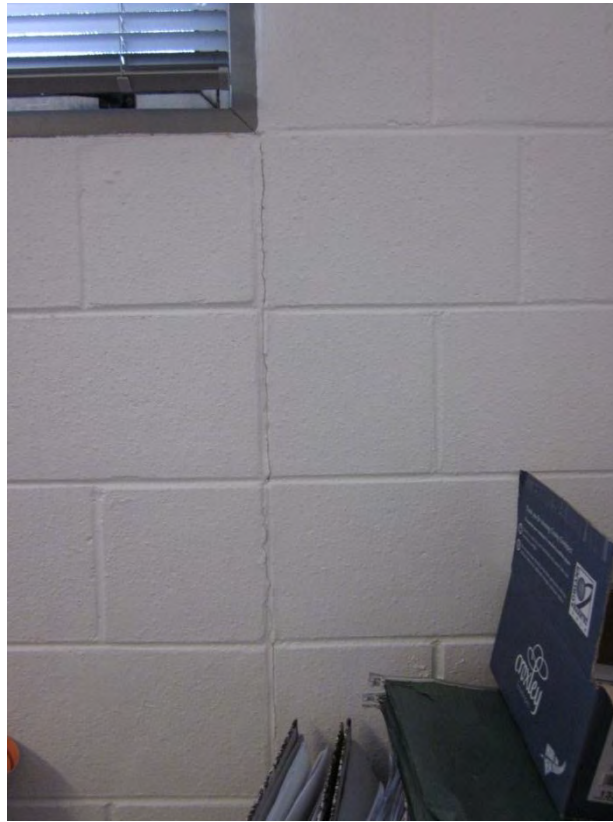
Photograph 20 Internal cracking beneath window on front face of building

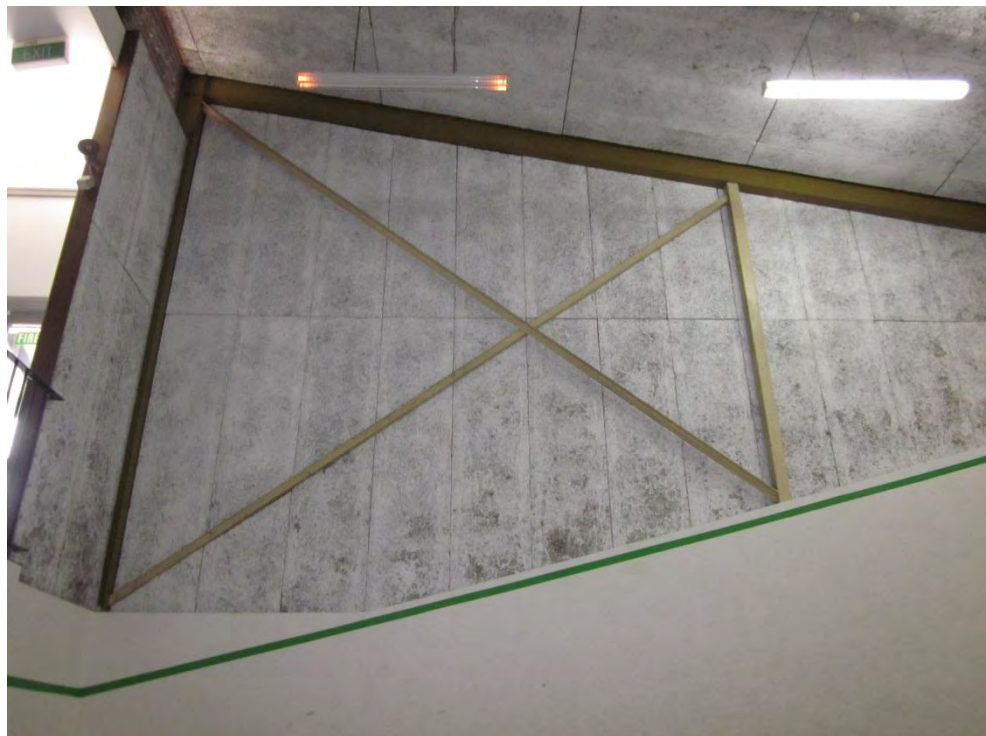
Photograph 21 Steel portal frame bracing in the short direction of the building

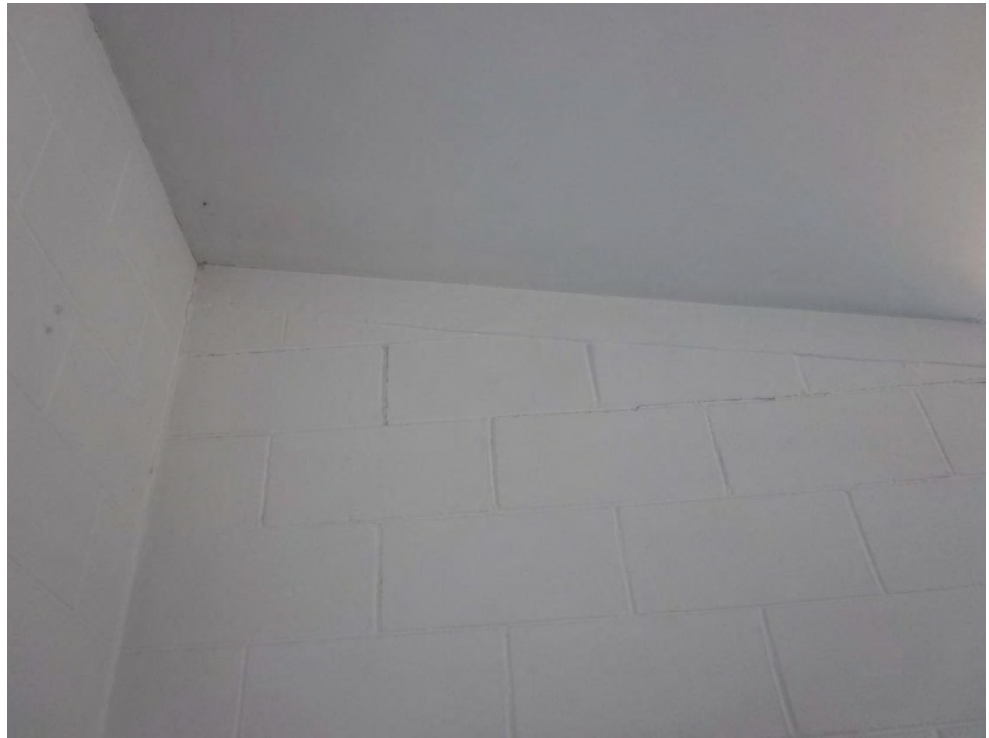
Photograph 26 Cracking on the south-western wall of second story

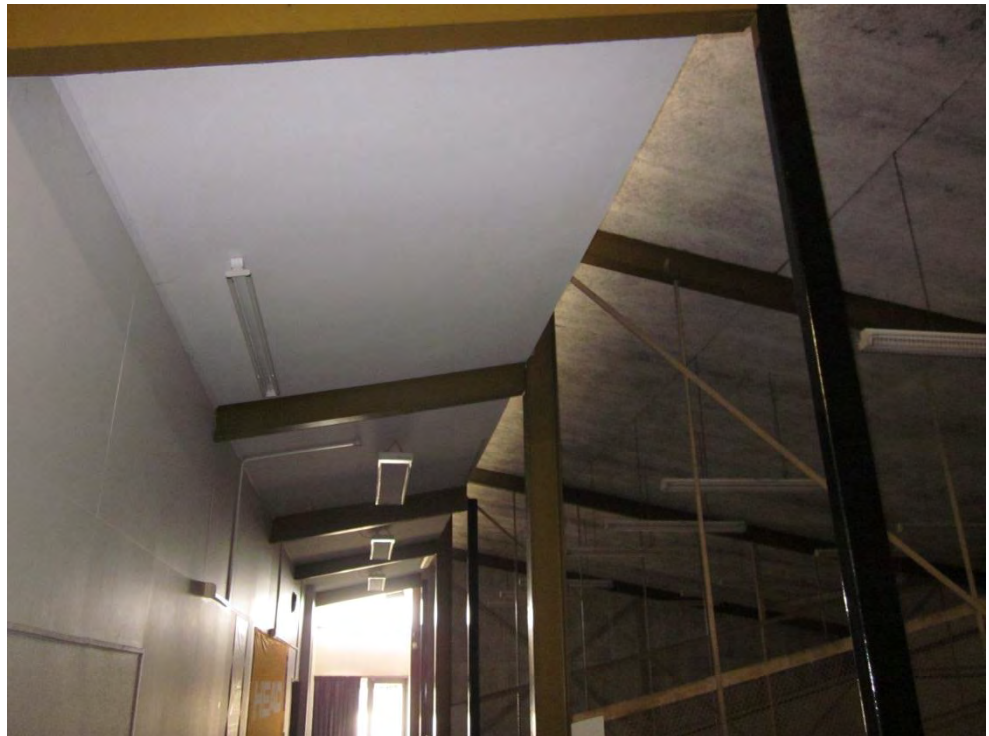
Photograph 27 Rafter to portal frame connections

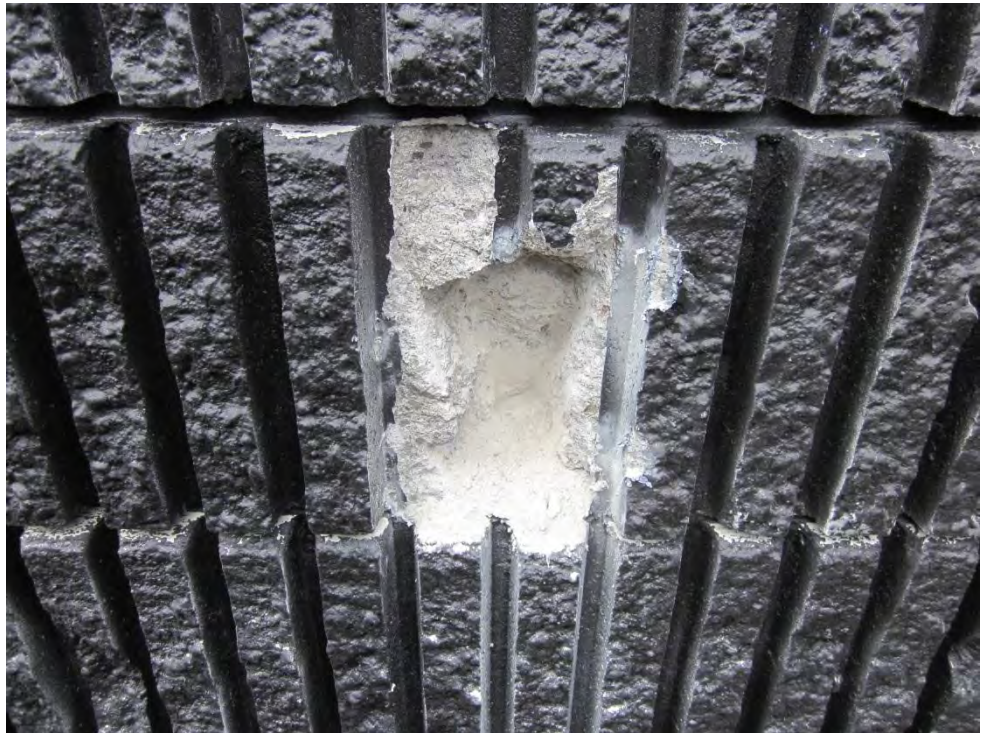
Photograph 28 Opening up works at crack location on left side of front face of the building. No reinforcement was observed.

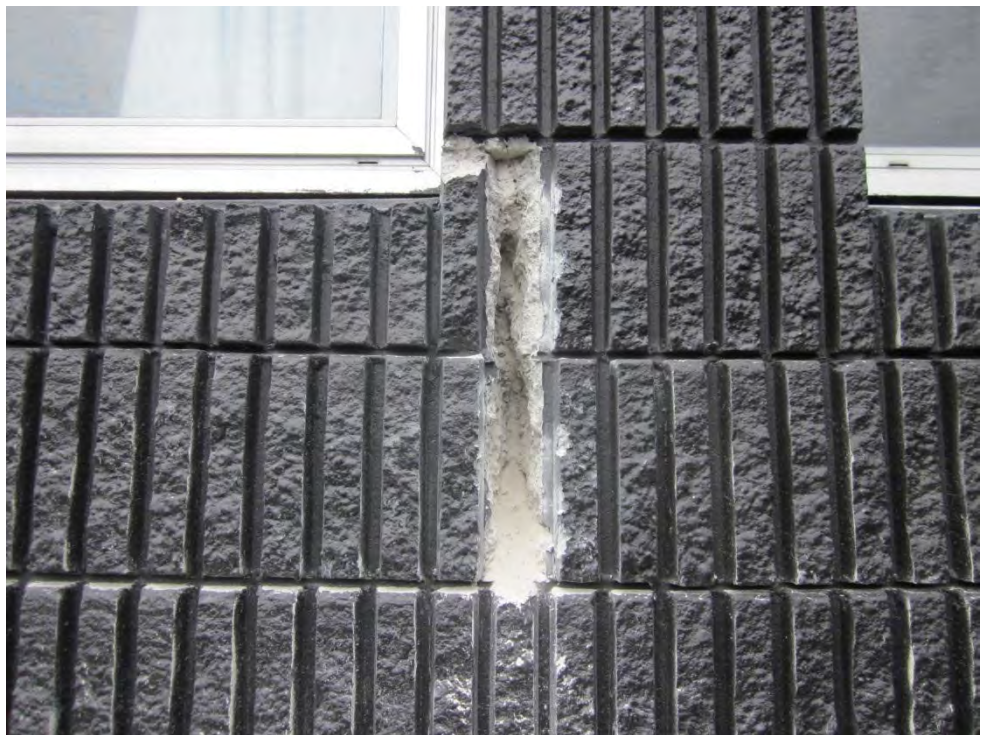
Photograph 29 Opening up works at crack location below concrete masonry column. No reinforcement was observed.

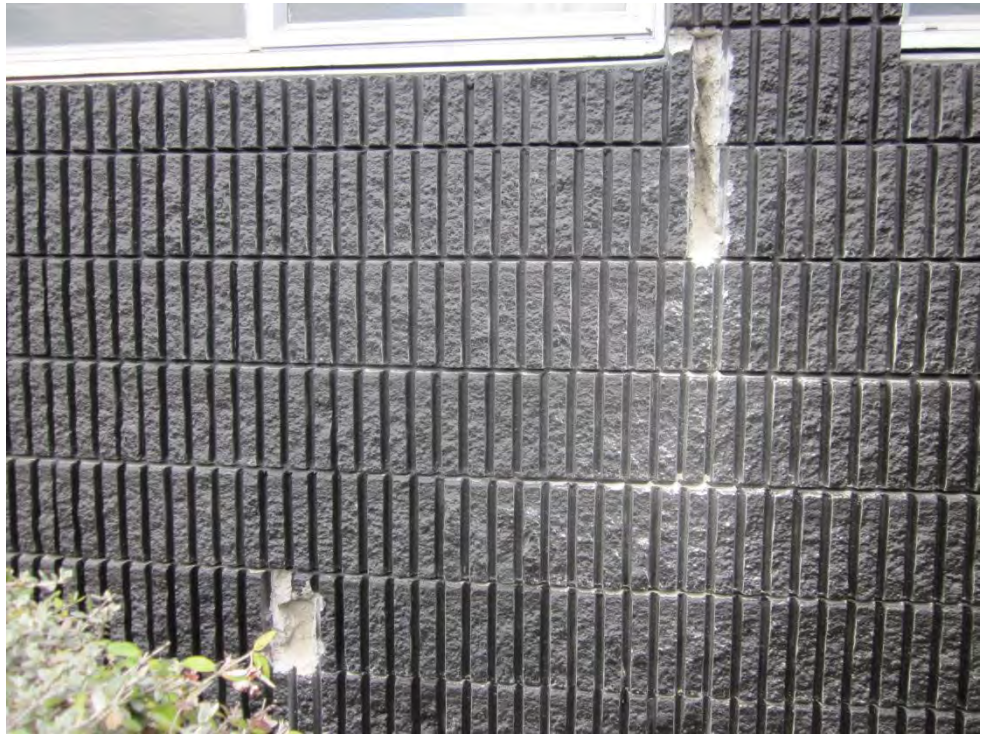
Photograph 30 View of external opening up works undertaken

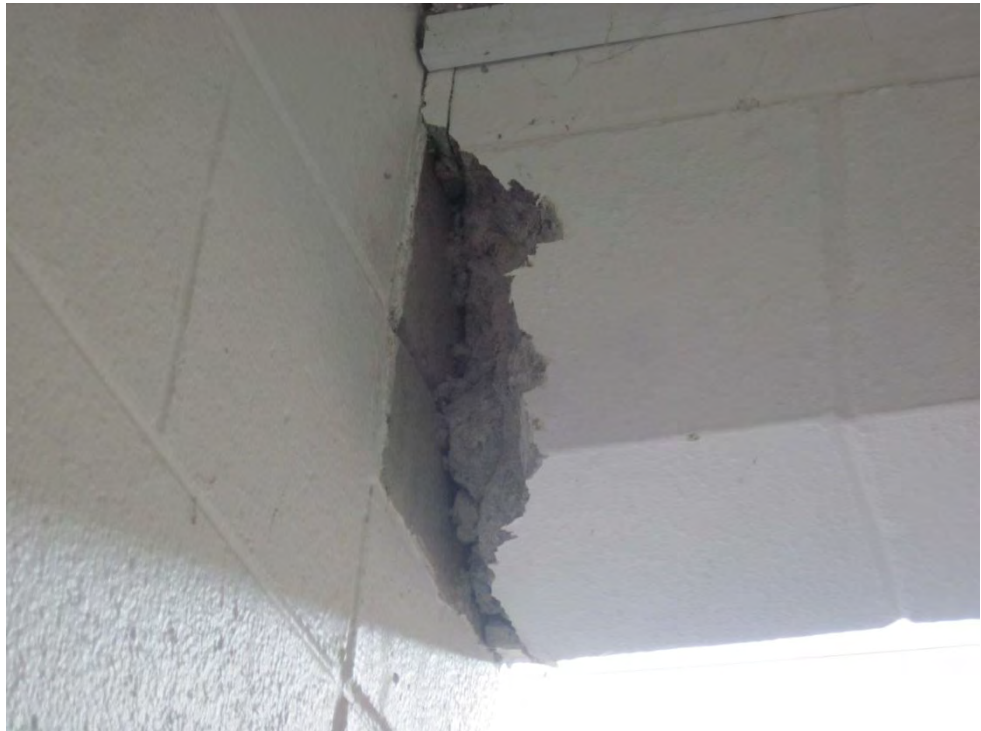
Photograph 31 Opening up works undertaken at location of cracking around connection between original structure and addition. No reinforcement was observed.

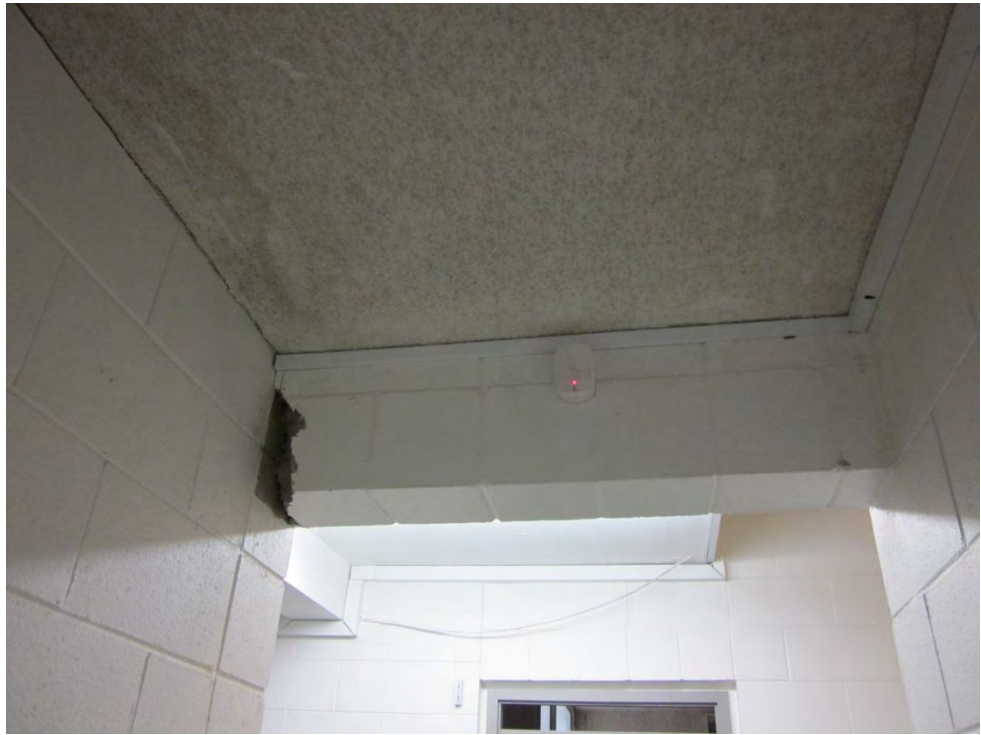
Photograph 32 View of location of internal opening up works

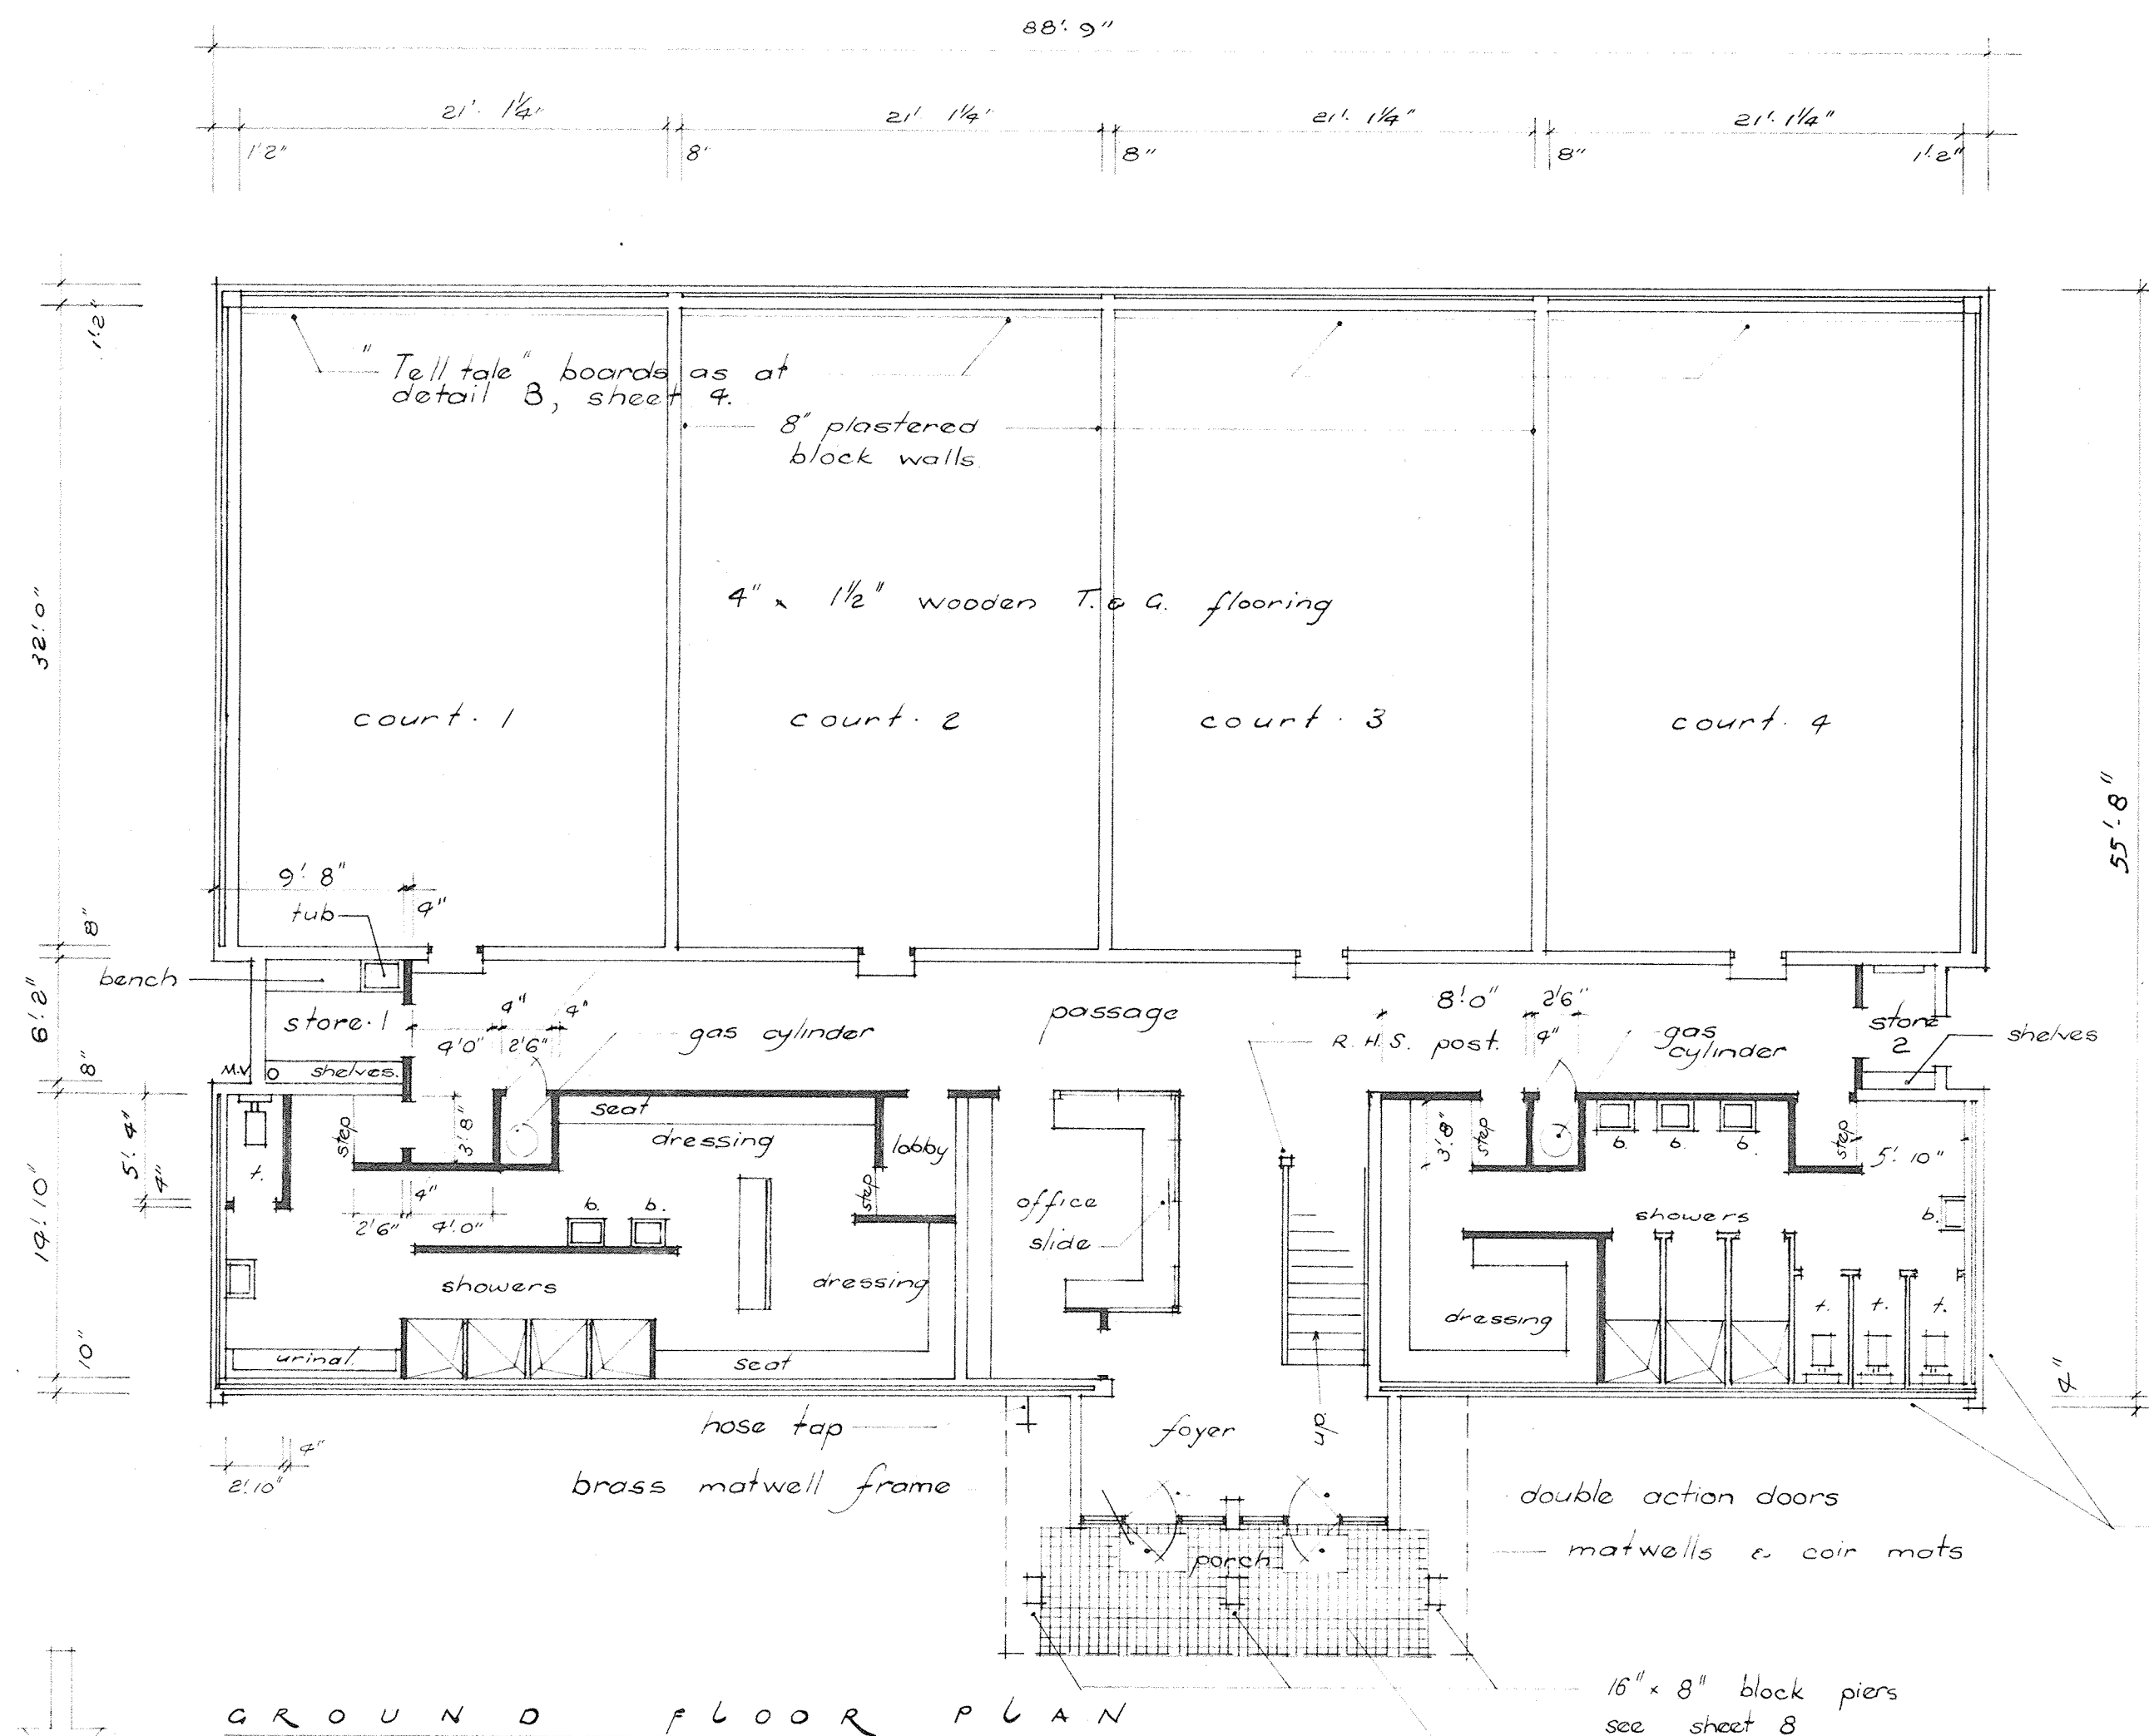
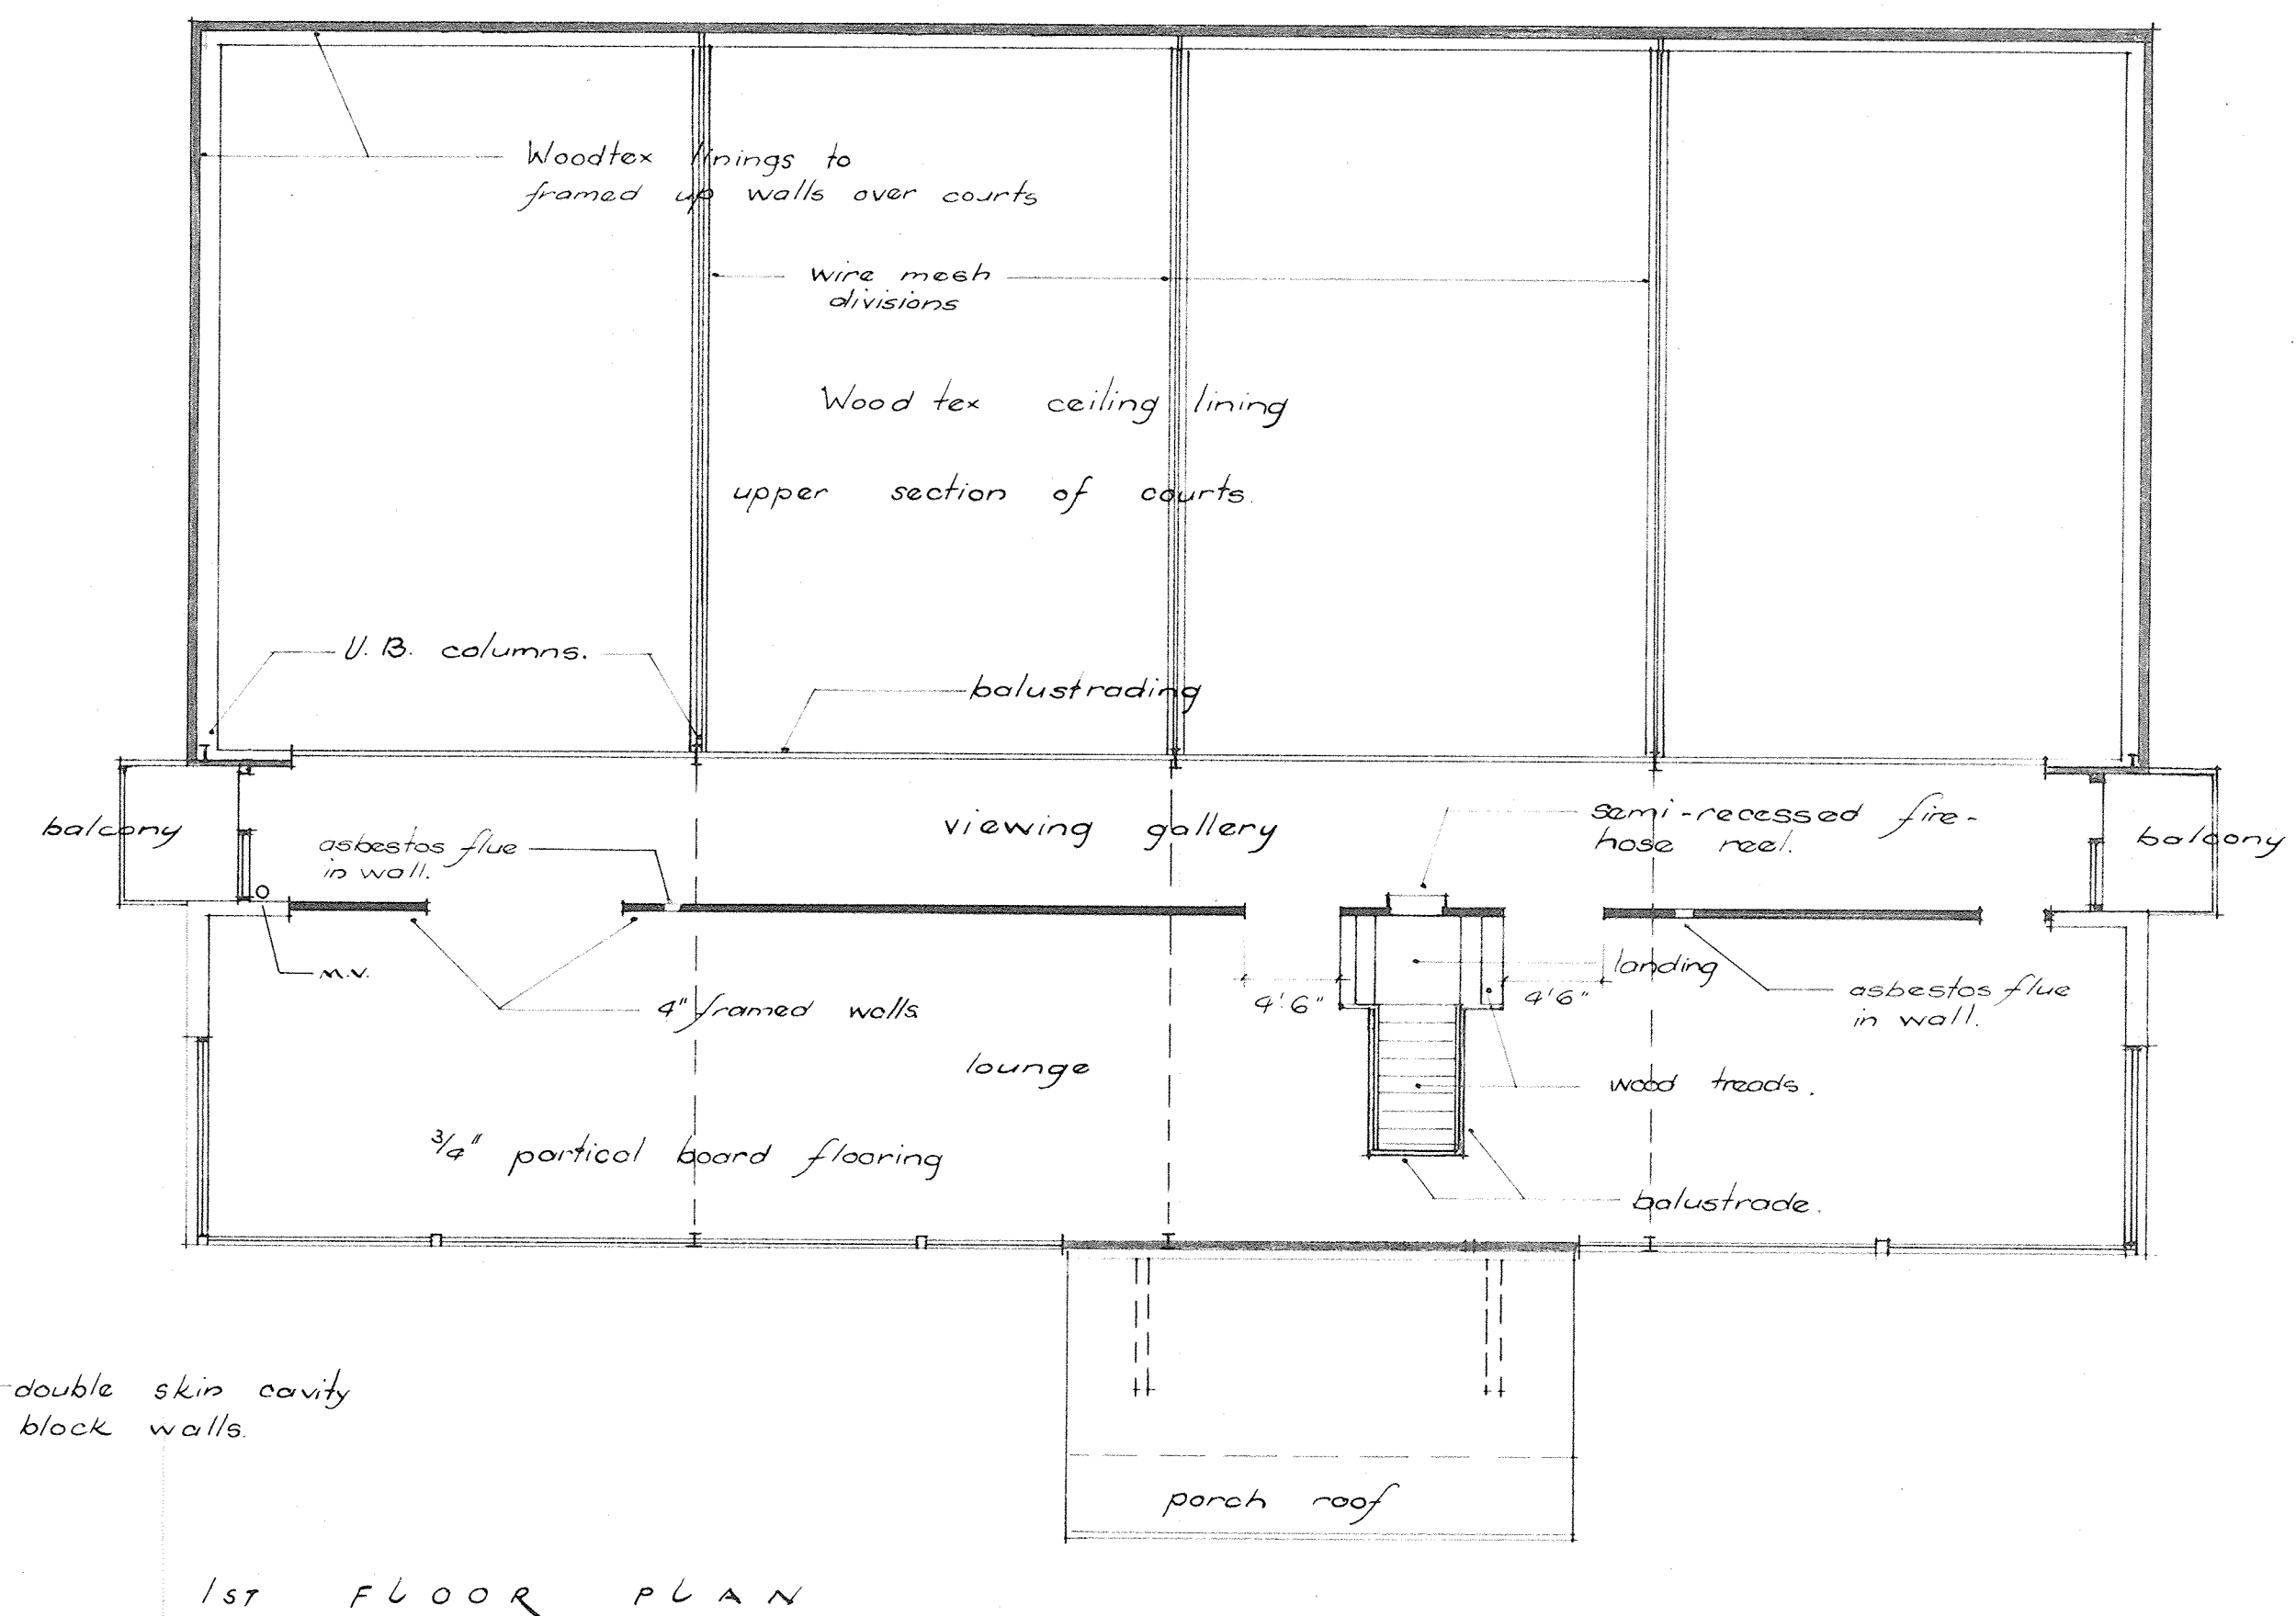
Contractors are to verify all measurements on site and general site conditions
