CLIENTS | PEOPLE | PERFORMANCE

Sockburn Squash Centre
BU 1564-003 EQ2
Detailed Engineering Evaluation
Quantitative Report
Version FINAL-11/4/13

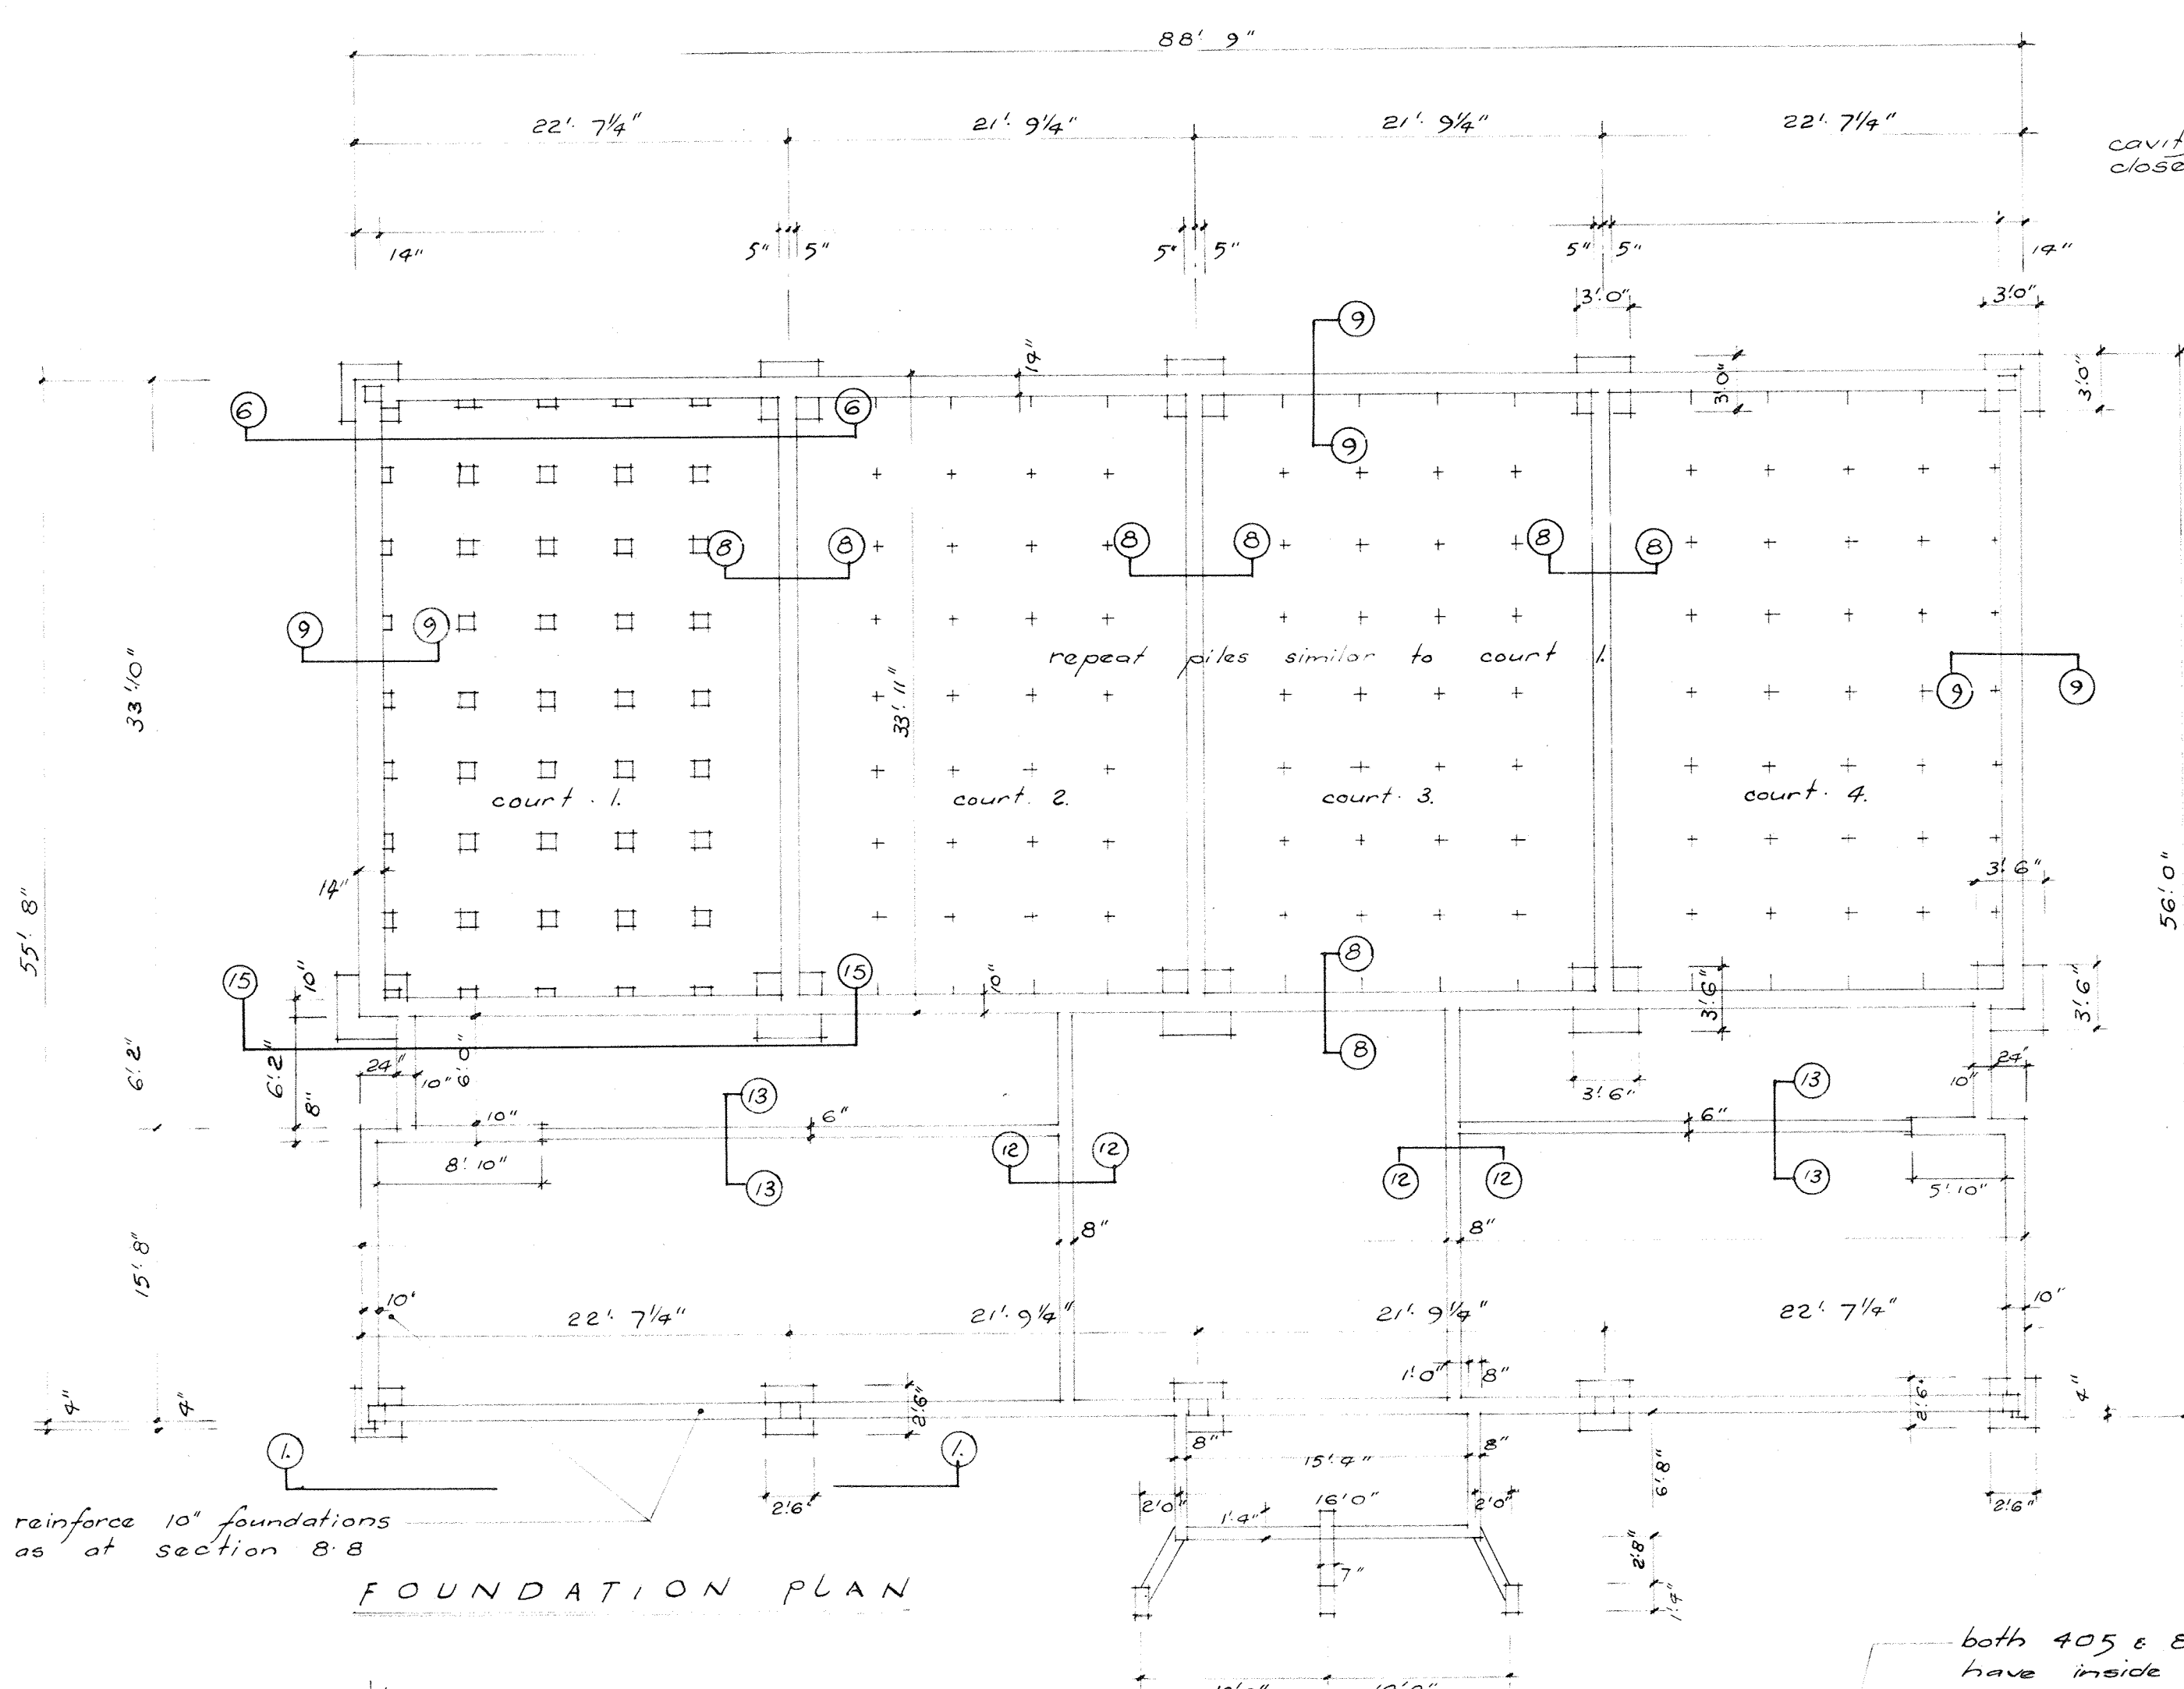
Contractors are to verify all measurements on site and weld braces to U.B. cols. brace at all four bays. 4. 3/8" rods & 1/4" stirrups at 8" c.c. 1/4" ties at 12" c.c.

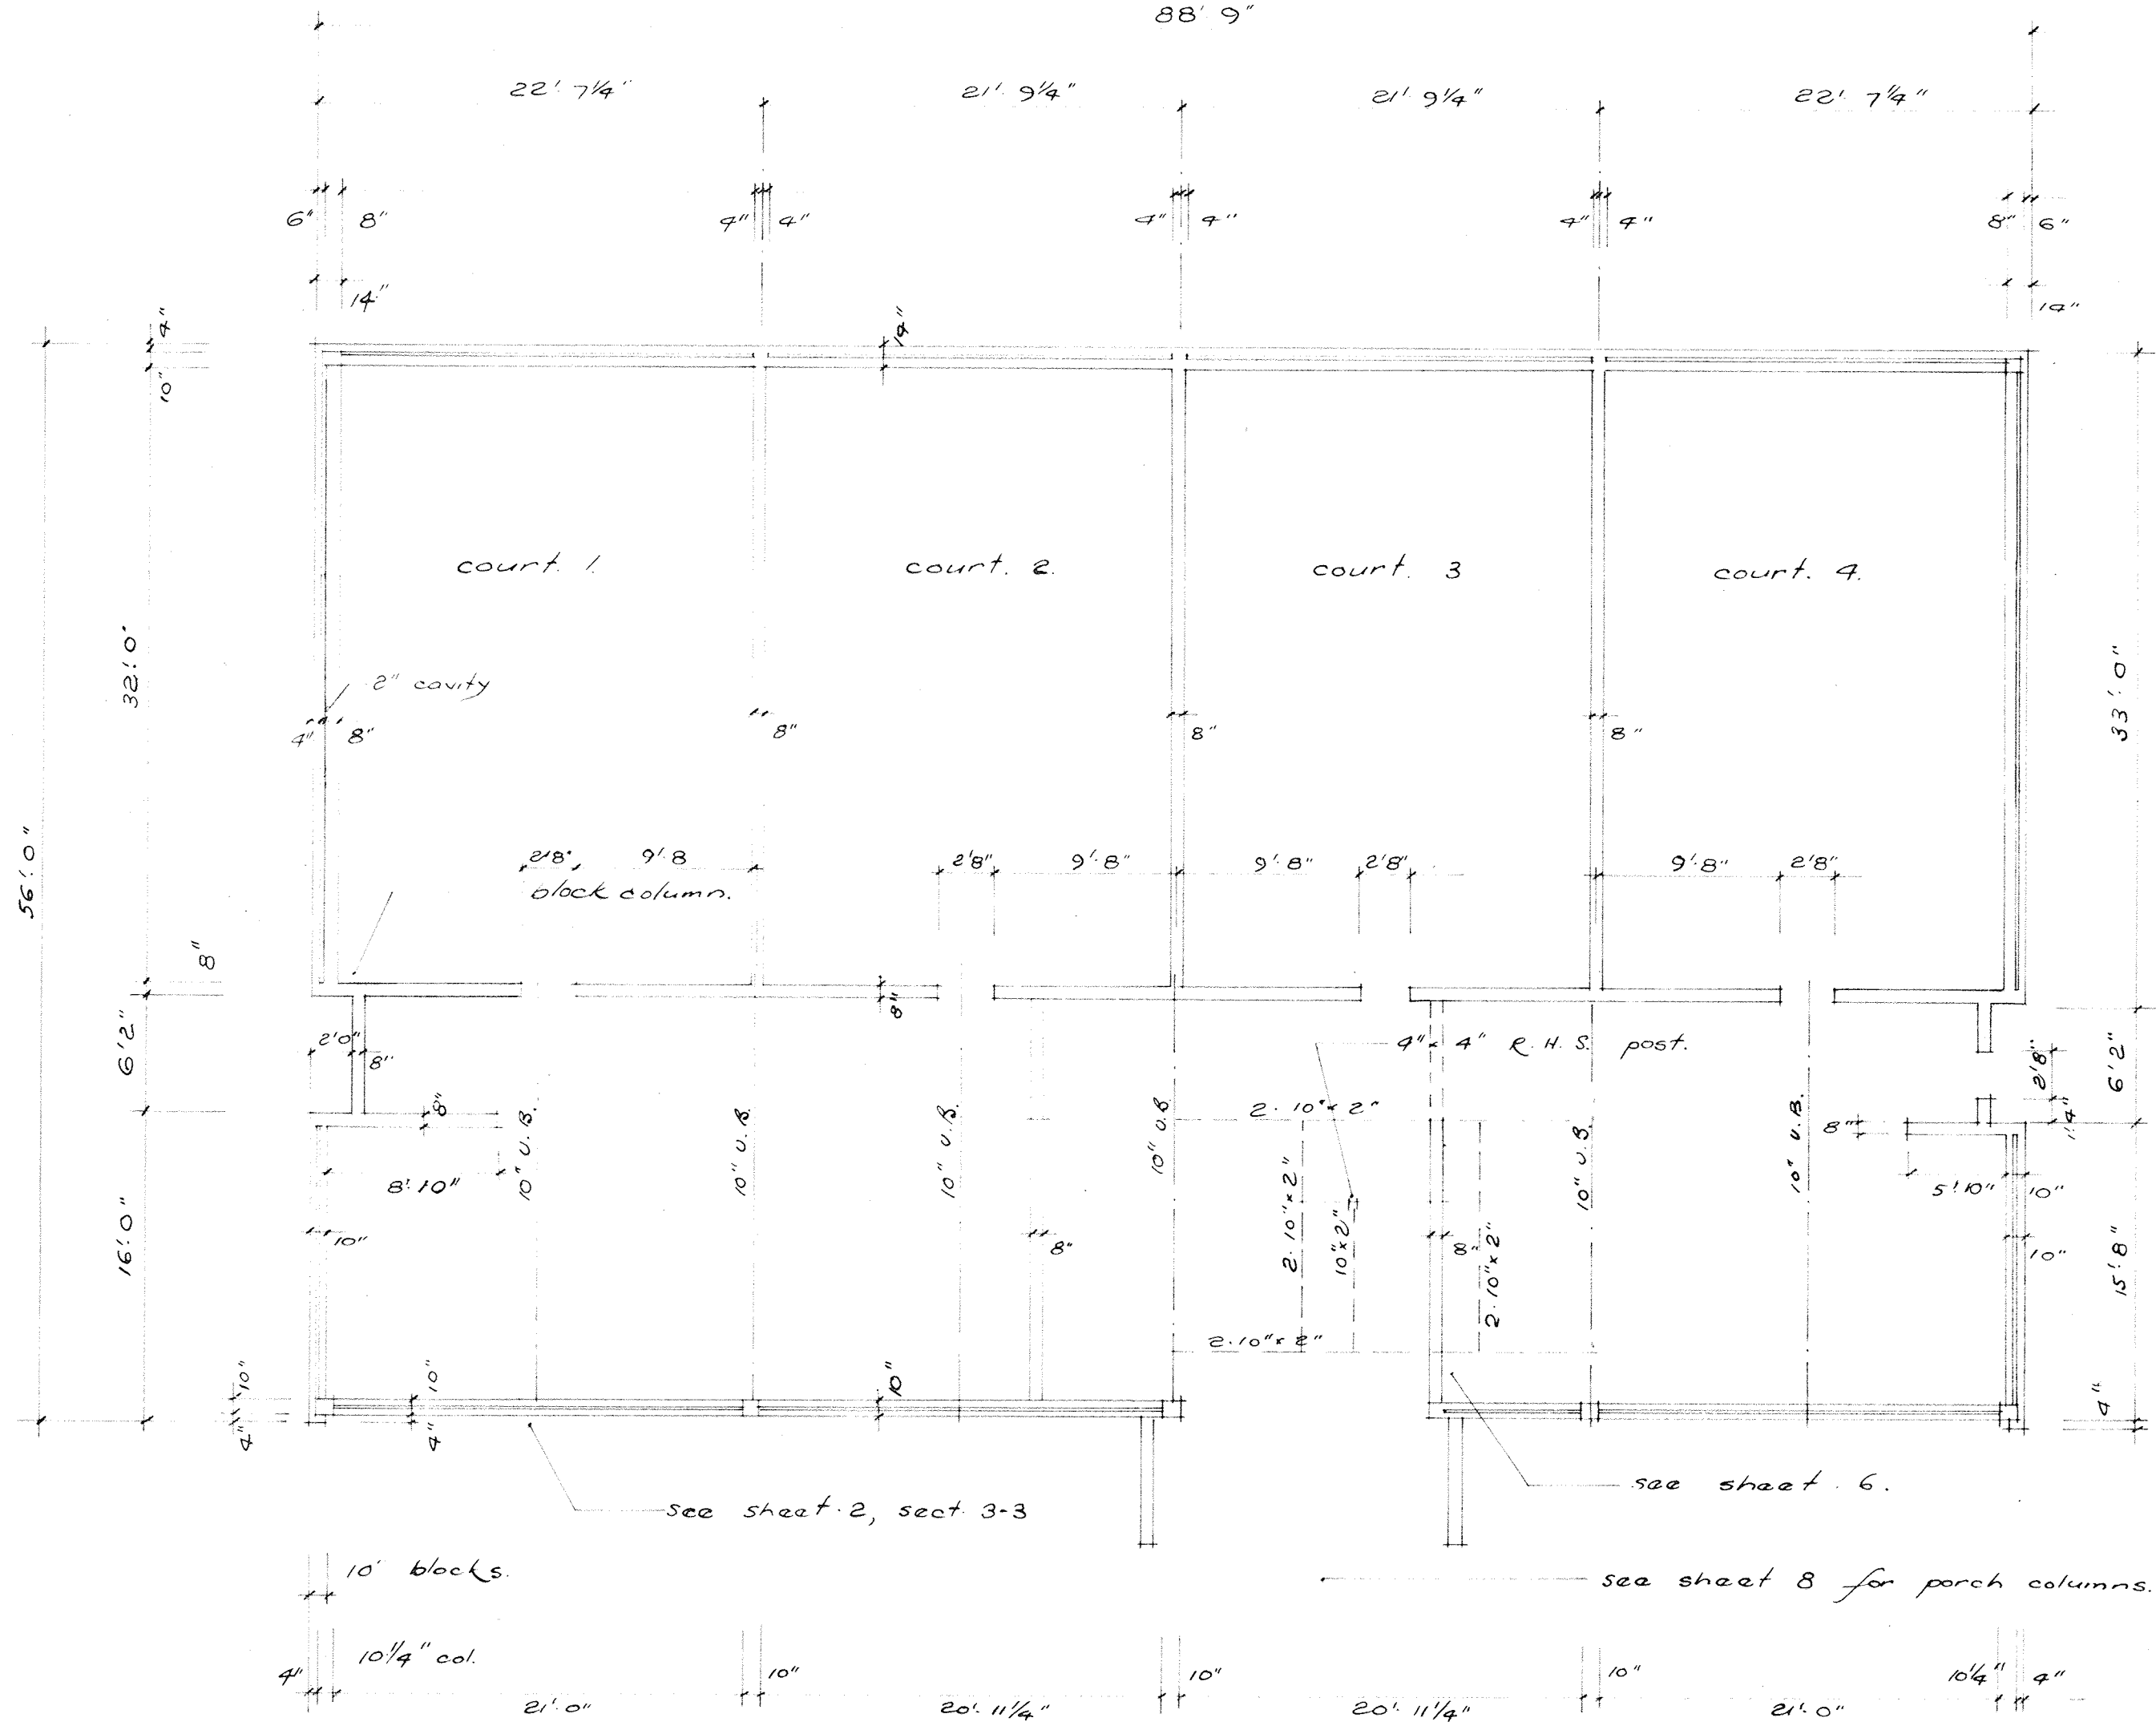
Contractors are to verify all measurements on site and general site conditions.

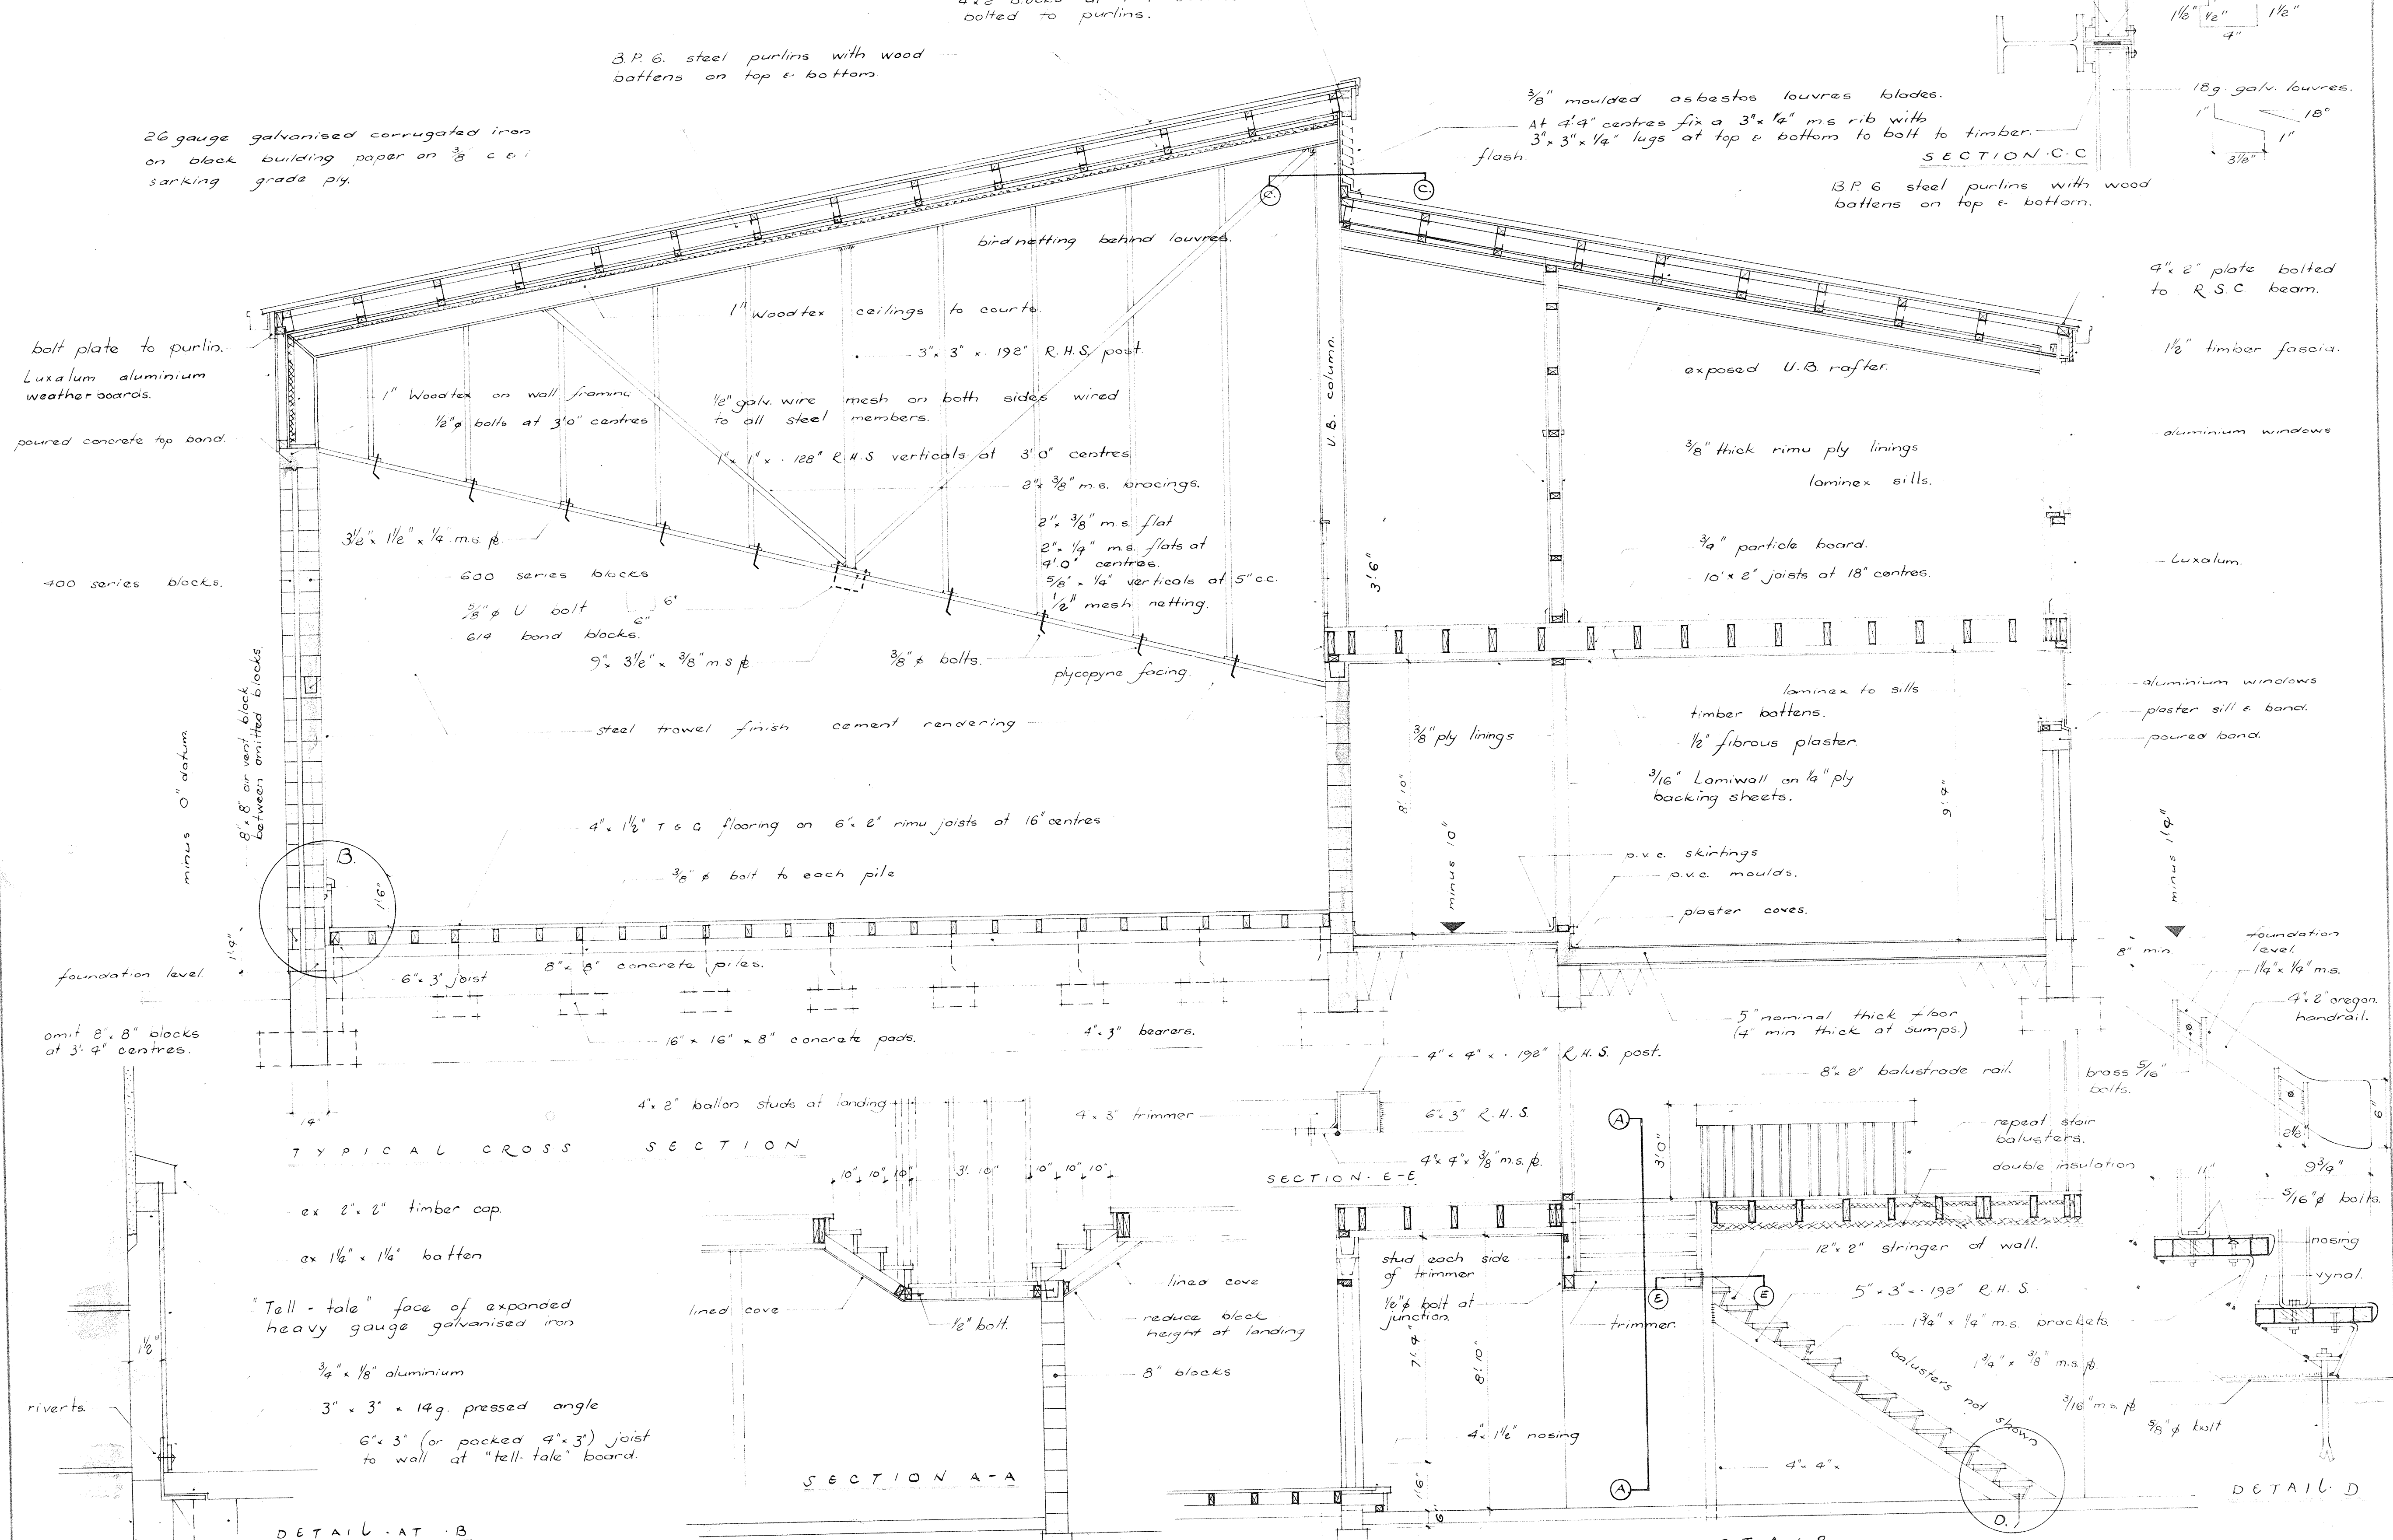
SQUASH COURTS FOR THE PAPARUA COUNTY COUNCIL

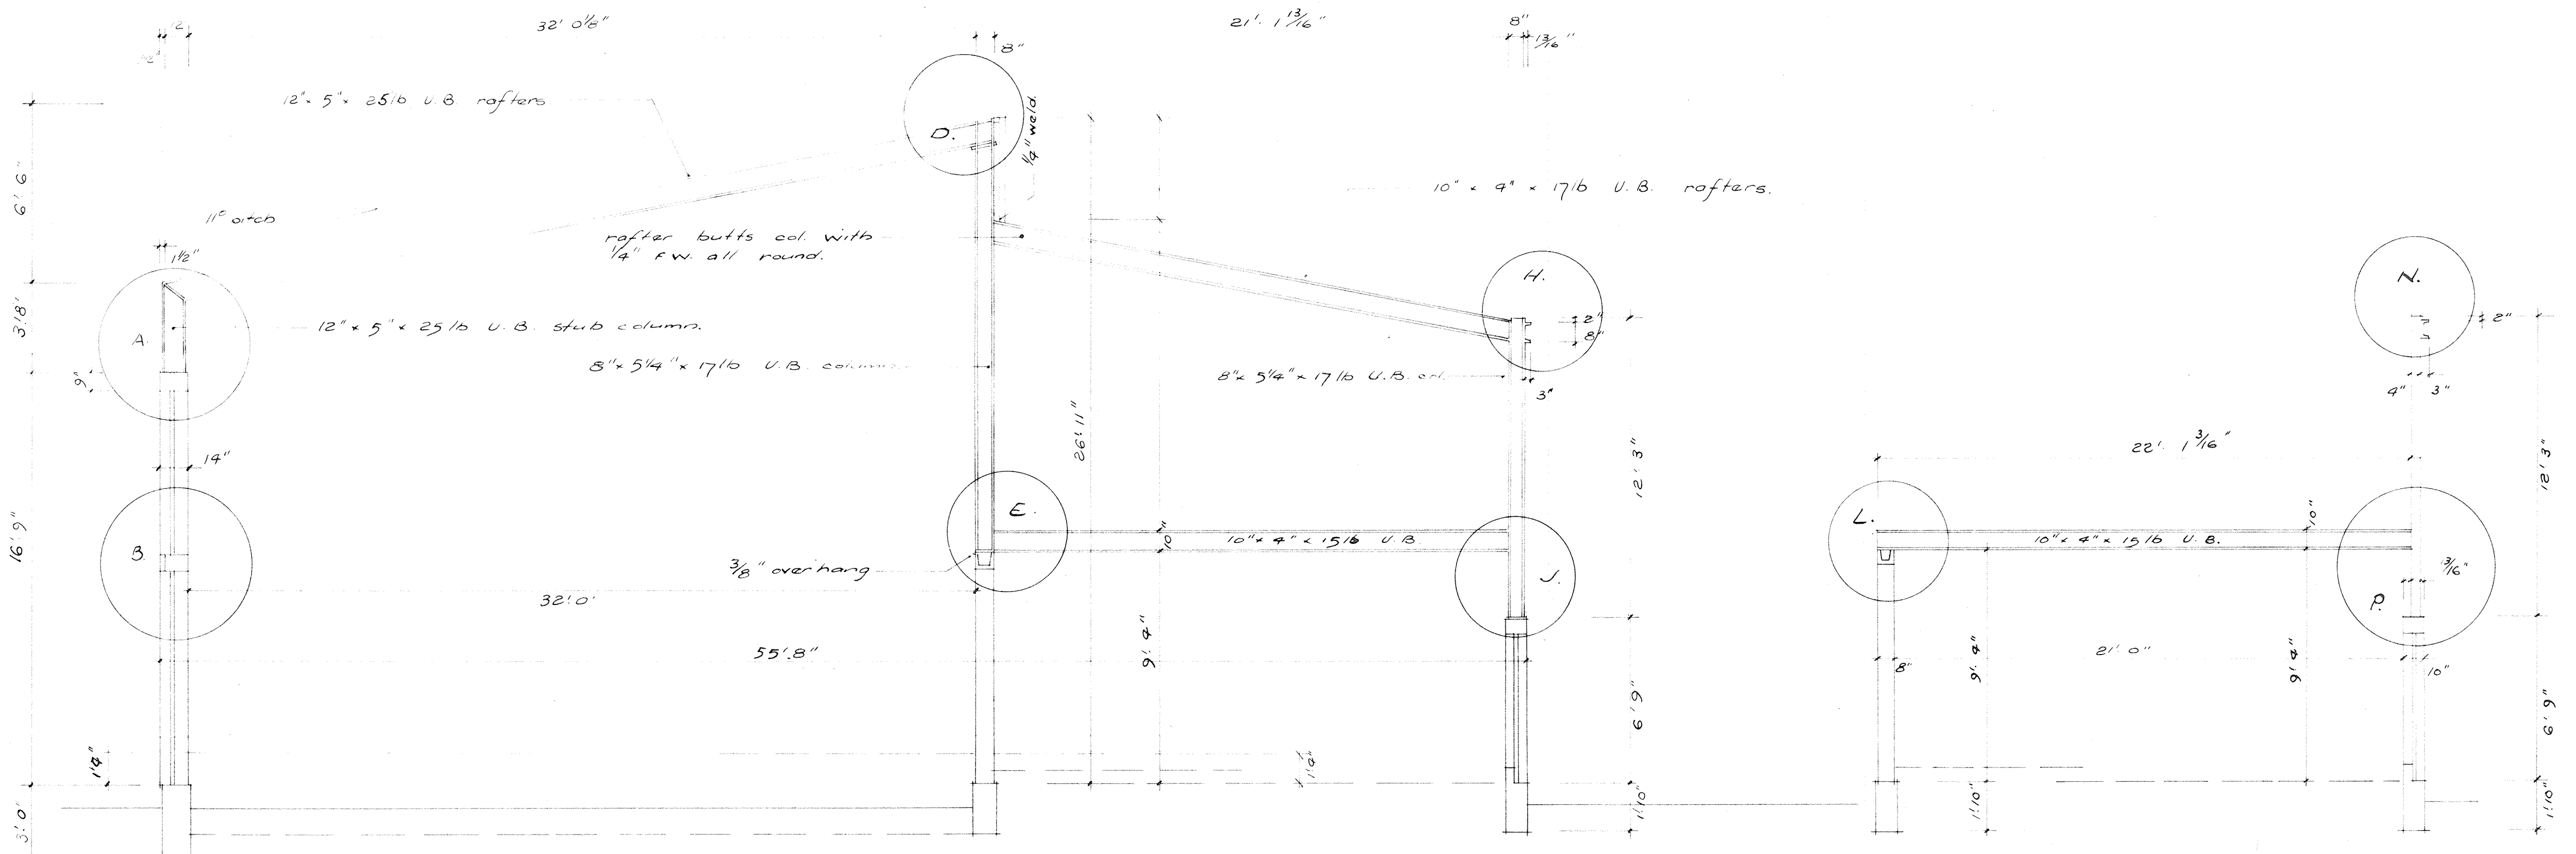
SECTION AT MAIN FRAMES

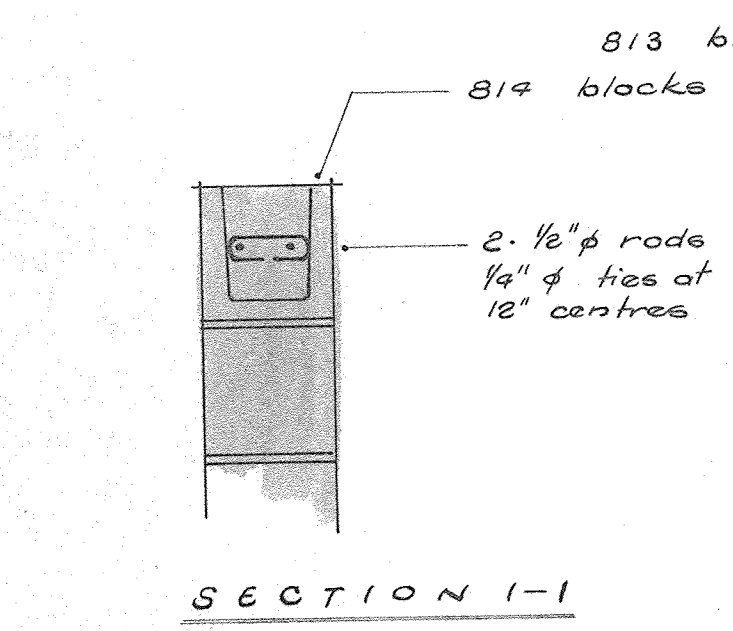
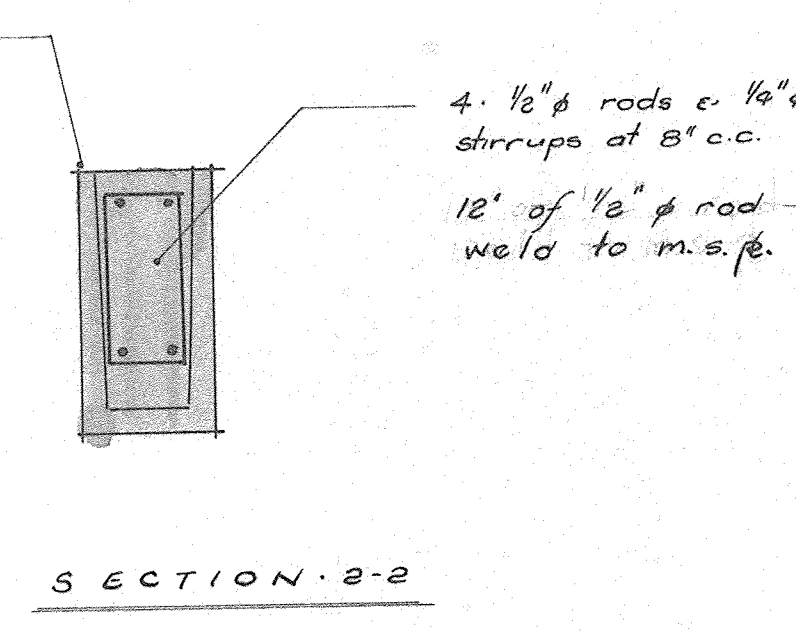
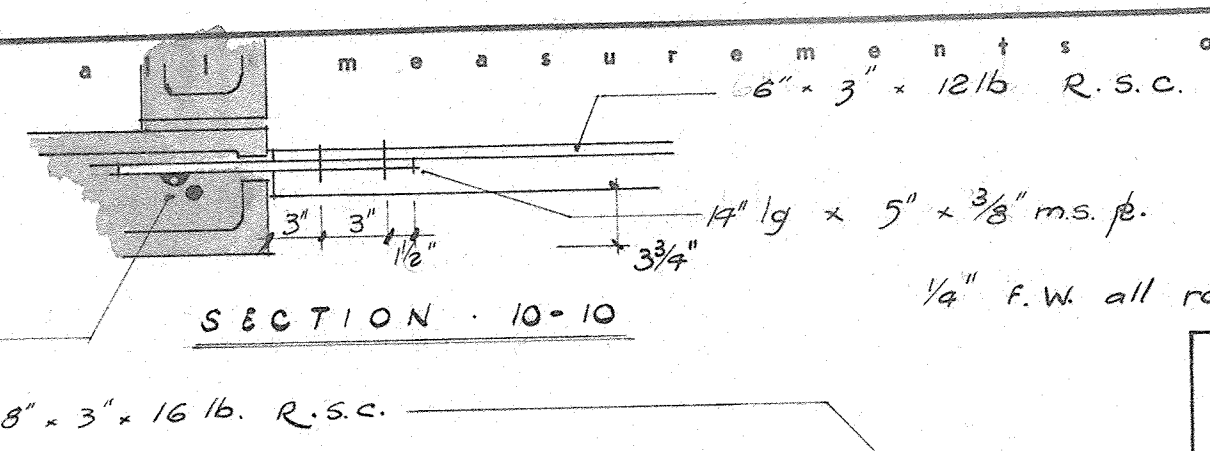
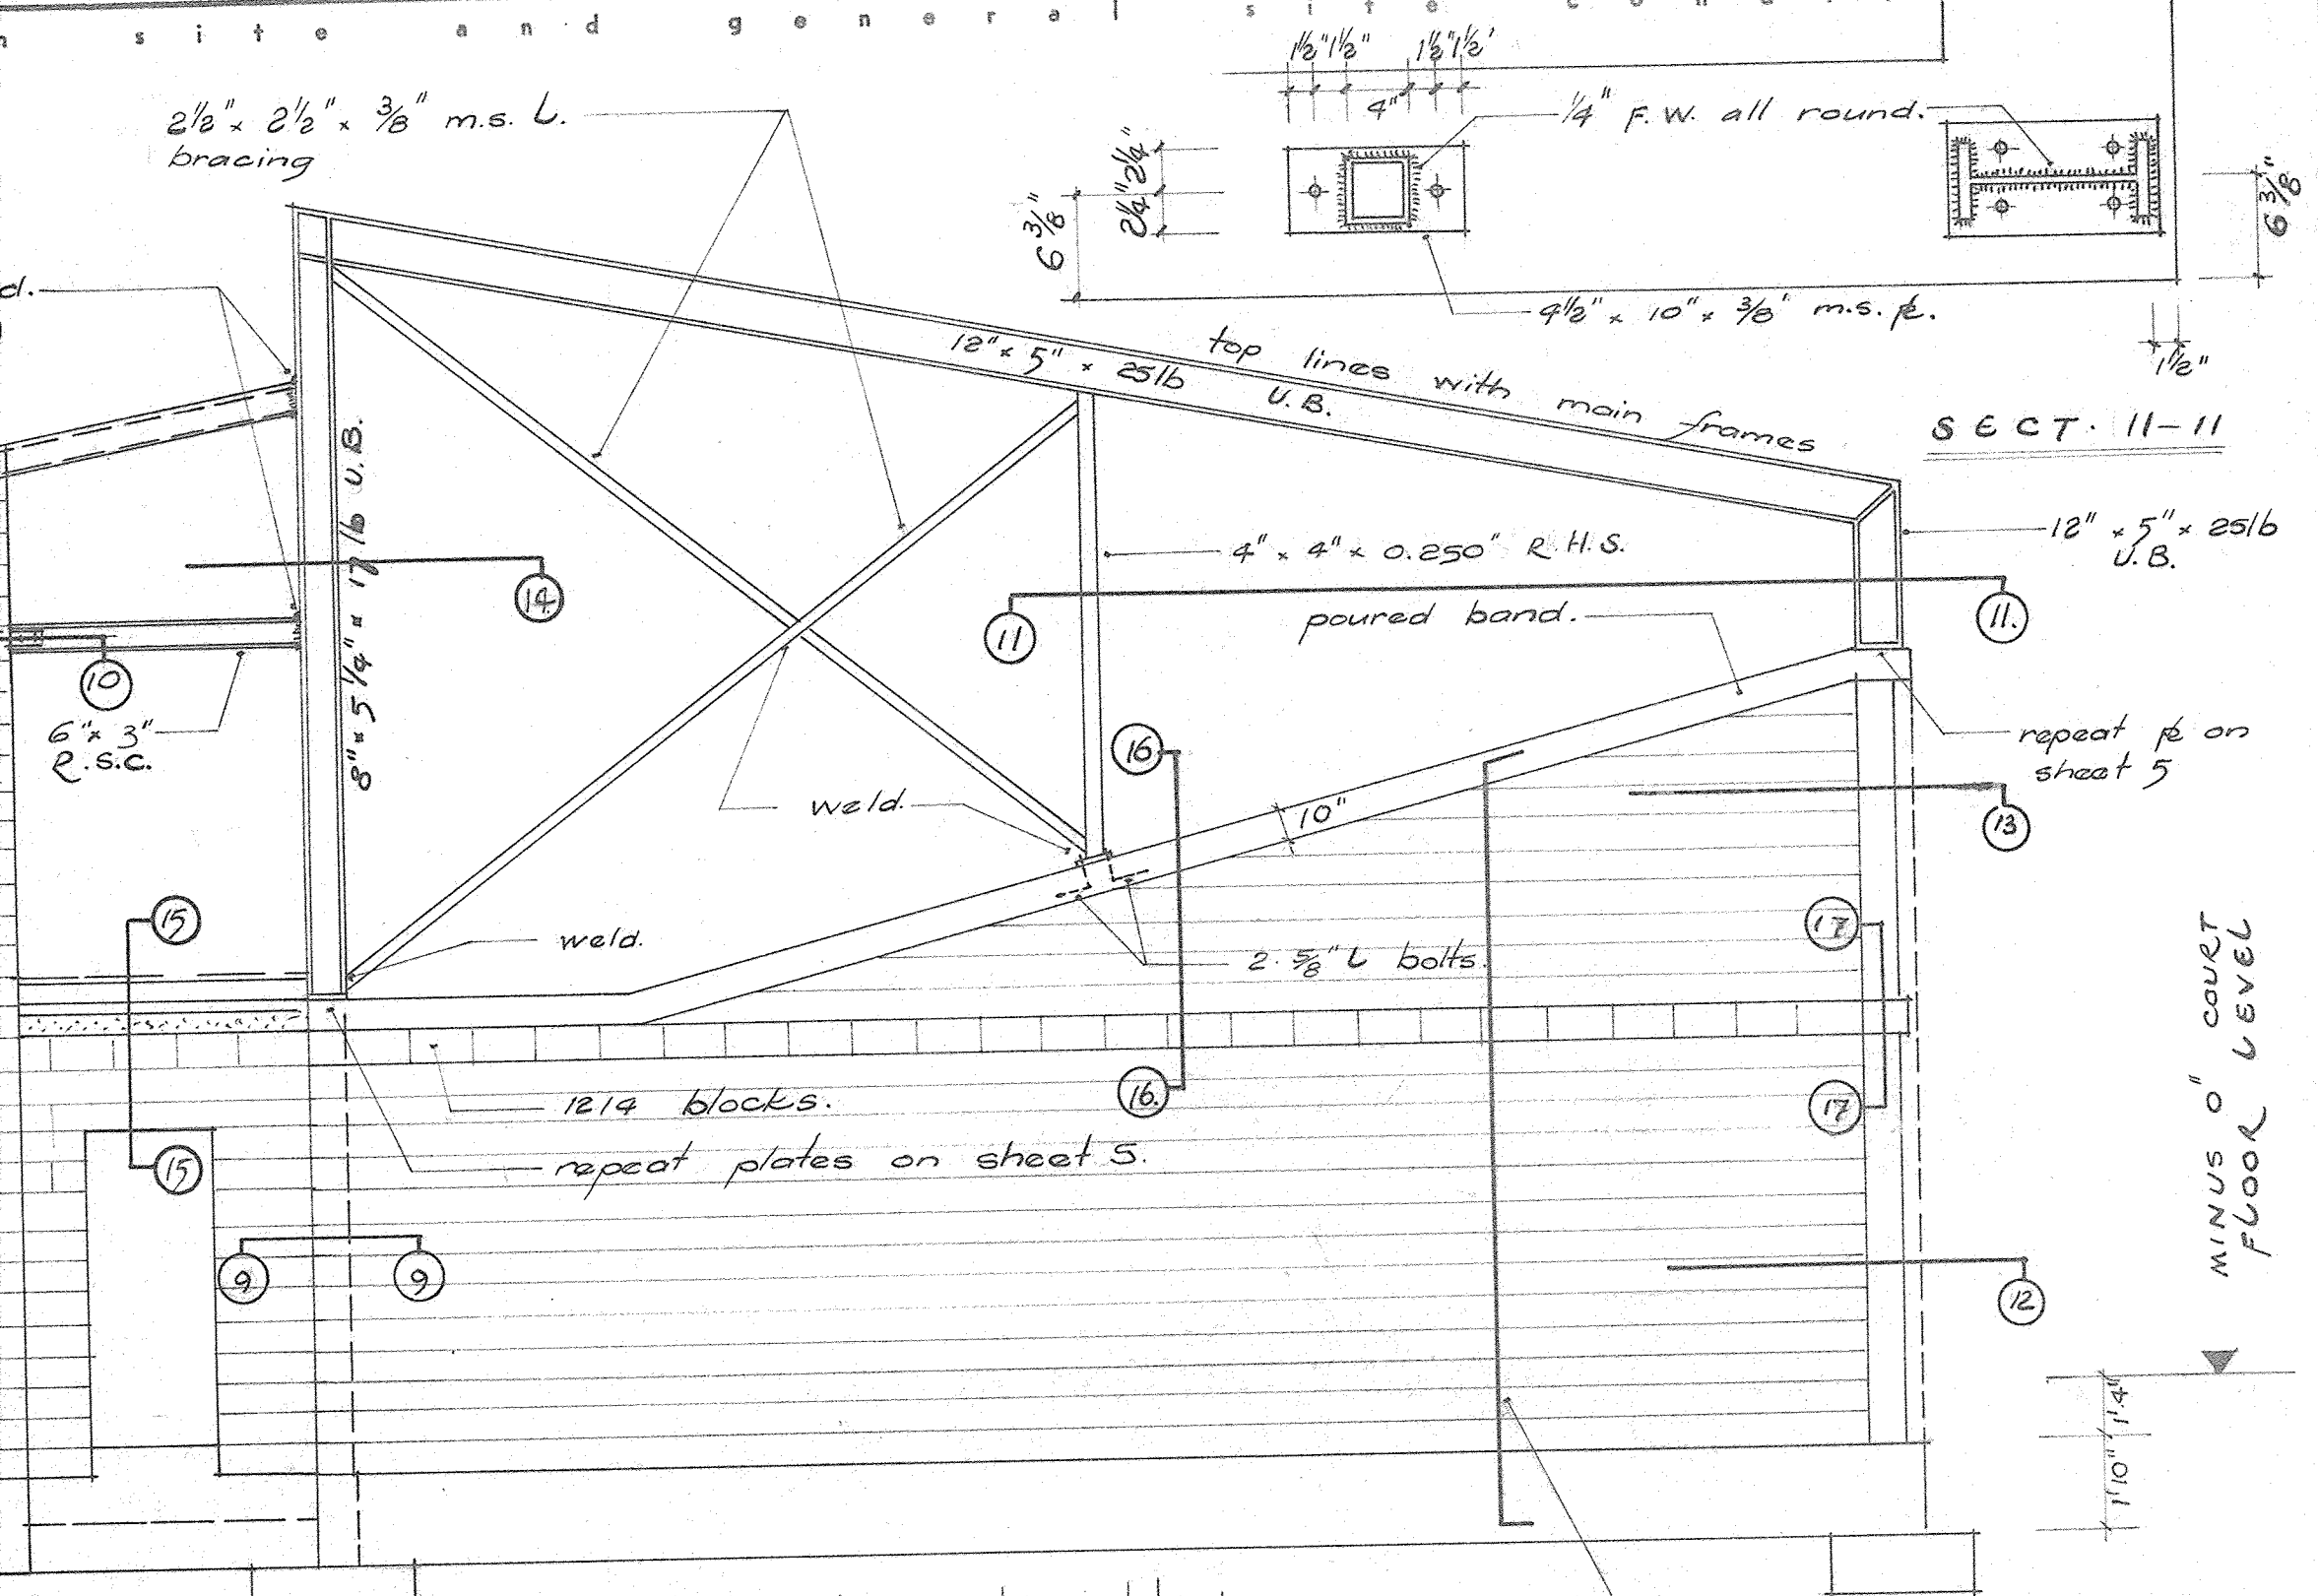
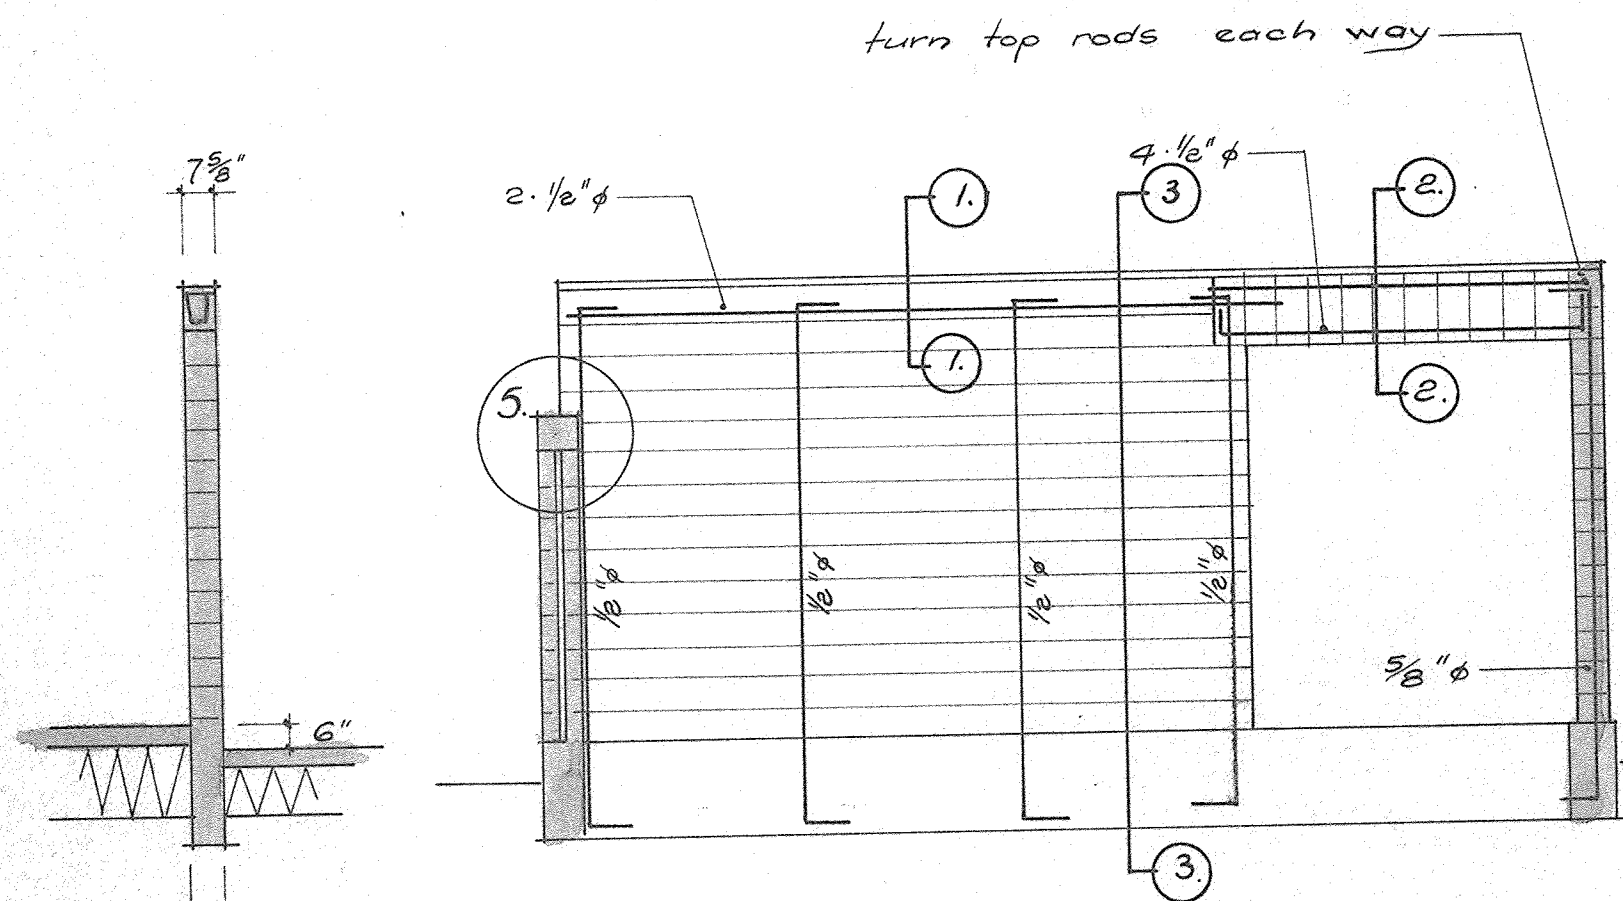
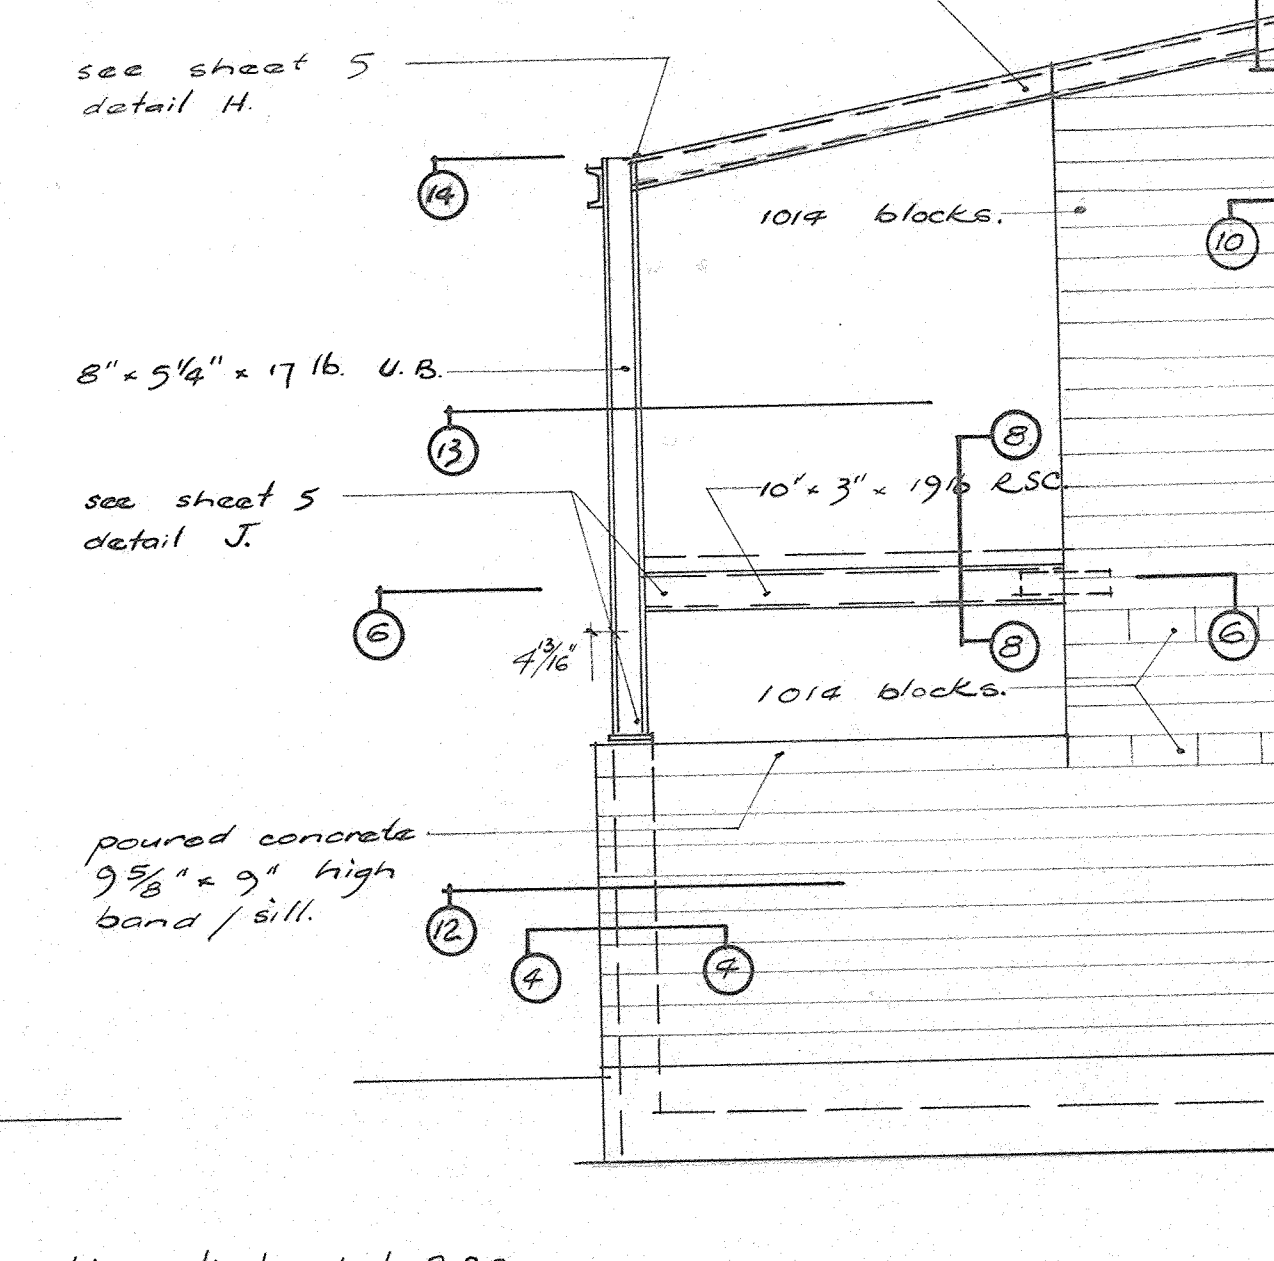
WALL BETWEEN LADIES DRESSING & STAIR LOBBY

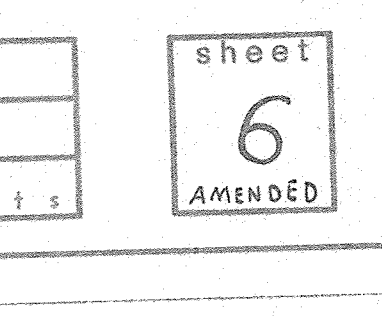
Contractors are to verify all measurements on site and general site conditions
