CLIENTS | PEOPLE | PERFORMANCE

Sockburn Squash Centre
BU 1564-003 EQ2
Detailed Engineering Evaluation
Quantitative Report
Version FINAL-11/4/13

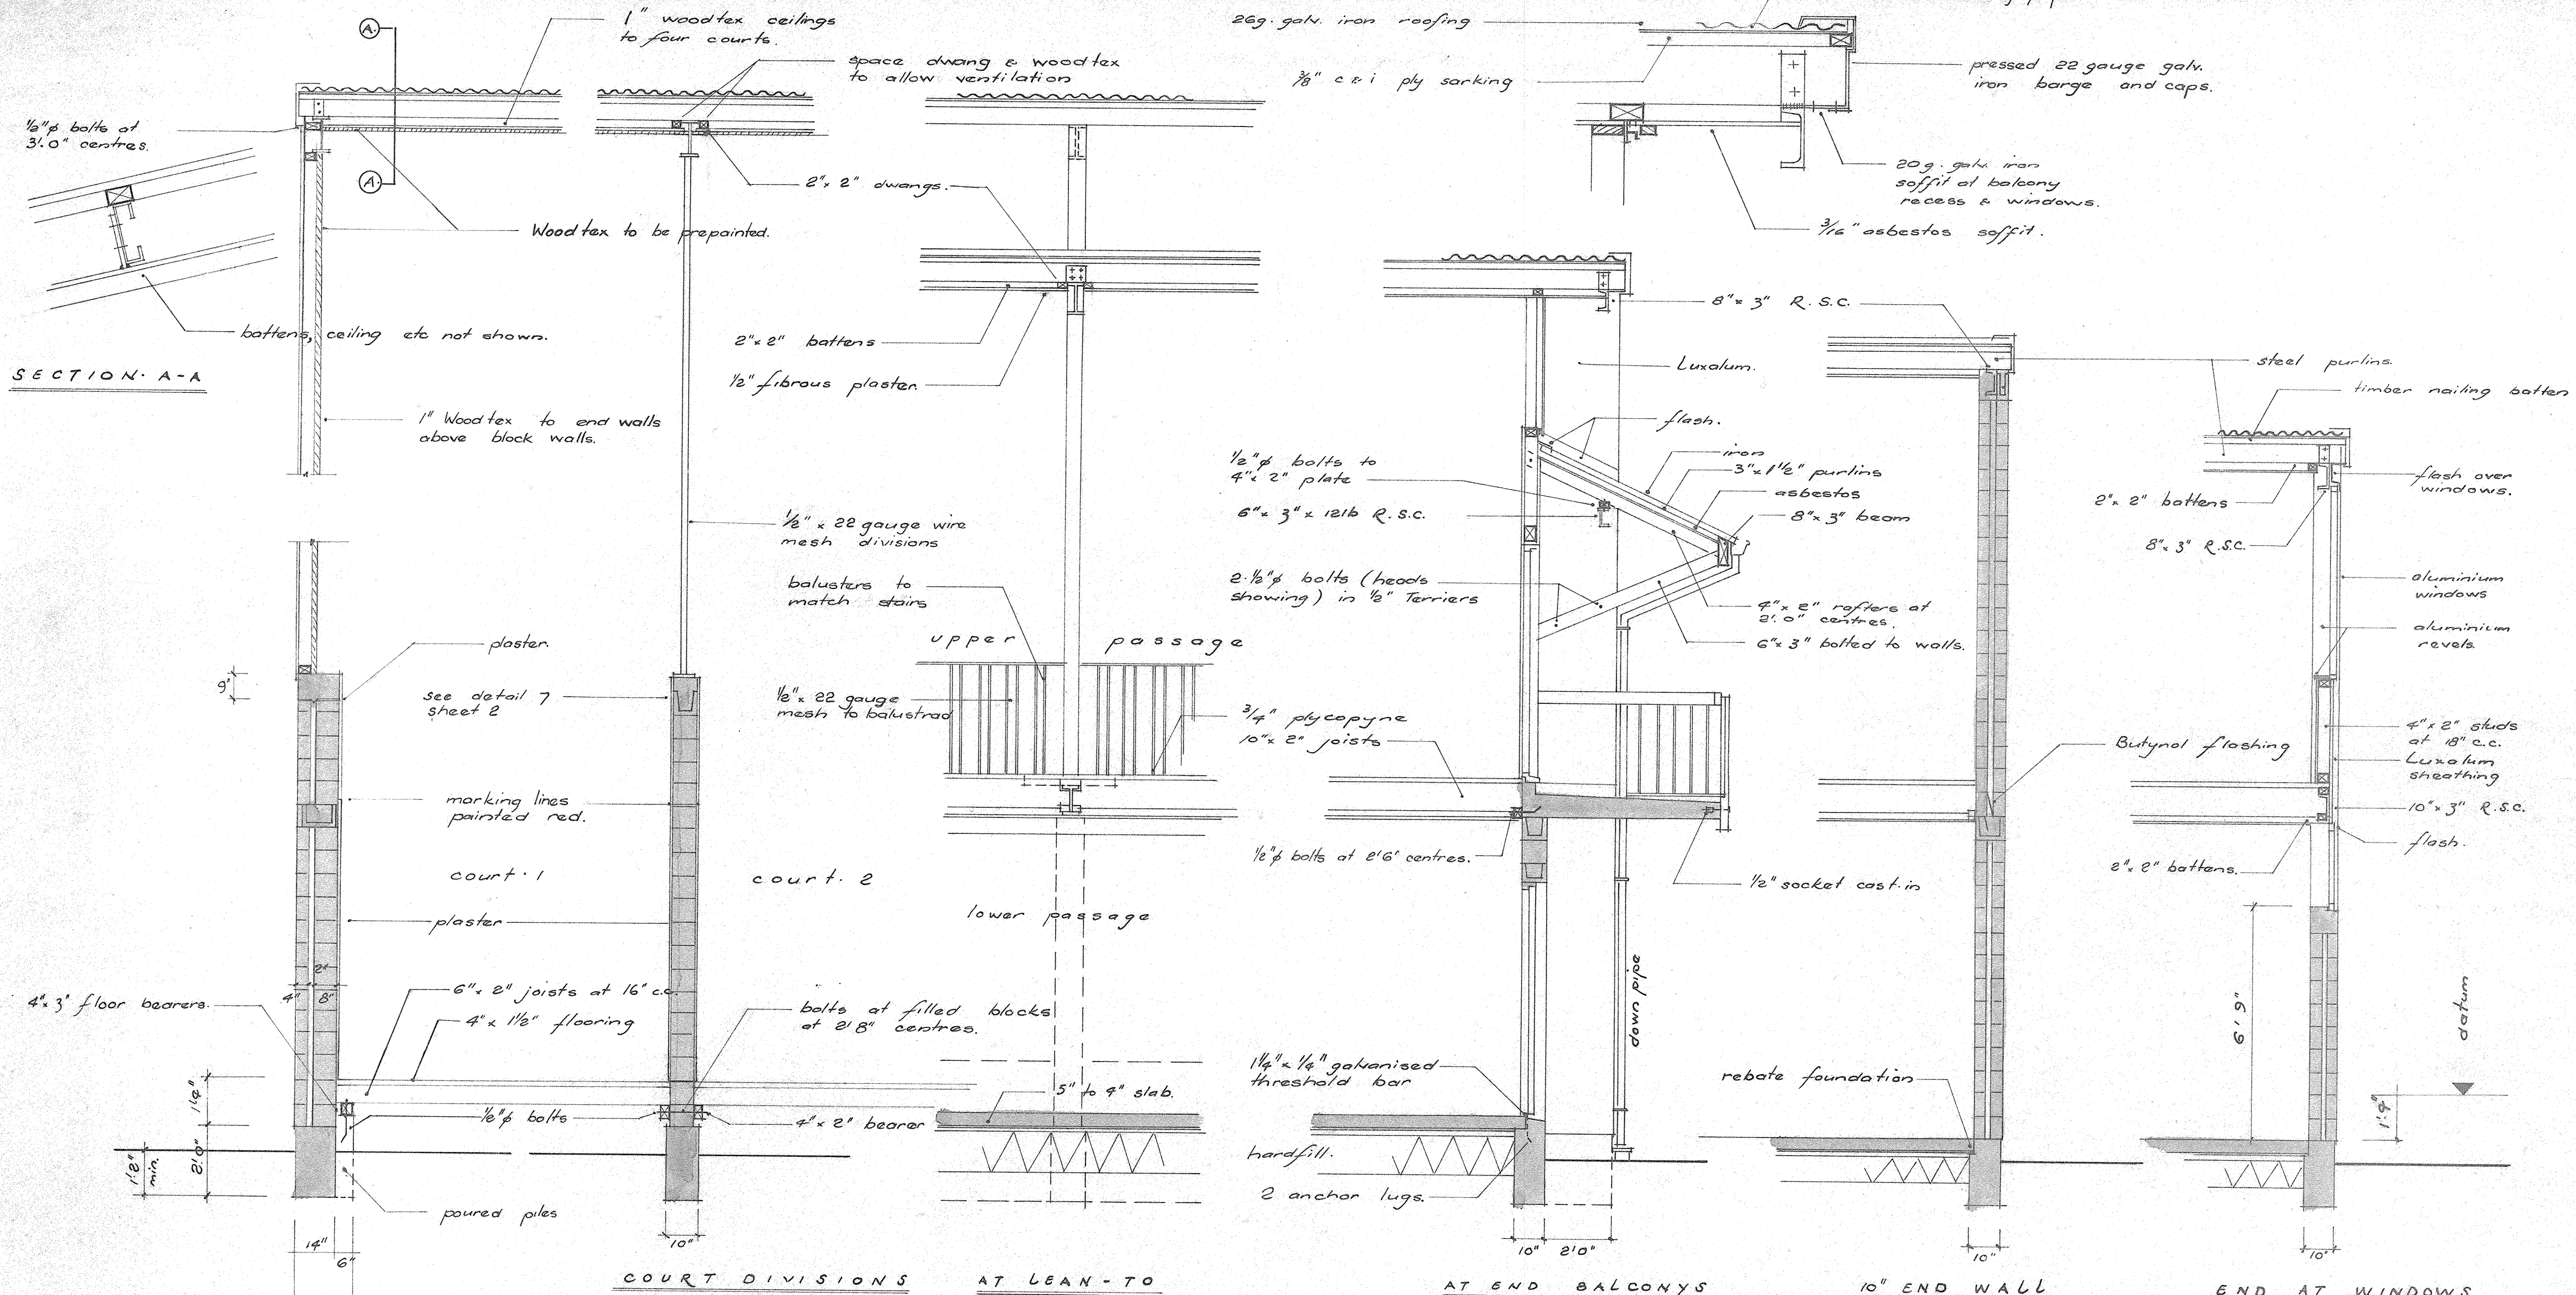
SQUASH COURTS FOR THE PAPARUA COUNTY COUNCIL

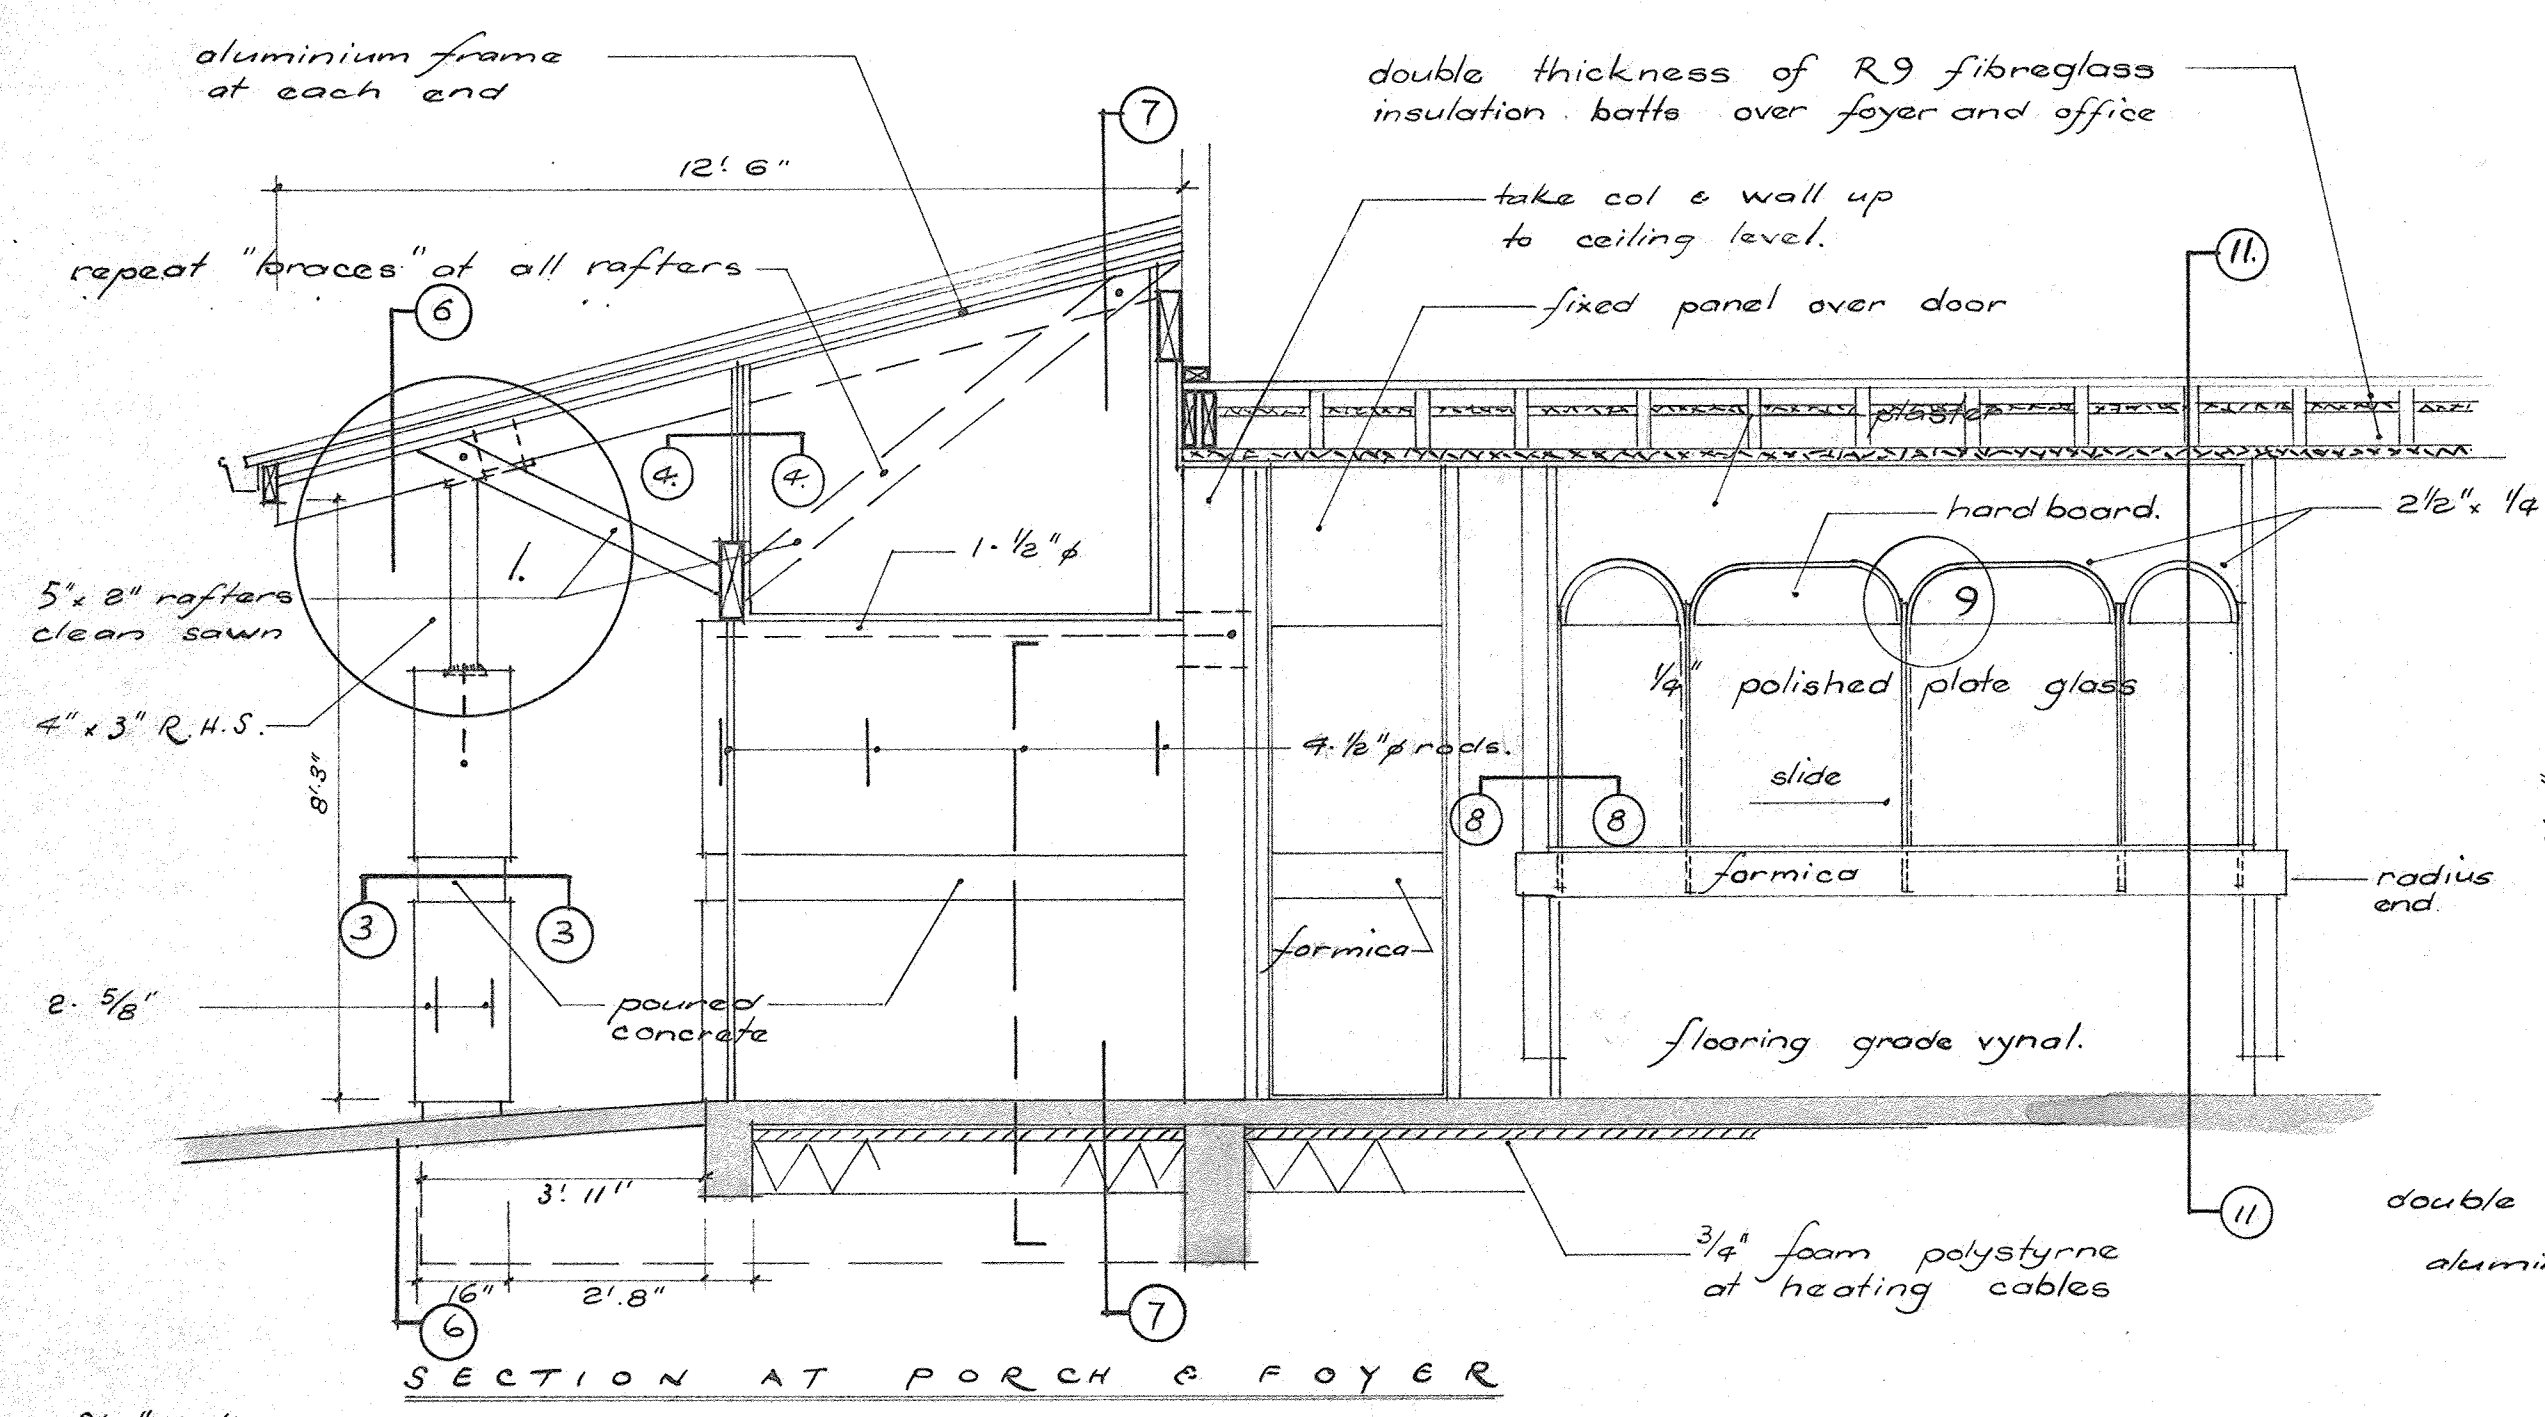
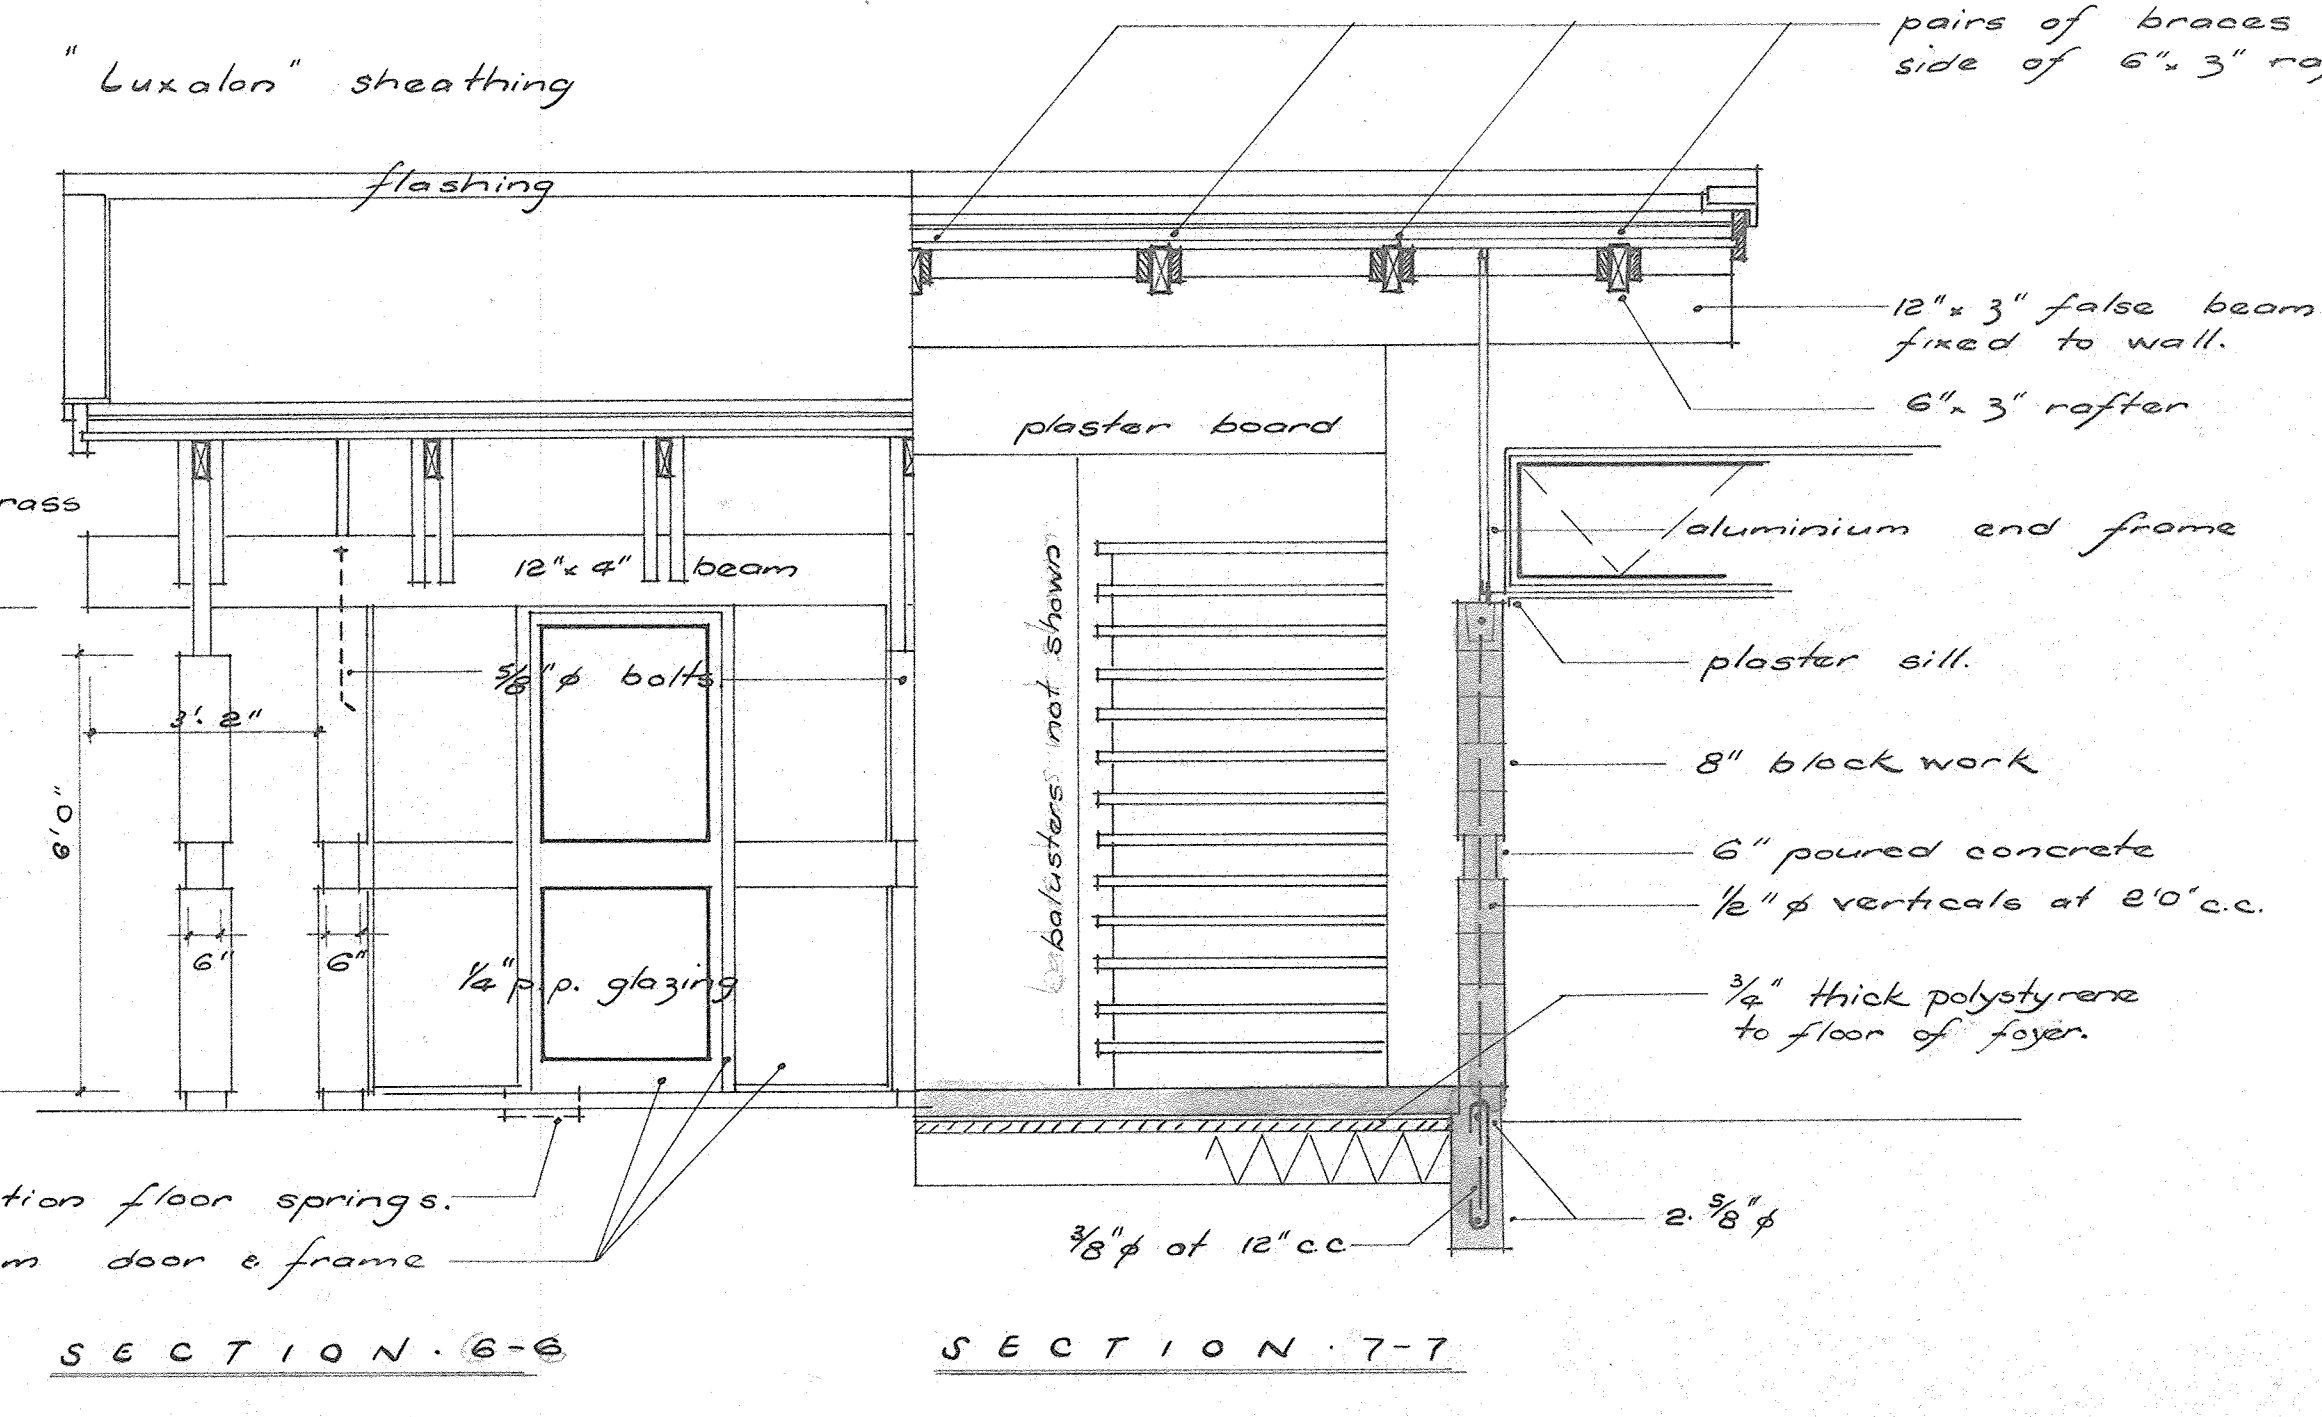
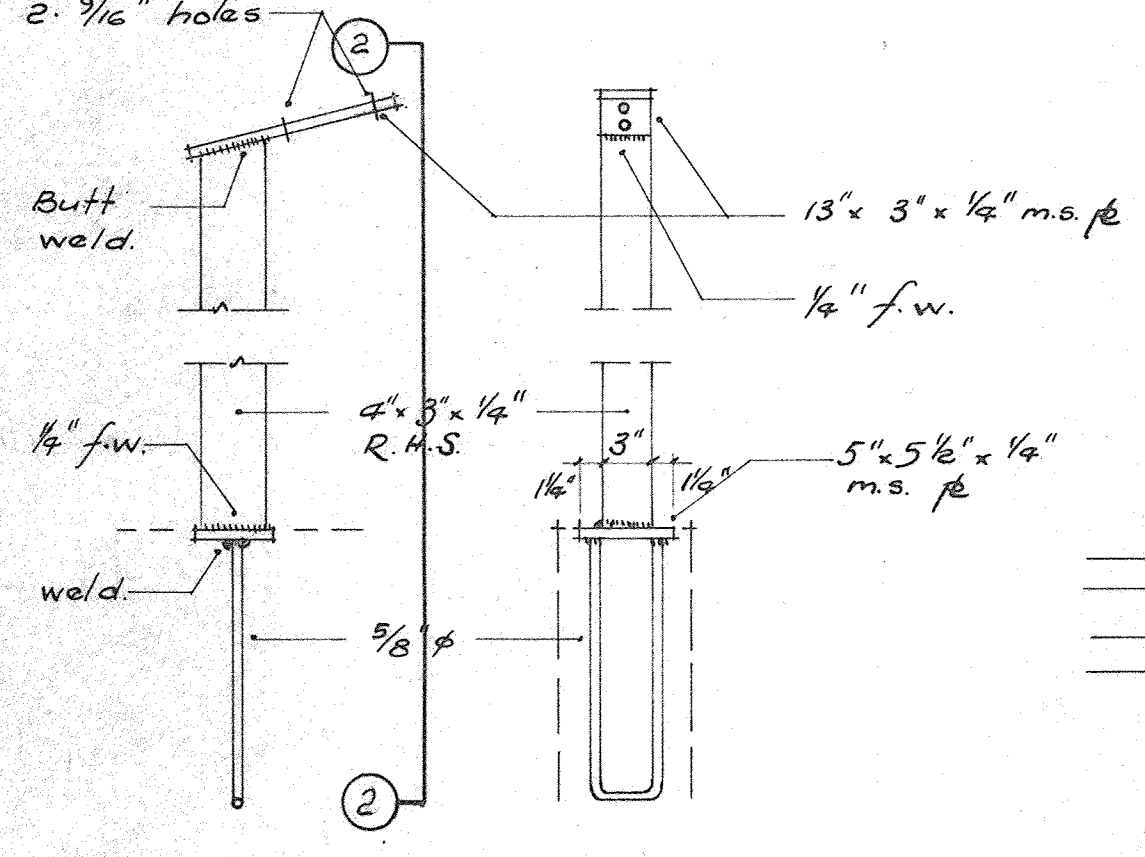
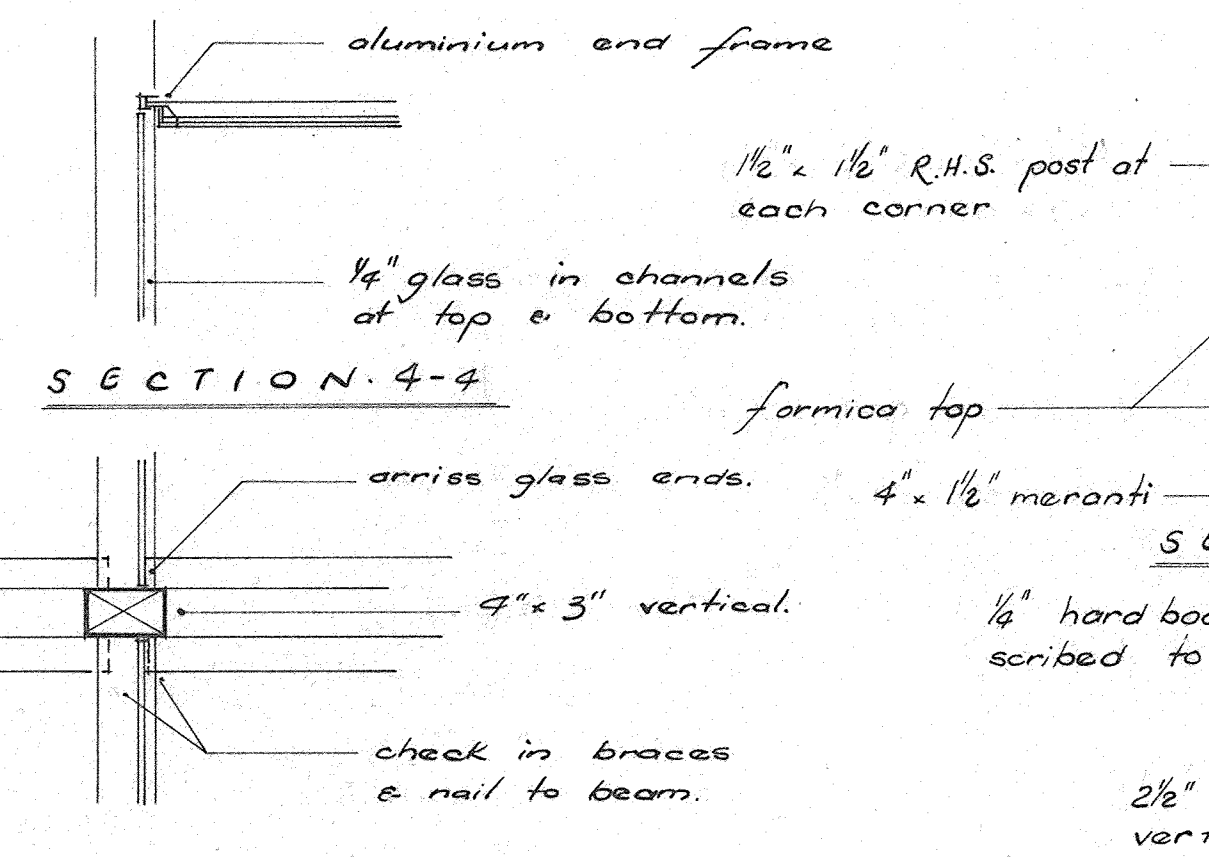
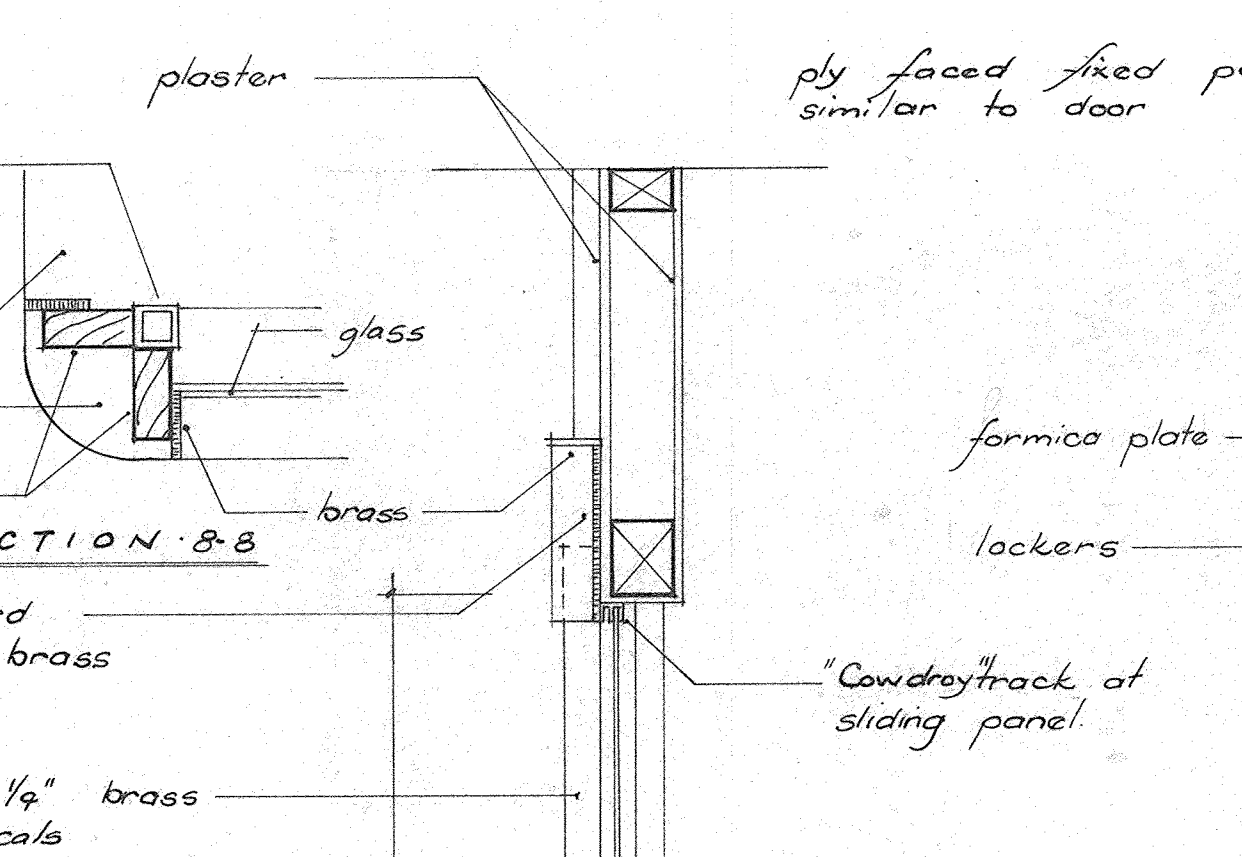
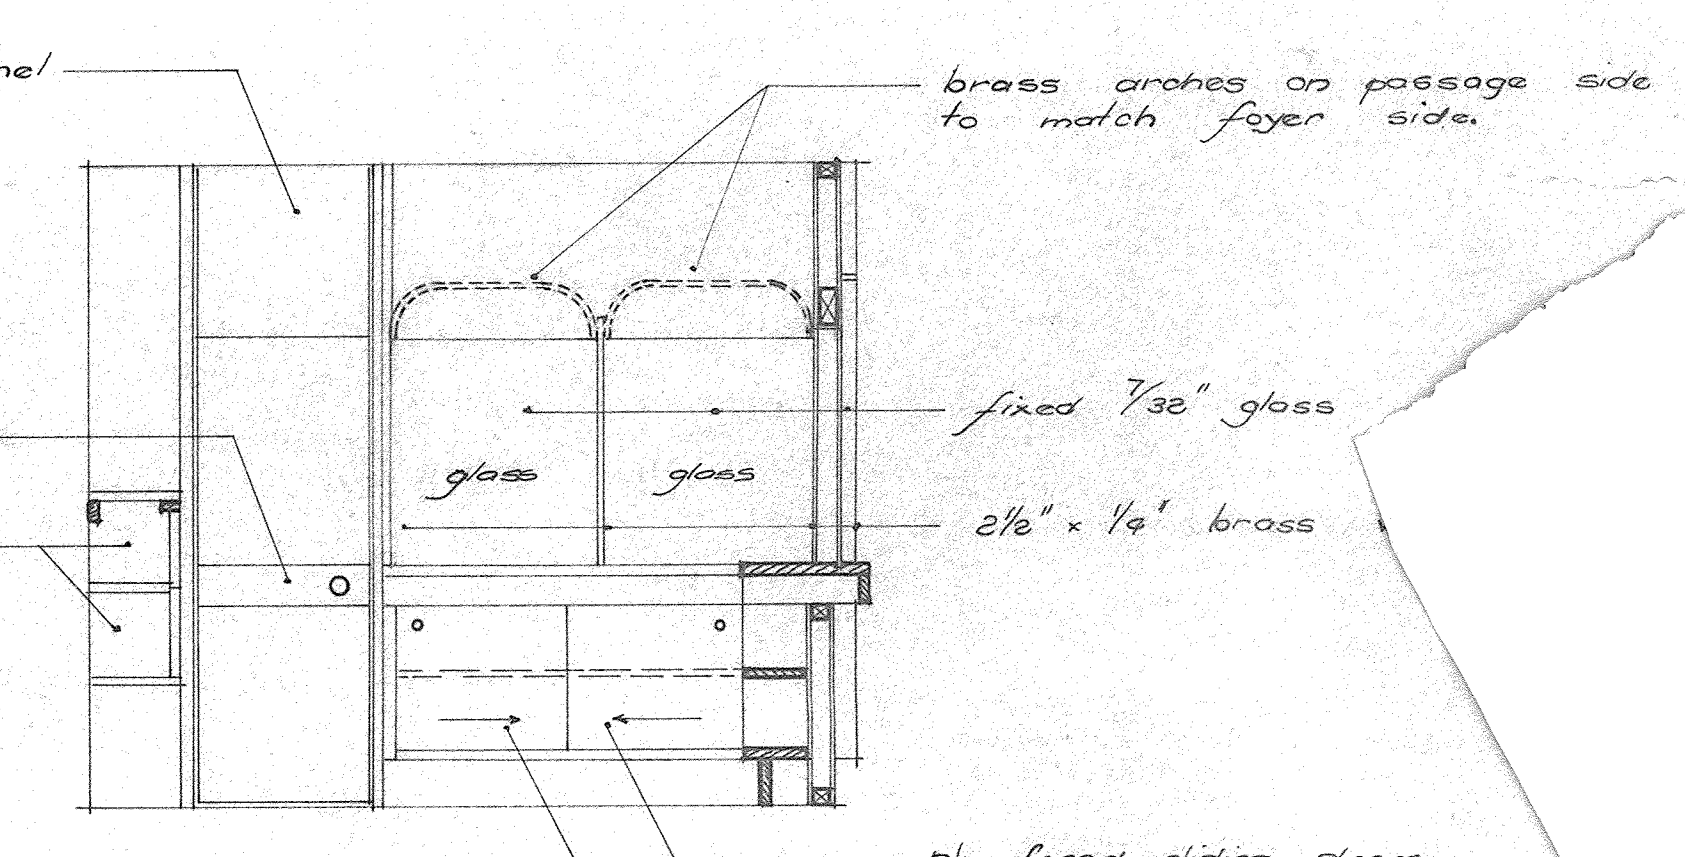
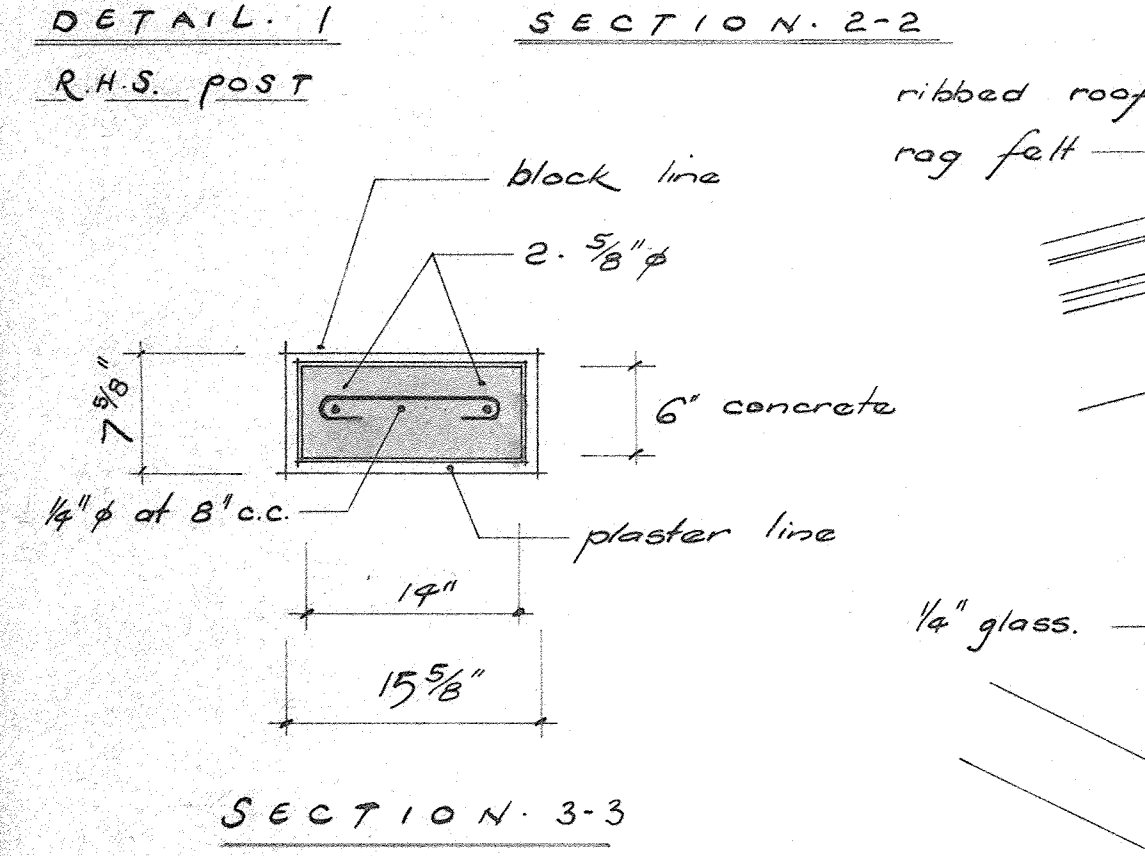
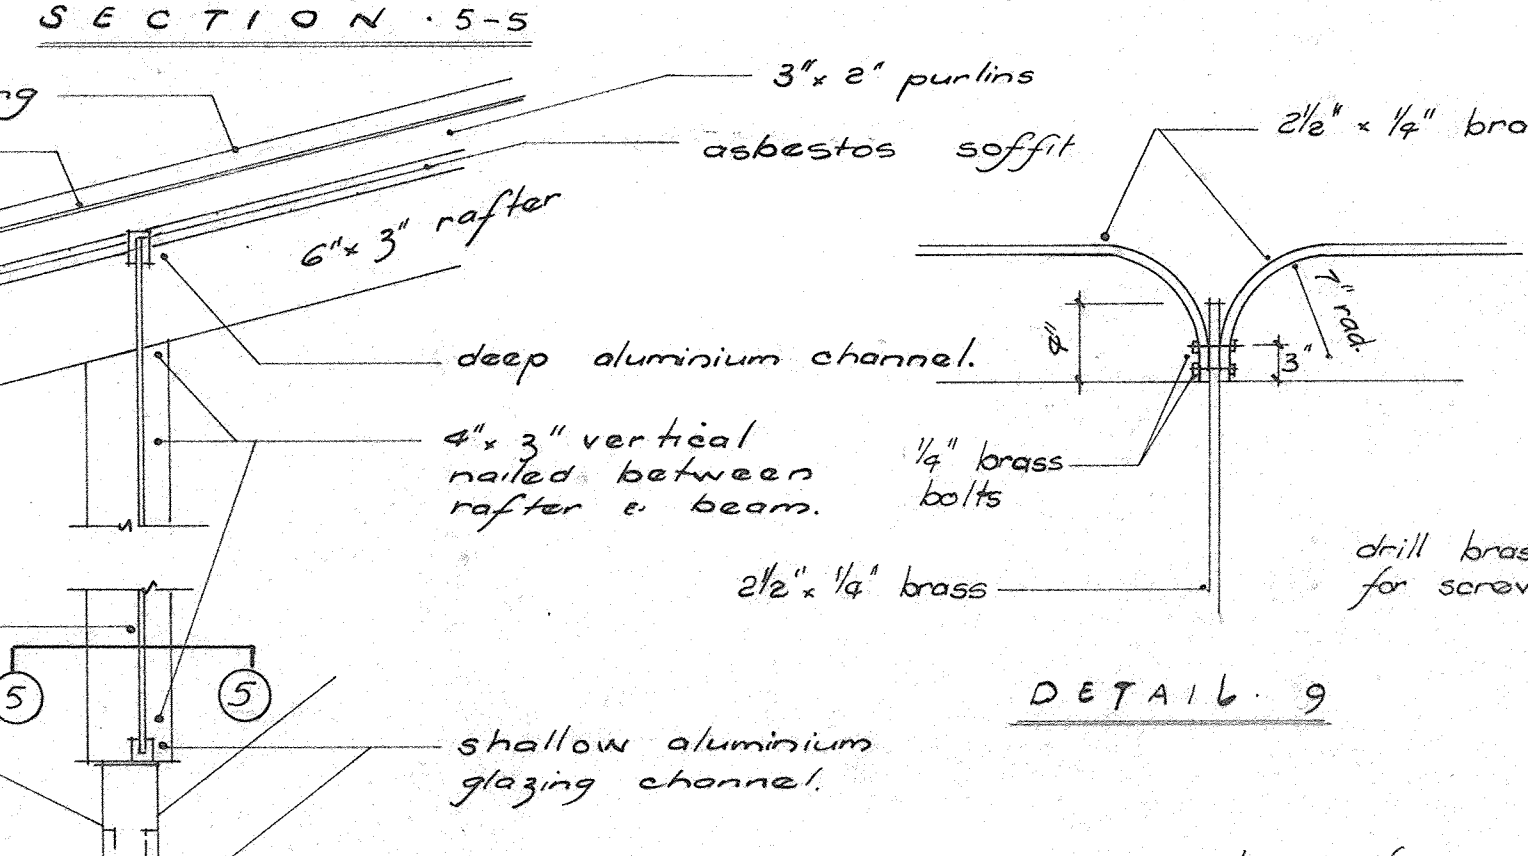
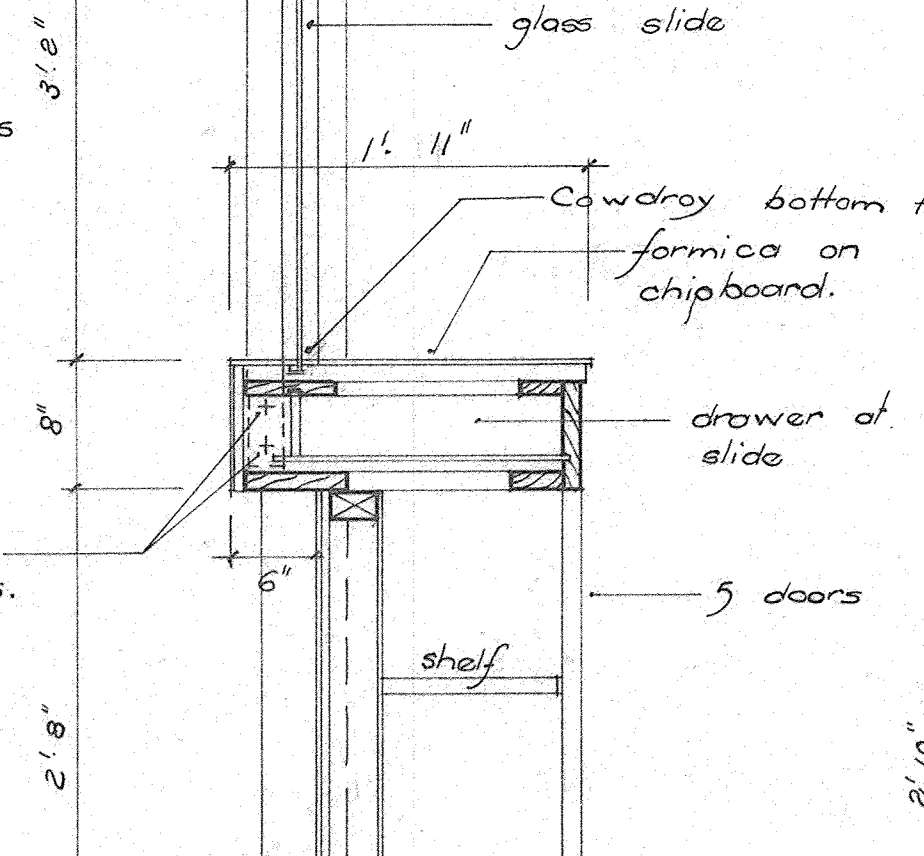
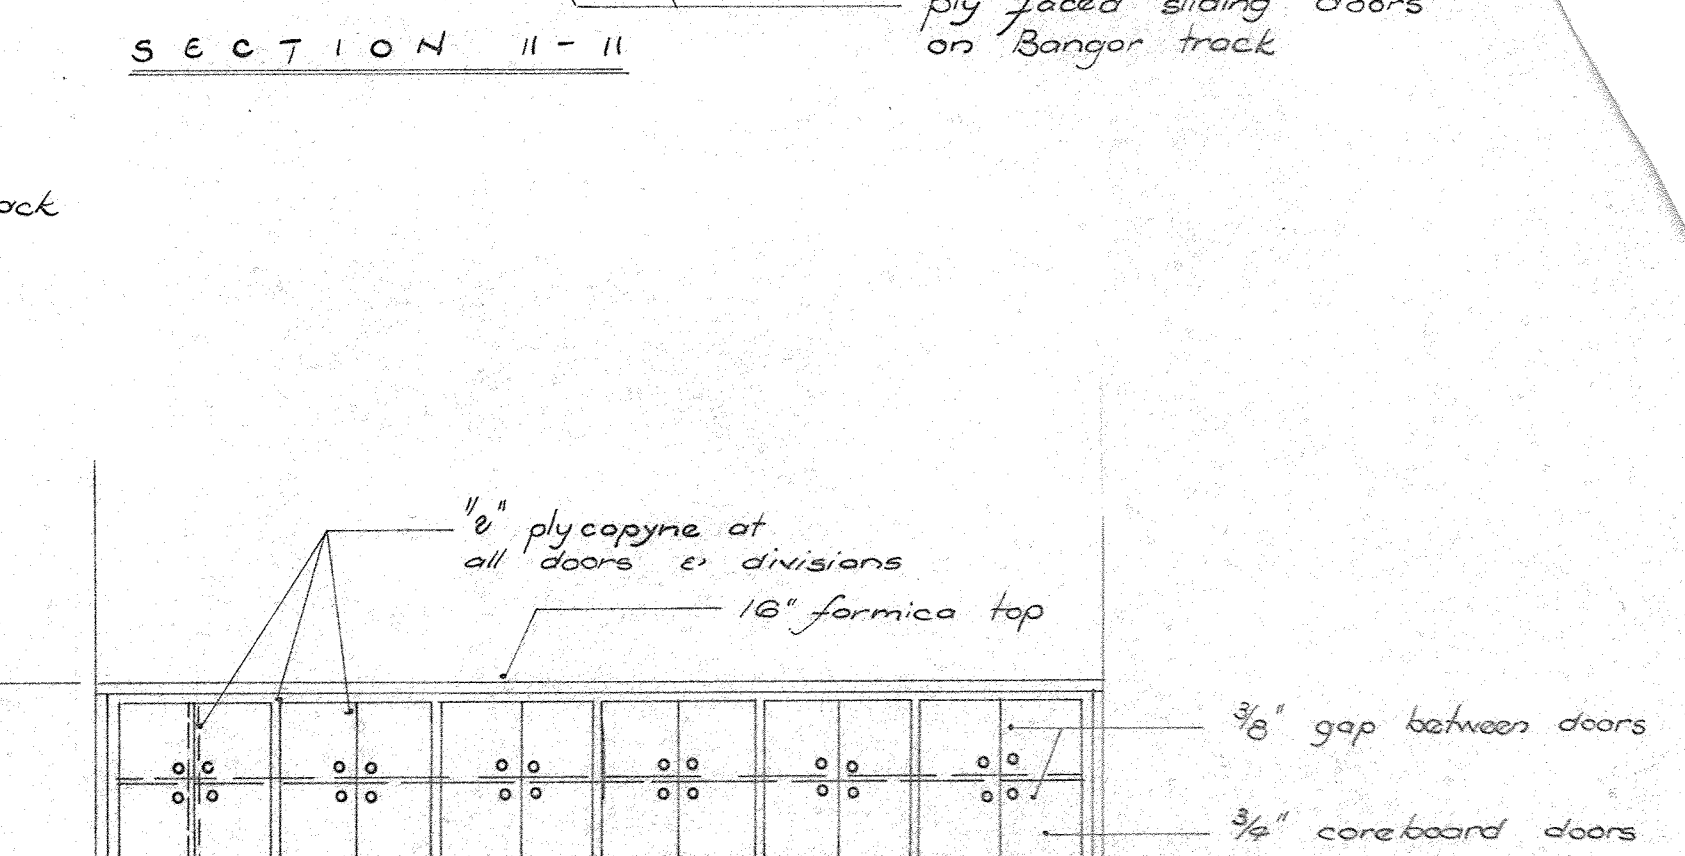
Contractors are to verify all measurements on site and general site conditions

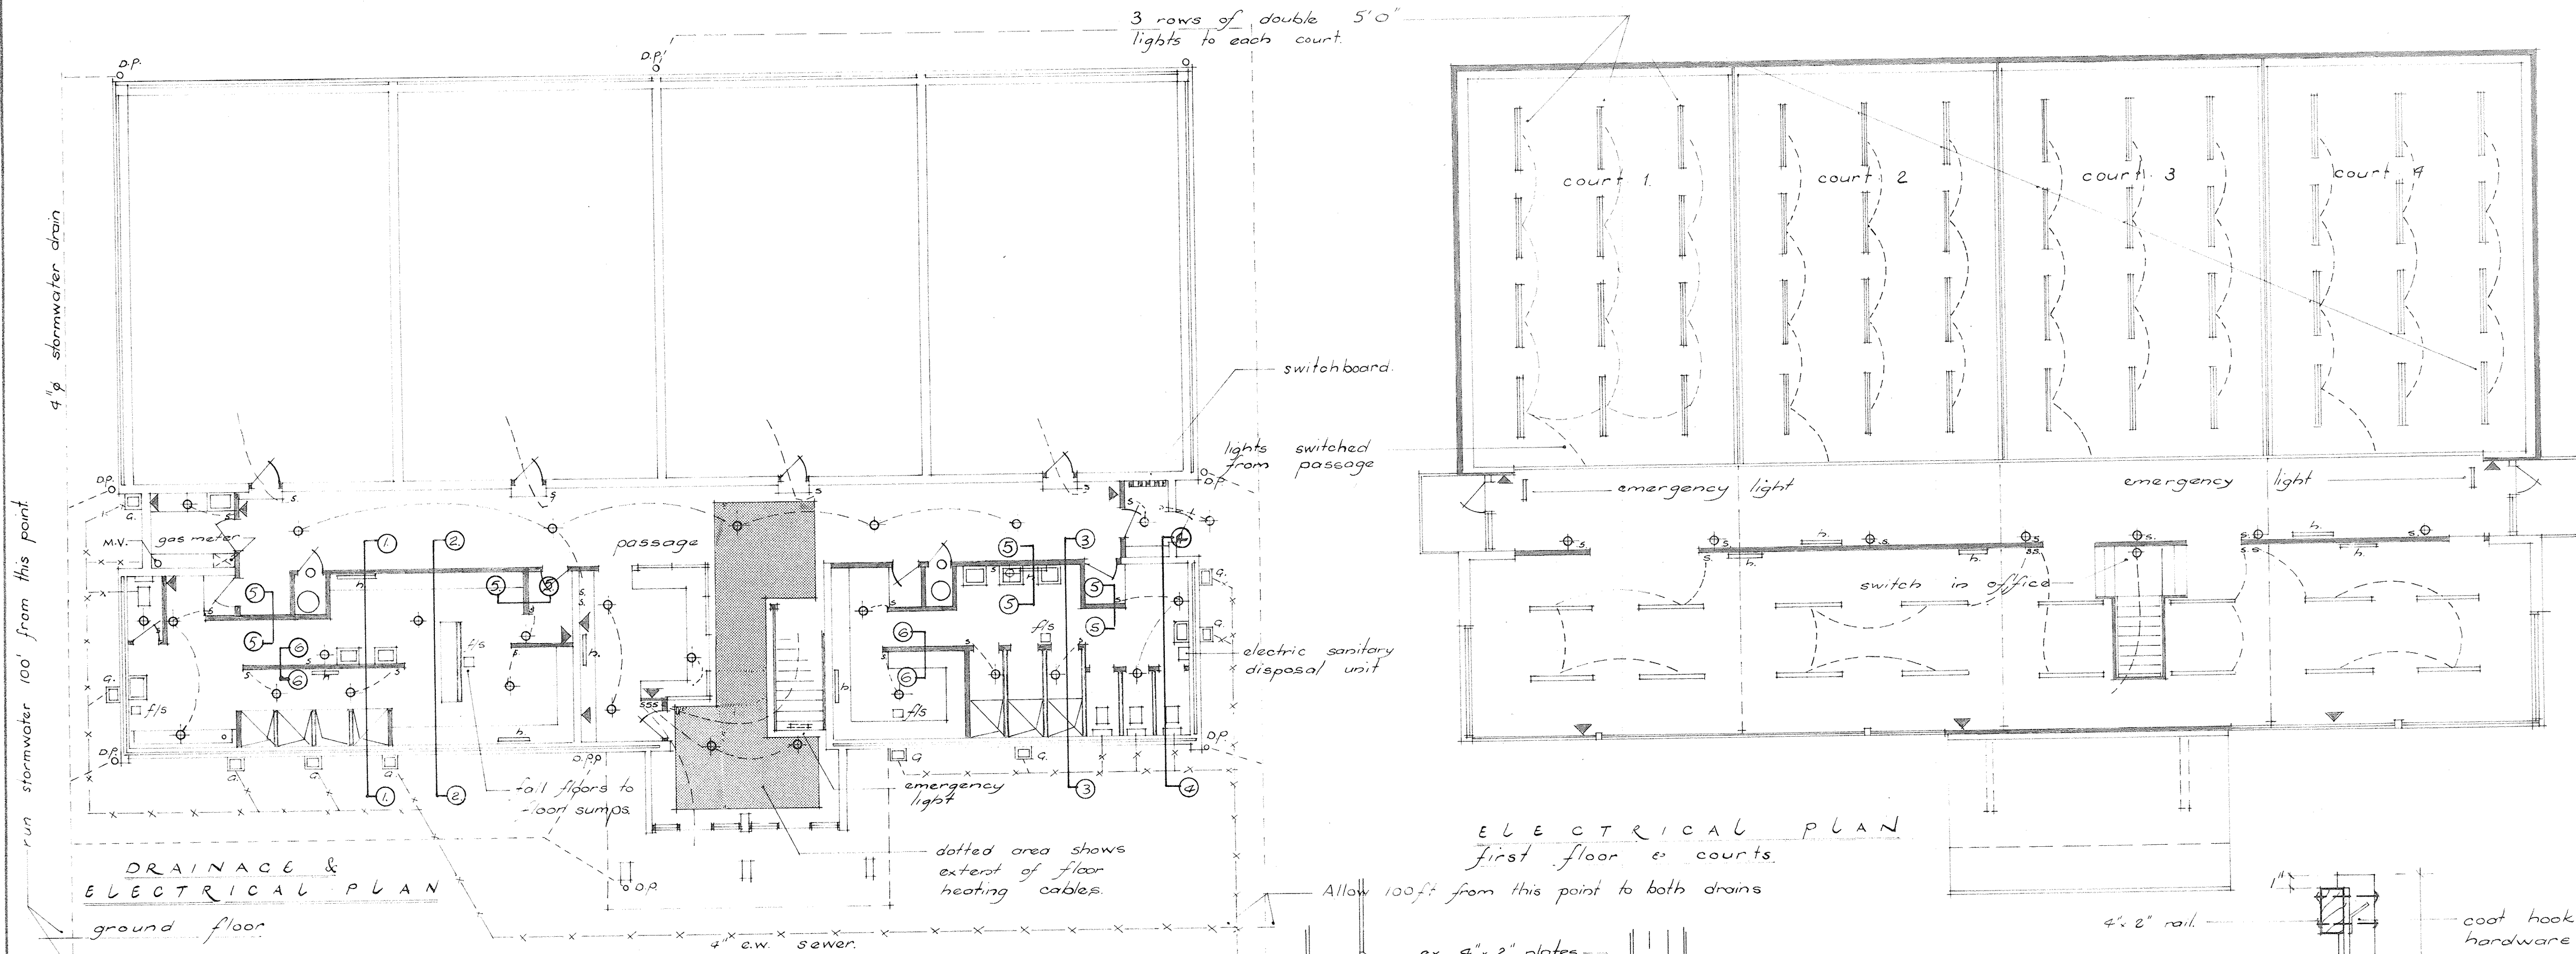
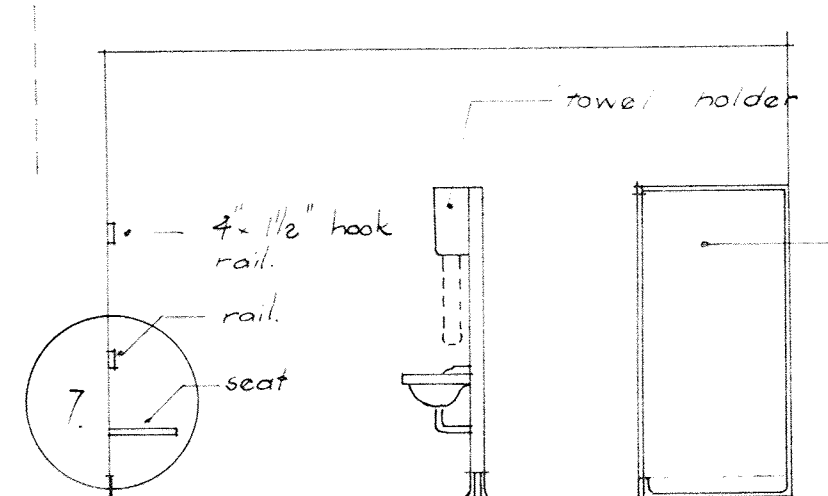
Contractors are to verify all measurements on site and general site conditions
