CLIENTS | PEOPLE | PERFORMANCE

Sockburn Squash Centre
BU 1564-003 EQ2
Detailed Engineering Evaluation
Quantitative Report
Version FINAL-11/4/13

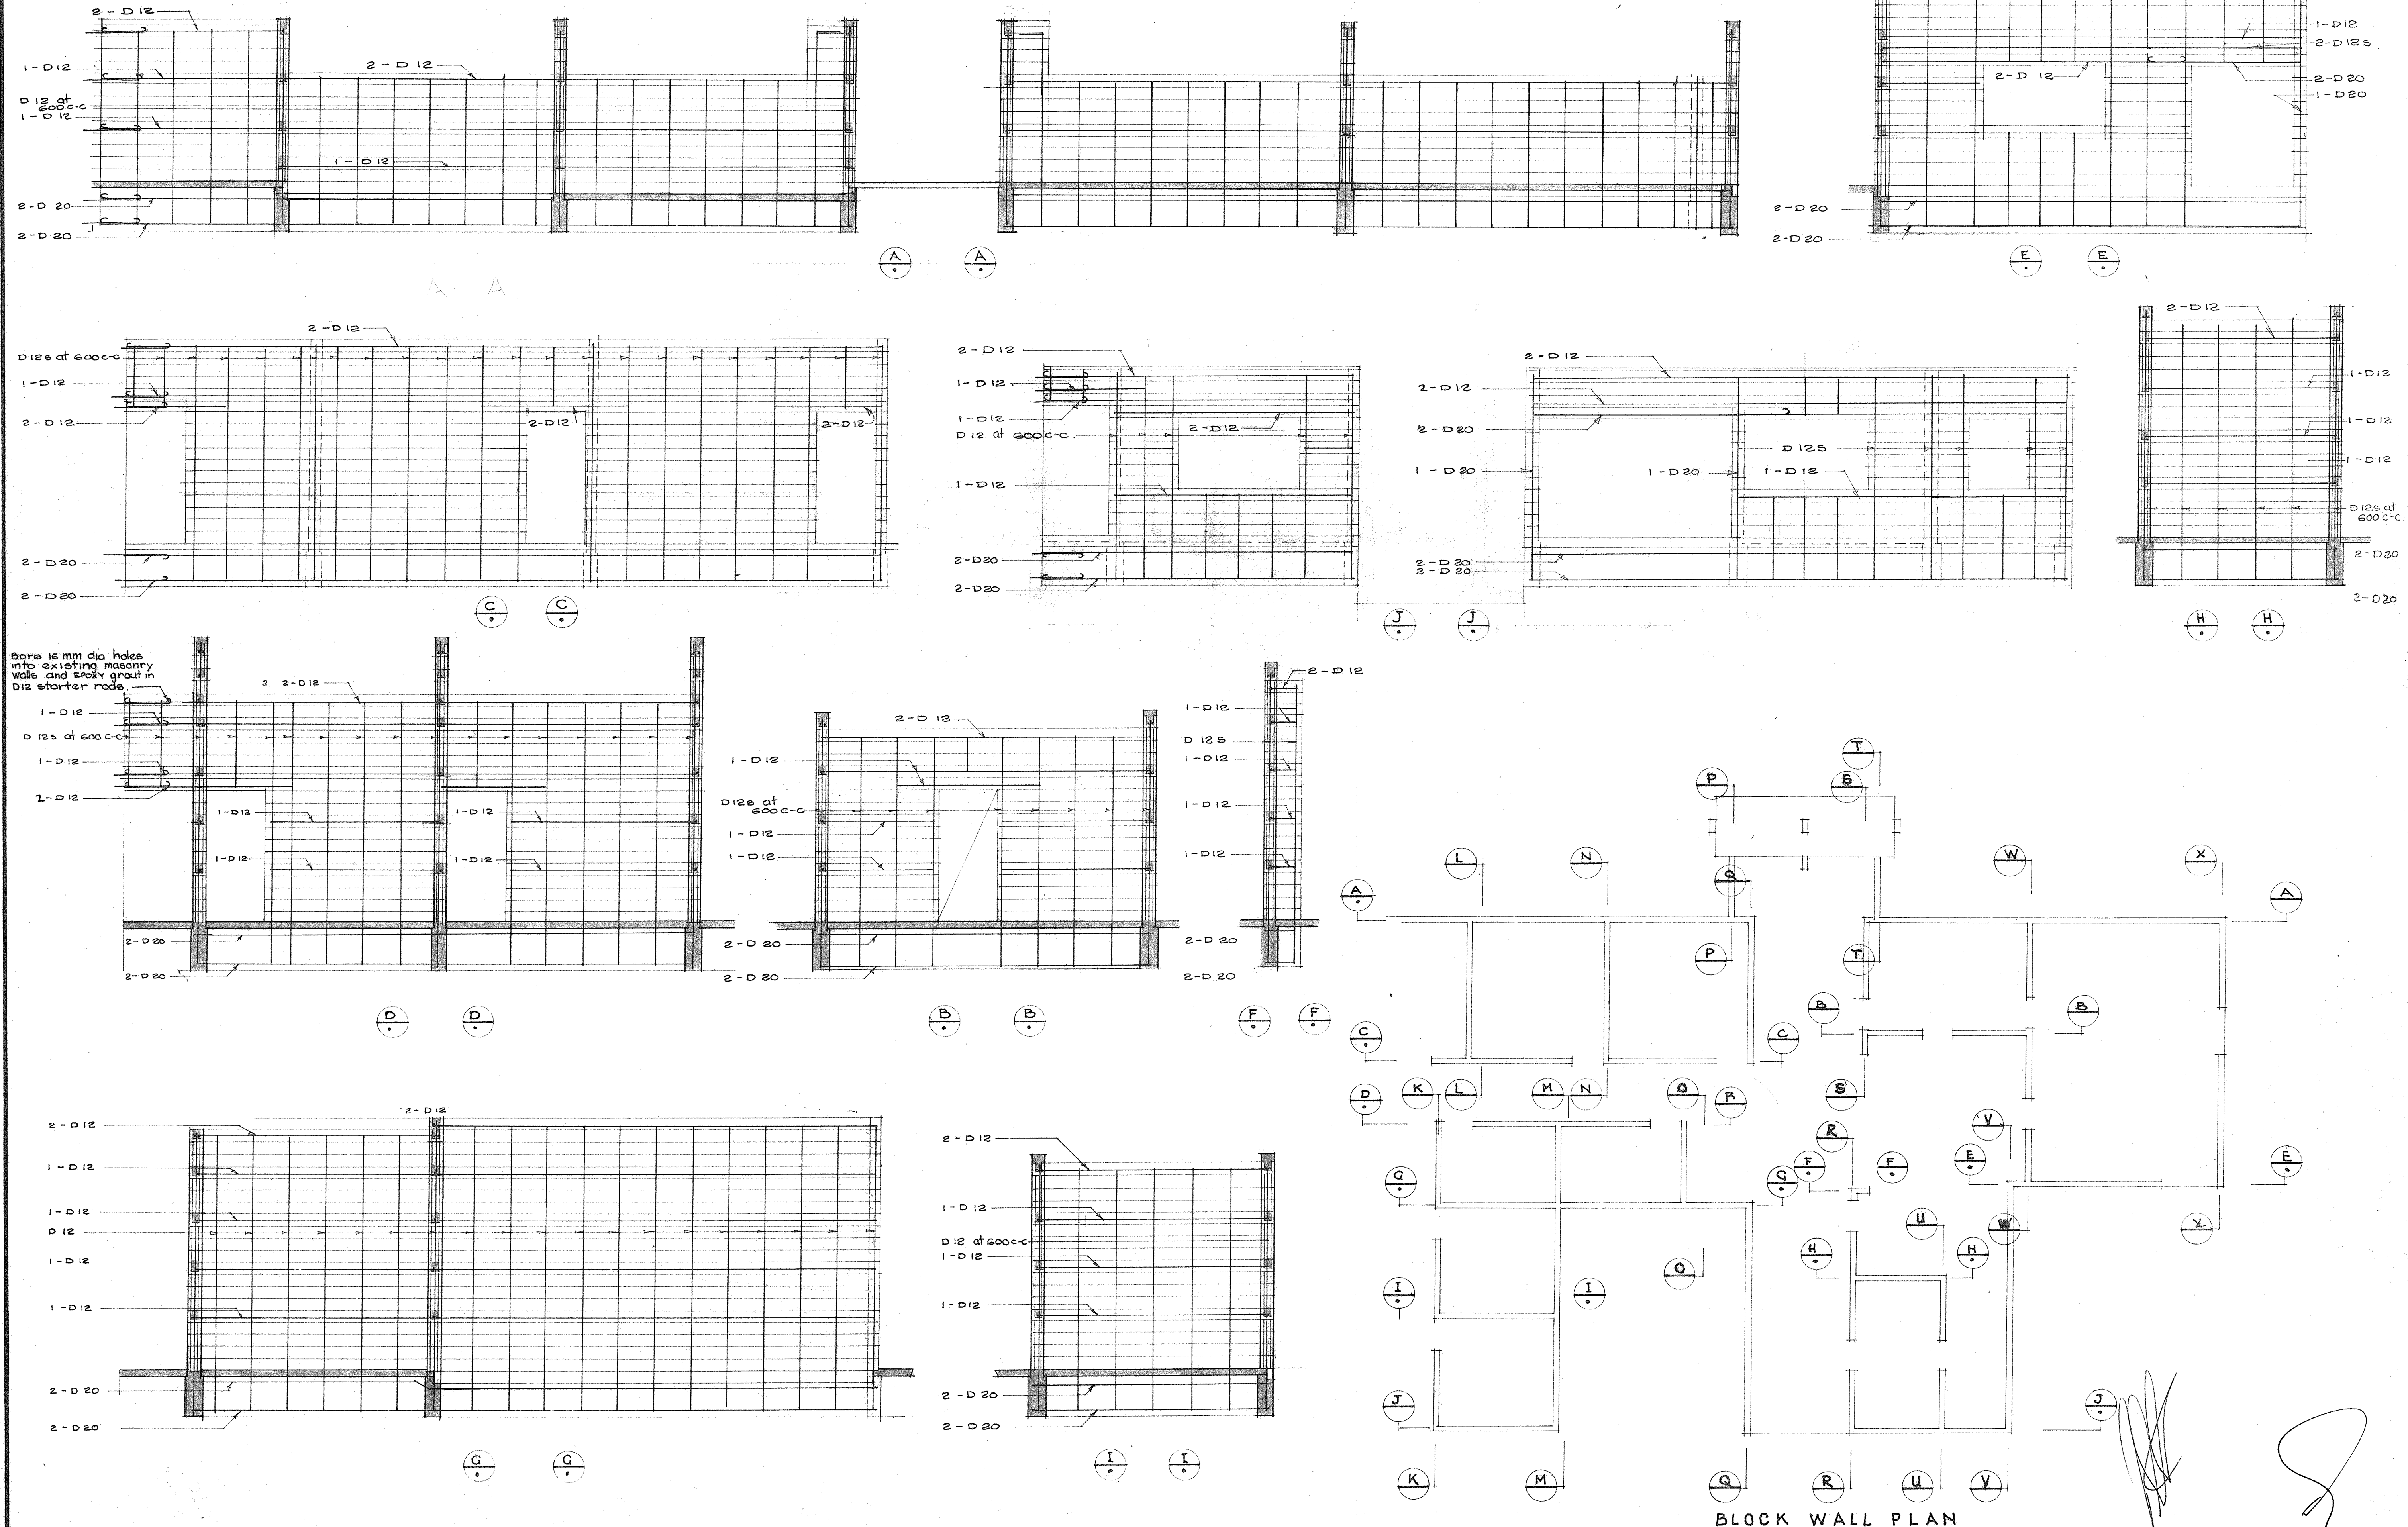
copyright arch goodwin design ltd

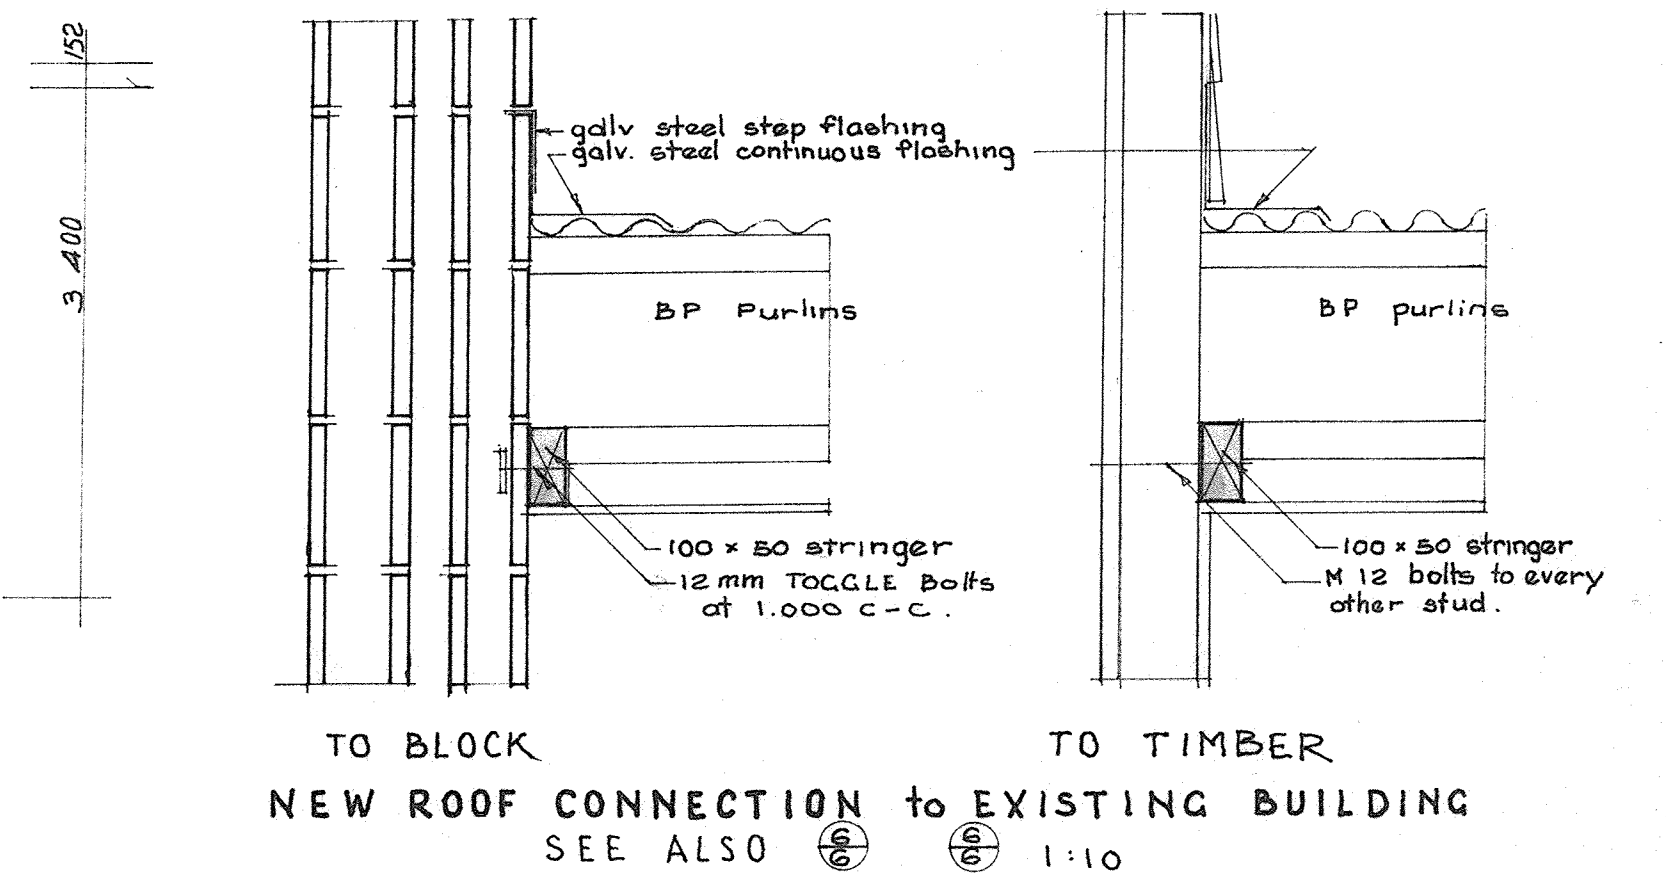
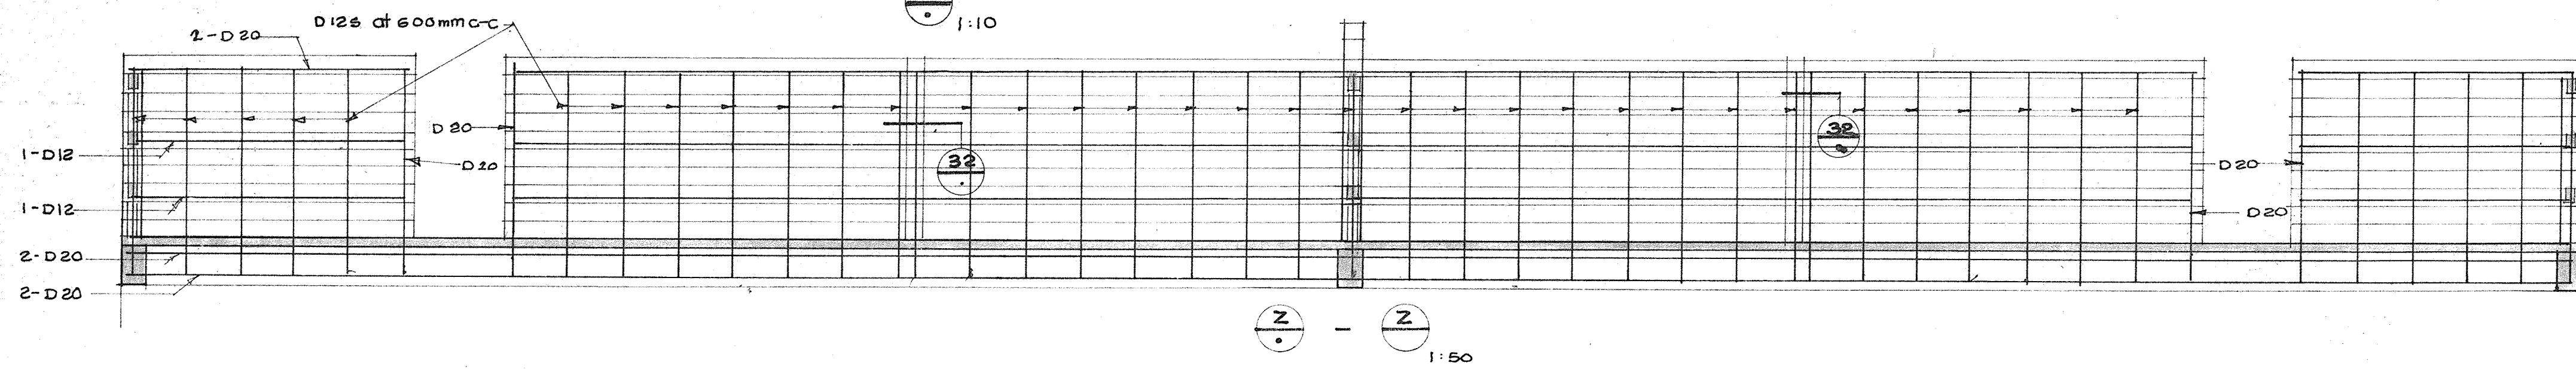
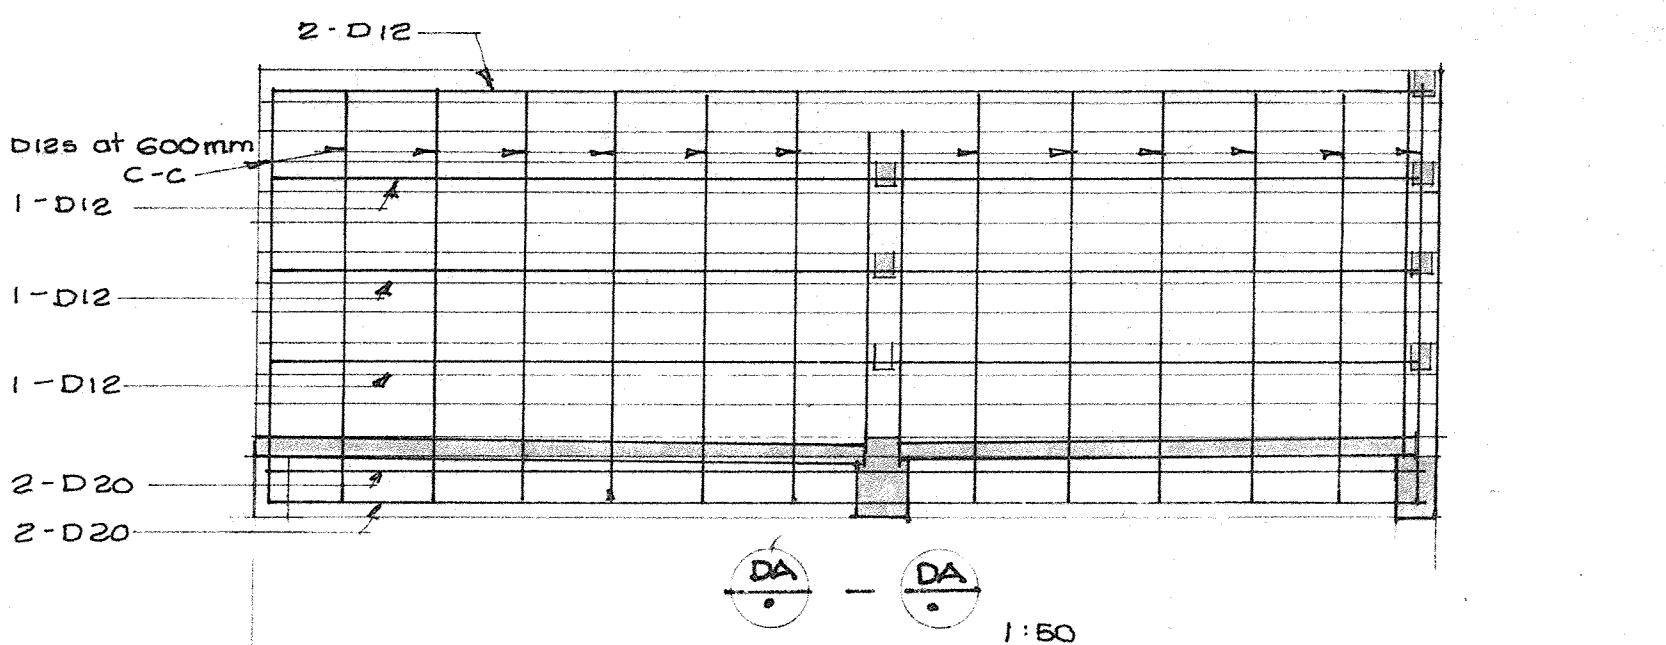
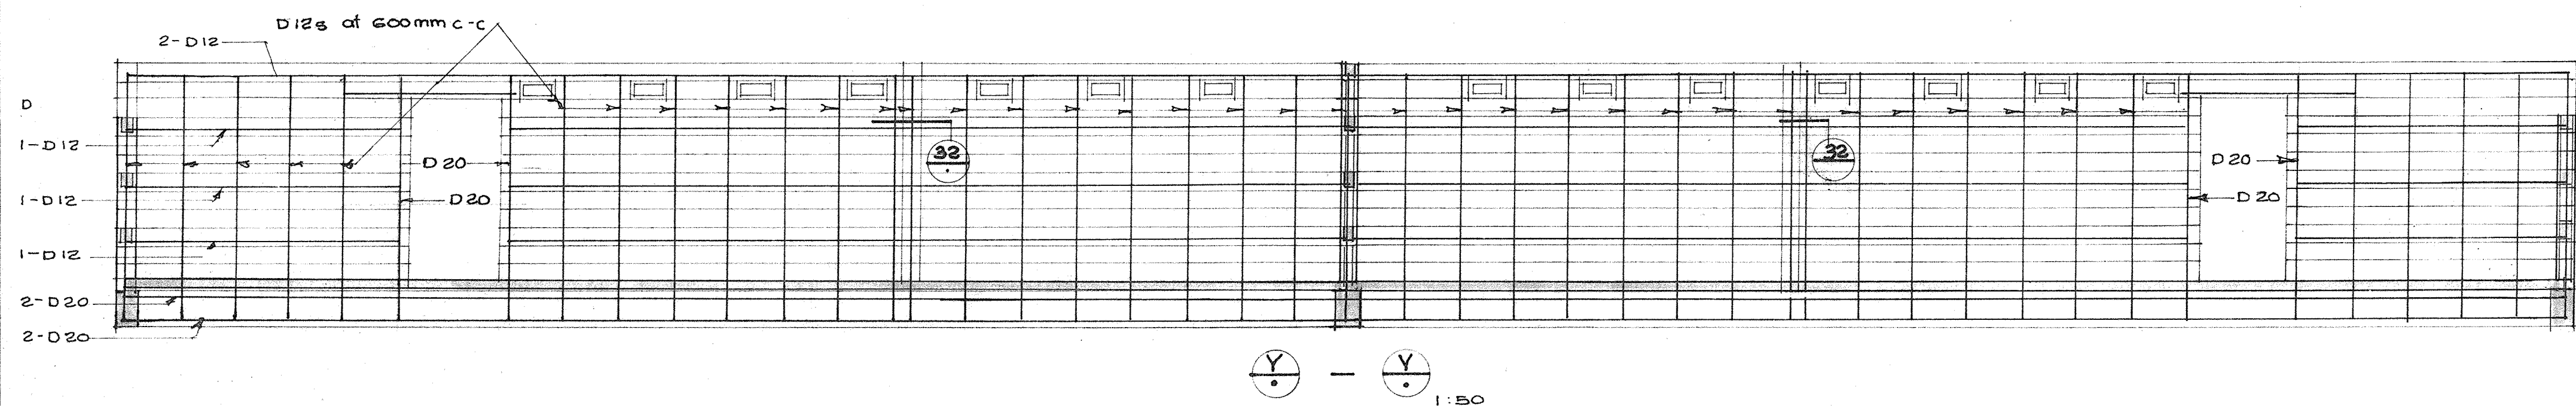
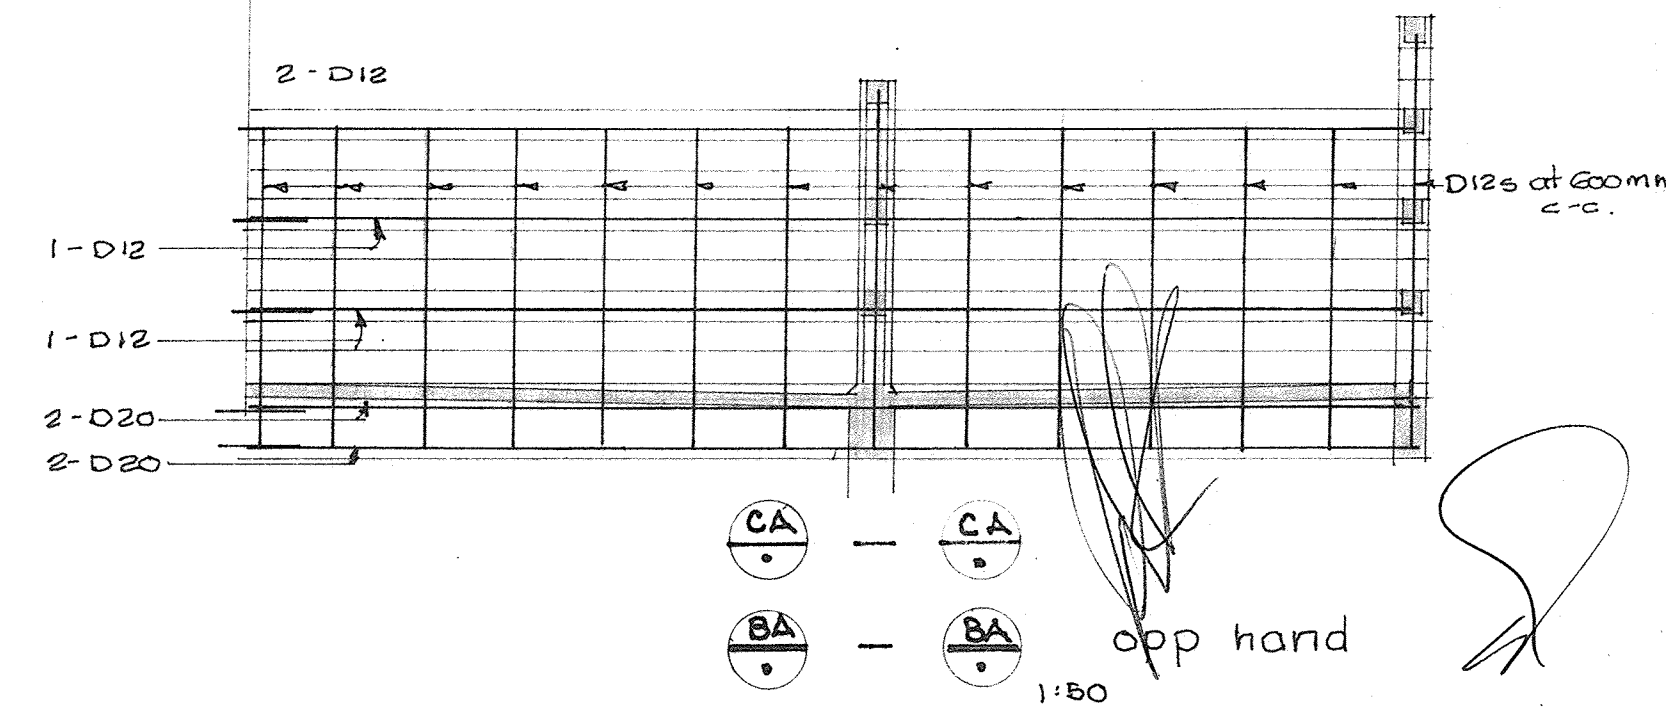
CHANGING SHED WALL PLAN 1:100

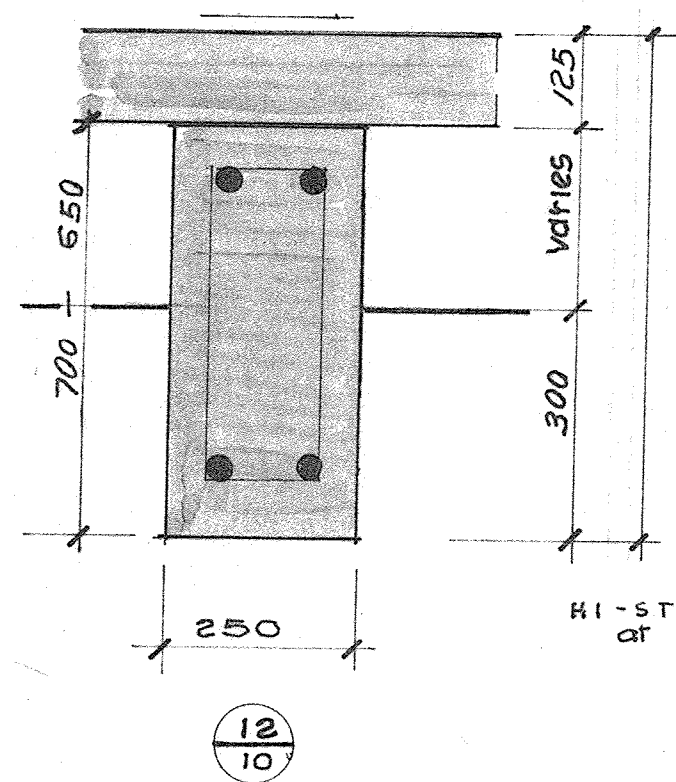
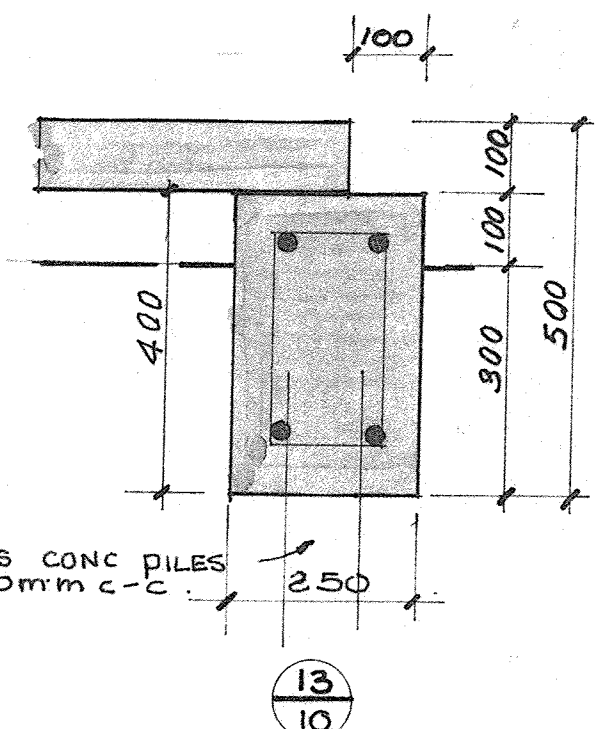
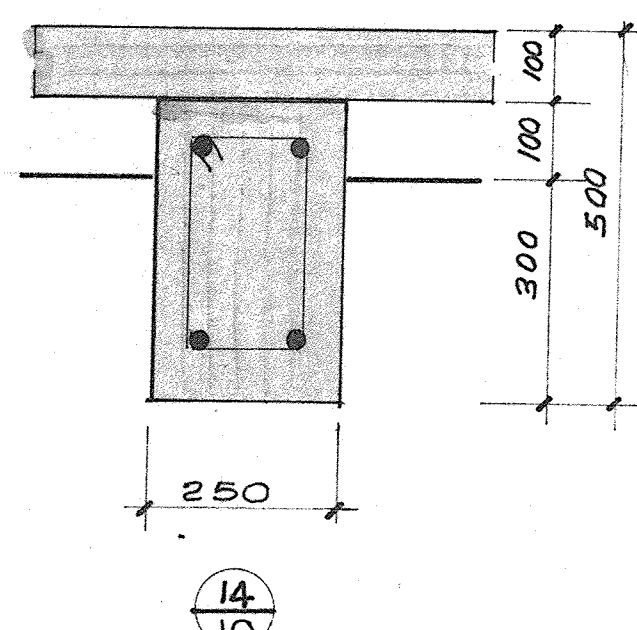
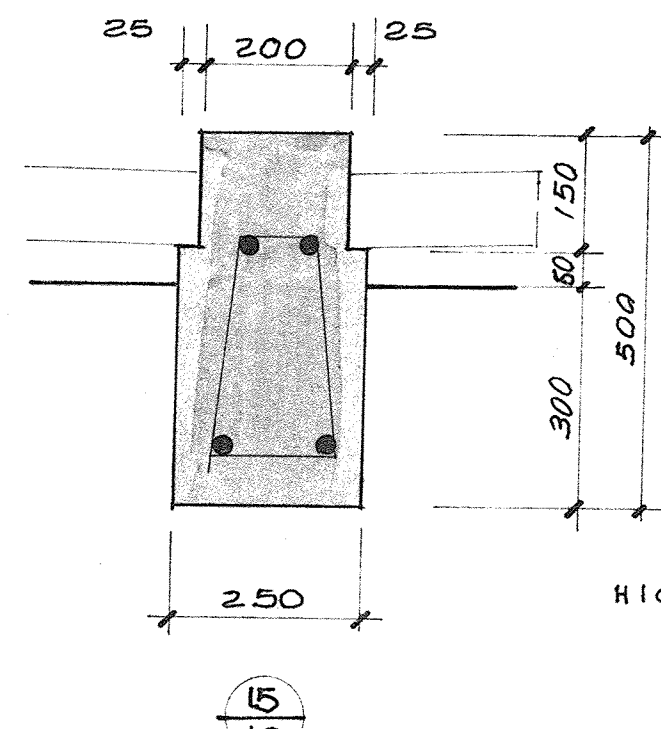
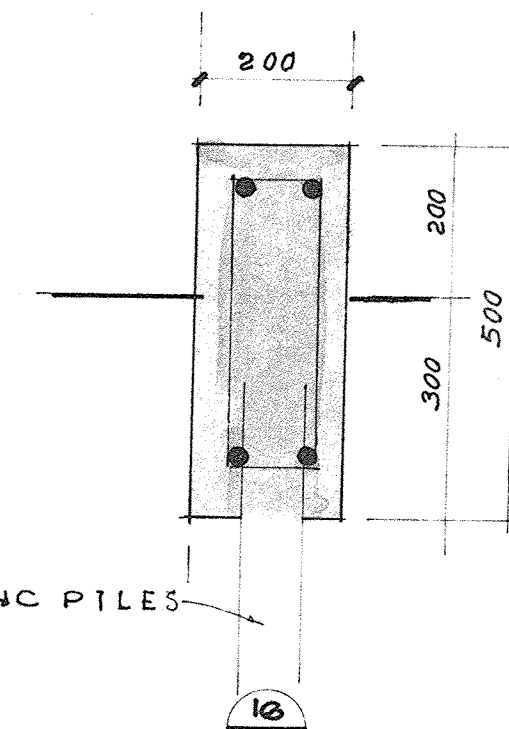
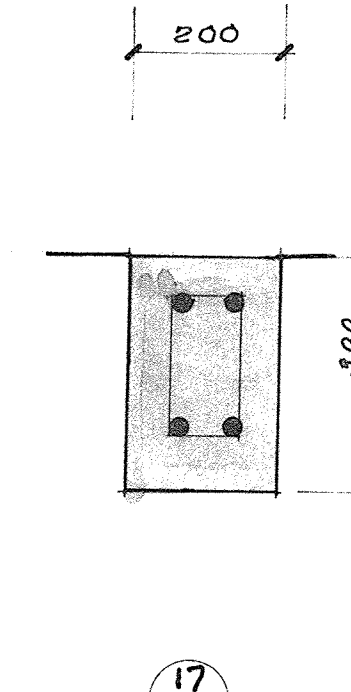
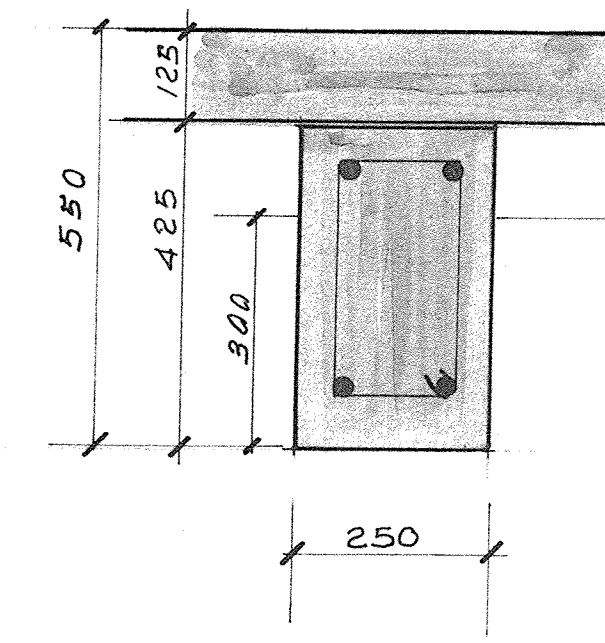
HIGH STRESS CONC PILES at 1200mm c-c
