Sockburn Testing Station
PRO 1530 B001
Detailed Engineering Evaluation
Qualitative Report
Version FINAL

538 Blenheim Road, Sockburn

Christchurch City Council

Date
16 September 2013

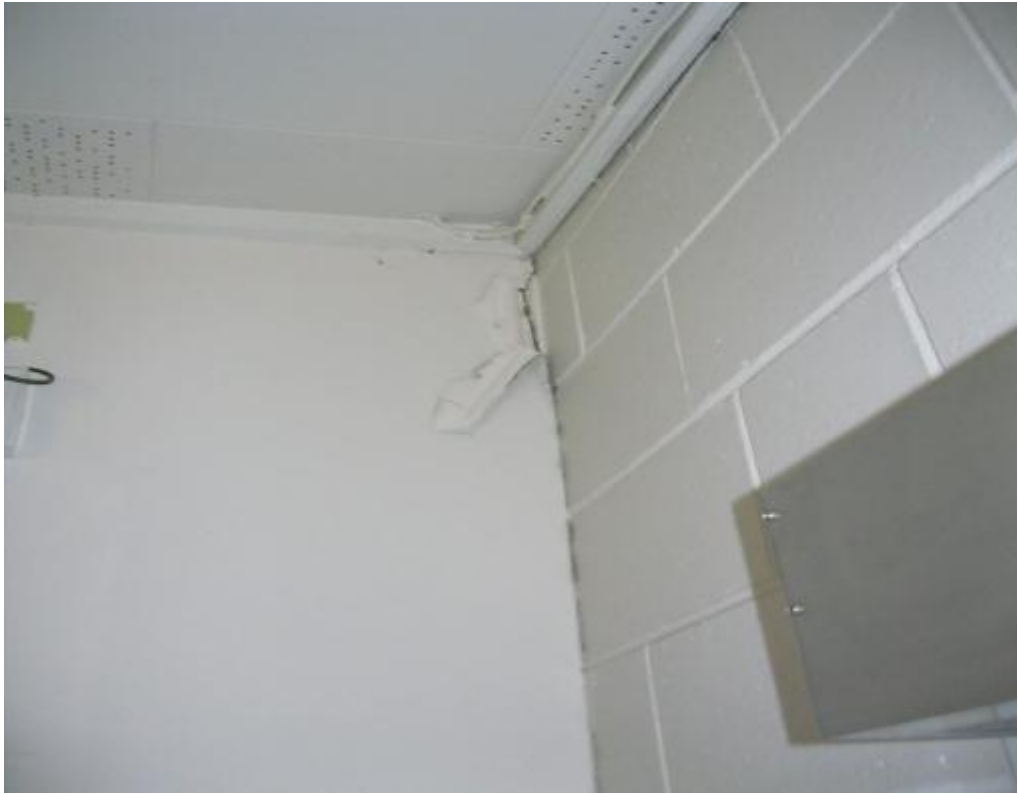
Minor separation was noted between the plasterboard lined timber framed walls and blockwork masonry to sections one and four.

Photograph 3: Separation between masonry blockwork and timber framed walls to Section one

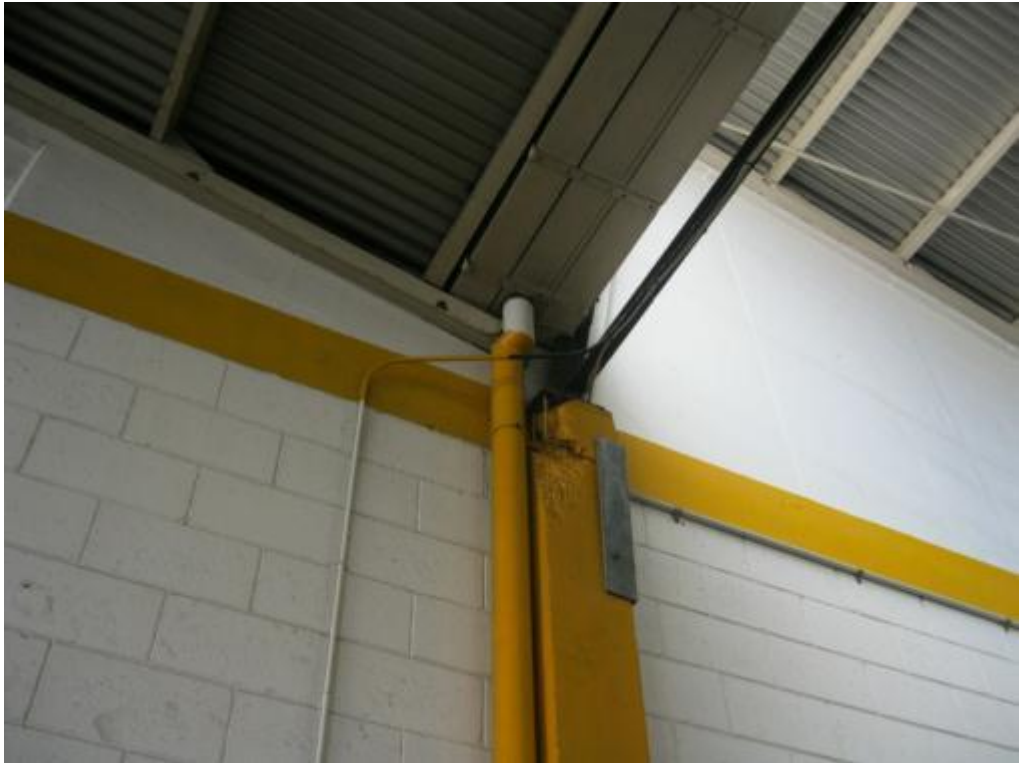
There was significant damage noted to the concrete columns in both sections two and three. Cracking and spalling of concrete has occurred particularly at the base of the columns and at the top where the equal angle roof beams are connected to the columns.

The concrete columns act as cantilevers under the lateral seismic load and were not able to carry the full extent of the seismic loads to the foundations resulting in the damage.

Photograph 7: Cracking and spalling of the concrete has occurred at the connection between the roof steel beams and the top of the concrete column

It is recommended that opening up works are carried out to determine if the reinforcement in the columns has fractured where the cracking to the concrete has occurred.

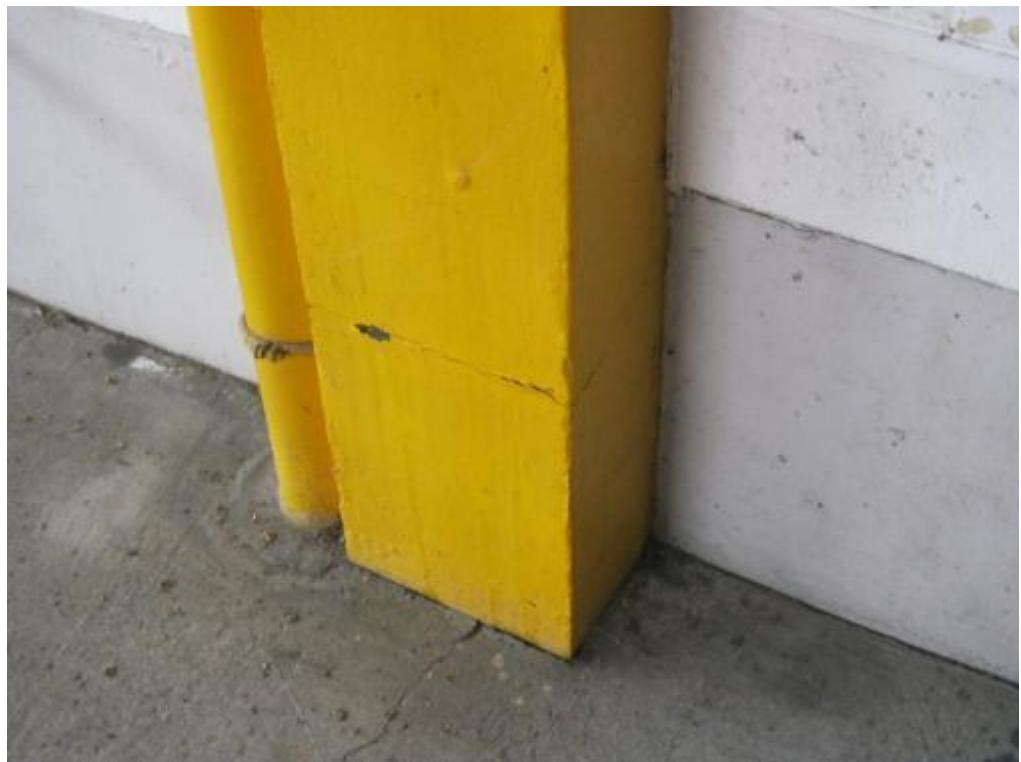
Photograph 8: Cracking at the base of the column indicates bending and movement

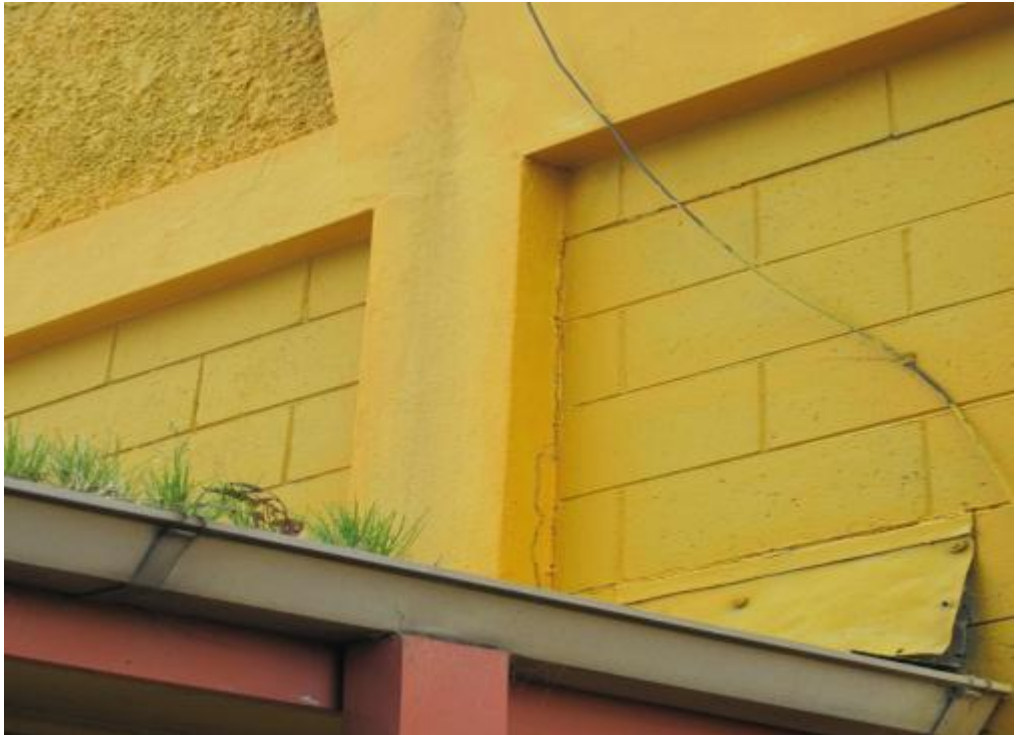
Cracking was noted to the masonry blockwork infill between the concrete frame structures to sections two and three.

Photograph 9: Externally cracking is evident to the concrete column and masonry blockwork

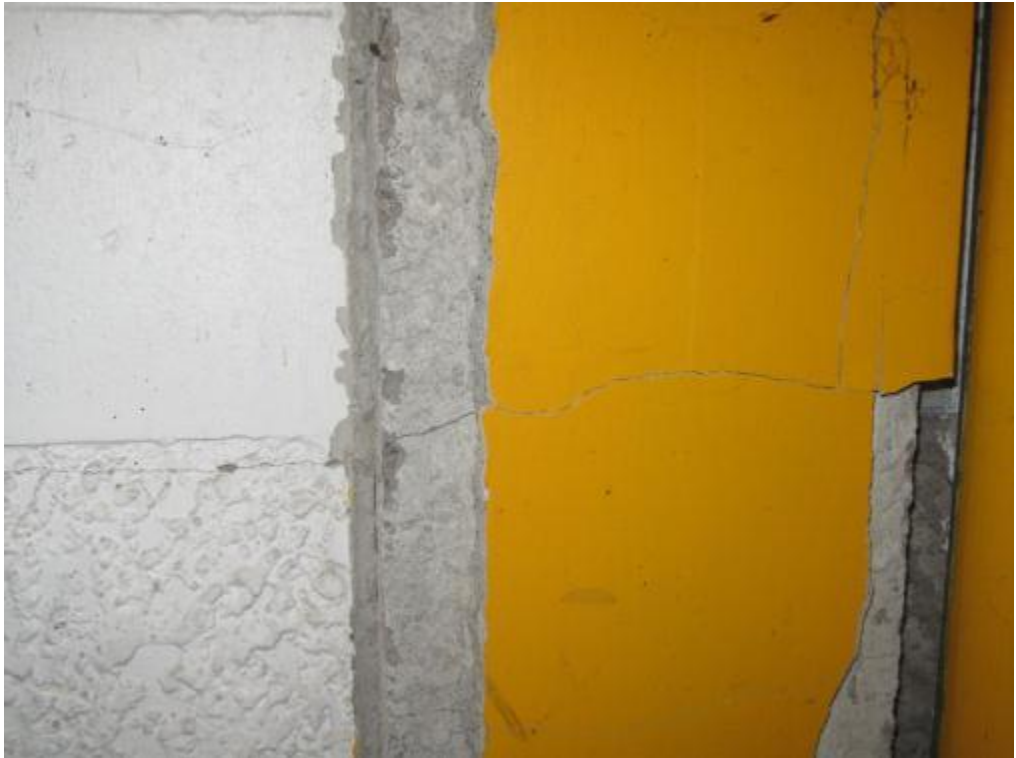
Photograph 11: Cracking and spalling of concrete at column base
